EXPERIMENTAL ABRASION ANALYSIS OF TEXTILE CAPACITIVE SENSORS

Marc Martínez-Estrada^{1(*)}, Heura Ventura², Ignacio Gil¹, Raúl Fernández-García¹

¹ Department of Electronic Engineering, Universitat Politècnica de Catalunya; Terrassa, Spain

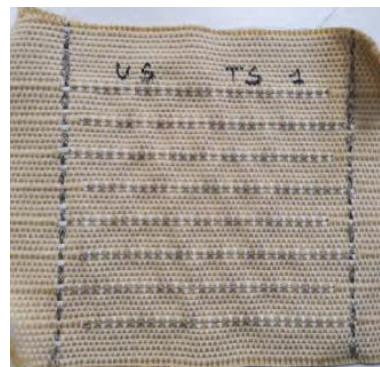
b) Sensor manufactured prototype

Figure 1. Interdigital geometry.

To integrate the sensor on the plain weave structure, two type of conductive yarns were used and analysed during the process; Shieldex 117/17 2-ply and Bekaert 20/2 Tex. Each yarn was produced by different processes. Shieldex yarn is based on a silver coating covering a polyamide filament, whereas Bekaert yarn was produced by mixing polyester and stainless-steel fibres with a 60/40% proportion, respectively.

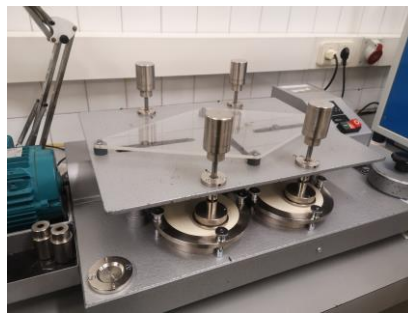
Figure 2. Martindale machine performing a test.

To analyse the impact of abrasion on sensor functionality, Martindale abrasion test was performed with the manufactured sensors (Figure 2). The test consists on the abrasion of the fabric under test against a normalized abrasive fabric. The force applied during the movement is determined by the EN ISO 12947-2:2016 [2], which determines that for upholstery fabric the weight used is (795 ± 7) g. The movement performed by Martindale follows a Lissajous curve pattern. The fabric physical state and the properties of the measured conductive yarn are verified periodically after each step of the Martindale test, Table 1. The test is finished when more than three yarns are broken or conductive yarns lost completely their electrical continuity (i.e. resistance lower than 50Ω).
