Durability of Gerber Saddles in RC Bridges: Analyses and Applications (Musmeci Bridge, Italy)

Giuseppe Santarsiero * , Angelo Masi and Valentina Picciano

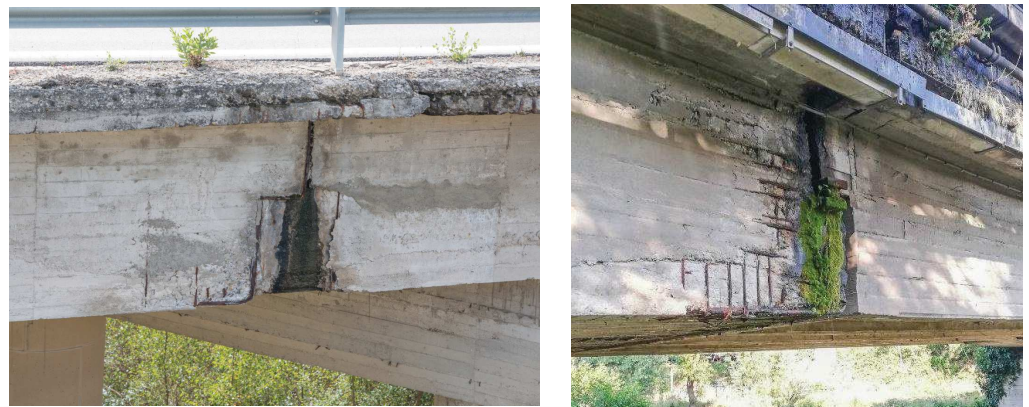
Figure 1. Examples of deteriorated Gerber saddles in RC road bridges.

technical standard. This applies especially for older 2nd and 3rd category bridges, even more if they are placed in industrial areas subjected to expansion and development after the construction of bridges. These bridges were sometimes conceived according to a cantilever scheme needing the presence of Gerber saddles, which were originally thought for railway bridges, where there is no water accumulation on the deck. Road bridges should expel the deck water through side drains, while expansion joints across the Gerber saddles should be waterproof to avoid water seepage. Actually, lack of maintenance to drains and joint degradation systematically allow water seepage through them, inducing deterioration of the underlying structural elements, which is even heavier when the water contains de-icing salts (Figure 1).

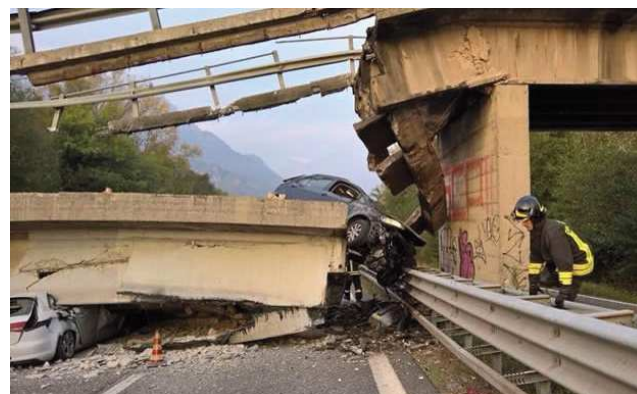
Figure 2. The Annone Brianza overpass collapse.

Exemplary of the joint effect of increased loads (with respect to design ones) and material degradation is the collapse of the Annone Brianza (Lecco, Italy) overpass in October 2016, which caused one fatality and three injuries [21]. The structure was designed as a 2nd category bridge according to the code Circolare 14 Febbraio 1962 n. 384 [22]. The collapse started in one of the Gerber saddles due to passage of an exceptional 1080 kN heavy convoy [21]. The external saddle’s collapse transferred the load to the others, which progressively collapsed too (Figure 2). Therefore, even local damage to a single Gerber saddle can cause severe consequences to the whole bridge structure.

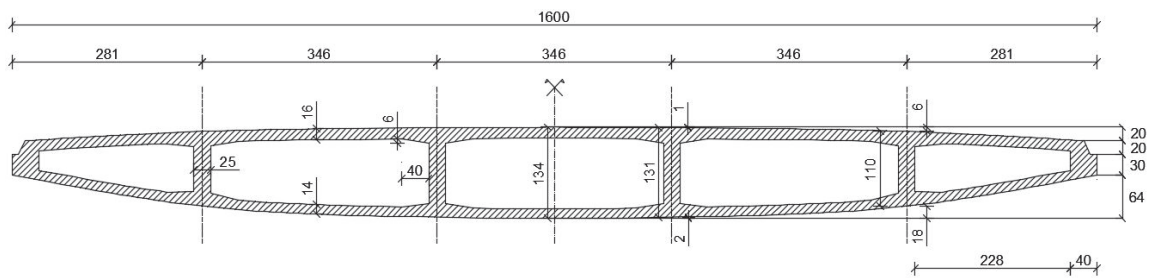
Figure 4. RC box deck cross-section of the Musmeci bridge.

compression [37]. The vault is 0.30 m thick and forms four equal spans 69.20 m long and is provided with thicker ribs at joints with the deck. The RC box deck is 16 m wide and supported by the vault every 17.30 m for total length of 300 m (Figure 4). Moreover, the deck is interrupted by simply supported sections (10.38 m long) connected by Gerber saddles corresponding to the expansion joints (see Figure 5).

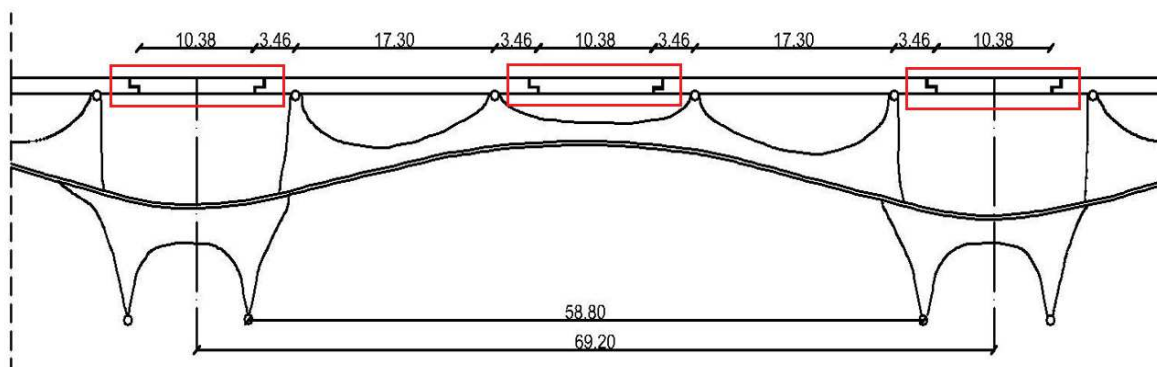
Figure 5. Scheme of a single bridge span and indication of simply supported sections (original sketch by Sergio Musmeci).

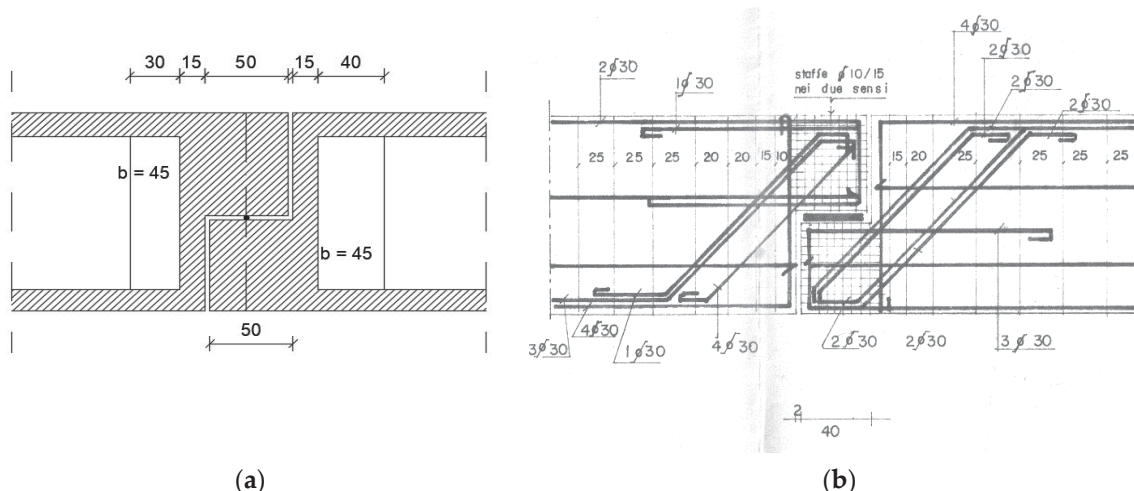
Figure 6. (a) Geometry and (b) structural details of Gerber saddles from the original design drawings by Sergio Musmeci (dimensions in cm).

Structural details of Gerber saddles are shown in Figure 6. Diagonal and horizontal 30 mm diameter reinforcement bars are present along with 10 mm diameter stirrups with variable spacing. Further, the corbels are provided with 10 mm diameter confining hoops spaced 50 mm and placed in the two orthogonal directions with 20 mm cover. Horizontal rebars typically have 50 mm cover, while diagonal ones have 50 mm minimum cover near the corbel junction. More detailed schemes of reinforcement bars are shown in the following.

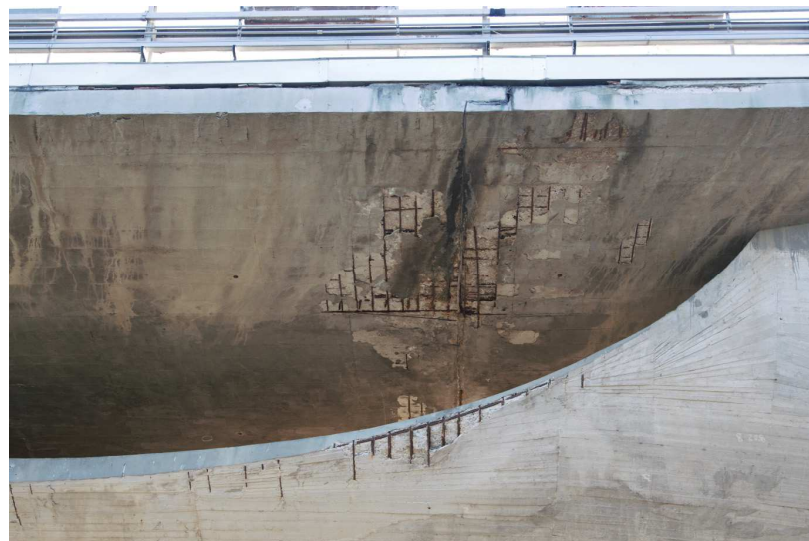
Figure 7. Deterioration of Gerber saddles and underlying vault.

Today, the bridge is affected by a significant deterioration level especially near the Gerber saddles, where expansion joints are placed. The lack of maintenance on the water drainage system causes continuous seepage across the joints and Gerber saddles, causing evident corrosion which induces cracking and spalling, also to the underlying vault sections (Figure 7). The necessary restoring interventions are planned to be carried out in the next few years by the Municipality of Potenza. However, technical difficulties related to the bridge shape and structural scheme are amplified by the fact that the structure has now become a symbol known throughout Italy and abroad, being a modern artwork officially recognized by the Italian Ministry of Cultural Heritage and Activities and Tourism. Due to these reasons, the bridge cannot sustain traditional intervention techniques used for ordinary bridges, but advanced and low-impact techniques are needed for the preservation of its historic value. In summary, the Musmeci Bridge is an artwork supporting high traffic loads, and rehabilitation measures must respect the bridge aesthetic and spirit given by its designer, Sergio Musmeci.

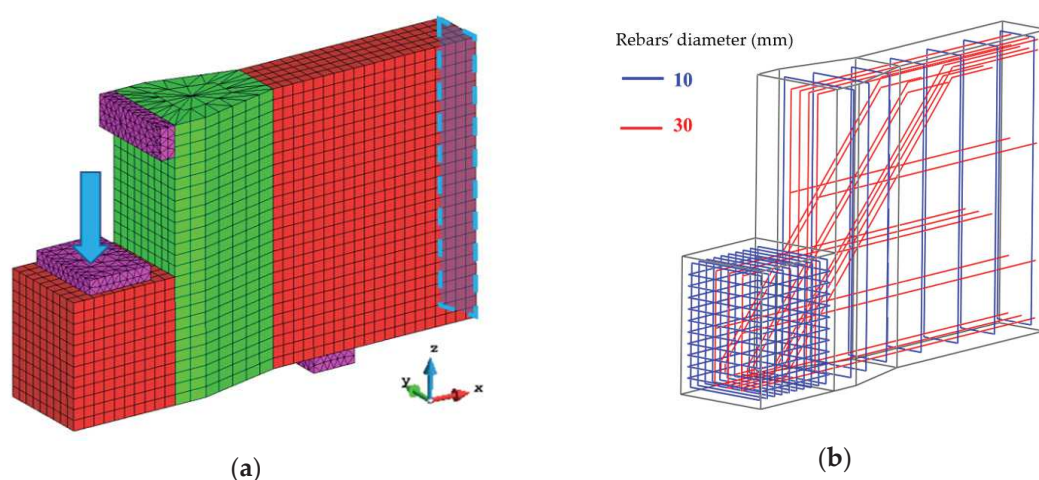
Figure 8. Finite element model: (a) concrete mesh and (b) reinforcing steel mesh.

The finite element model is made of three main volumes. Figure 8 shows two volumes meshed with hexahedral elements (in red) and the connection volume meshed with prismatic elements (in green). Moreover, steel plates (purple coloured volumes in Figure 8a) have been used to reproduce boundary and loading regions. The plate placed on the corbel is devoted to the load application, while the two others are used to constrain the model. The bottom plate restrains z and y displacements, and the upper plate restrains only x -displacement. Finally, the rear vertical surface (blue dashed contour in Figure 8a) is restrained for rotation about the x -axis to simulate the continuity with the remaining part of the bridge girder. In total, the model has about 6500 volume elements representing concrete and 150 truss elements for reinforcement, with more than 25,000 nodes. Analyses for determination of the ultimate load were performed in displacement control (applied to the corbel centre, blue arrow in Figure 8a), monitoring the required force.

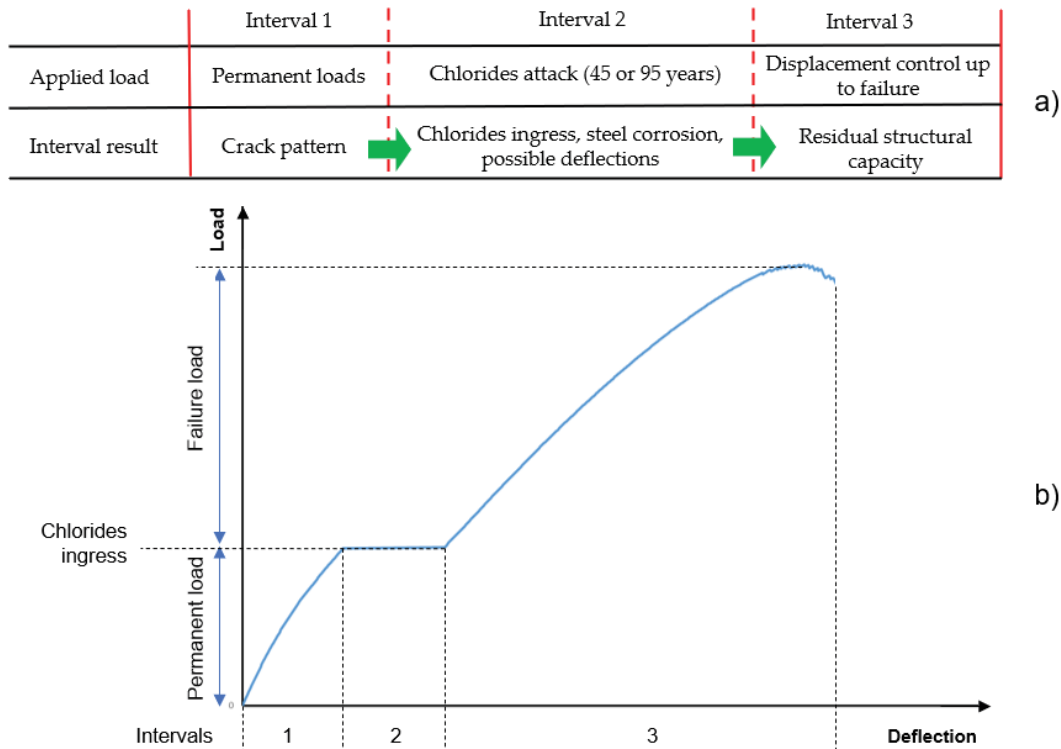
Figure 9. (a) Sequence of intervals in mechano-chemical analyses, (b) typical load-deflection curve in mechano-chemical analyses.

As reported in Figure 9a, the results of interval 1 are used in interval 2 to perform the chloride ingress analysis, accounting for cracks generated by permanent loads. Chloride ingress analyses at interval 2 are able to account for chloride diffusion into the concrete volume, detecting the initiation and progress of reinforcing steel corrosion. Specifically, based on the 1D chloride diffusion model reported in Equations (1)–(5), chloride content in the concrete volume is computed as a function of time, monthly. When the chloride content near the rebars exceeds the critical one, corrosion starts with the consequent reduction in rebars' cross sectional area. After each corrosion step (one month), based on the new structural configuration (the model is updated with the new values of steel rebars' area), a new static equilibrium iteration is computed to determine possible variations of the displacements, stresses and crack pattern, which, in turn, may influence subsequent corrosion steps. The latter reflects on the static equilibrium condition because a reduction in steel area may increase deflection under a constant permanent load. Finally, in interval 3, accounting for the new crack pattern and steel corrosion, the structure is led to collapse, increasing the vertical displacement applied to the corbel. Therefore, interval 3 makes it

possible to evaluate the structural capacity after a given corrosion period. It is worth noting that the deflection amplitude under constant load in interval 2 is often very small compared to those due to permanent and failure loads. Indeed, the representation of Figure 9b is only as an example.

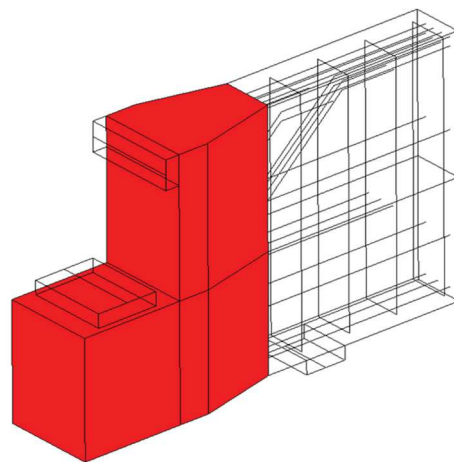
Figure 10. Surfaces exposed to chloride attack.

In order to model the corrosion attack, red surfaces shown in Figure 10 were exposed to chlorides based on parameters summarised in Tables 3 and 4. These surfaces were selected considering the water seepage from the platform containing chlorides due to de-icing salts.

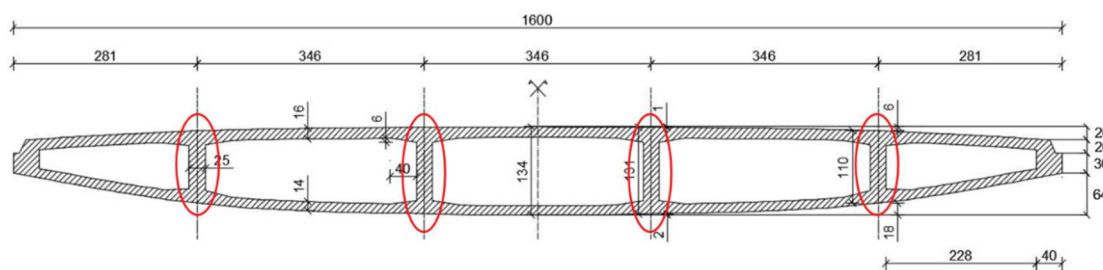
Figure 11. The four effective Gerber saddles (dimensions in cm).

The crack pattern due to self-weight of the simply supported bridge span (interval 1) is considered in the chloride analysis. It is worth remembering that the effective Gerber saddles, according to the original design by Musmeci, are four, namely those highlighted in Figure 11. The most external ones cannot be considered effective due to their reduced depth. A single Gerber saddle’s reaction due to permanent gravity loads (self-weight of structural and non-structural deck components related to the single simply supported span: deck box section, road pavement, guard rails) is equal to $R_p = 270$ kN.

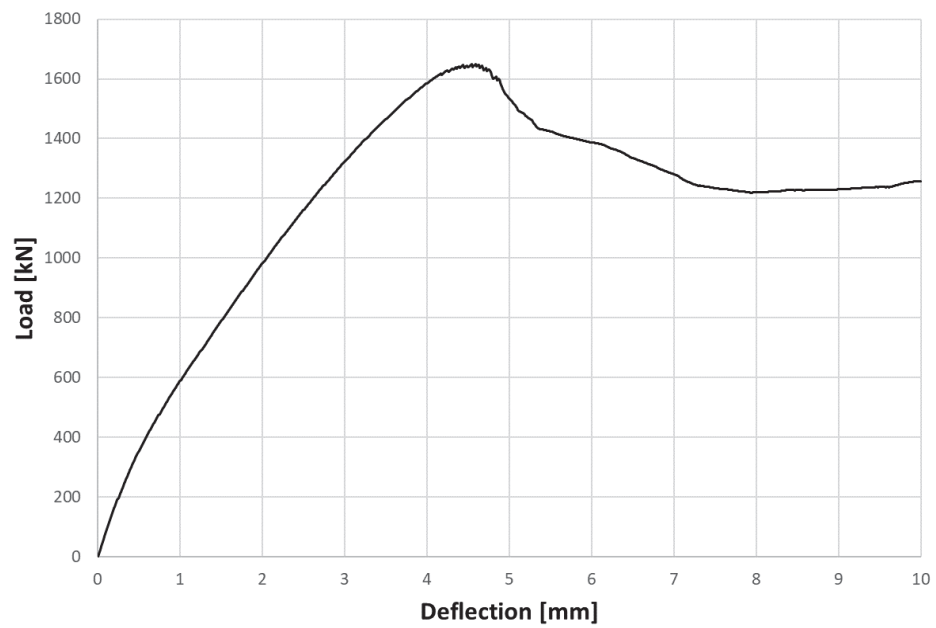
Figure 12. Load-deflection curve of the saddle.

The saddle’s qualitative response is shown in Figure 12 with reference to analysis “ t_0 ”, in the absence of permanent loads and corrosion. As expected, the behaviour of such a type of element does not show a significant ductility, and collapse modalities are similar to those observed in other experimental research [21]. The peak load is equal to 1648 kN achieved at a deflection value of 4.6 mm (Figure 12). Then, a load drop leads the saddle capacity to about 1200 kN, at a deflection of about 8 mm, with a loss of 25%, meaning that the structural element is practically collapsed.

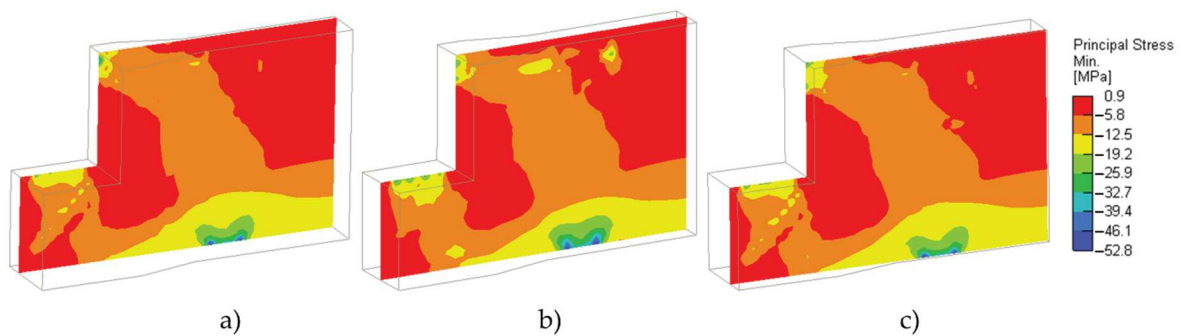
Figure 13. Principal stress distribution in concrete at peak load (analysis “t0”) for side (a,c) and centre (b) cutting planes.

Analysis of principal stresses at peak load shows the saddle’s pronounced three-dimensional behaviour due to the variable width of the connection between corbel and girder. The latter is proved by the fact that an evident compression strut formed inside the corbel is subjected to higher stresses upon a section plane cutting the corbel at the centre (Figure 13b), while stress values decrease in section planes near to the sides, as shown in Figure 13a,c. This 3D effect cannot be considered when assessing this type of element with plane-stress approaches such as those based on strut-and-tie methods [44], highlighting the importance of 3D simulations.

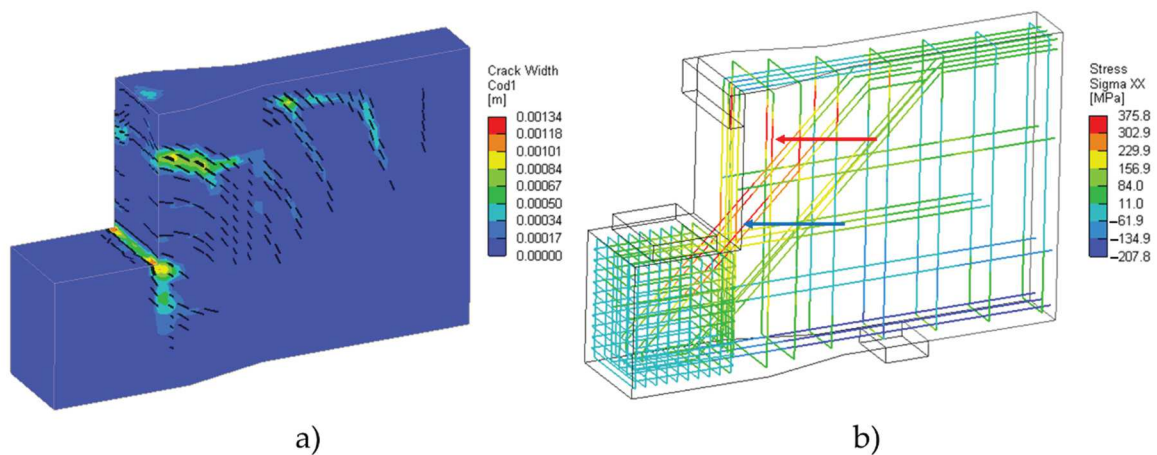
Figure 14. (a) Crack pattern and (b) reinforcement stress distribution at peak load (analysis “t0”).

The damage pattern at peak load is represented by inclined cracks in the saddle’s upper part and cracks at the interface between the corbel and the saddle’s remaining part (Figure 14a). In that region, the maximum estimated crack width is about 1.3 mm, while in the upper part it is 0.8 mm.

The saddle behaviour is mainly influenced by concrete since, as shown in Figure 14b, the maximum stress in reinforcement is almost always less than the yielding value, $f_y = 375$ MPa. In fact, the stress exceeds yielding only in the vertical stirrups located in the connection zone (red arrow, 375.8 MPa). Inclined rebars have stress values around 363 MPa (blue arrow).

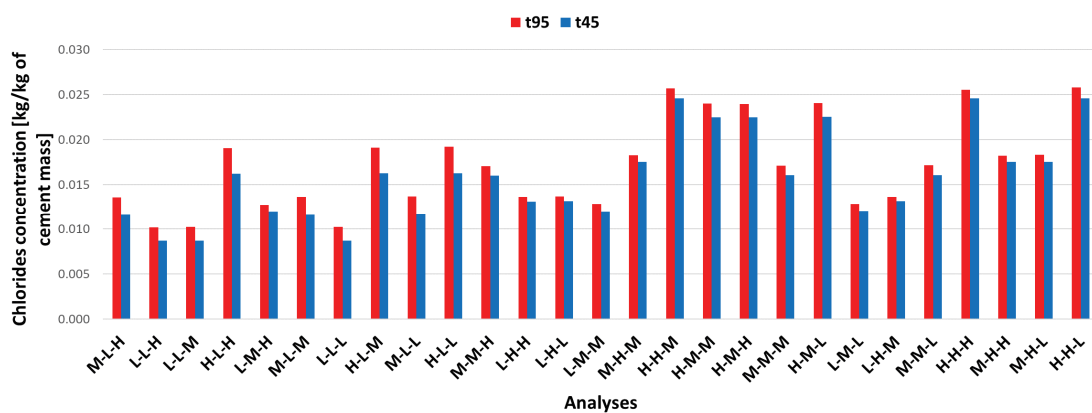
Figure 15. Chloride concentration at reinforcement depth as a function of chloride parameter combination and corrosion period (t45 = 45 years, t95 = 95 years).

Different combinations of the three parameters also affect the amount of chloride presence inside concrete at a reference depth of 2 cm from the external surface. Figure 15 shows the amount of the detected chlorides according to the different analyses at 45 and at 95 years. As can be seen, analyses at 95 years, being subjected to longer chloride exposure, exhibit higher concentrations than analyses at 45 years, thus increasing the amount of reinforcement corrosion.

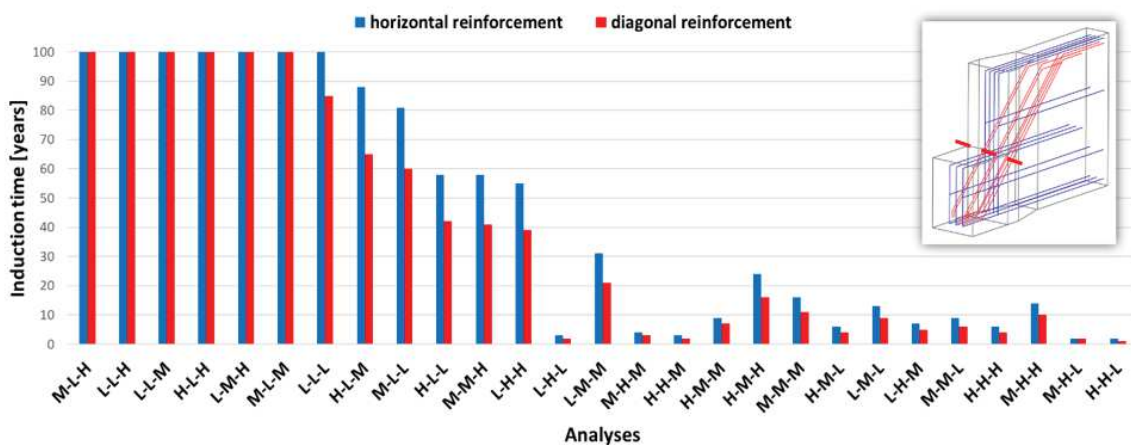
Figure 16. Induction time as a function of the chloride parameter combination.

Further monitored data are the number of years necessary to exceed critical chloride concentration, C_{crit} , to start corrosion, namely the induction time, referred to diagonal and horizontal reinforcement. Figure 16 shows that for some combinations of durability parameters, even after 95 years of corrosion, no reinforcement corrosion is triggered. For these analyses, an initiation period of 100 years (i.e., >95 years) was indicated. On the contrary, other analyses exhibit a very low induction time due to high chloride attack and low values of the critical threshold.

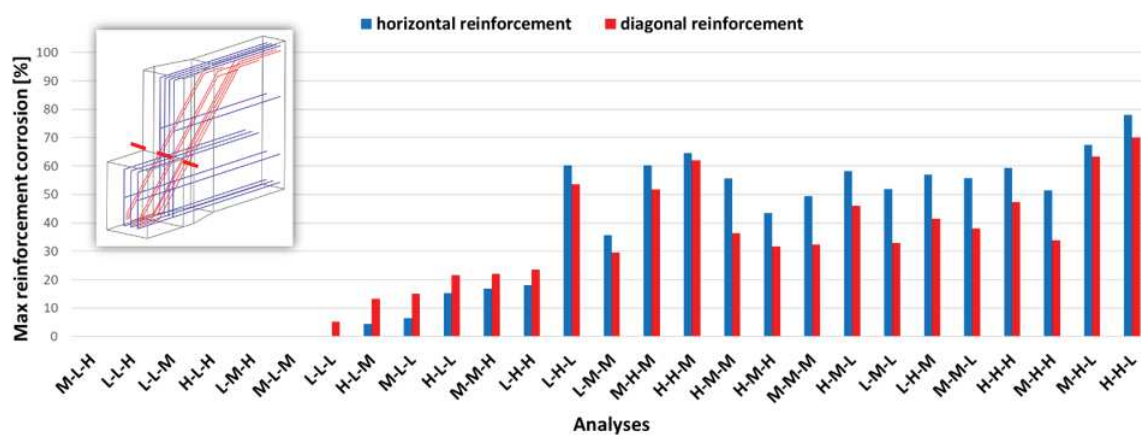
Figure 17. Reinforcement corrosion as a function of chloride parameter combination for case t95.

Figure 17 shows the maximum values of diagonal and horizontal reinforcement corrosion for t95 (t45 are negligible), confirming that the higher ones are obtained from the same analyses causing high values of chloride concentration and low values of induction time. Combinations with induction time larger than the corrosion period yield an absence of reinforcement corrosion. Further, horizontal reinforcement is subjected to higher corrosion, although it has a longer induction time. In fact, most of the horizontal rebars are parallel to the concrete surface from which chlorides enter. Diagonal rebars have a minimum distance from the concrete surface smaller than horizontal ones (corner between corbel horizontal surface and the vertical one, i.e., the red dashed line in schemes of Figures 16 and 17) and for this reason, their induction time is smaller. The remaining part of them is rather far from the concrete surface, and therefore, corrosion propagation is slower.

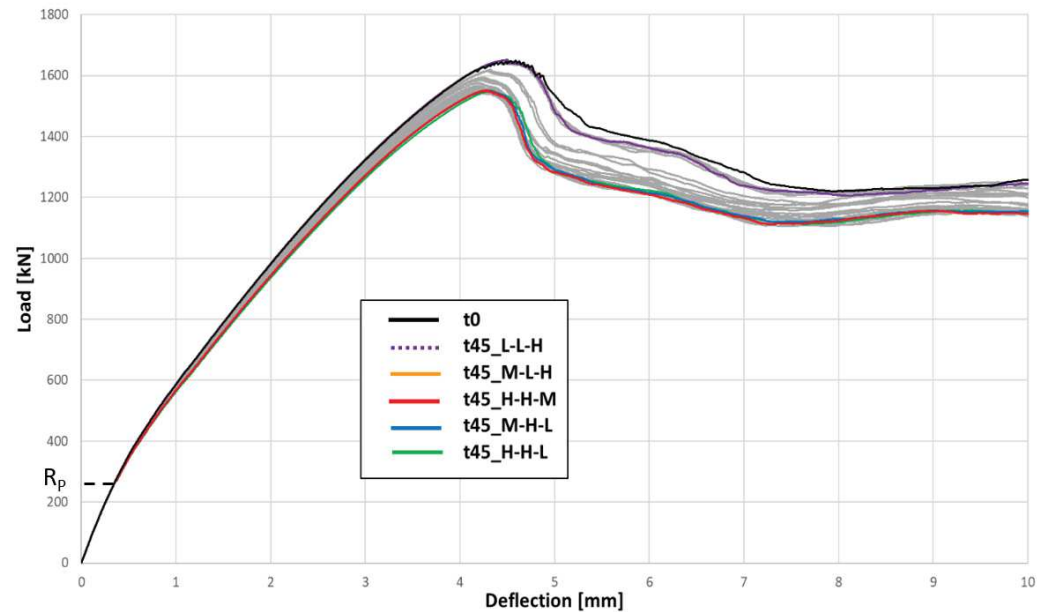
Figure 18. Envelope of load-deflection curves of chloride-induced corrosion analyses at 45 years.

Figures 18 and 19 show the envelope of load-displacement curves of t45 and t95 analyses, respectively, while Figure 20 shows peak load values for the different analyses. In both cases, the load-deflection curve for case t0 is reported to evaluate the loss of strength and behaviour differences due to corrosion. In these graphs, the coloured curves are related to the most (t45_H-H-M, M-H-L, and H-H-L) and the least (L-L-H and M-L-H) severe chloride parameter combinations. It is worth noting that the corrosion effects of these latter do not provide enough corrosion to cause a reduction in the load-bearing capacity of the saddle, even for a corrosion period of 95 years. Other intermediate load-deflection curves are shown in grey.

Especially for t95 analyses, a significant stiffness reduction is observed in load-deflection curves. In fact, for load values higher than the permanent one ($R_p = 270$ kN) corresponding to interval 3, the curves are less steep and, for the most severe chloride parameter combinations, they achieve the peak load for a deflection of about 6 mm instead of 4.5 mm. Moreover, in these cases, the post-peak behaviour is different, showing a faster strength degradation.

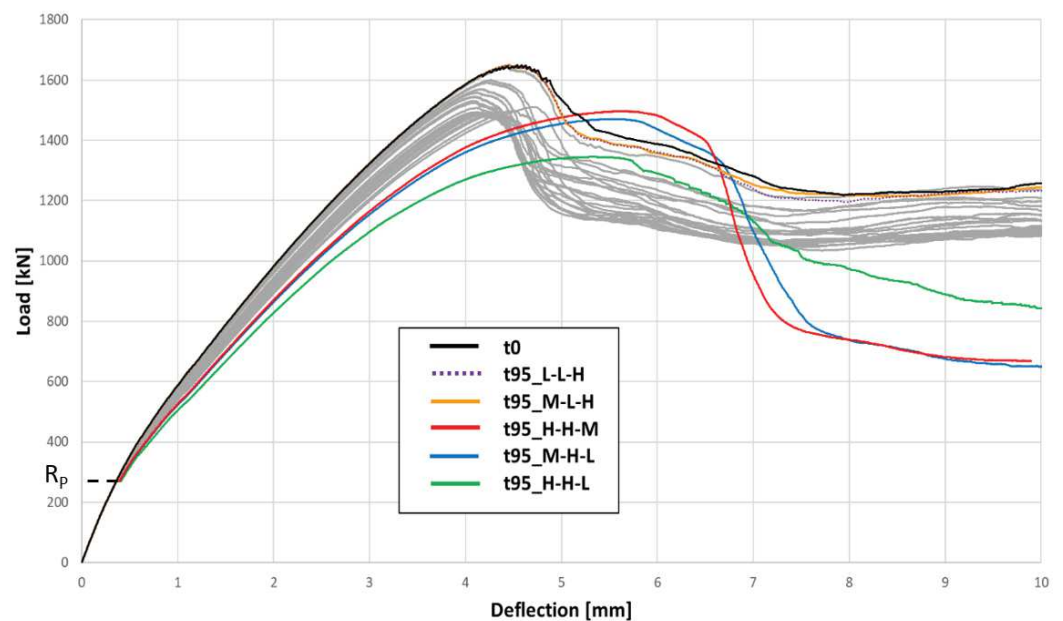
Figure 19. Envelope of load-deflection curves of chloride-induced corrosion analyses at 95 years.

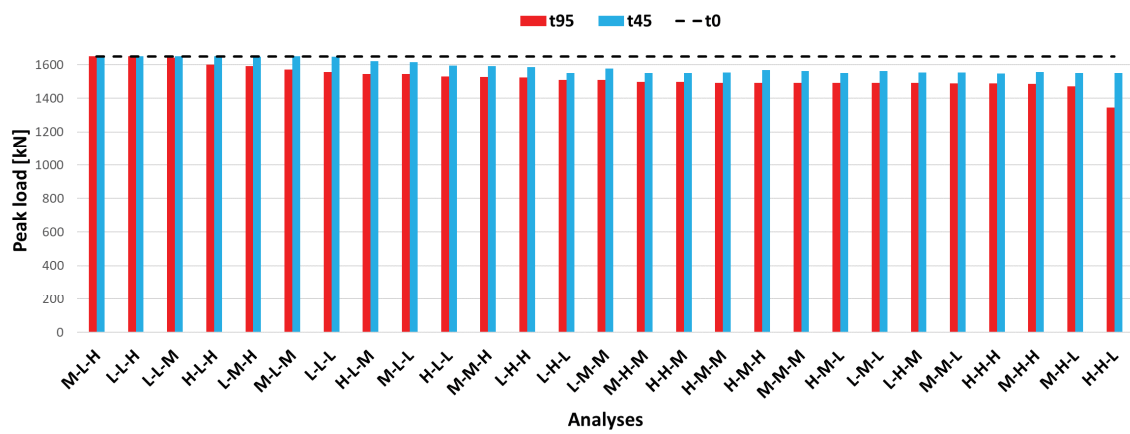
Figure 20. Load-carrying capacity of the saddle as a function of chloride parameter combination.

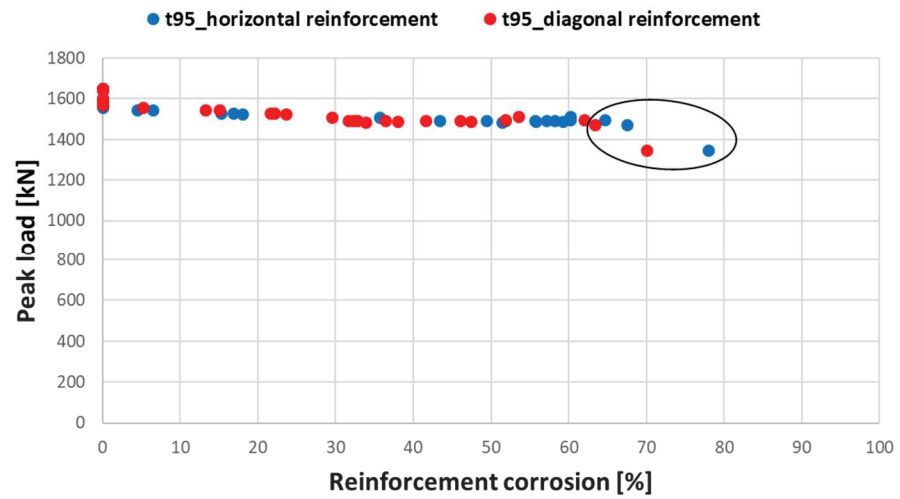
Figure 21. Correlation between peak load and reinforcement corrosion (t95).

for both t45 and t95 cases. Figure 21 shows this correlation for horizontal and diagonal reinforcement at t95. When corrosion is under 60%, it has a low influence on the peak load value. Once this threshold is overcome, strength significantly reduces. For case t45 (see Figure 22), corrosion is not enough to trigger the same effect as for t95. Figure 23 shows that the influence of corrosion of vertical stirrups (reported only for the t95 case) is negligible since for 100% corrosion there is also a large variability of the peak load, which depends on the horizontal and diagonal steel rebars. This means that the saddle’s structural behaviour is mainly governed by phenomena specifically referred to concrete crushing effects in specific locations of the saddle.

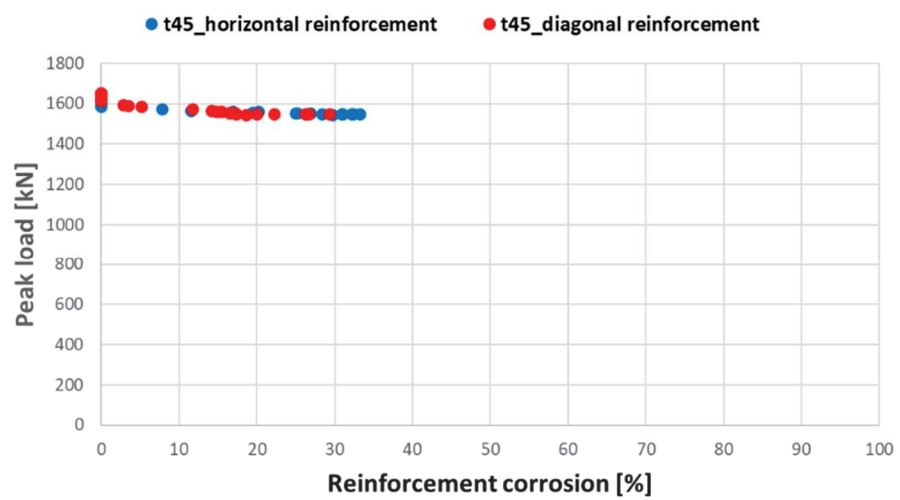
Figure 22. Correlation between peak load and reinforcement corrosion (t45).

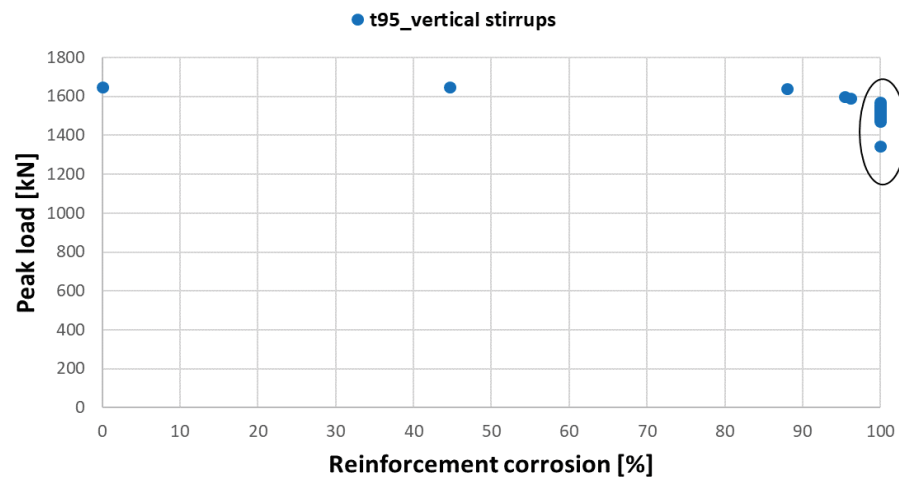
Figure 23. Correlation between peak load and vertical stirrups corrosion (t95).

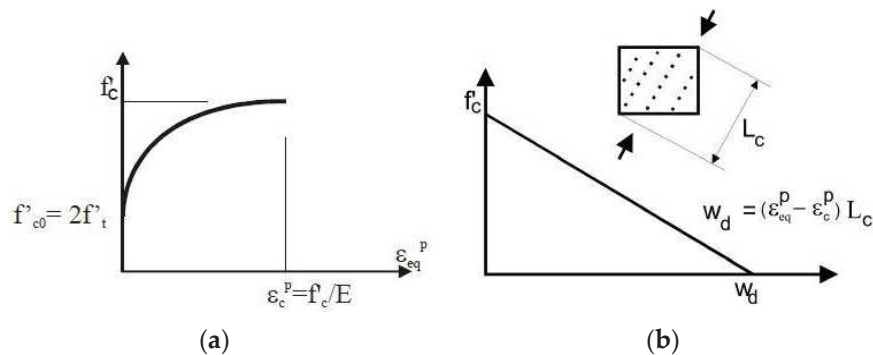
Figure 24. (a) Compressive hardening and (b) softening concrete constitutive law [23].

In order to show the above-mentioned concrete crushing effects, it is necessary to select a proper monitoring parameter, capable of describing the concrete strength degradation under compression. The equivalent plastic strain E_{ps} , computed as the minimum value (compression is assumed to be negative), is selected among the different concrete strain components. The softening of concrete in compression can be identified by the condition $E_{ps} > \epsilon_{cp}$, where ϵ_{cp} is the plastic strain at peak stress (Figure 24a). When plastic strain exceeds ϵ_{cp} , the softening branch of the concrete constitutive law starts according to a linear behaviour governed by displacements, ending at the critical compressive displacement w_d (Figure 24b).

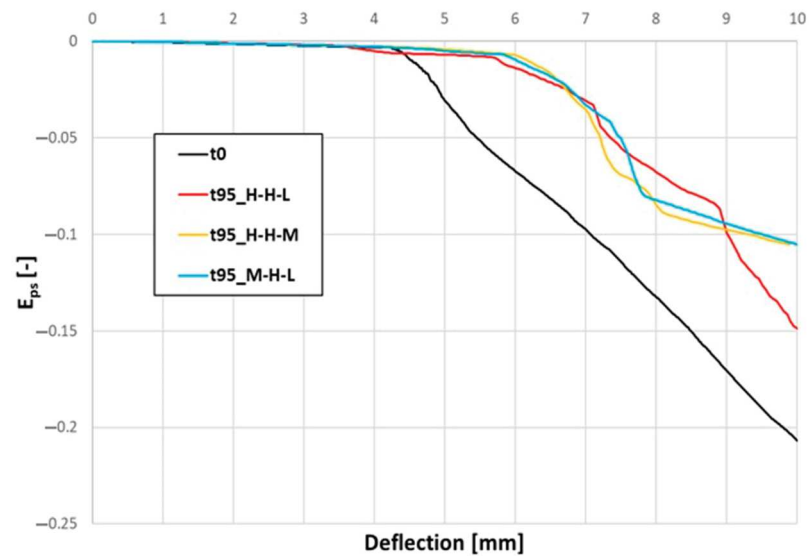
Figure 25. Minimum equivalent plastic strain-deflection curves.

Keeping this in mind, the graphs of Figure 25 show variations in the minimum equivalent plastic strain of concrete, E_{ps} , as functions of the applied deflection (and load) for case t0 (absence of corrosion) and for the most severe chloride parameter combinations (t95_H-H-L). Figure 26a,b shows the region of the saddle where this value is detected, i.e., the most damaged concrete zone under compression.

As reported in Figure 25, in the absence of corrosion (t0), E_{ps} rapidly increases when deflection reaches a value of 4 mm, meaning that concrete is increasing its plastic deformation and then crushing phenomena occur. On the contrary, in the presence of huge corrosion (t95_H-H-L, H-H-M and M-H-L, which provide diagonal and horizontal corrosion above 60%), absolute values of E_{ps} begin to increase at higher displacement values (i.e., about 6 mm). Further, the location where the maximum crushing effects are reached significantly differs from case t0 (Figure 26a) to case t95_H-H-L (Figure 26b). In fact, corrosion modifies the internal equilibrium of the saddle, moving the crushing zone from the junction between the girder and corbel (frame in Figure 26a) to the corbel strut (frame in Figure 26b).

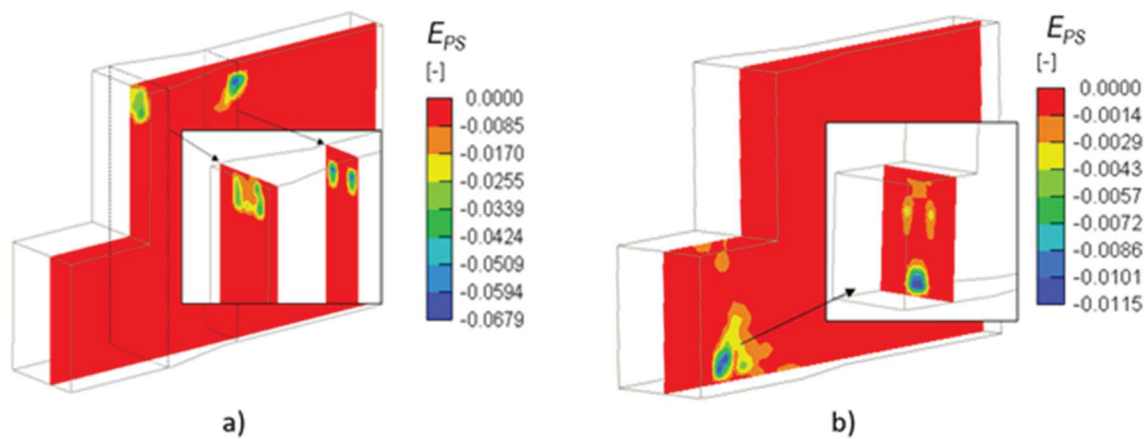
Figure 26. Colormap of E_{ps} for cases t0 (a) and t95_H-H-L (b).
