Re-Tightening the Large Anchor Bolts of Support Structures for Signs and Luminaries: Phase II

Bridge Engineering Center

Research Report

Final Report 2021-23

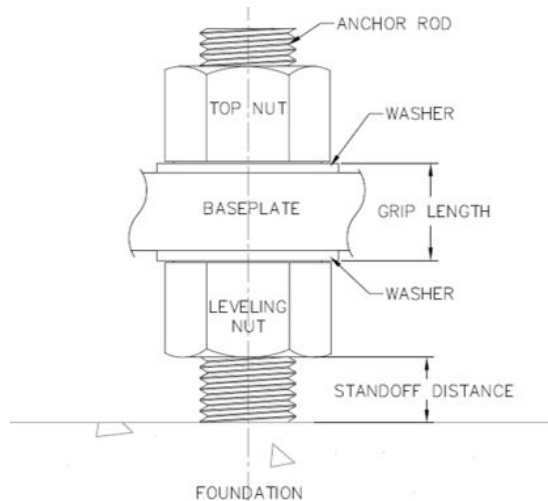
To transfer forces on its SLTS structures to foundation bases, MnDOT employs double nut connections on anchor rods cast into a concrete foundation (Figure 1.1).

Figure 1.1. Typical double nut anchor rod connection

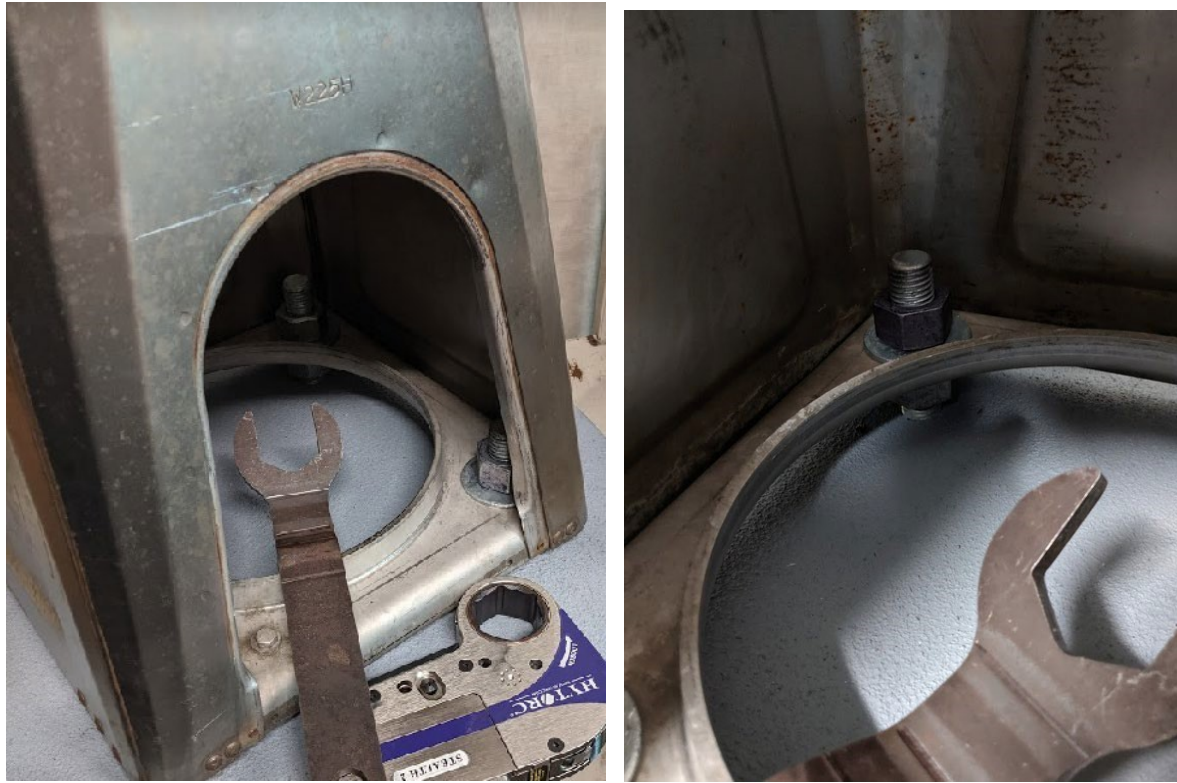
Much like the overhead signs, leveling nuts are also difficult to access on lighting poles. Figure 2.1 shows a sample stainless steel light pole base brought in to demonstrate the clearance issues.

Figure 2.1. Exterior of light pole base (left) and Interior of base (right)

Figure 2.1 makes it clear that the exterior overhang makes the observation of leveling washers under the structure difficult. Figure 2.1 also shows the 12 in. long offset flat specialty wrench made by the pole manufacturer that is used to snug tighten the leveling nuts of stainless steel light poles because of the baseplate overhang that covers the leveling nuts.

The specialty wrench is a stamped wrench, cold-punched from sheet metal. Because the wrenches are not forged or heat treated, the open ends will spread easily under forces greater than the snug-tight condition. The hydraulic wrench is shown for reference in Figure 2.1 (left). In the inspectors' experience, the specialty wrench tends to bend under repeated uses when used in conjunction with a pipe extension and is not designed to use for the final turn of nut. The pole manufacturer's instructions state to use the specialty wrench for snug-tight condition only. The consensus among the Metro District construction lighting inspectors was that the base design, in Figure 2.1, for standard stainless steel light poles is less than ideal for anchor rod tightening.

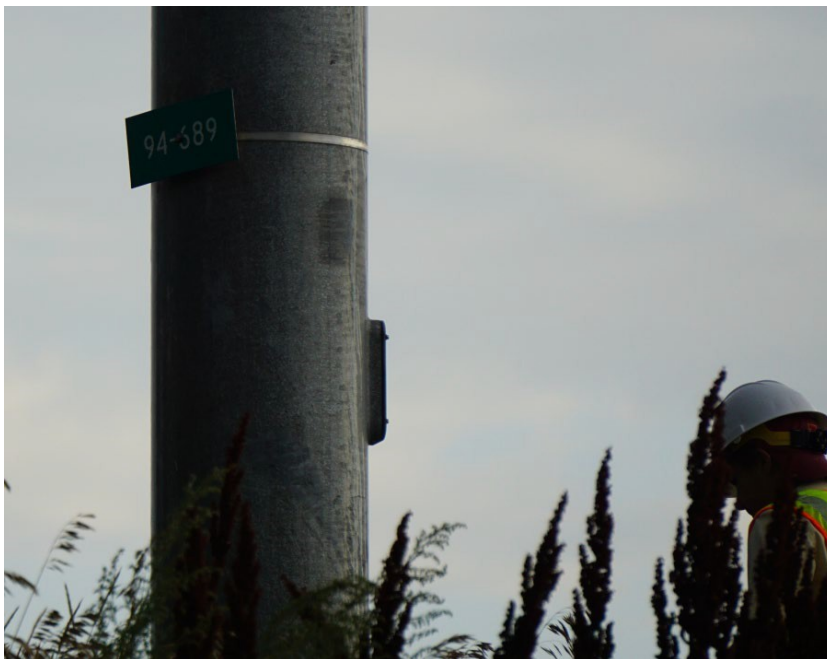
Nine months after installation, during July 2019, both of the overhead sign structures in the installation videos were checked to ensure that no nuts had come loose with the new procedures. The full-span truss sign OH I94-689 (Figure 2.2) was found to have no loose nuts after checking both the top and leveling nuts. It was, however, missing the MnDOT-specified rodent guard along the base.

Figure 2.2. Inspection of full truss OH I94-689 sign

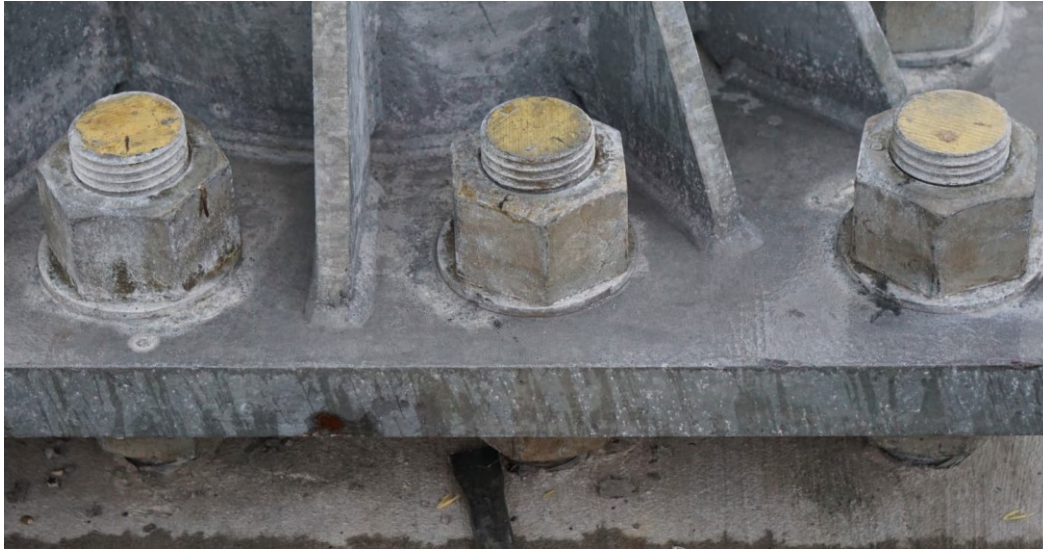
On the cantilever sign, OH 280-023, all of the top nuts were tight, but, when the leveling nuts were inspected, it was found that nut 8 was slightly angled, with the rod itself out of plumb (Figure 2.3), likely causing the issue.

Figure 2.3. Rod 8 out of plumb

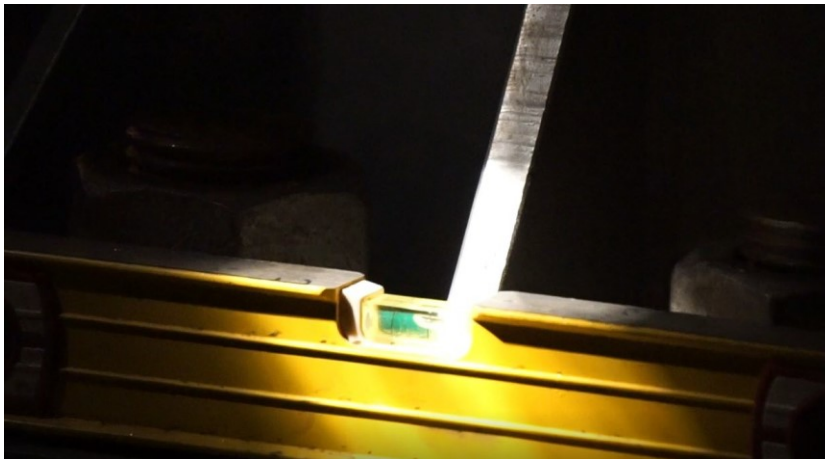
When further investigated, it was discovered that the leveling of this particular installation took about 30 minutes, and the final installation was slightly out of level (Figure 2.4).

Figure 2.4. Final installation of OH 280-023 out of level

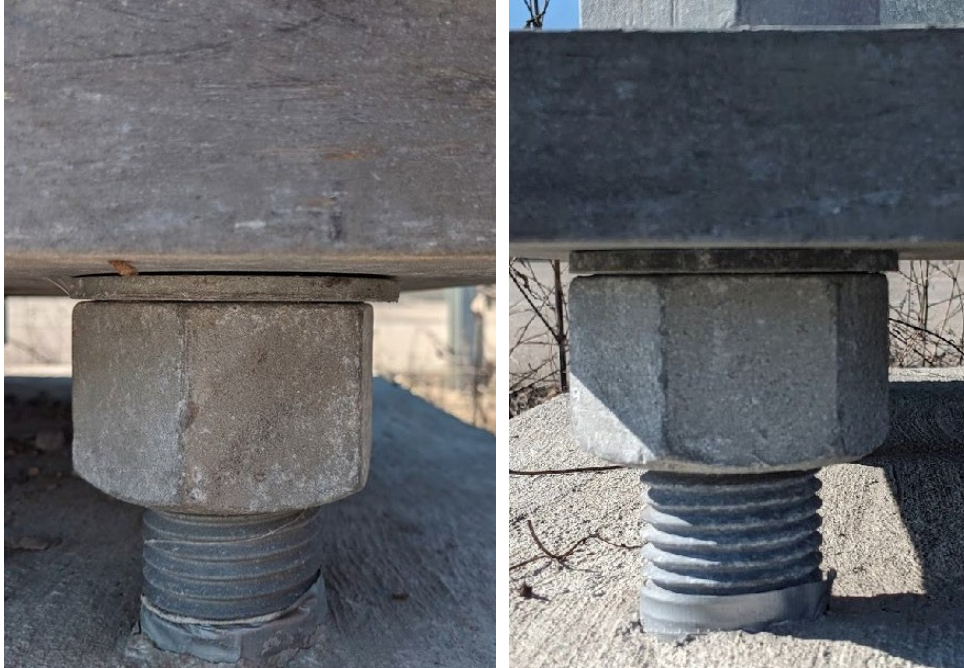
washer of rod 5 has a space between it and the baseplate when compared to Figure 2.5 right, which is rod 8 on the same structure.

Figure 2.5. Rod 5 (left) and Rod 8 (right) on OH I35-31

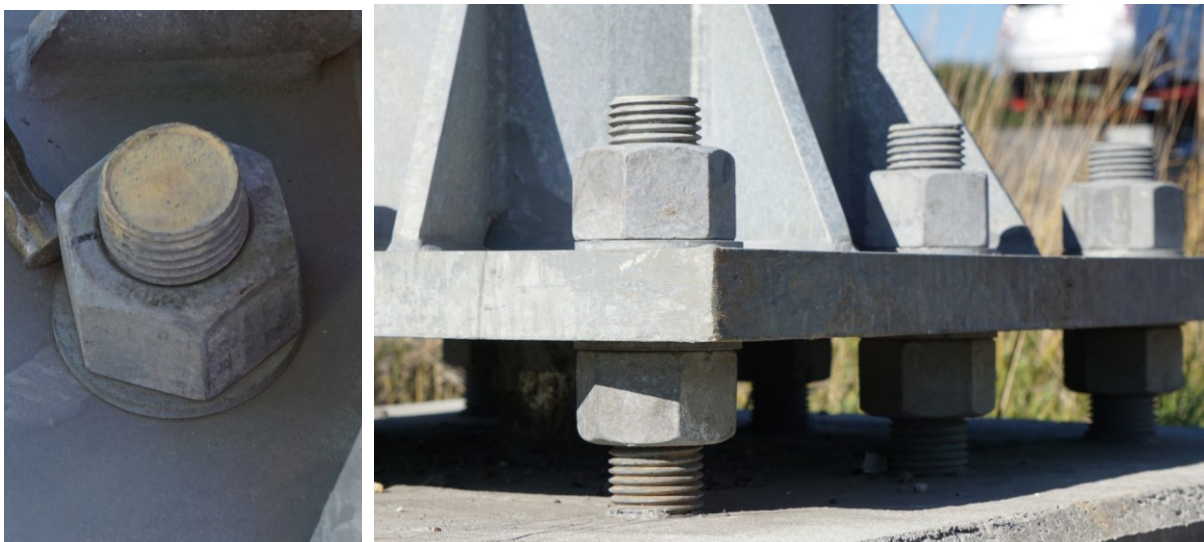
Although one anchor rod was tilted, the remainder of the installations were in good condition. As an example of an ideal structure, OH I94-688 was installed exactly to specification, even with the turn-of-nut marks still visible on the nuts (Figures 2.6 left and right).

Figure 2.6. Turn-of-nut marks on nut (left) and baseplate of OH I94-688 (right)

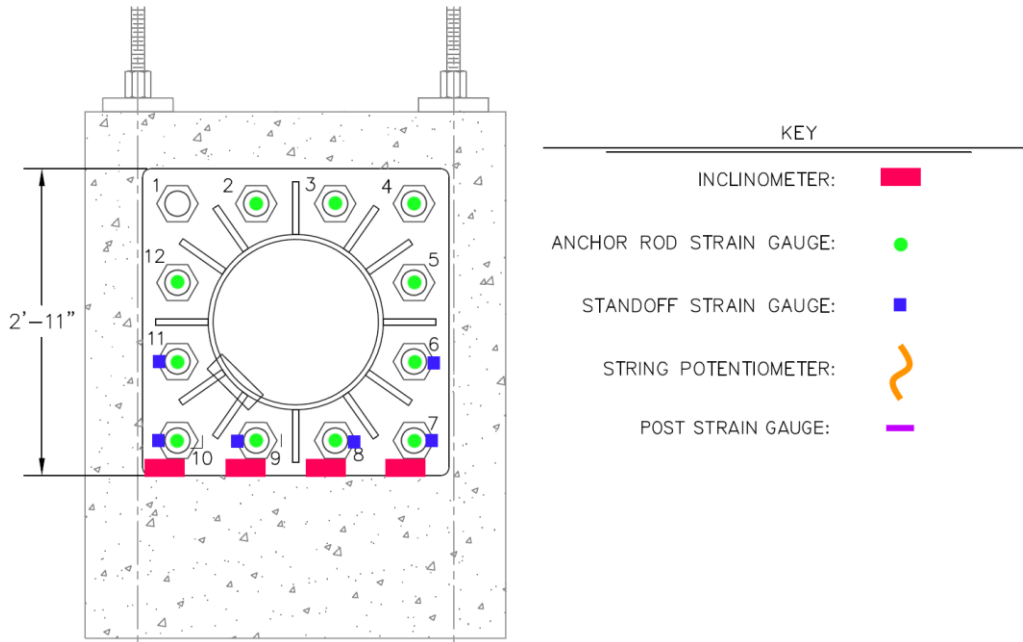
Figure 3.1 outlines the base and anchor rod instrumentation.

Figure 3.1. Base instrumentation

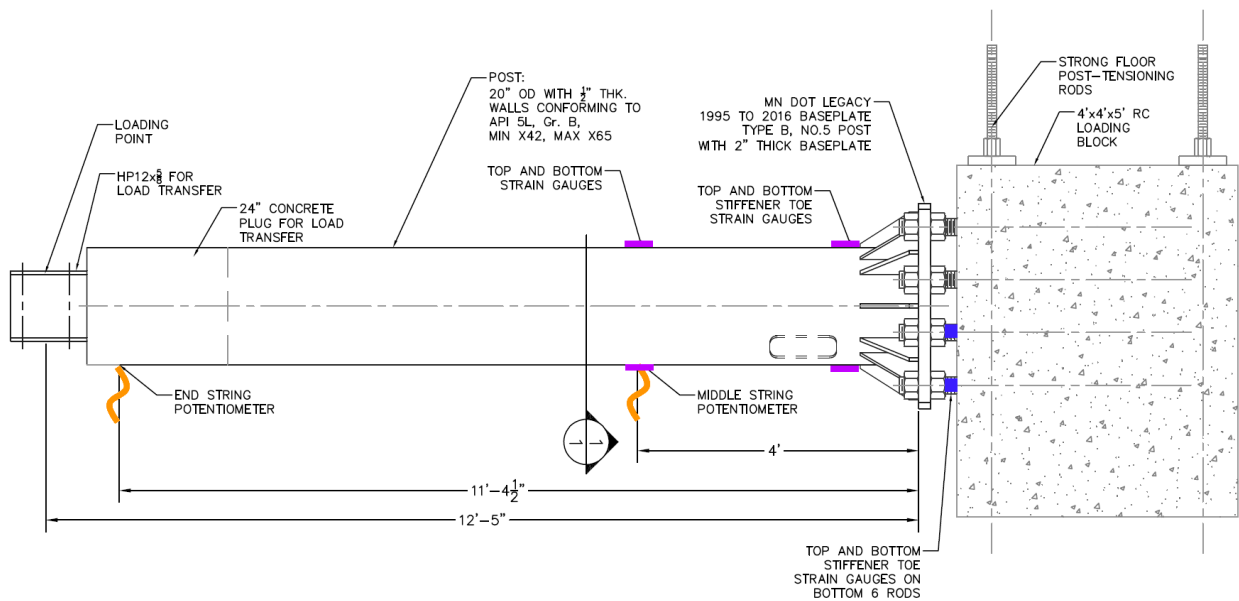
Figure 3.2 illustrates the sign-post instrumentation and overall test setup.

Figure 3.2. Sign-post instrumentation and test setup

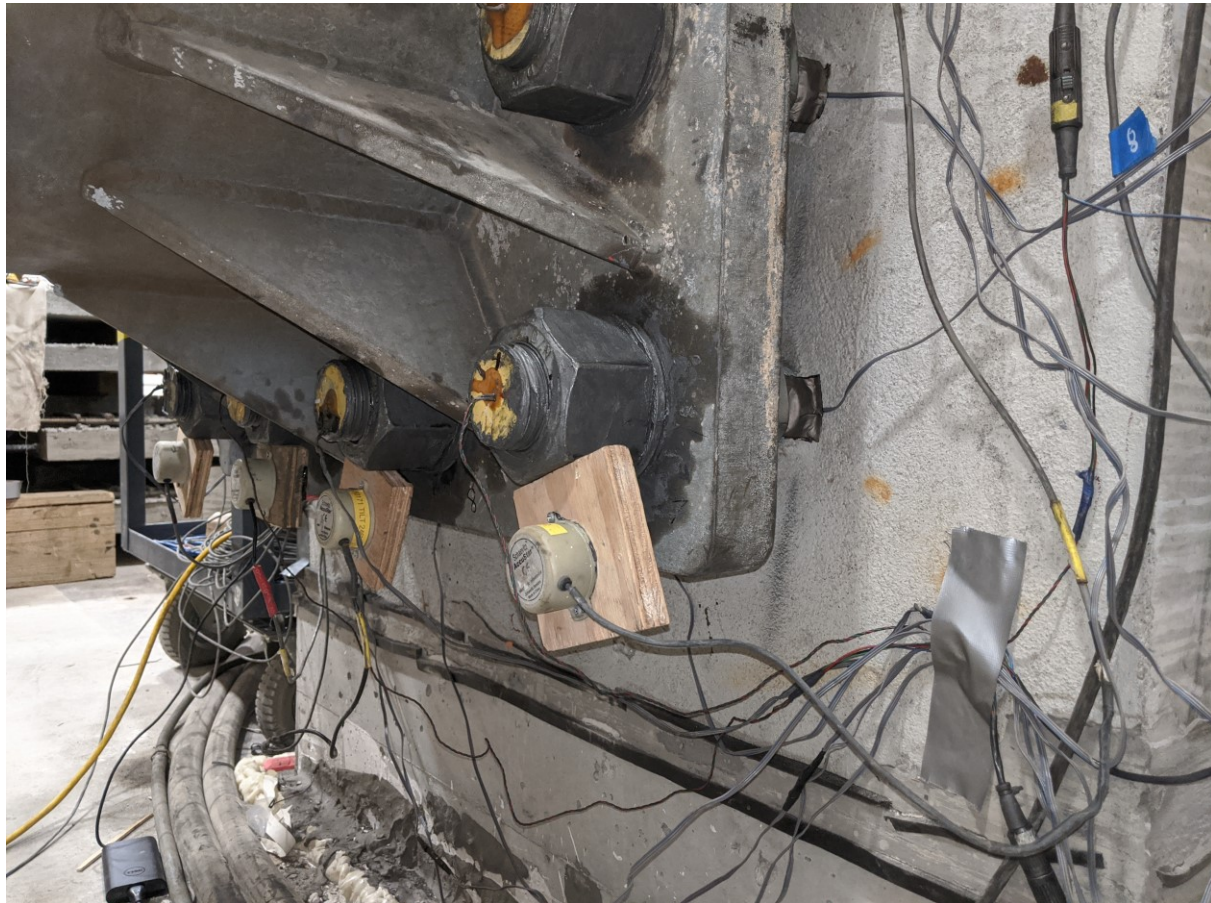
manufacturer. They were epoxied into the anchor rods in the grip length. Middle strain gauges on the posts were affixed at the same distance from the base as those on the field monitoring structure. Figure 3.3 shows the standoff strain gauges and the top of the anchor rod strain gauges.

Figure 3.3. Lower sign-post instrumentation

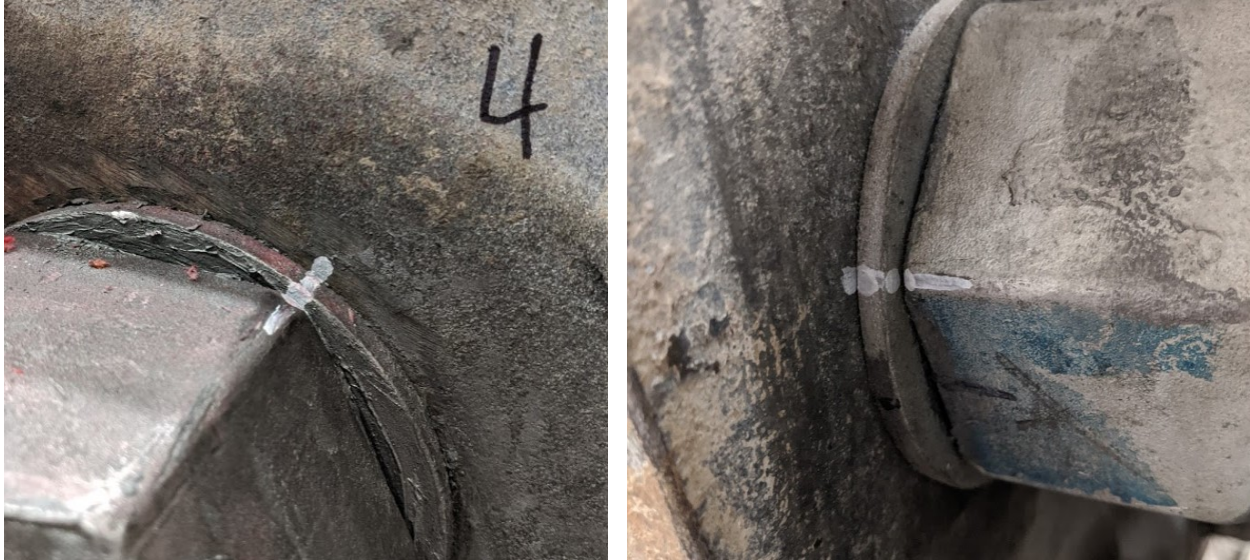
The standoff gauges were located on the sides of the anchor rods to minimize strain readings from moment forces and measure axial forces. Schaevitz AccuStar inclinometers were used to monitor any nut turns on the lower four nuts. The inclinometers were mounted on timber boards, as shown in Figure 3.3, to avoid damaging the instruments during attachment to the nuts. The inclinometers measure around the center of the instrument, which, from geometry, would be equivalent to any nut turns observed. For turn verification, all nuts were also marked with turn lines after ing on the top nut (Figure 3.4 left) and the leveling nut (Figure 3.4 right).

Figure 3.4. Turn marks after tightening on top (left) and on leveling nuts (right)

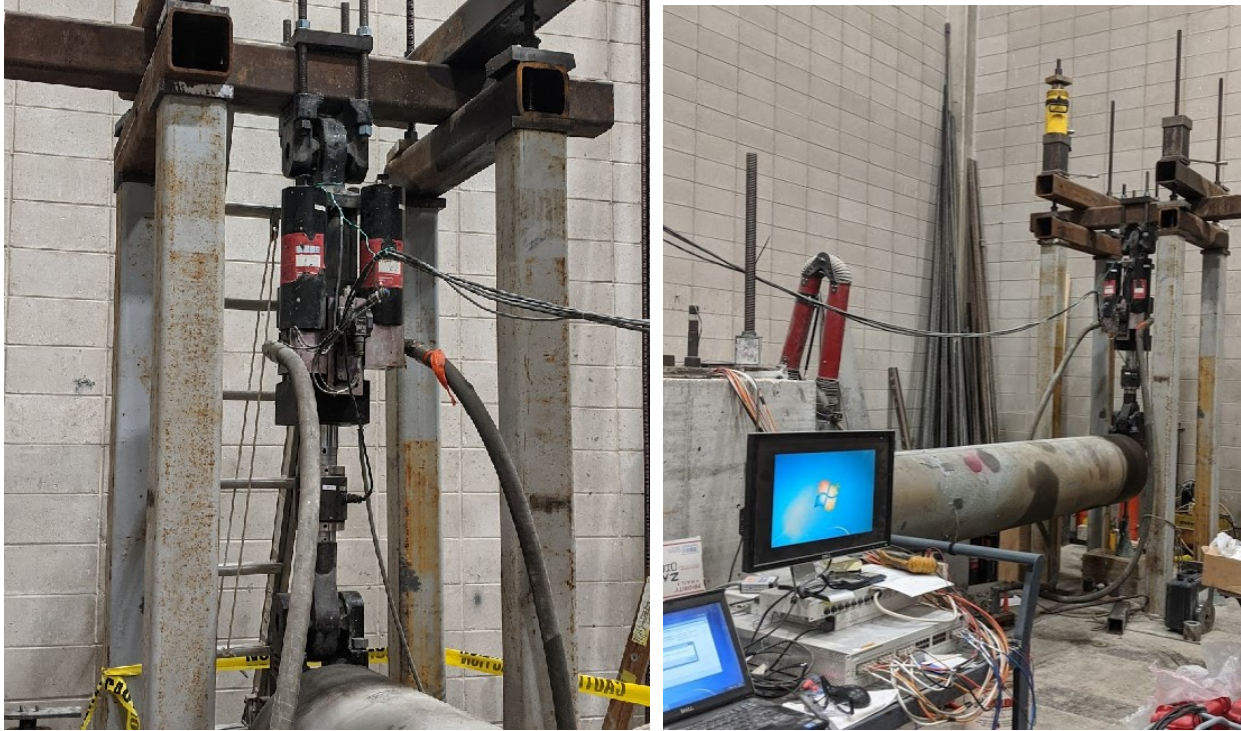
The anchor rods were cast into a reinforced concrete loading block during previous research activities. The loading block was post tensioned to the strong laboratory floor with 100 kips on each post-tensioning rod to provide an approximate fixed condition. Loading was applied with an MTS Systems Corporation hydraulic actuator (Figure 3.5 left) to a HP 12x74 steel section that was cast with concrete into the end of the post.

Figure 3.5. Hydraulic actuator (left) and data acquisition system and loading frame (right)

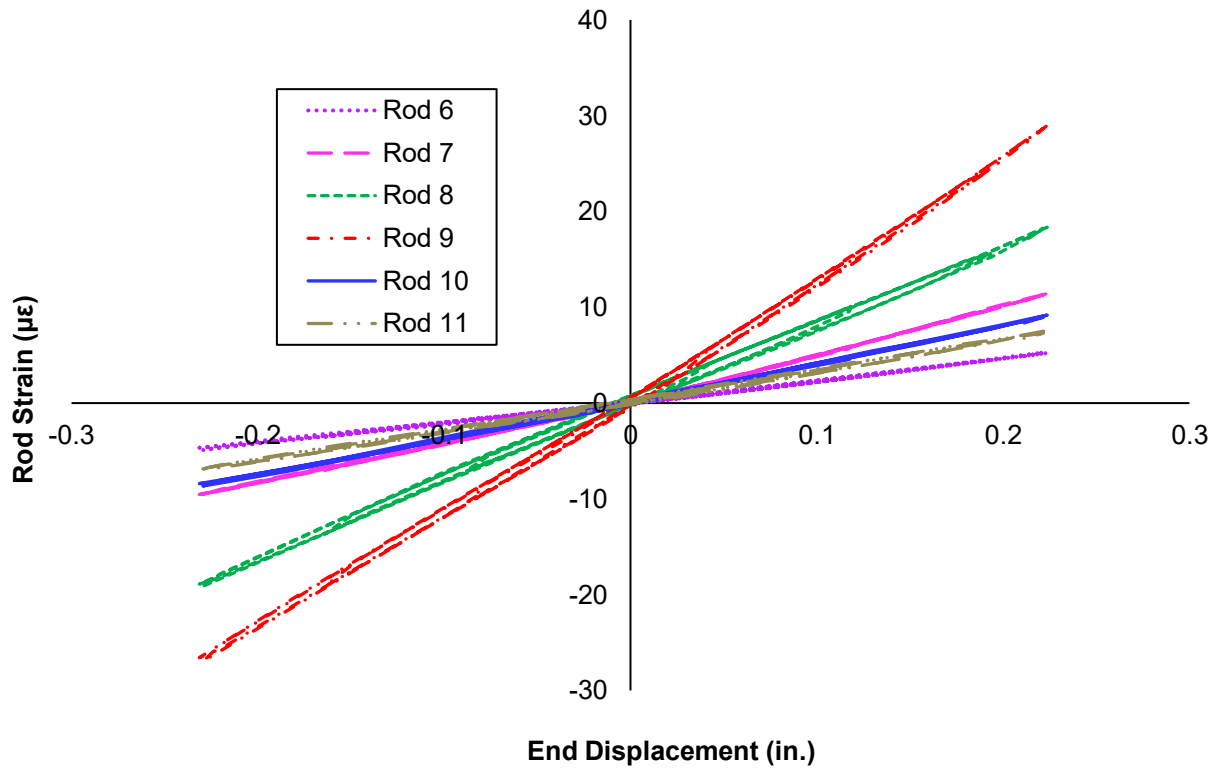
Figure 3.6. Anchor rod response to static loading

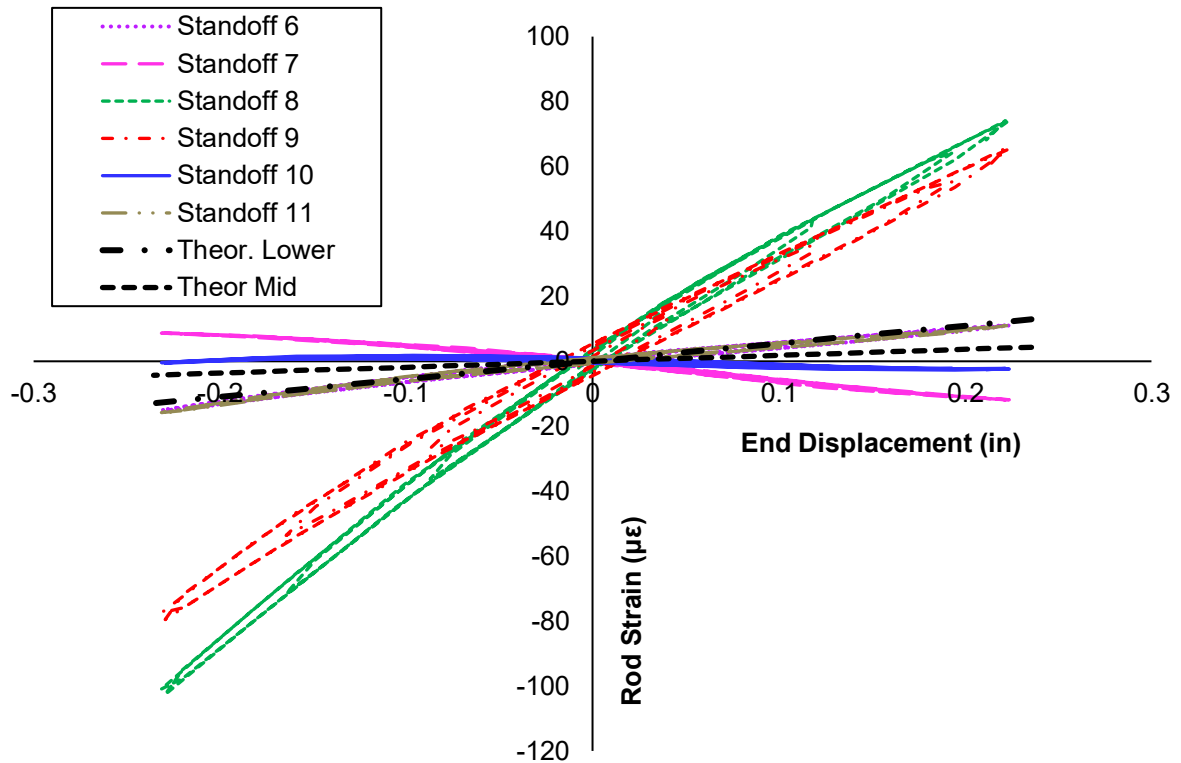
Figure 3.7. Standoff strain response from static loading

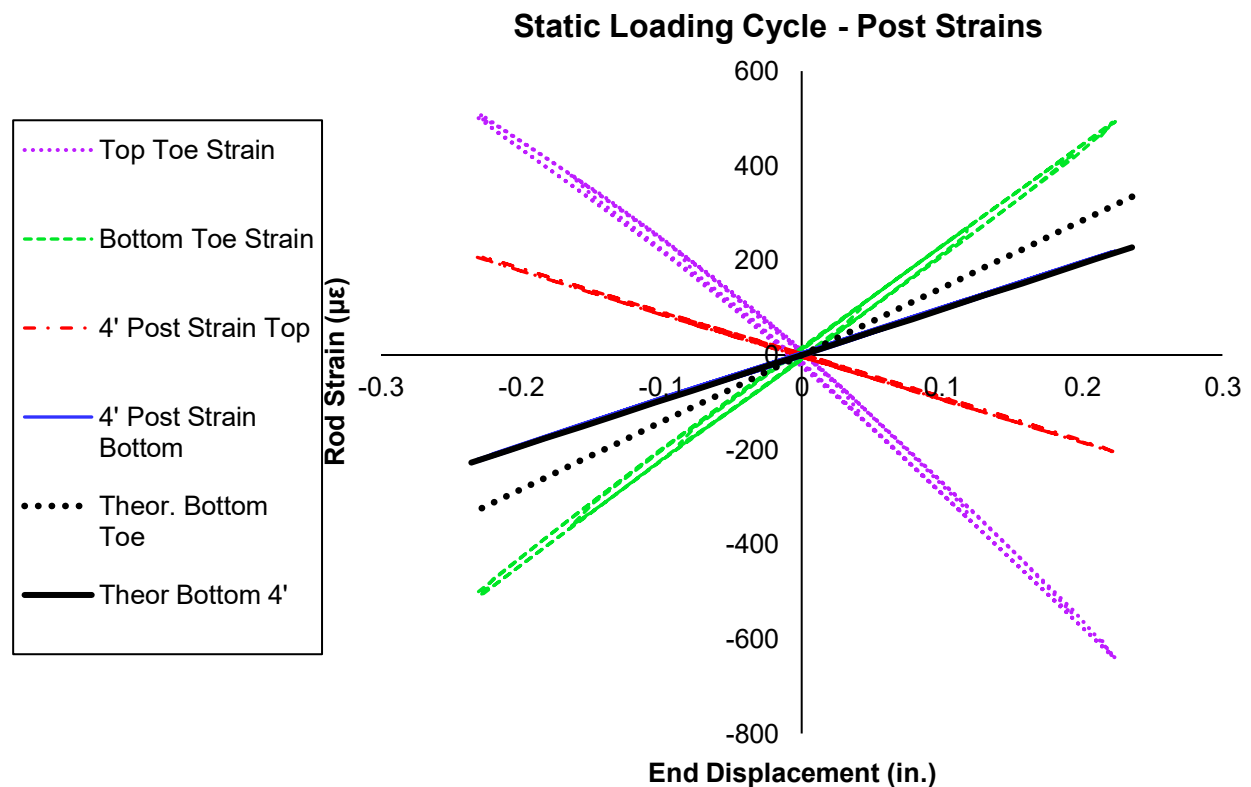
Figure 3.8 shows the sign-post strain response under static loading.

Figure 3.8. Sign-post strain response from static loading

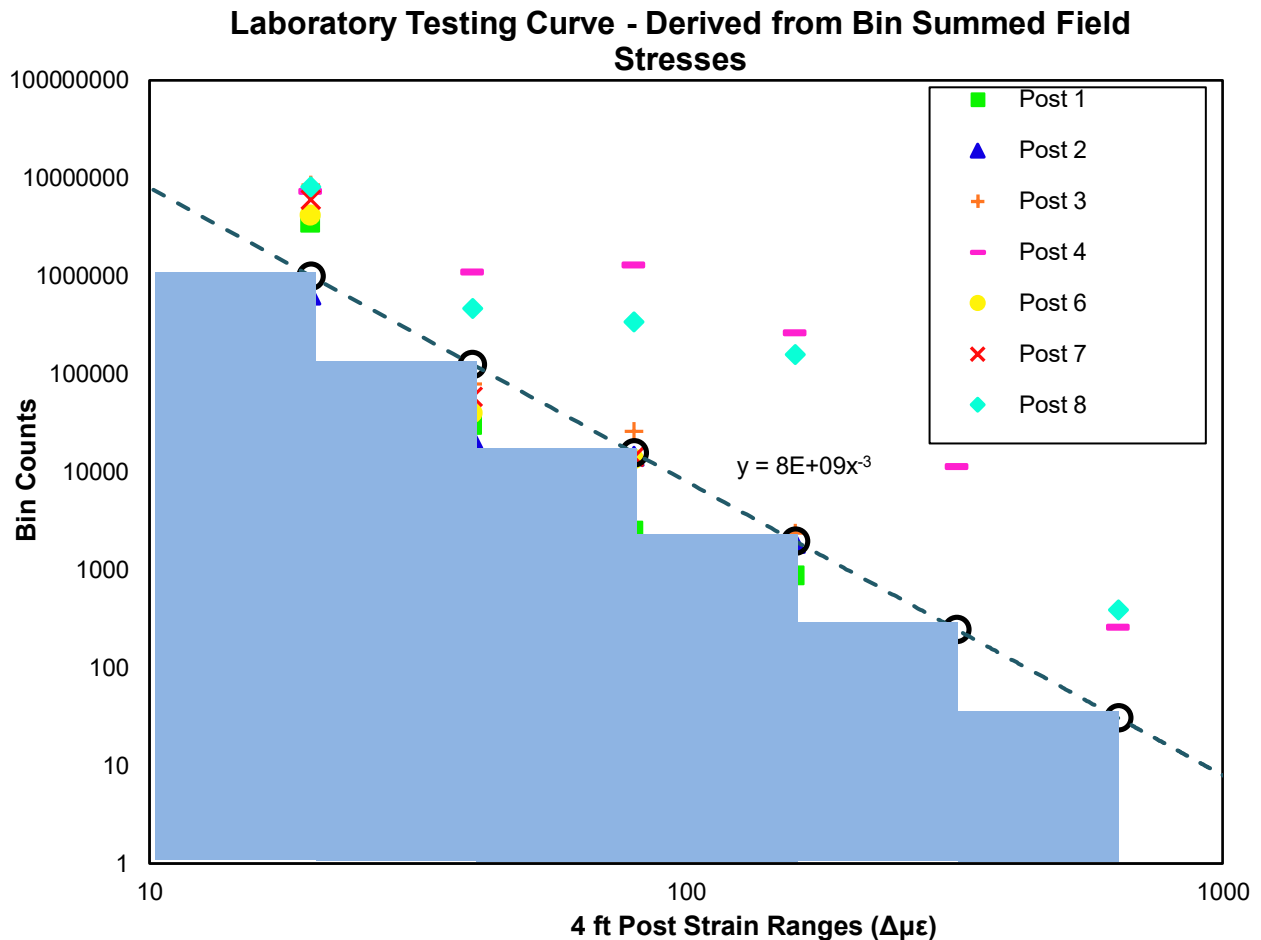
Figure 3.9 outlines the laboratory testing cycles compared to the summed stress range cycles.

Figure 3.9. Field-derived laboratory testing curve

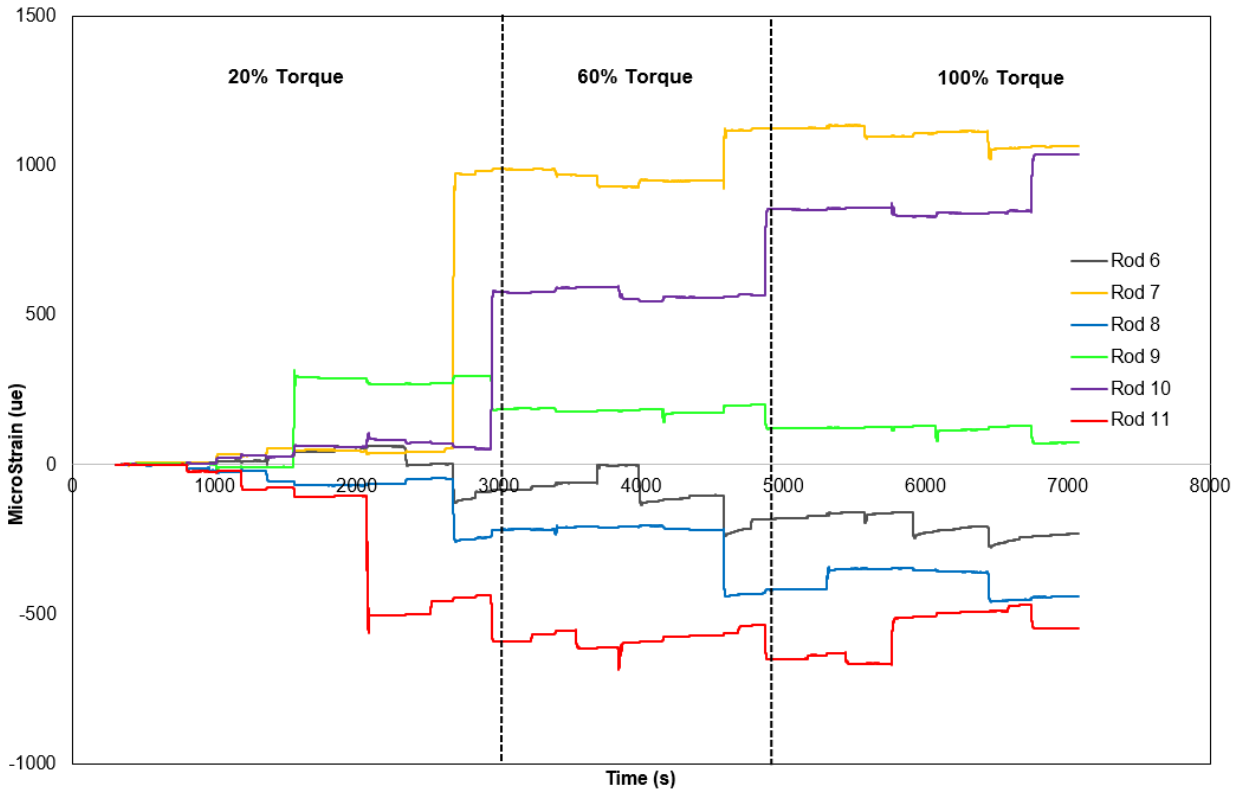
Figure 3.10. Standoff strains during anchor rod pre-tensioning

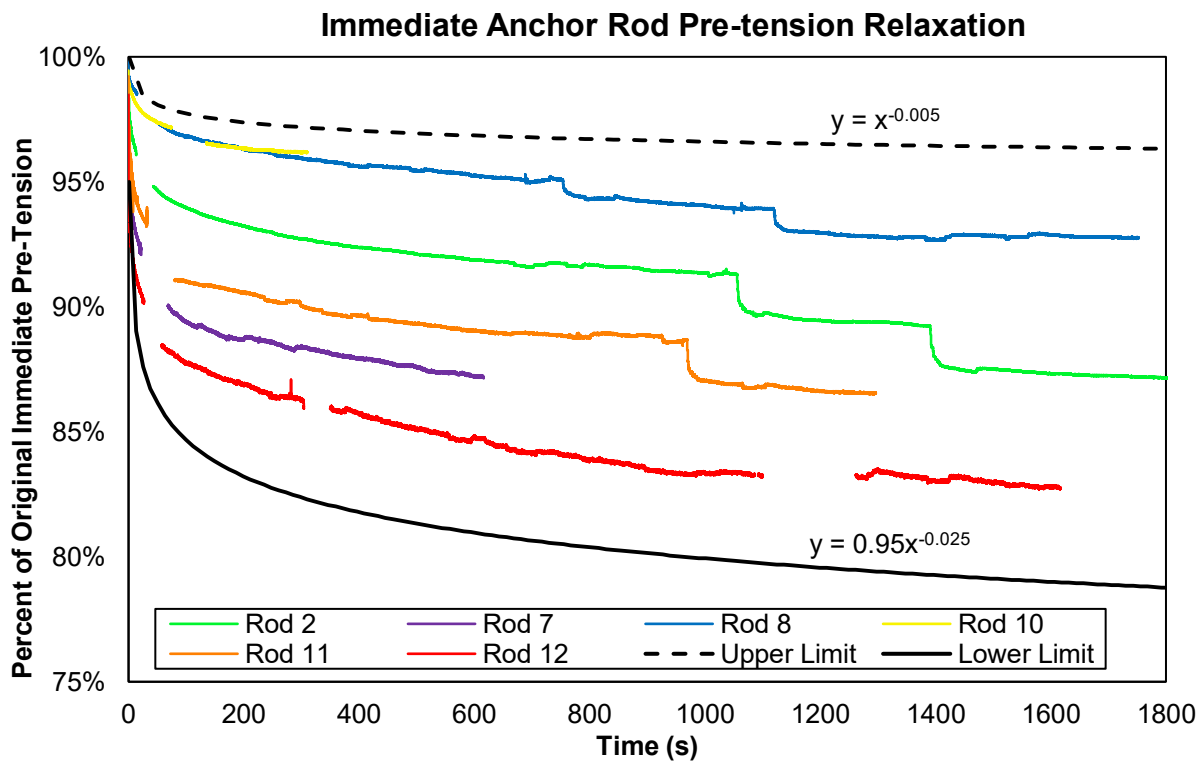
Figures 3.11 and 3.12 present the relative relaxation data for the initial 30 minutes after pre-tensioning for the tightened and retightened cases, respectively.

Figure 3.11. First 30-minute anchor rod pre-tension loss without retightening

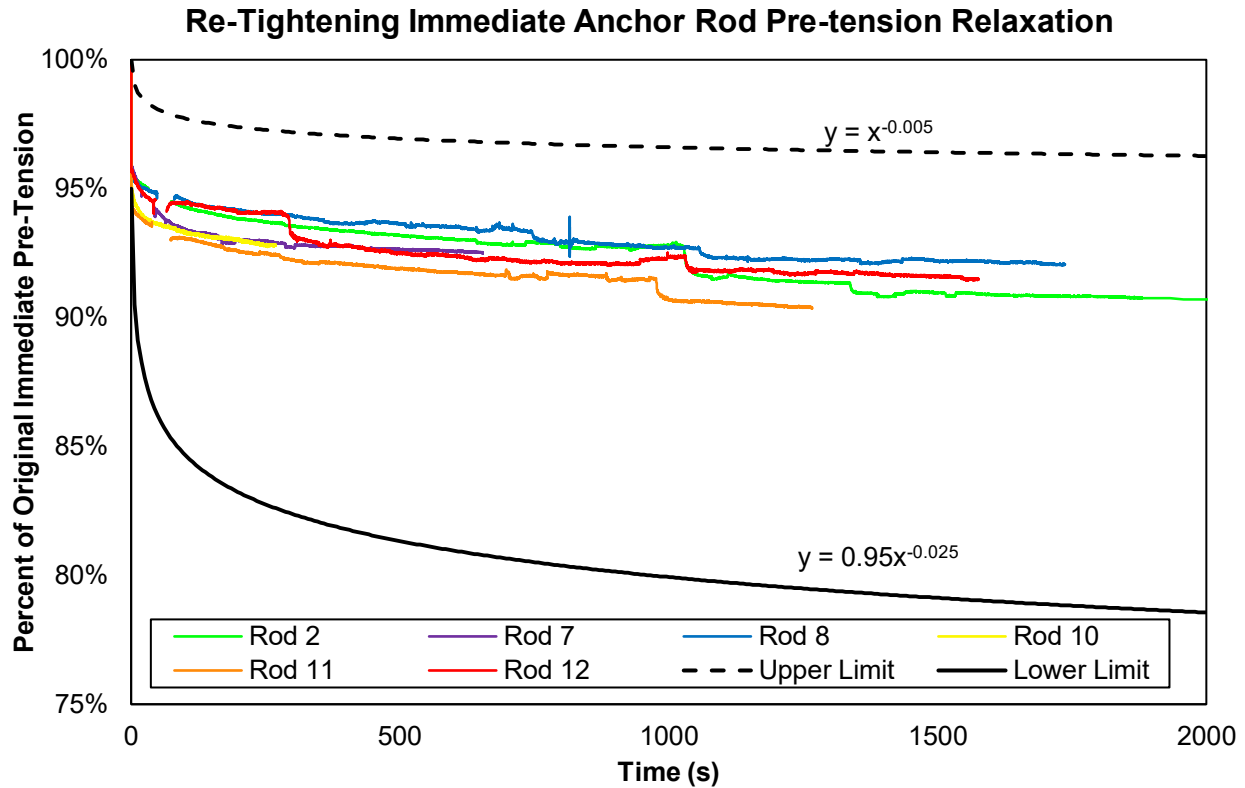
Figure 3.12. First 30-minute anchor rod pre-tension losses after retightening

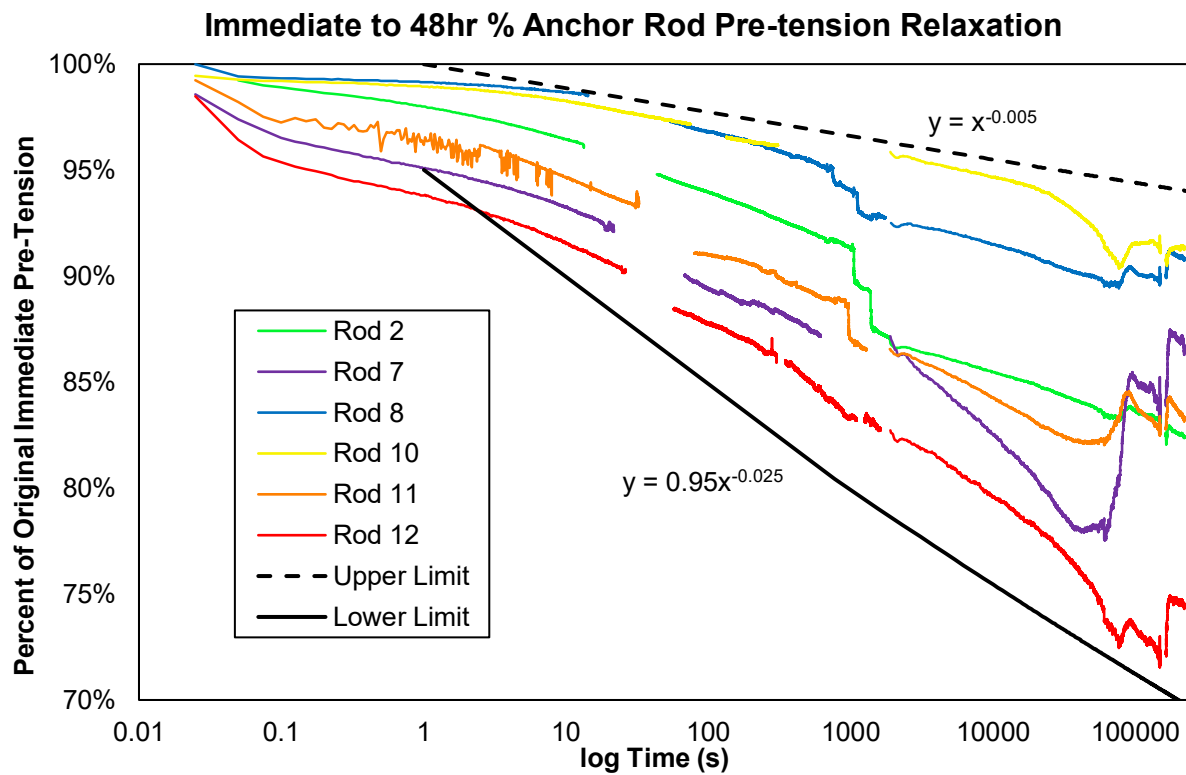
Figure 3.13 presents the combined initial and 48-hour relaxation data for the tightened case but with time on a log scale.

Figure 3.13. Combined initial and 48-hour anchor rod pre-tension relaxation on a log scale

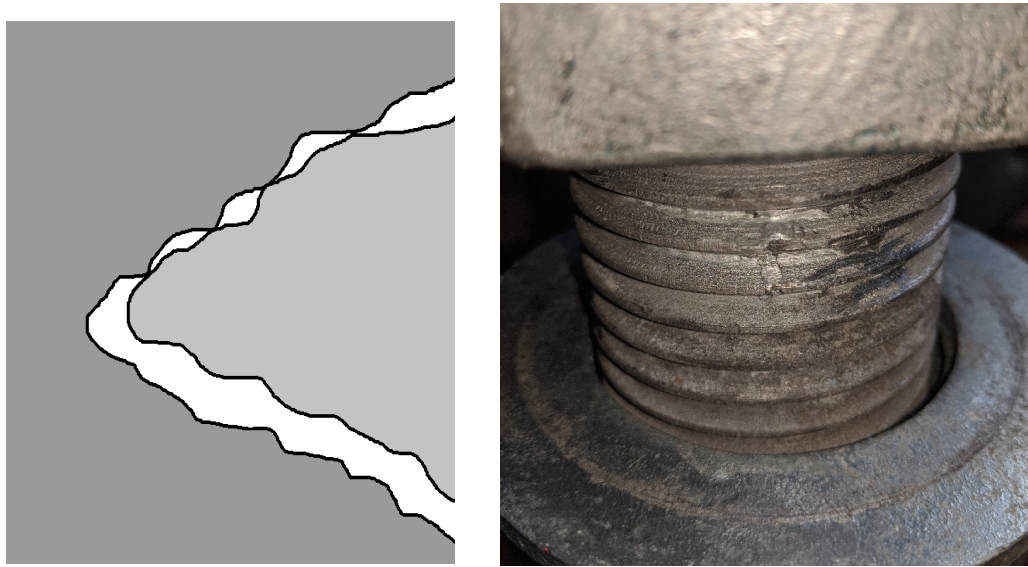
Figures 3.14 presents roughness that leads to some degree of anchor rod relaxation.

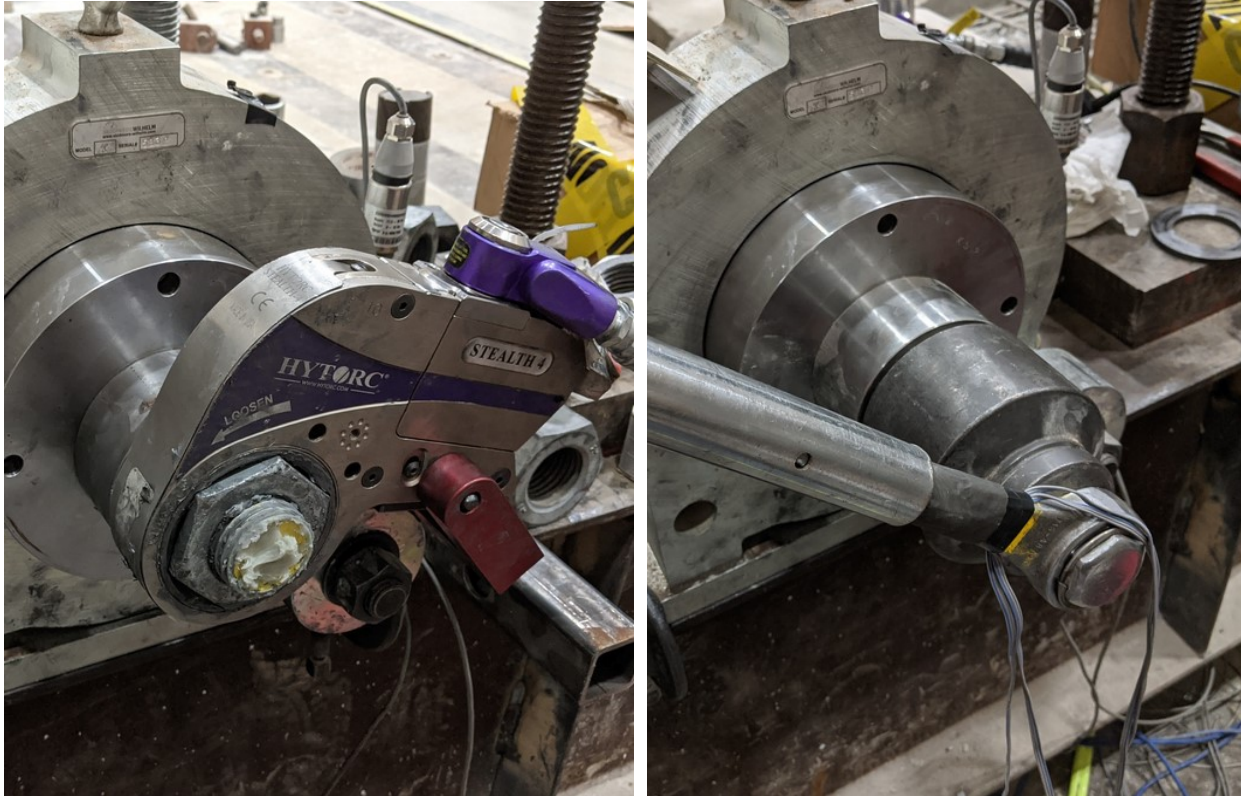
Tightening tests focused on torque-controlled pre-tensioning on three different anchor rod diameters with five different lubricants. Each lubricant and rod combination was tested five times. Three different wrenches were utilized due to various limitations and to ensure that different torque measurement methods provided consistent results. The first wrench was a HYTORC Stealth 4 with a Vector pump, as shown in Figure 3.15 (left).

Figure 3.15. Skidmore Model K pre-tensioning with hydraulic wrench (left) and calibrated strain wrench (right)

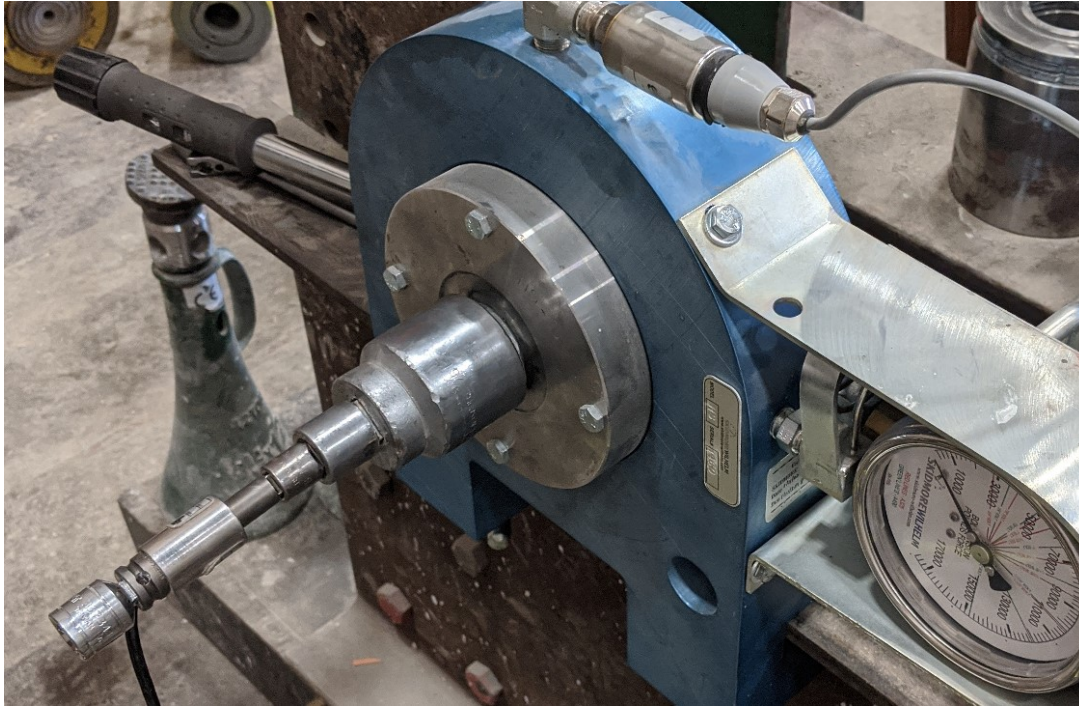
Pressure was measured with a Schaevitz 10,000 psi hydraulic pressure transducer that could be correlated to torque through a calibration curve. The second wrench, shown in Figure 3.15 (right), had a fixed-end socket with four foil strain gauges mounted near the base to measure torque indirectly. The calibration curve for this wrench was developed with basic mechanics equations and verified using the other two torque wrenches. Finally, for lower torque measurement, a 100 ft-lb torque transducer was used (Figure 3.16).

Figure 3.16. Pre-tension testing with Skidmore Model MK and torque transducer

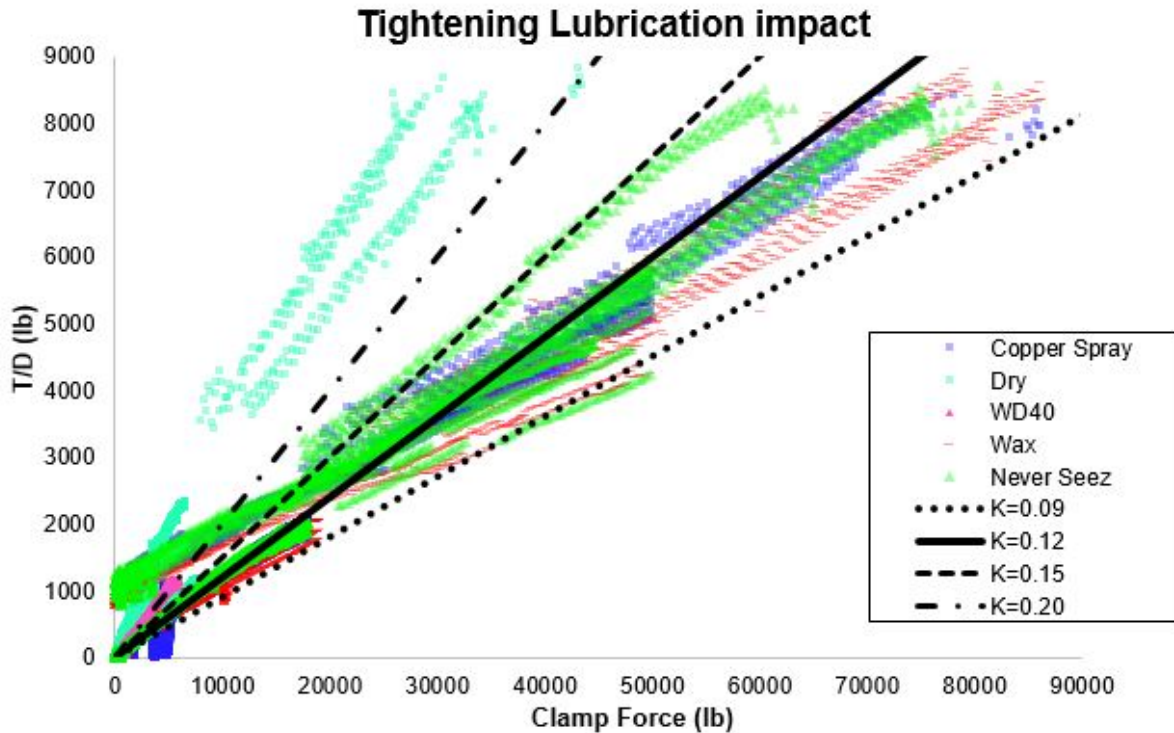
All of the nut factors are laboratory derived, with lubrication thoroughly applied and no environmental variables. Also, as experienced on site, ideal conditions will often not be the case, generally resulting in an increased nut factor. Figure 3.17 shows the scatter of these tightening data along with reference nut factors.

Figure 3.17. Tightening laboratory tested properties

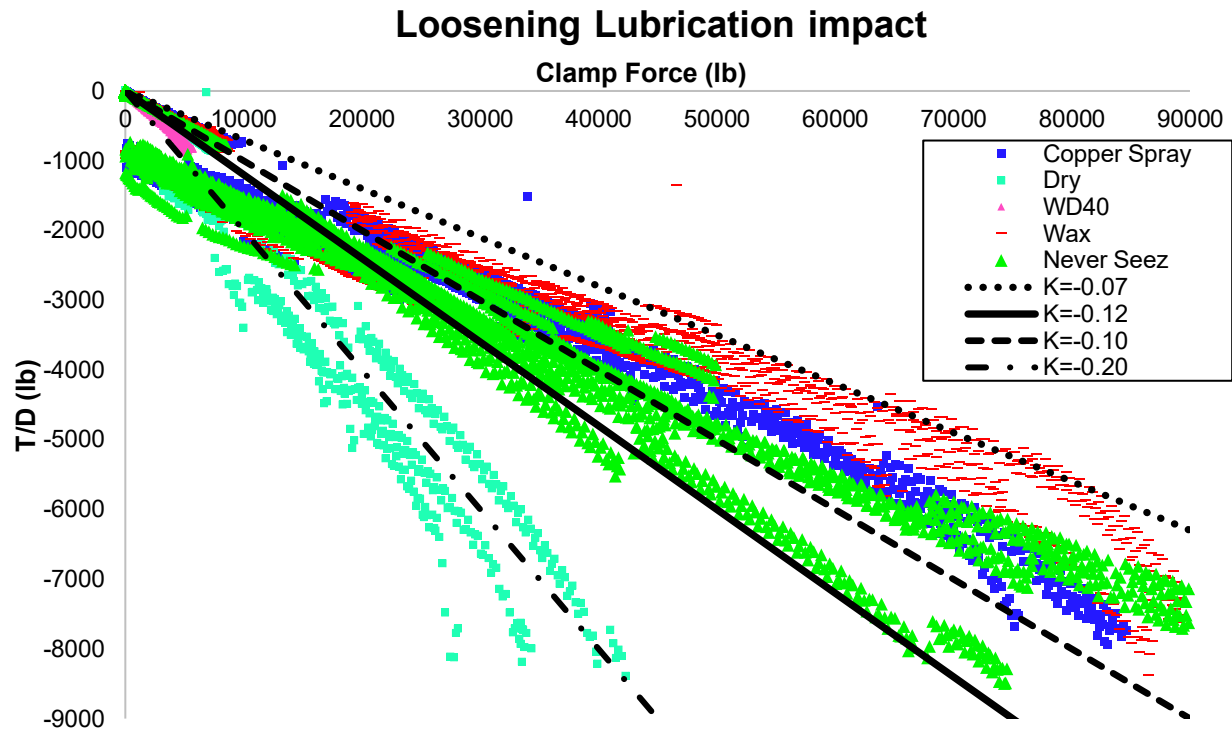
The loosening data resulted in about 80% of the tightening nut factor and generally had a greater standard error, which aligns with the available literature (Bickford 1995). For the combined anti-seize lubricants, a loosening k of -0.09 was observed with a 95% confidence interval of +/- 7.8 kips of clamping force. In addition, the starting point of all of the loosening torques would be impacted by the immediate relaxation of the anchor rods. Figure 3.18 shows the distribution of the loosening data points with reference negative nut factors.

Figure 3.18. Loosening laboratory tested properties

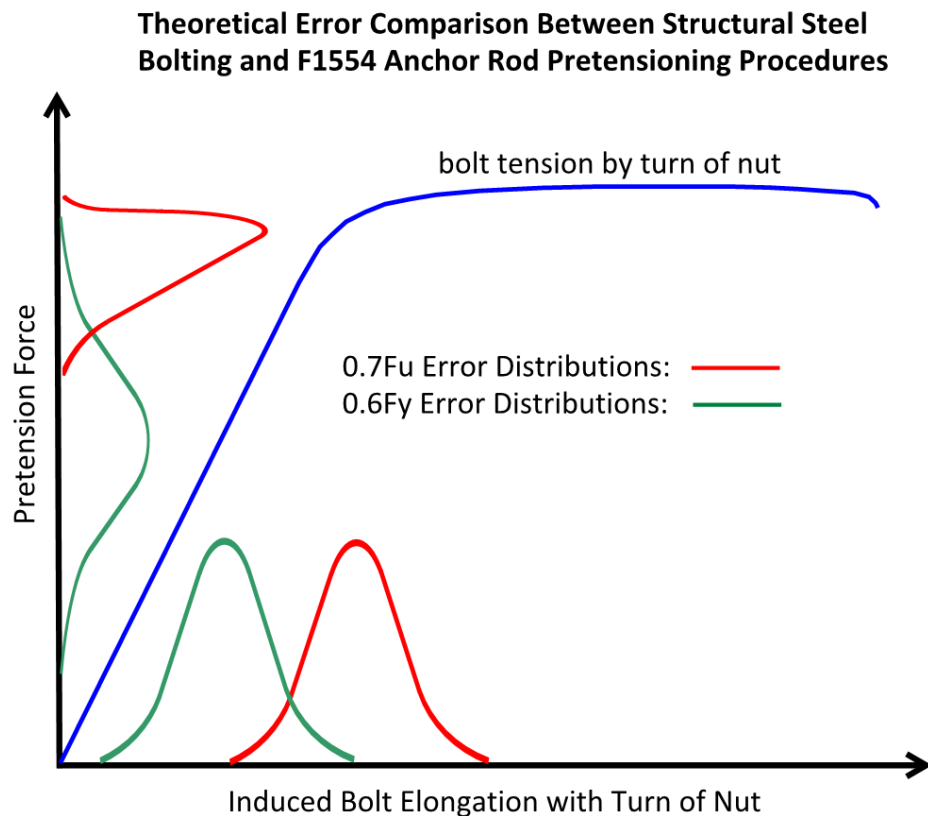
The high degree of accuracy in structural steel connections, as covered in various literature (Kulak 2002, RCSC 2015), is from the yielding of the bolt as outlined in Figure 3.19.

Figure 3.19. Final pre-tension error differences between structural steel bolts and anchor rods
