Re-Tightening the Large Anchor Bolts of Support Structures for Signs and Luminaries: Phase II

Bridge Engineering Center

Research Report

Final Report 2021-23

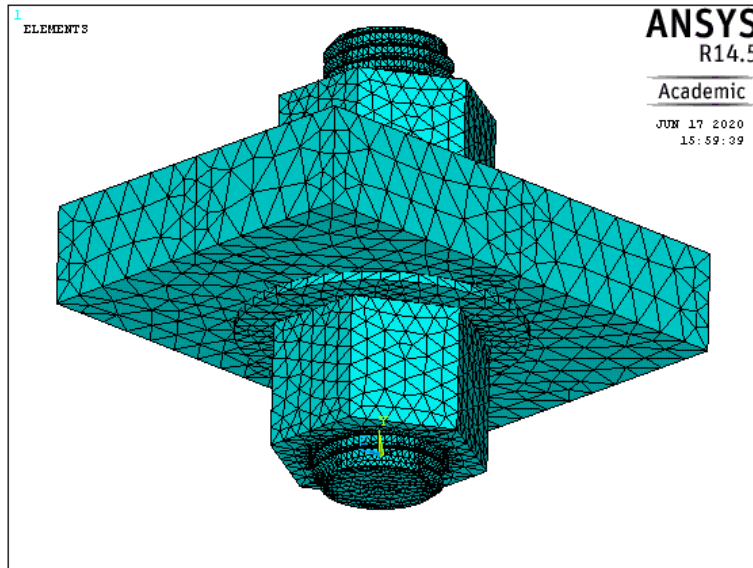
The model was developed with one 2 in. diameter anchor rod, two nuts (one near each end of the rod), a 2 in. thick plate (between the two nuts) that represents the load cell on the Skidmore machine, and two washers between the nuts and the plate. Figure 4.1 shows the geometry of the FEM for the Skidmore test.

Figure 4.1. FE model for Skidmore-tested specimen developed during preliminary study

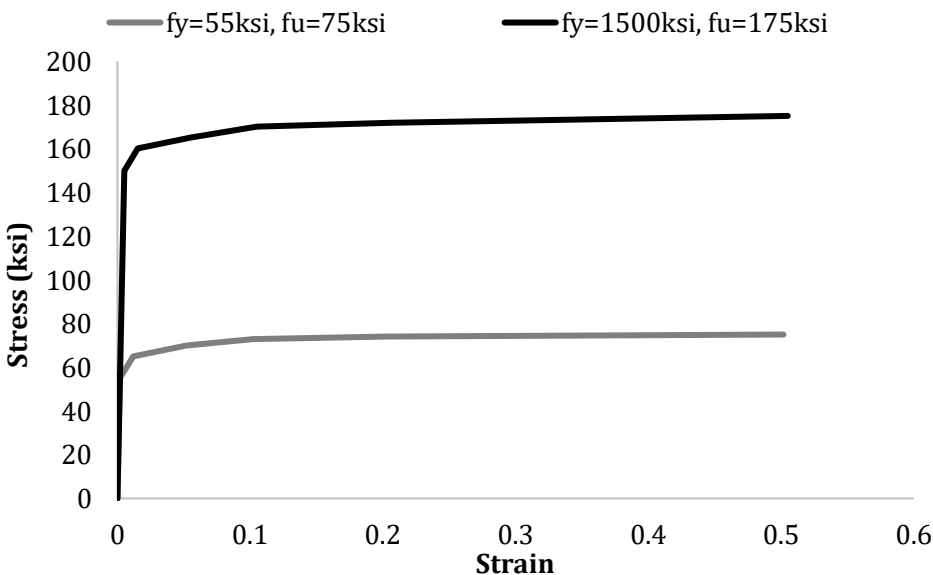
The yield and ultimate strength of each component was determined based on the Skidmore-tested specimen (2 in.) as detailed. For example, the rod was defined with a yield strength of 55 ksi and ultimate strength of 75 ksi. The nuts were designed with a yield strength of 150 ksi and ultimate strength of 175 ksi. Given the local stress concentrations occurring on the threads may result in local stresses beyond the yield strength, and this stress concentration could cause permanent local damage and eventually affect the tightening/loosening behavior of the structure, the material properties were defined to be able to simulate this elastic-plastic behavior. Figure 4.2 shows the elastic-plastic stress-strain behavior for the two material types used in the FEM.

Figure 4.2. Material properties used

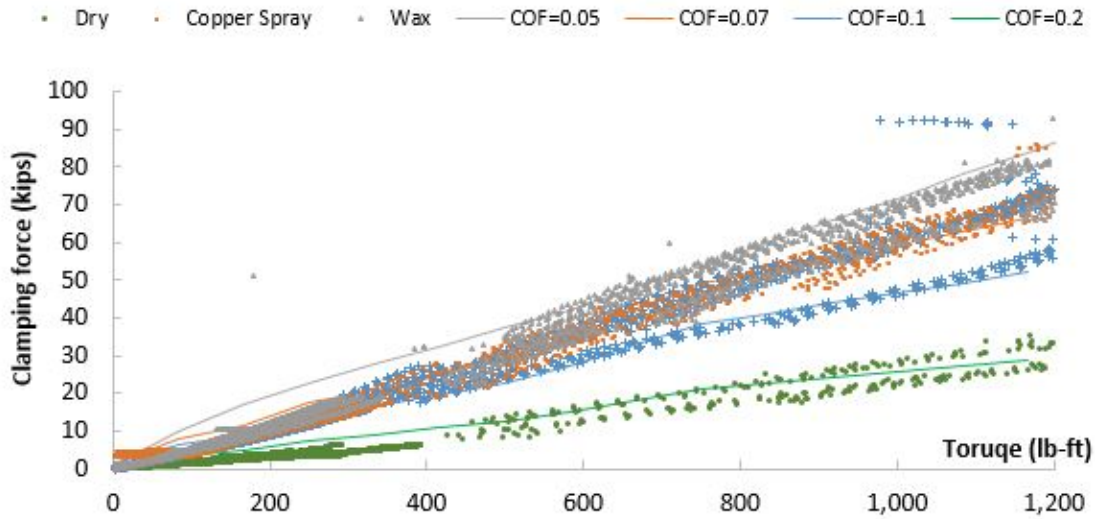
During the laboratory test, four lubrication methods were studied, and the clamping force vs. torque relation was captured. During the calibration of the FEM, the model was calibrated with the COF increment of 0.005 to 0.01 to look for the best COF that could represent the friction on the tested specimen. The torque and clamping force data were output from the models with a COF of 0.05, 0.07, 0.1, and 0.2, respectively. The results are shown in Figure 4.3.

Figure 4.3. Model calibration for the friction coefficient

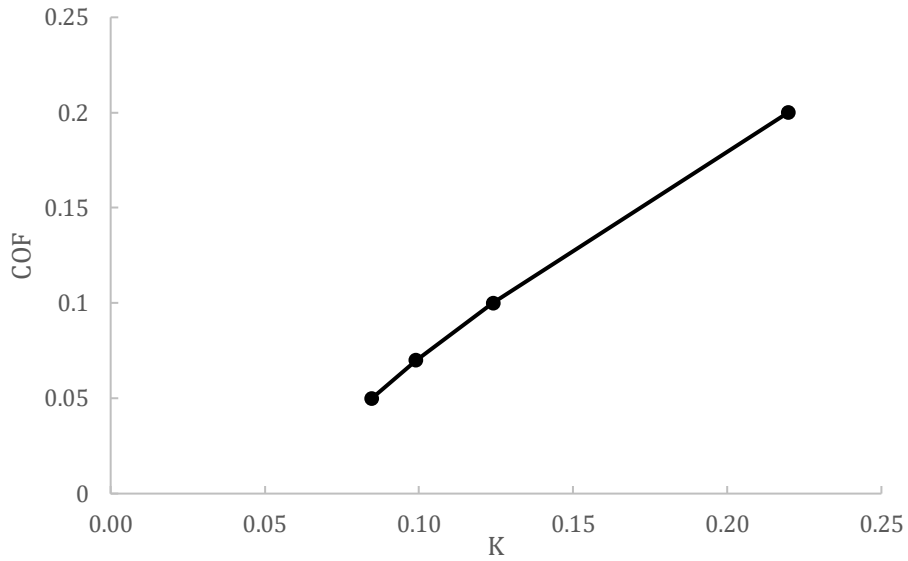
Figure 4.4 shows the relationship between K and COF.

Figure 4.4. Relation between K and COF

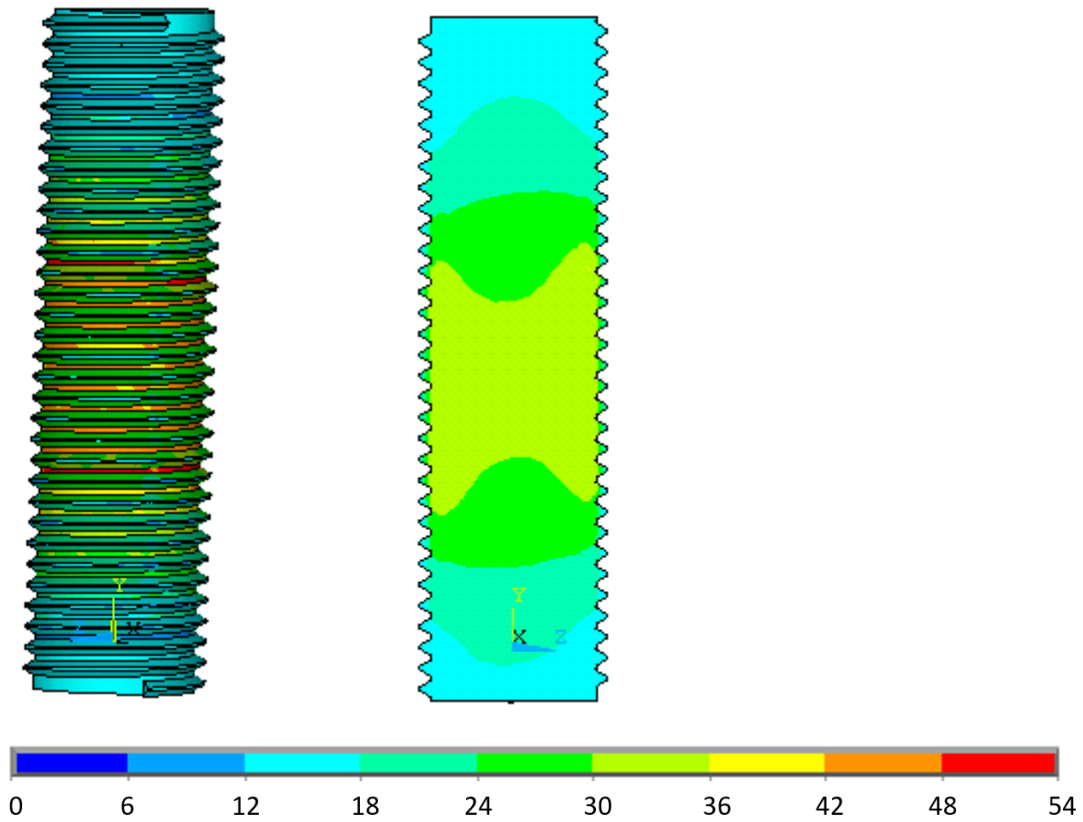
Figure 4.5 and Figure 4.6 show the von Mises stress distribution on the rod and nut, respectively.

Figure 4.5. Vertical stress distribution in the rod (Skidmore)

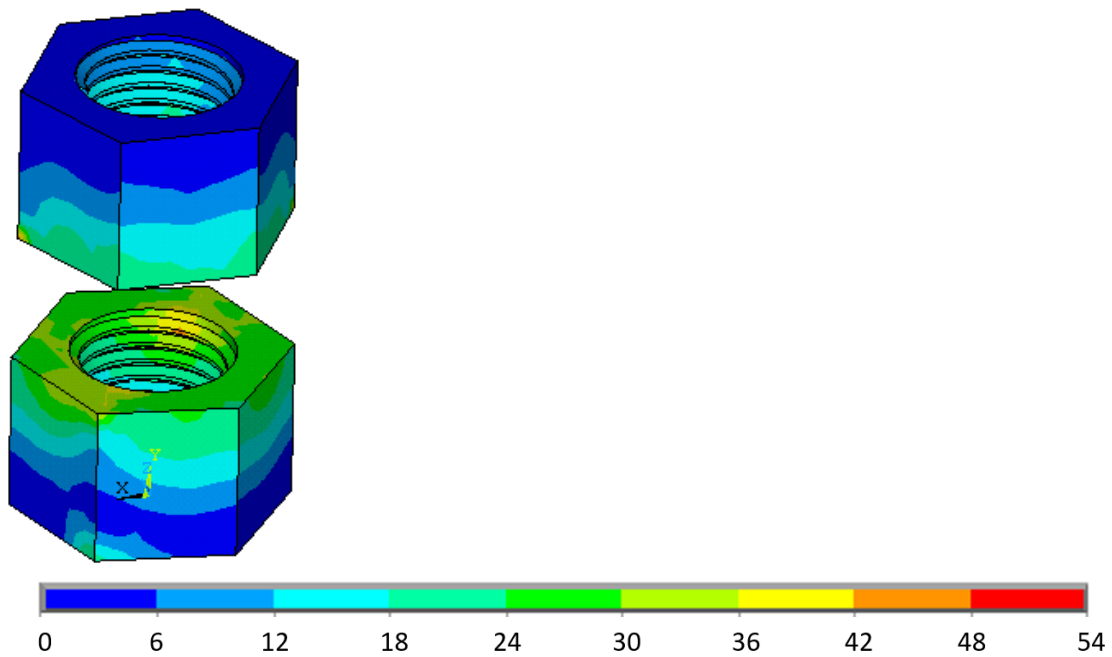
Figure 4.6. Von-mises distribution in the nut (Skidmore)

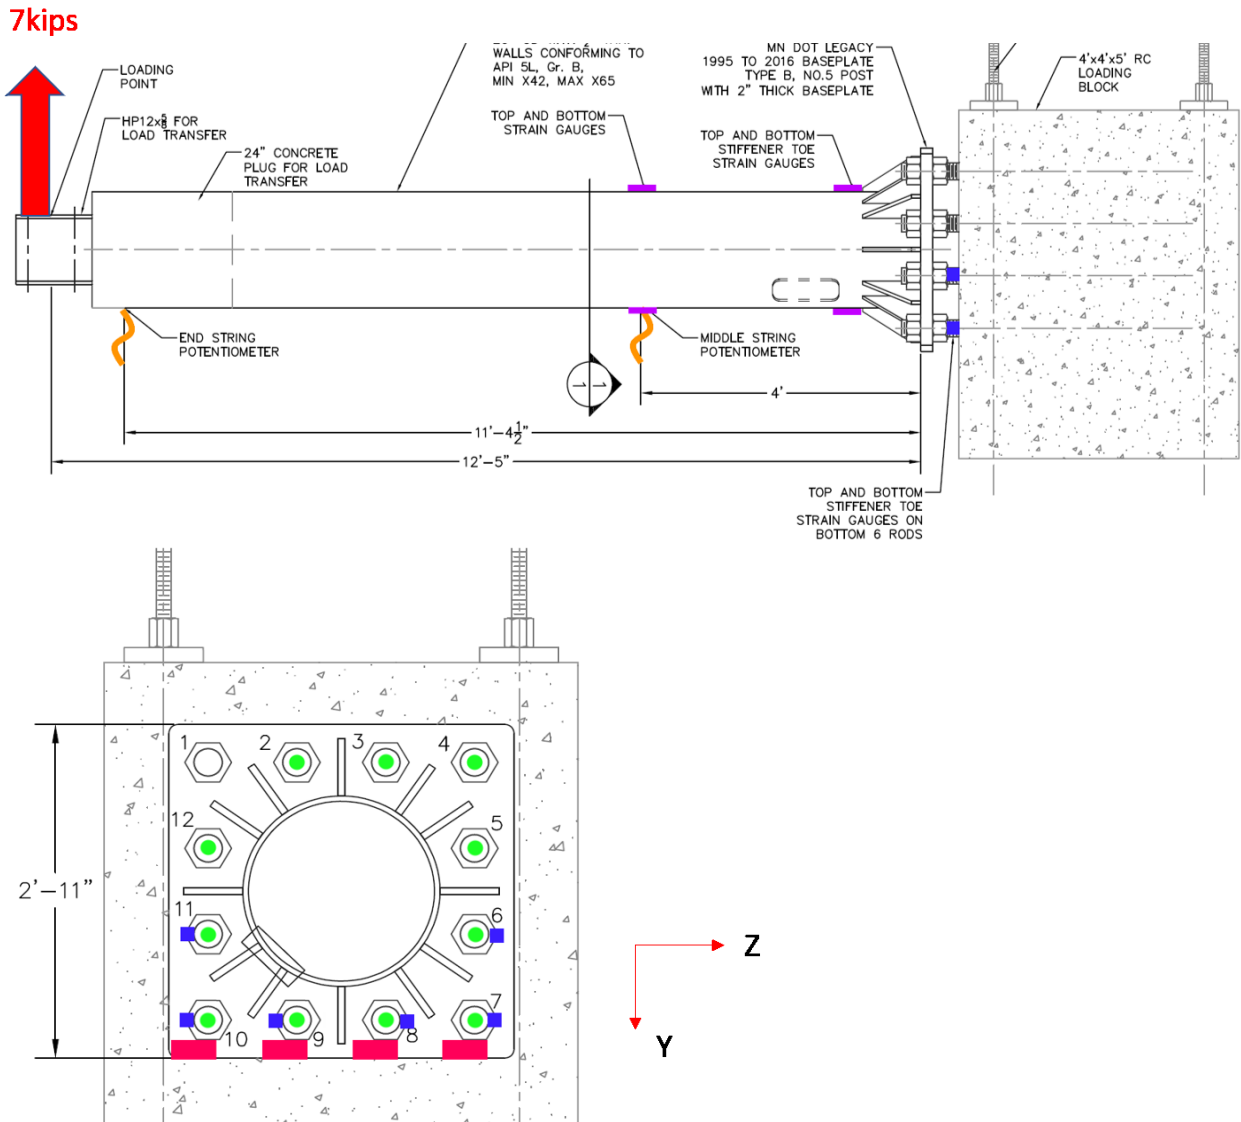
To compare the results from hand calculations with those from the FEM, a 7 kips vertical load was assumed to be placed at the end of the post. Figure 4.7 (top) shows the load protocol and Figure 4.7 (bottom) shows the location and labeling for each rod.

Figure 4.7. Static load protocol: elevation view (top) and front view (bottom)

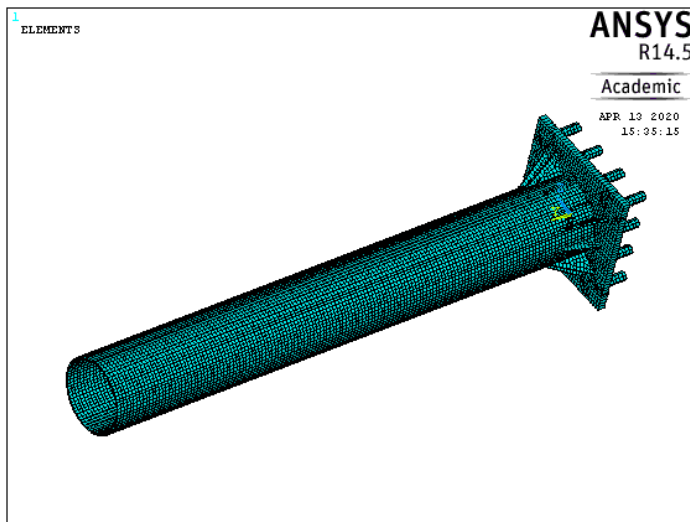
The model developed in this step consisted of the post, post toe stiffeners, baseplate, and rods. Figure 4.8 shows the FEM, and Table 4.2 shows the modeling details.

Figure 4.8. FE model for laboratory-tested specimen

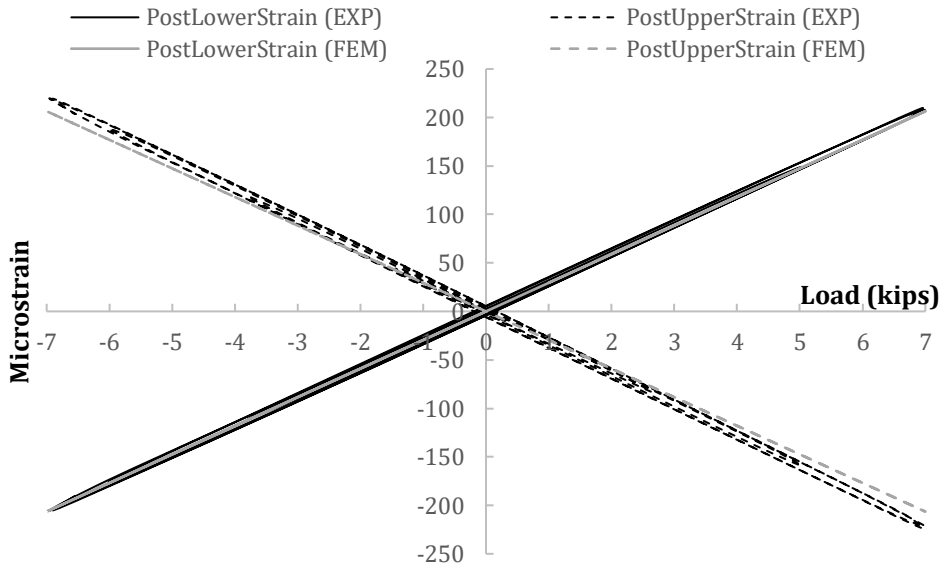
To validate the sign-post model, the strain on the post and end displacement results were output and compared with the data captured during the laboratory test. Figure 4.9 and Figure 4.10 validate the model against the strain and displacement data.

Figure 4.9. Model validation against the strain on post

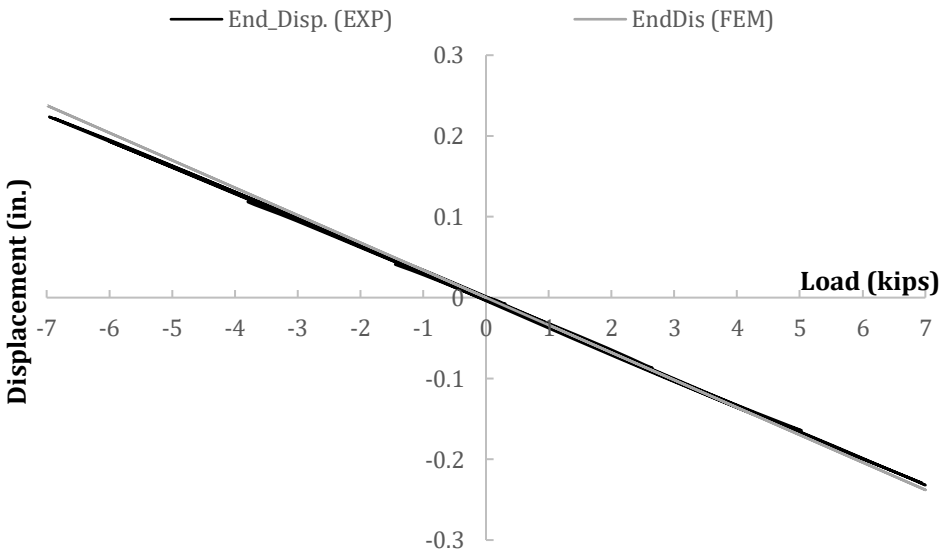
Figure 4.10. Model validation against post end displacement

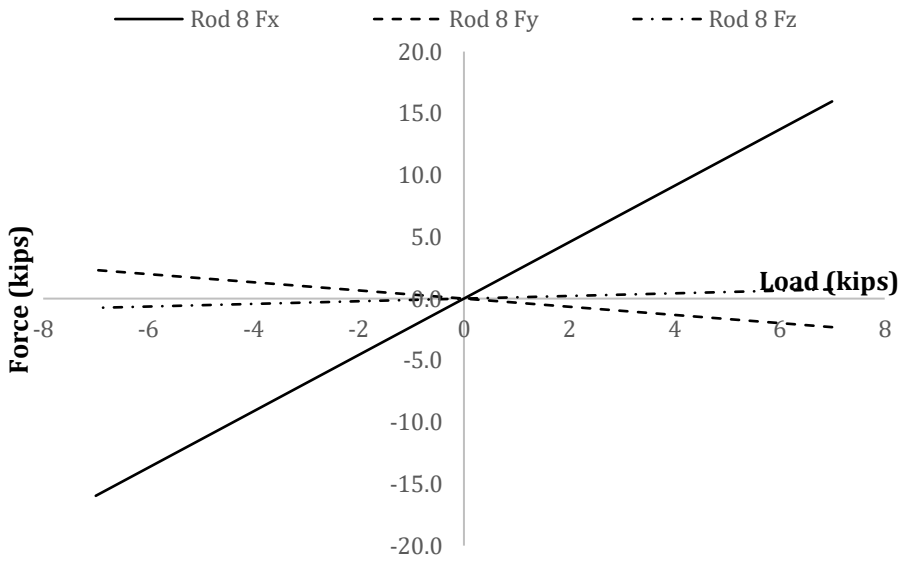
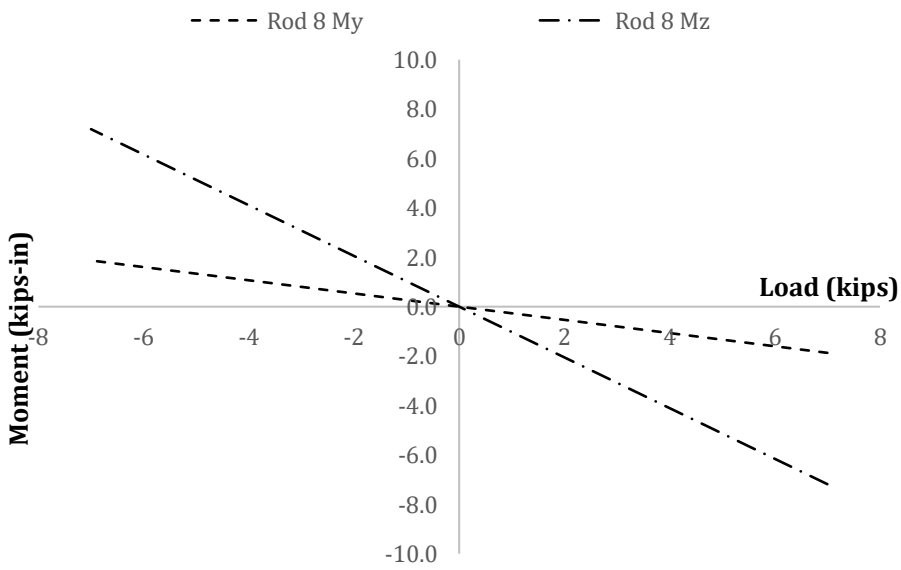
Figure 4.11 and Table 4.4 show the load experienced by rod 8 during one load cycle.

Fx, Fy, and Fz

My and Mz

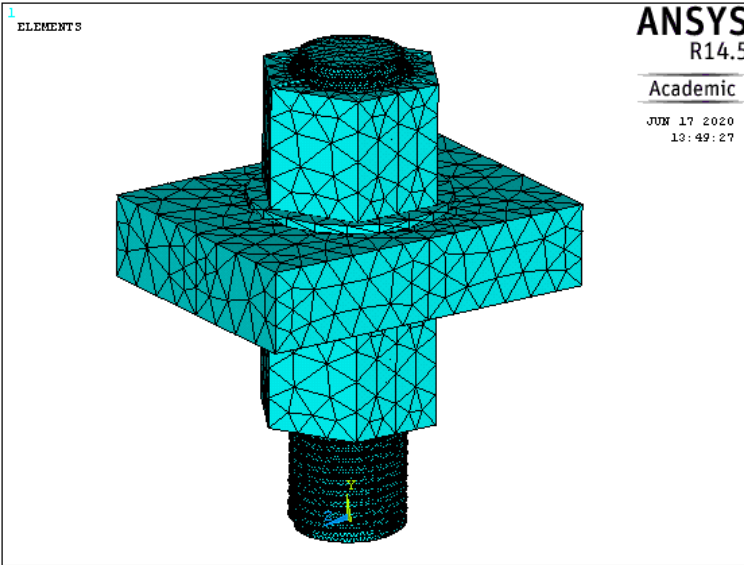
The model consists of one rod, two nuts, two washers, and one plate. Figure 4.12 shows the single-rod FEM.

Figure 4.12. Single-rod FE model

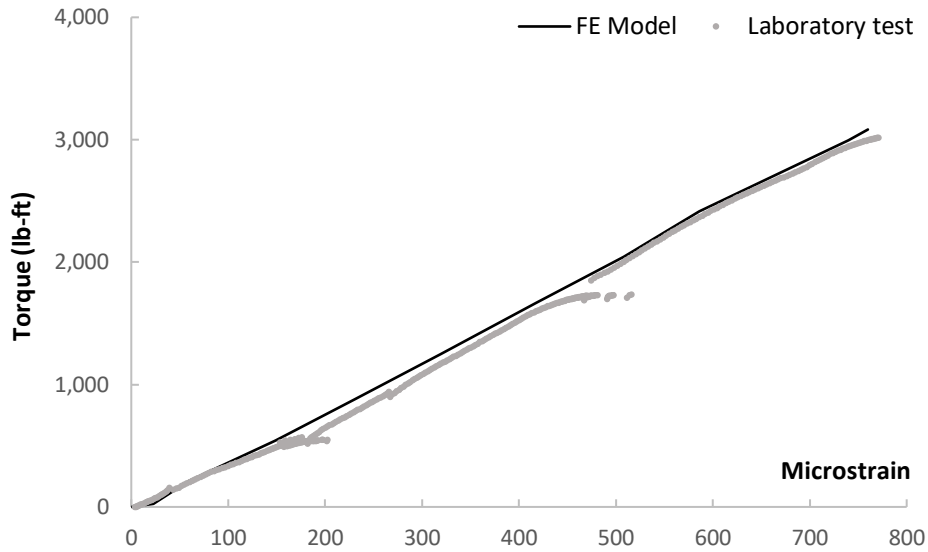
In this section, the model was validated against the strain data collected from the laboratory test. The strain collected from the strain gauge embedded in the rod at the baseplate level was used to accomplish the validation (see the previous Figure 4.7 for the gauge location). During the laboratory test, rod 8 was tightened to a torque of 3,300 lb-ft, which resulted in an axial strain of 770 microstrain. Figure 4.13 compares the strain collected from testing and output from the FEM.

Figure 4.13. Model validation by rod strain at plate level (preload)

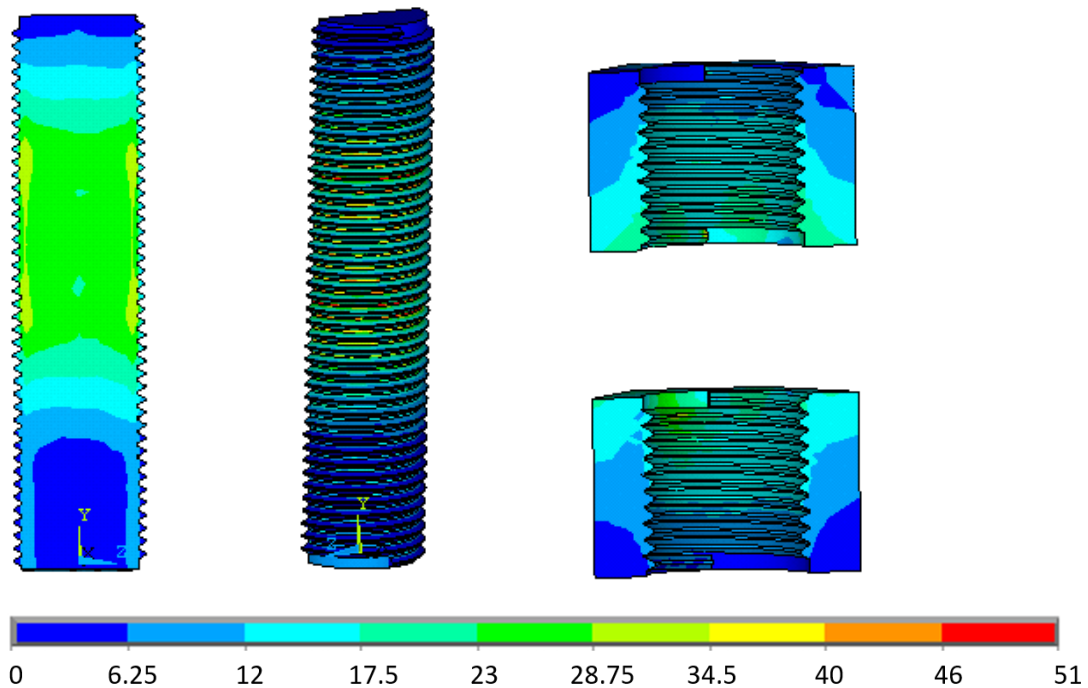
Figure 4.14 shows the von Mises stress distribution in the rod and nuts.

Figure 4.14. Von-mises distribution in the nut (preload)

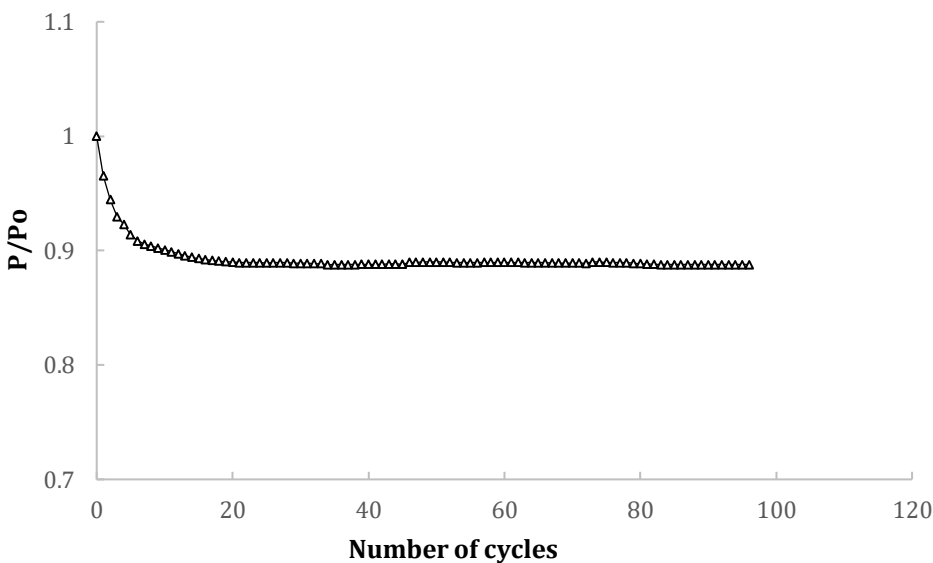
Figure 4.15 shows the clamping force (P) reduction with respect to the increase in load cycles.

Figure 4.15. Clamping force reduction with respect to load cycles

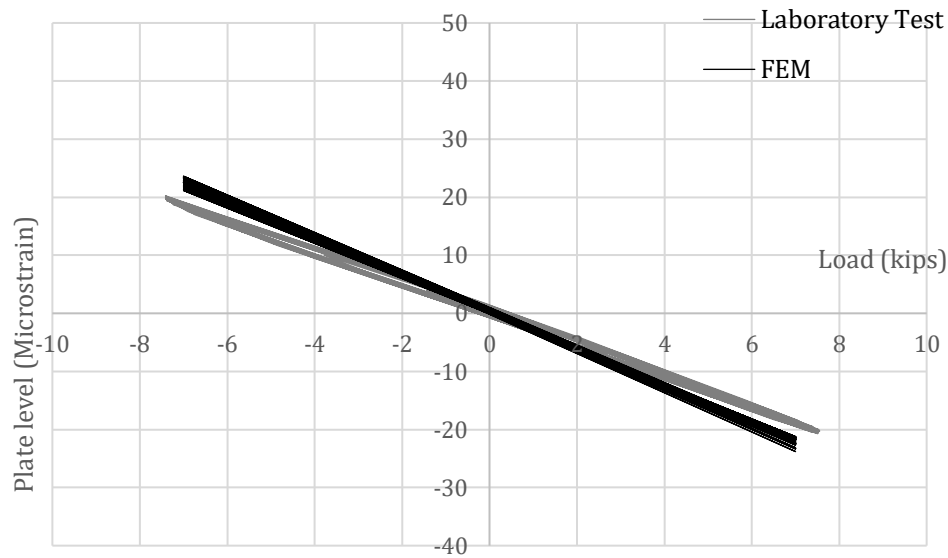
Because of the preload reduction on the FEM in the first 20 cycles, the strain data used in the validation were output from the load cycles after the first 20. The strain from both the embedded gauge and the standoff gauge were utilized for the validation. Figure 4.16 shows the model validation by rod strain at the plate level.

Figure 4.16. Model validation by rod strain at plate level (cyclic load)

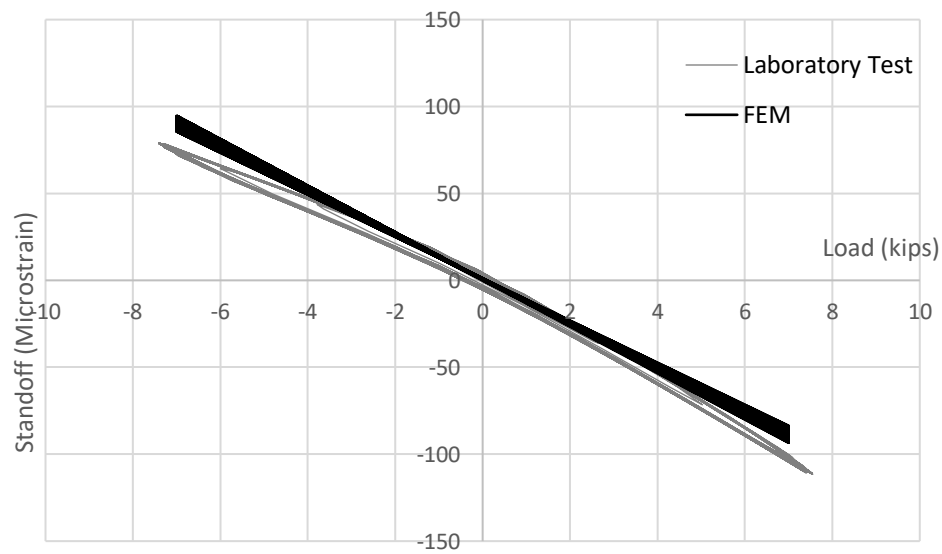
Figure 4.17. Model validation by strain from standoff strain gauge (cyclic load)

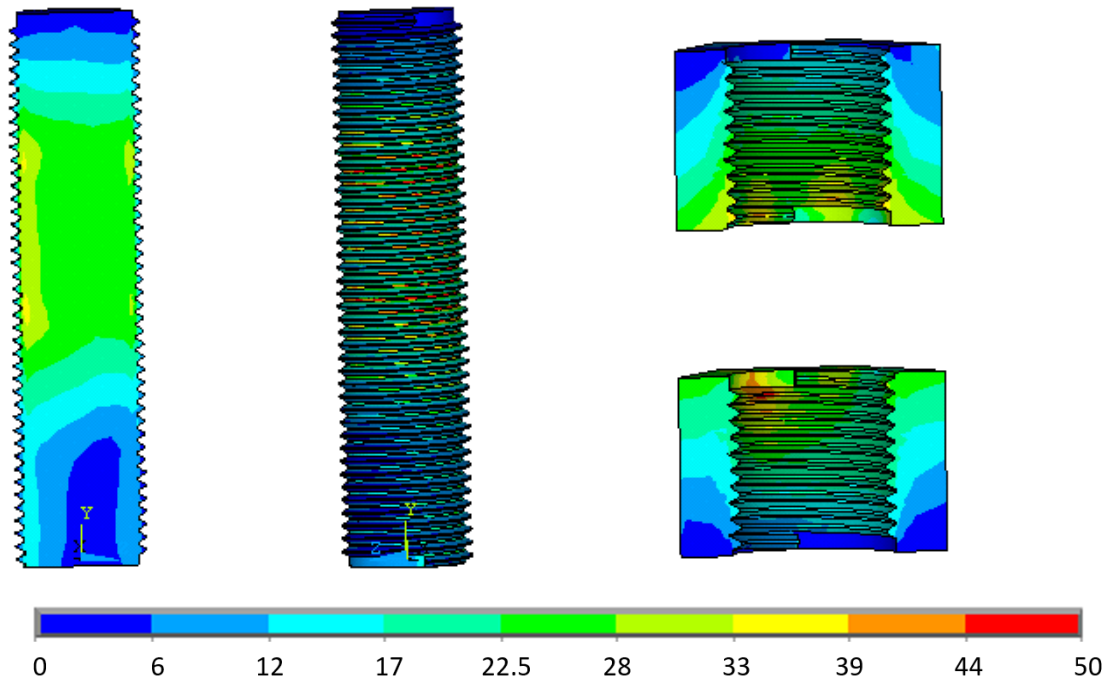
Figure 4.18. Von-mises distribution in the rod and nut (cyclic load)

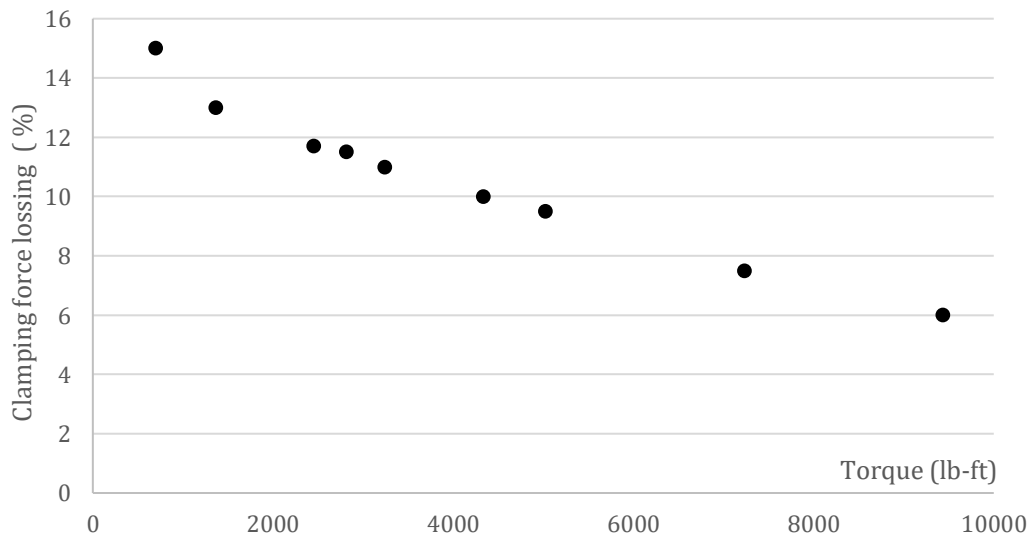
Figure 4.19. Stress loss after during first 20 load cycles (for Model 1 through Model 9 and calibrated model)

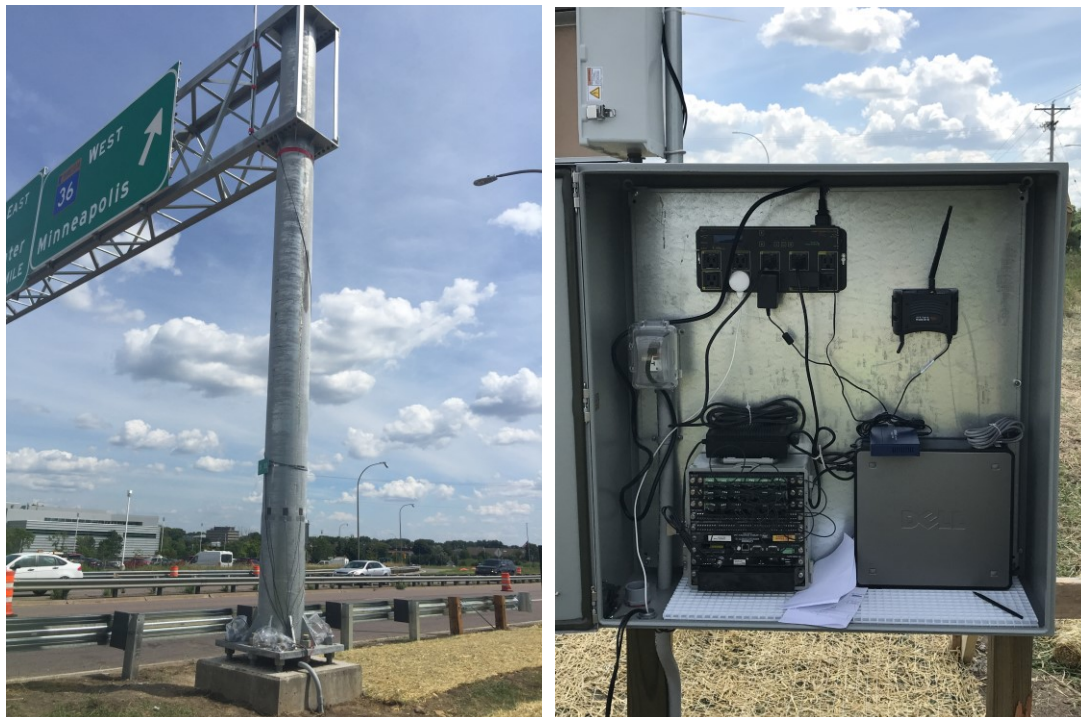
Figure 5.1. Instrumented sign post (left) and data logger cabinet (right)

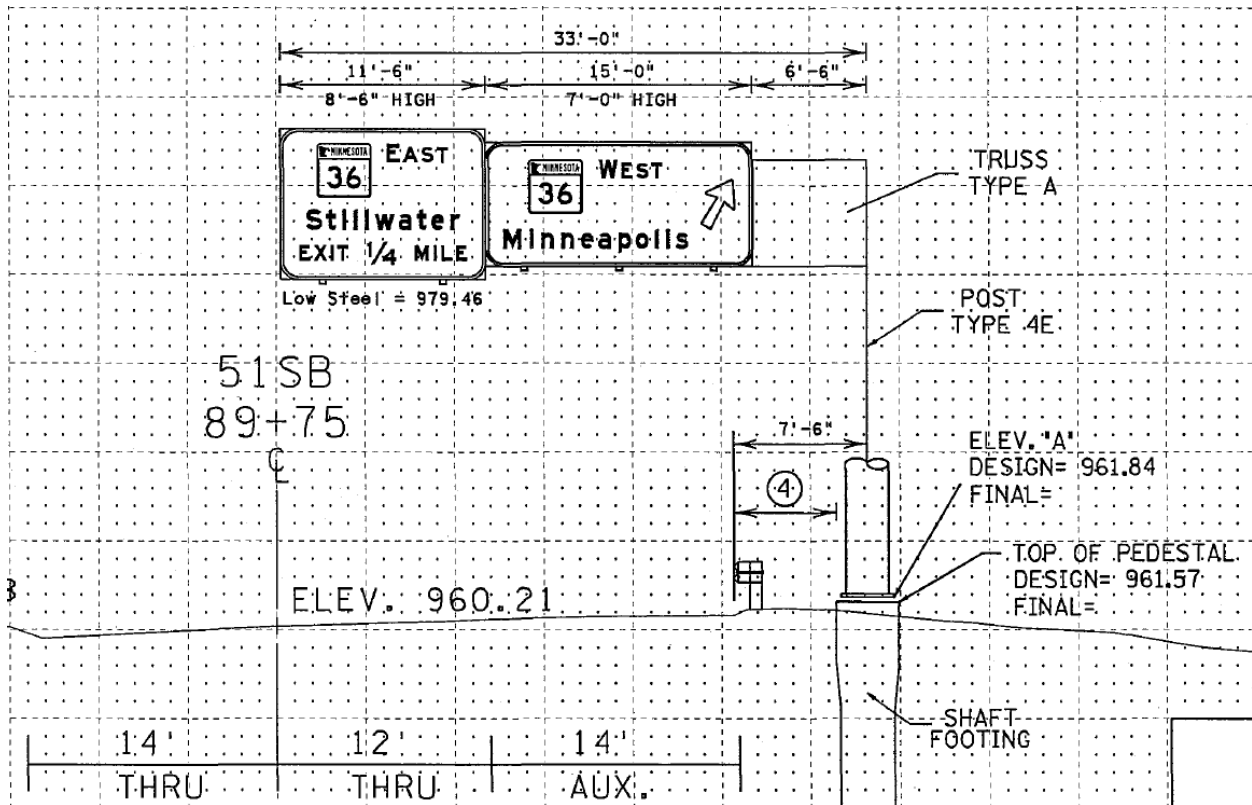
Figure 5.2. Elevation of sign structure from southbound travel

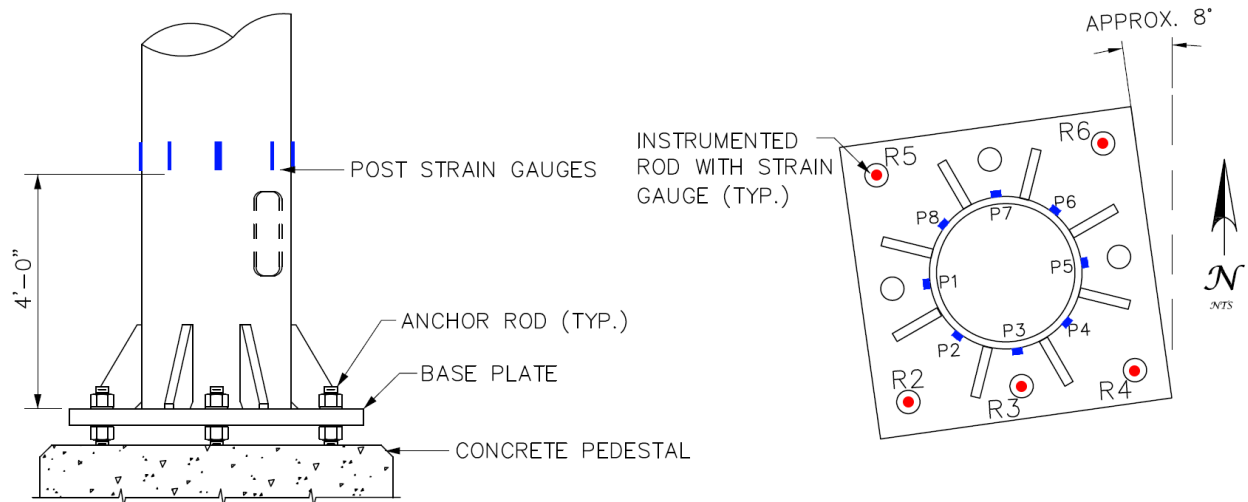
Figure 5.3. Lower post instrumentation elevation view (left) and post base instrumentation plan view (right)

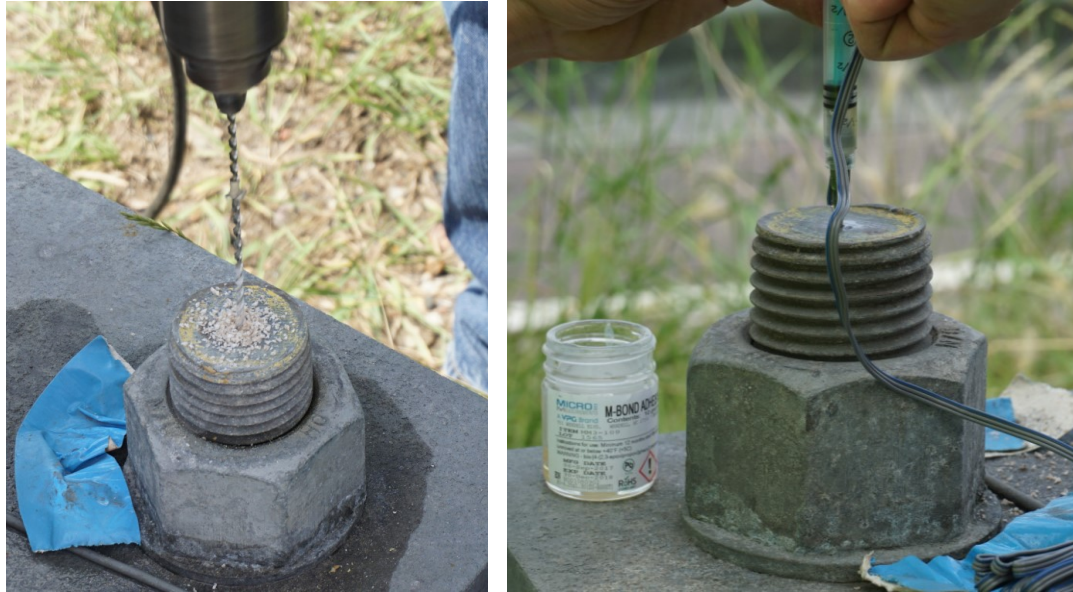
Figure 5.4. Drilling out failed strain gauge (left) and replacing strain gauge and injecting epoxy (right)

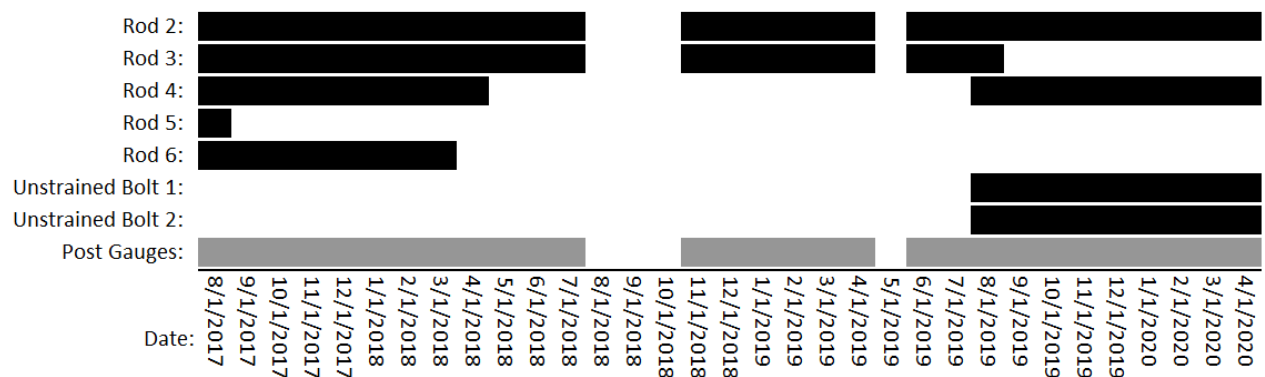
Figure 5.5. Instrumentation timeline

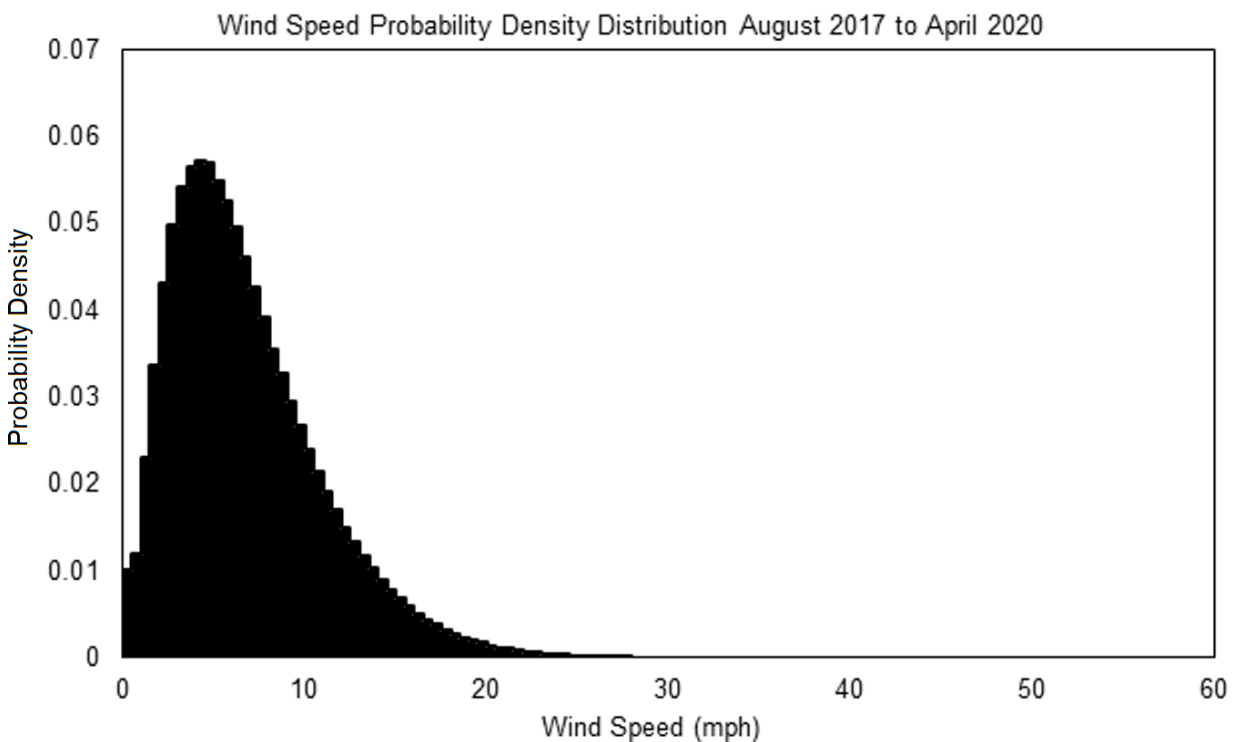
Figure 5.6. Overall wind speed probability density distribution

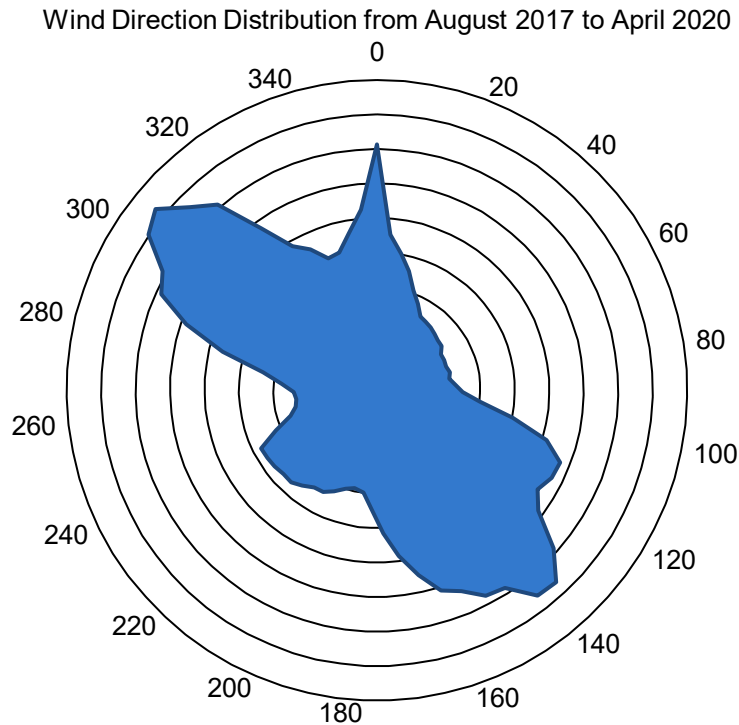
Figure 5.7. Overall wind direction distribution

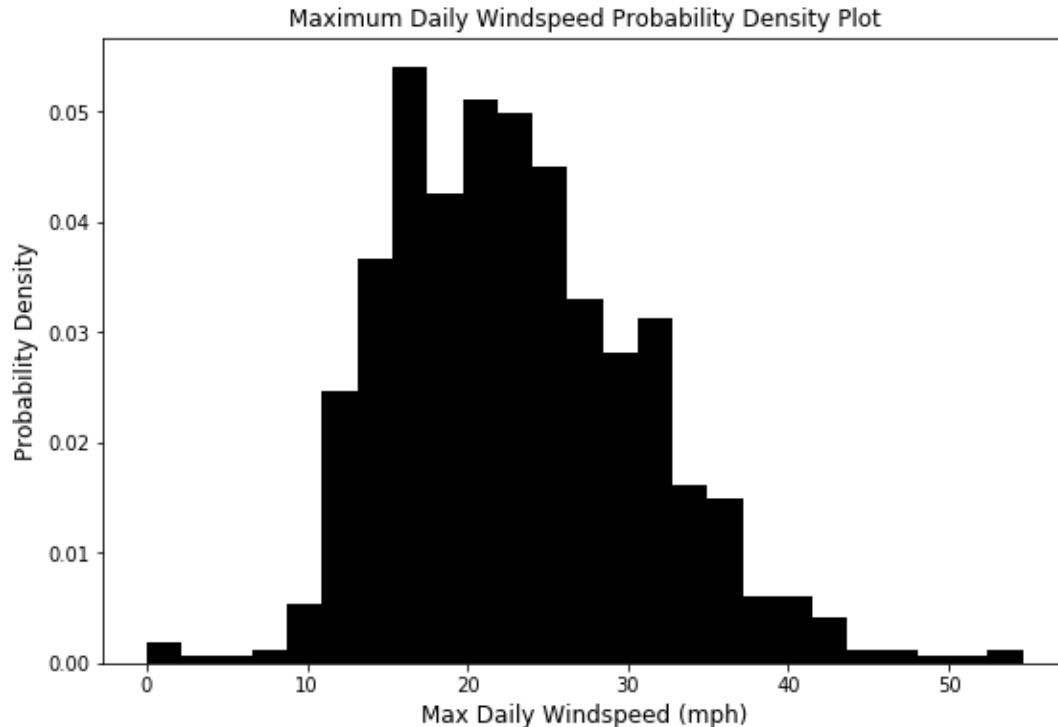
Figure 5.8. Maximum daily wind speed probability density distribution

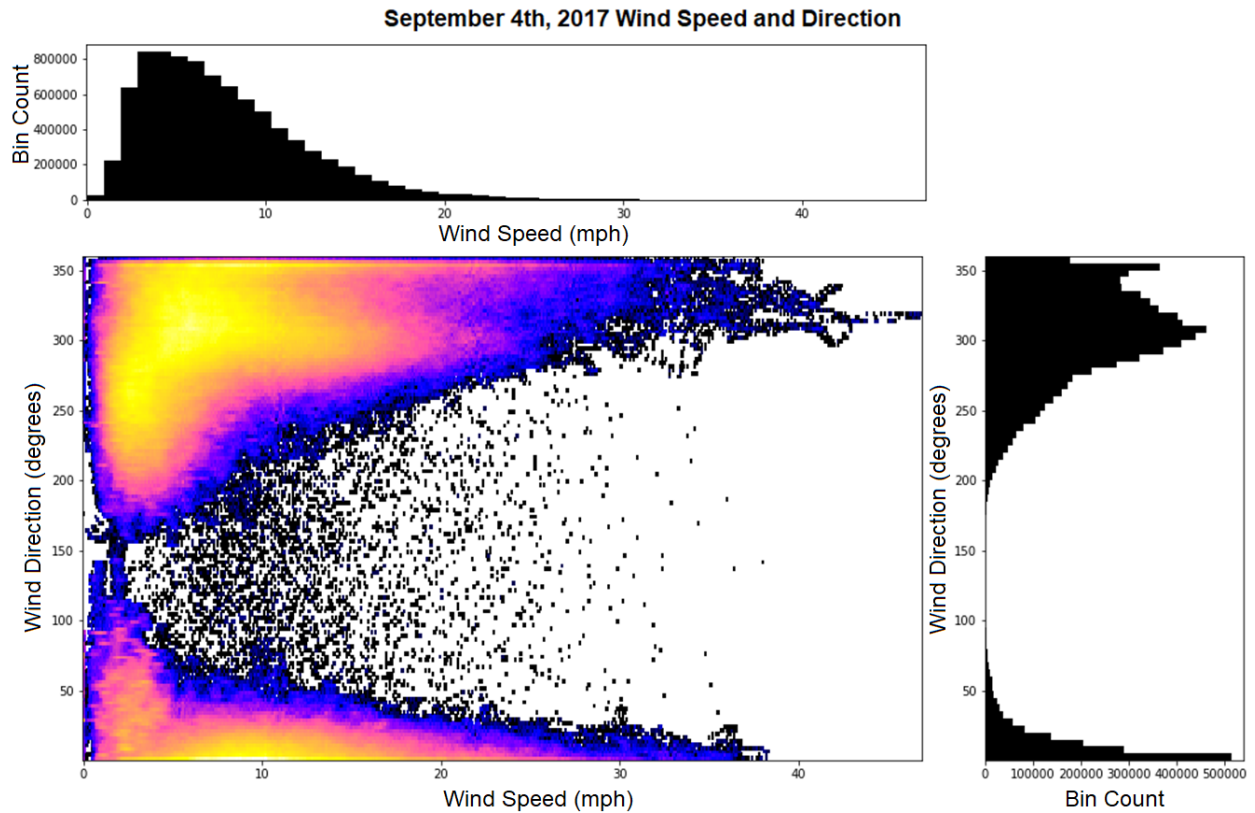
Figure 5.9. Wind characteristics for September 4, 2017

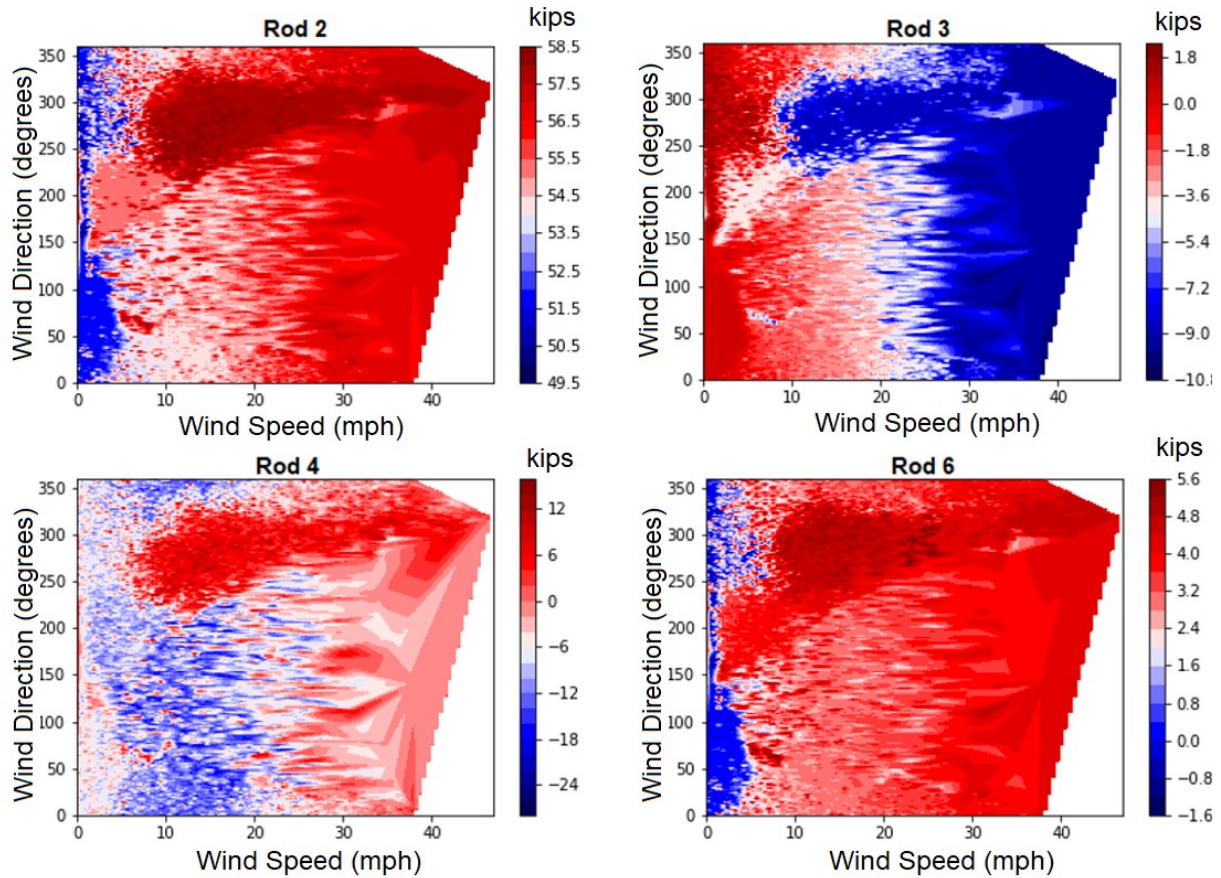
Figure 5.10. Anchor rod response to wind loading

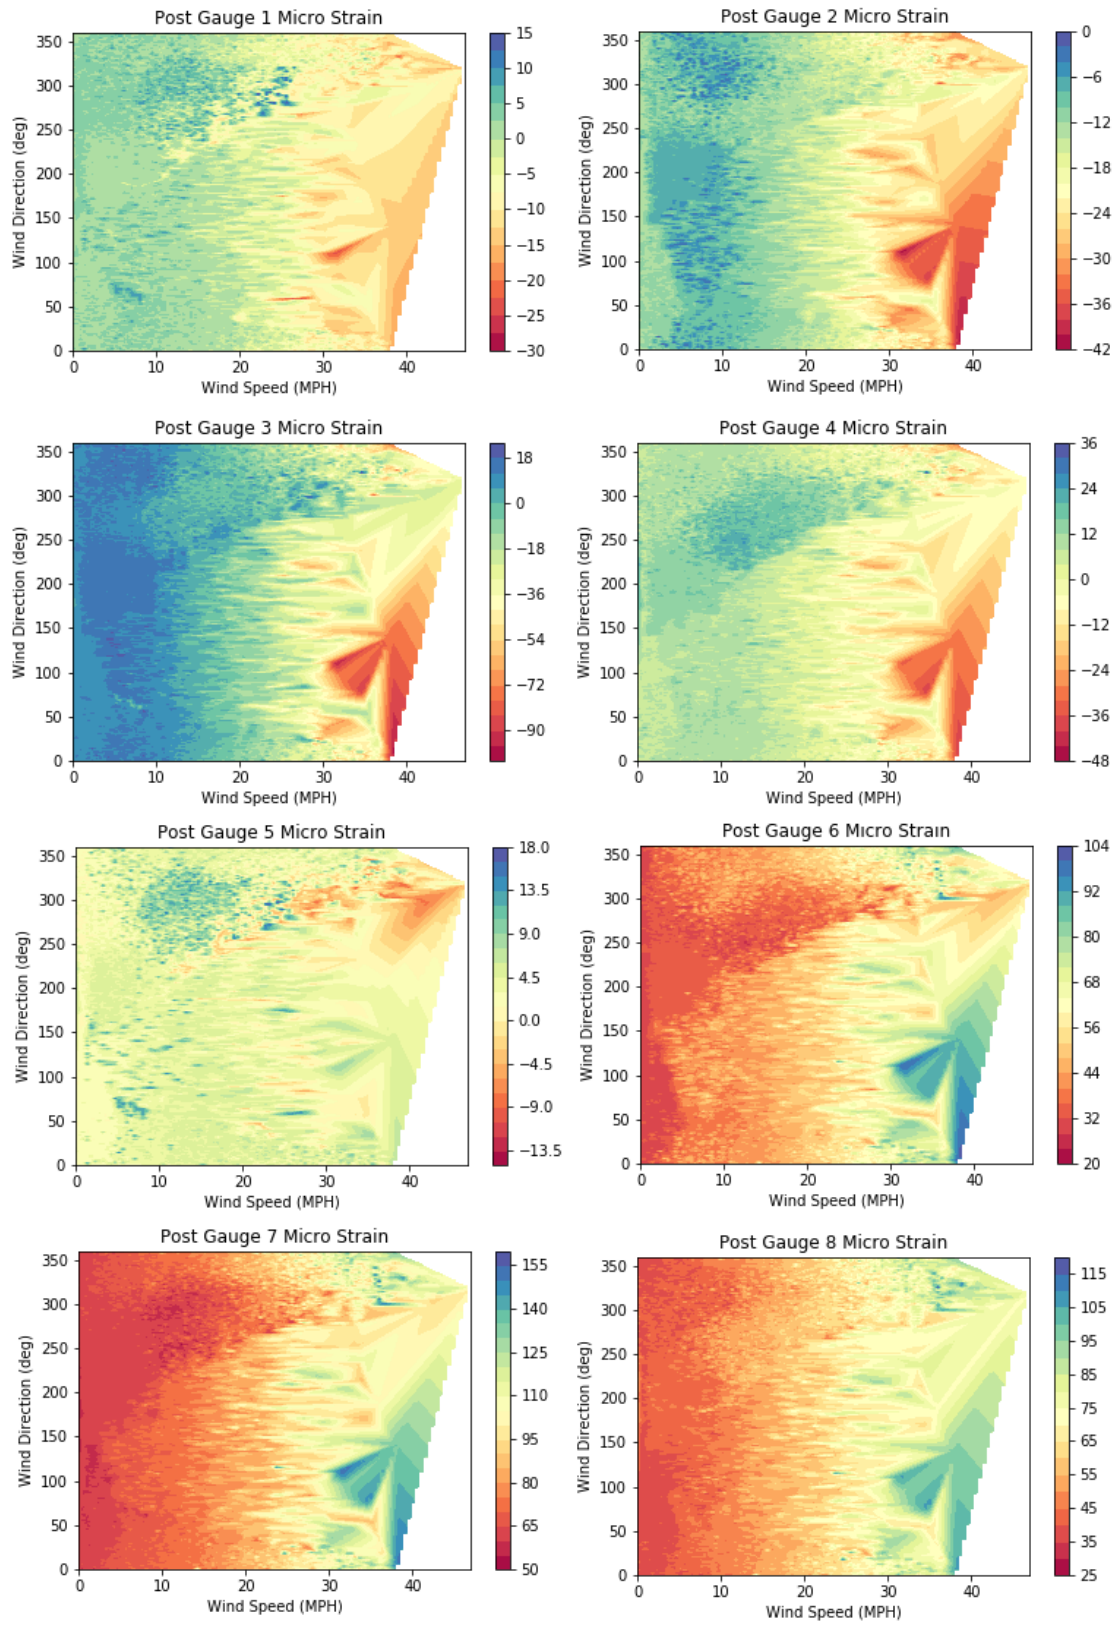
Figure 5.11. Post strains induced by applied loading
