Re-Tightening the Large Anchor Bolts of Support Structures for Signs and Luminaries: Phase II

Bridge Engineering Center

Research Report

Final Report 2021-23

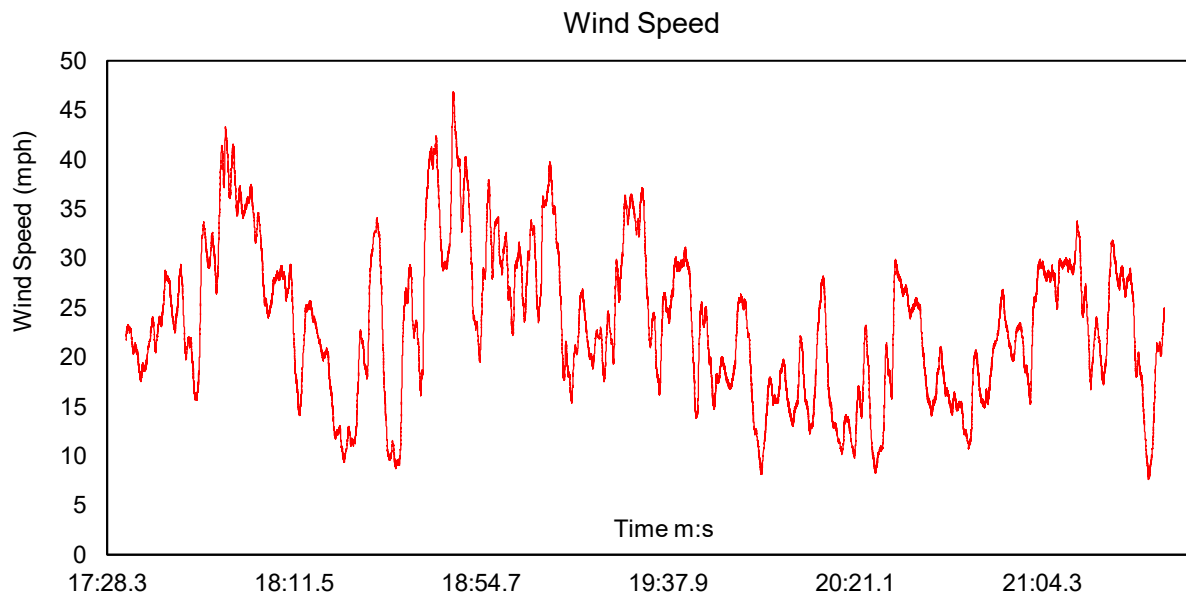
Figure 5.12. Wind loading over selected 250-second timeframe

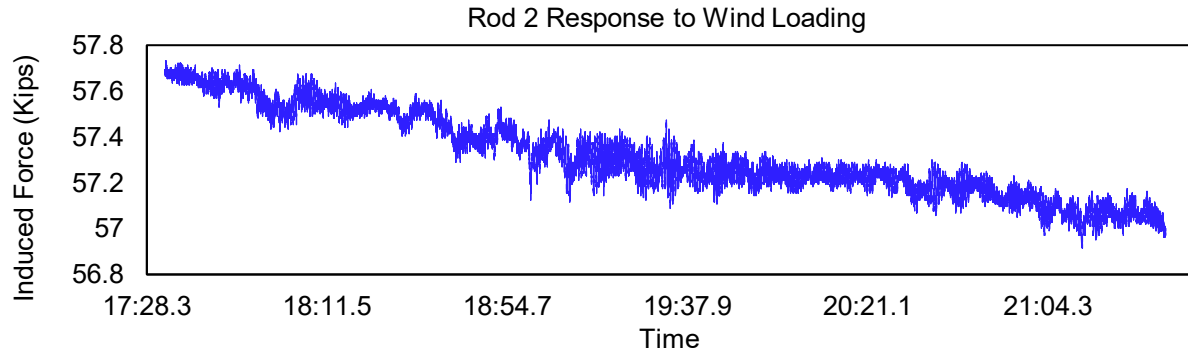
Figure 5.13. Rod 2 response to wind loading

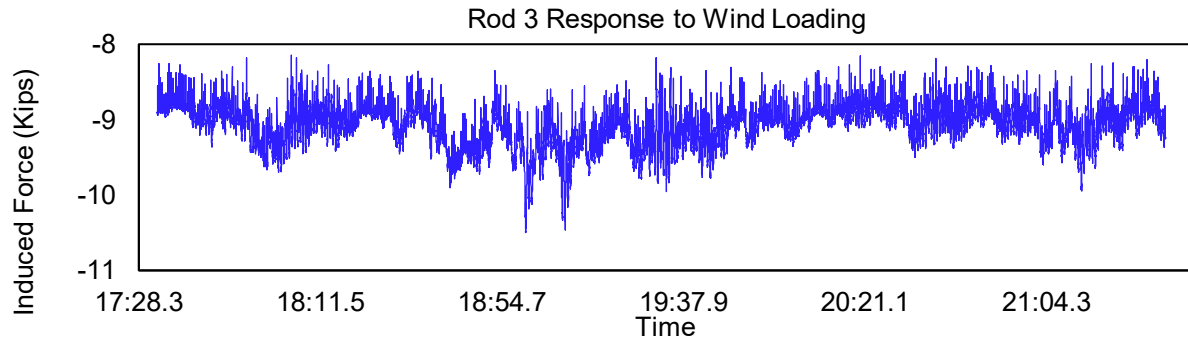
Figure 5.14. Rod 3 response to wind loading

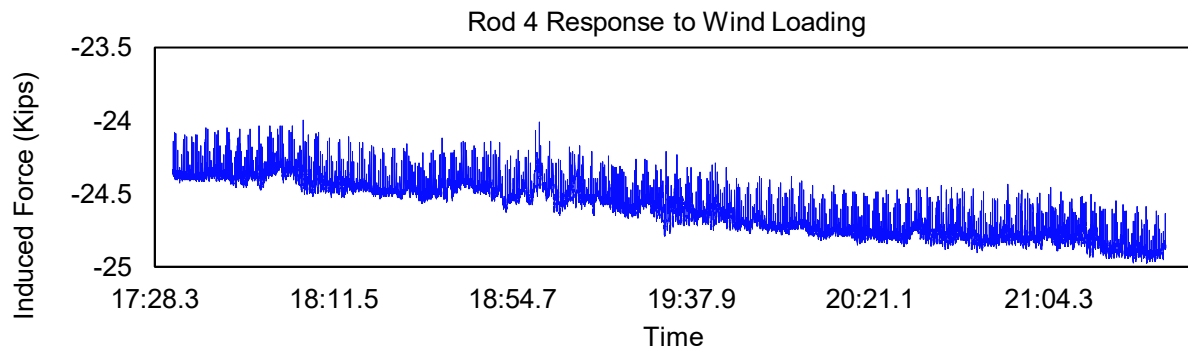
Figure 5.15. Rod 4 response to wind loading

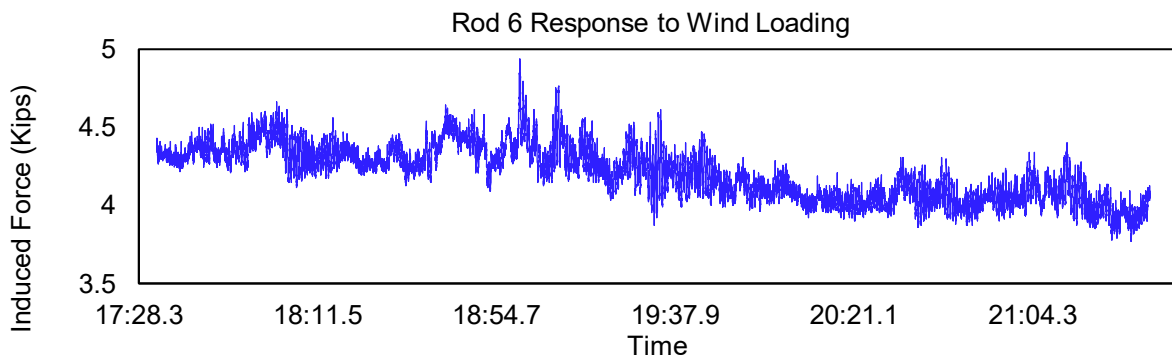
Figure 5.16. Rod 6 response to wind loading

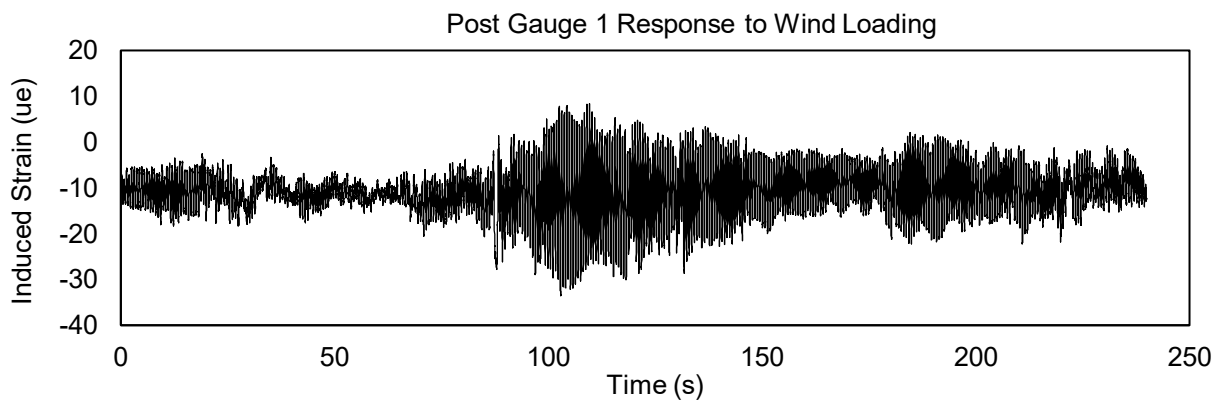
Figure 5.17. Post gauge 1 response to wind loading

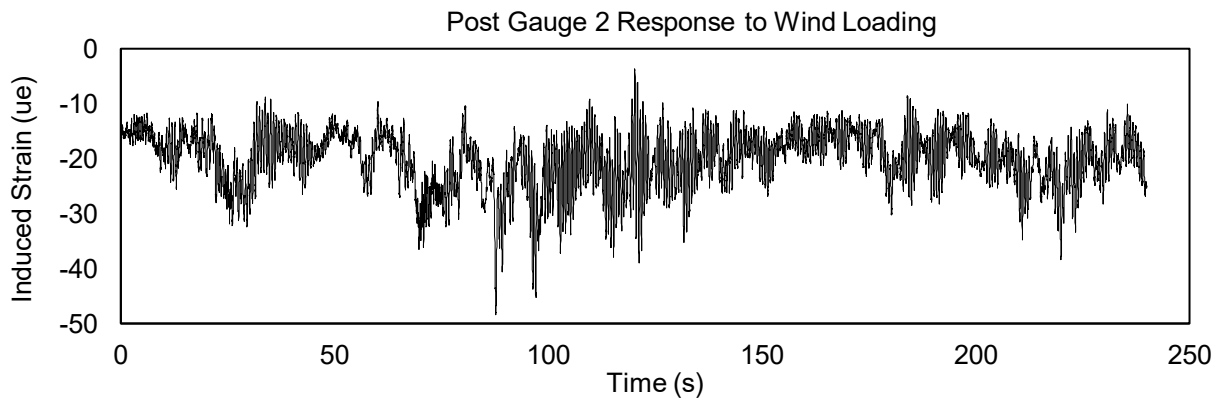
Figure 5.18. Post gauge 2 response to wind loading

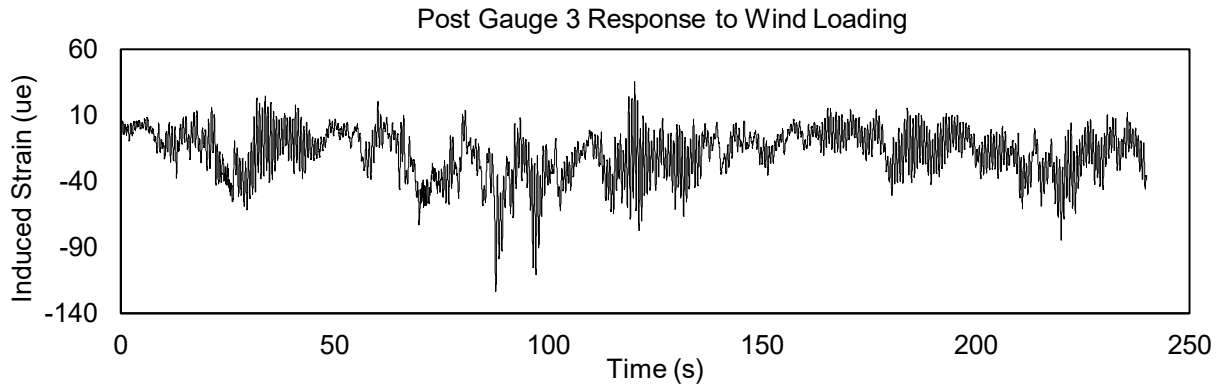
Figure 5.19. Post gauge 3 response to wind loading

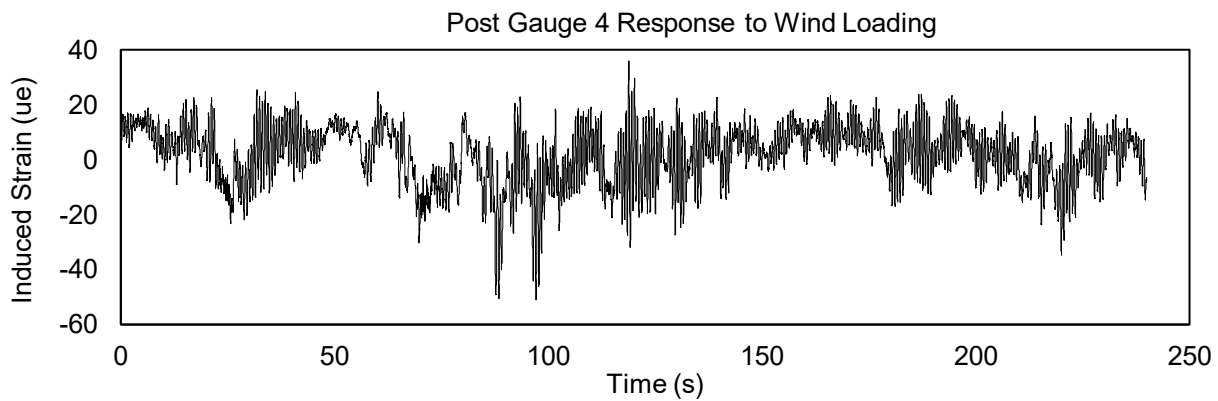
Figure 5.20. Post gauge 4 response to wind loading

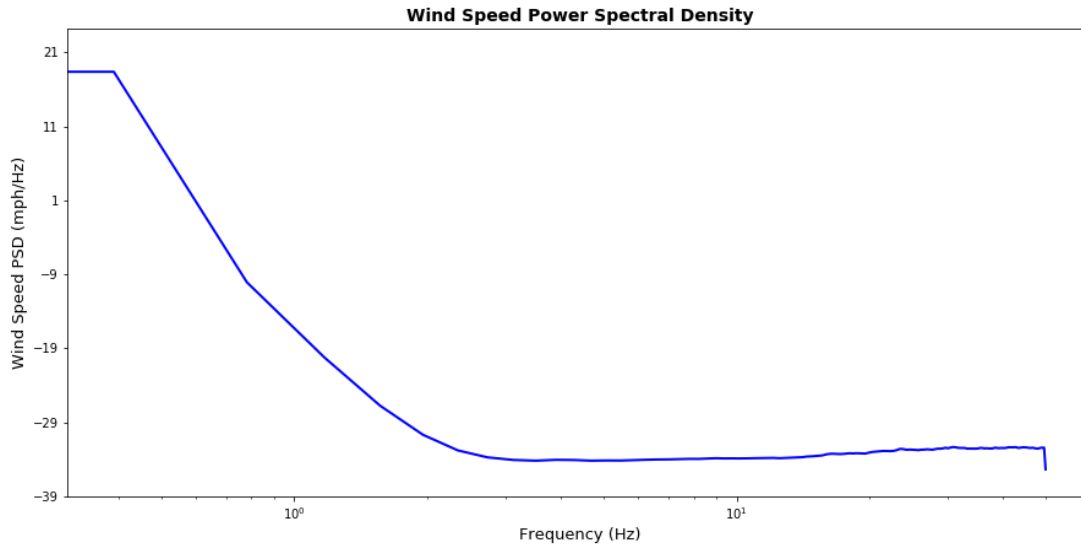
Figure 5.21. Wind speed power spectral density

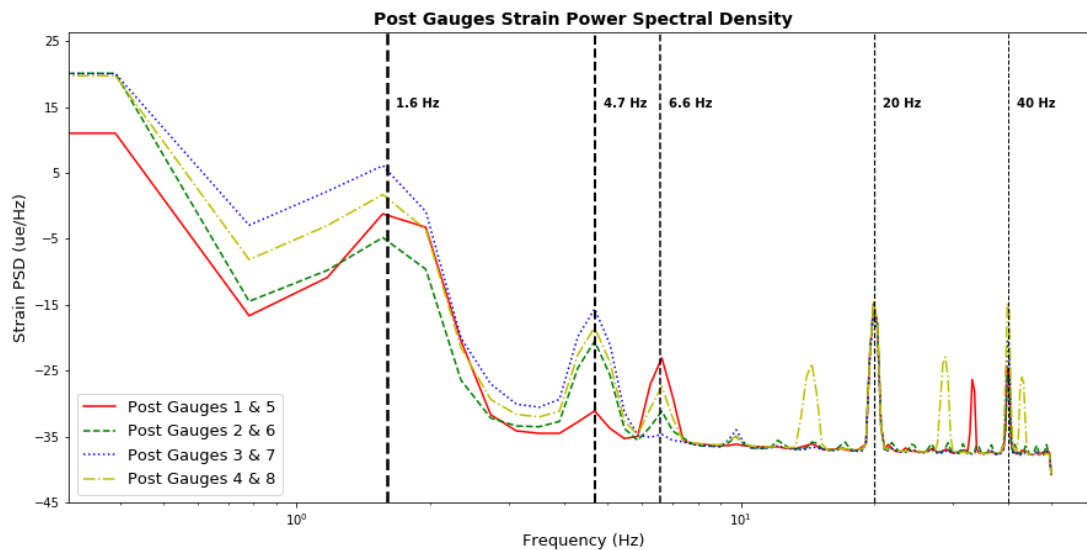
Figure 5.22. Post gauge power spectral density

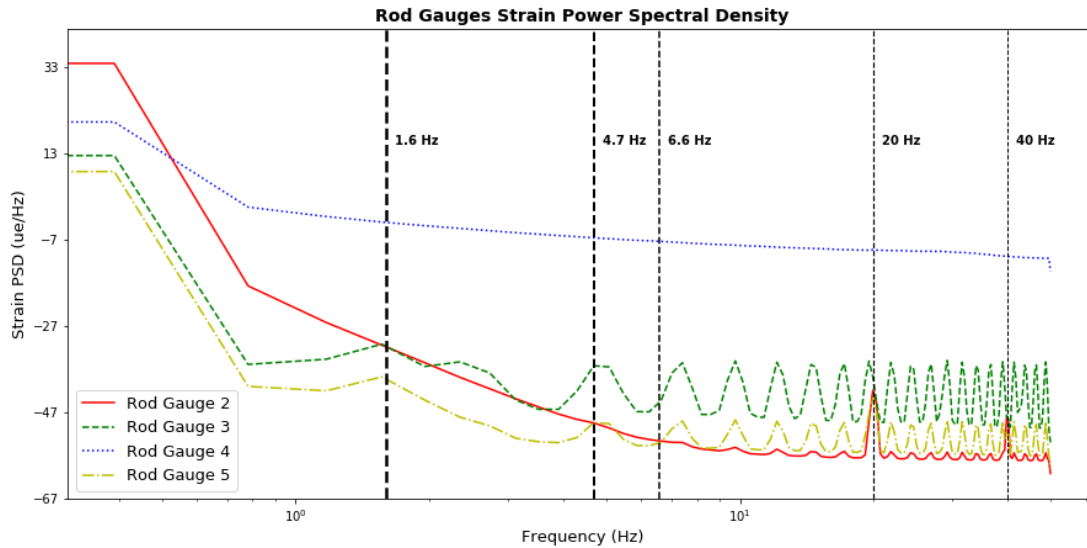
Figure 5.23. Anchor rod power spectral densities
