Article

Assessing the Prospects of Transboundary Multihazard Dynamics: The Case of Bhotekoshi–Sunkoshi Watershed in Sino–Nepal Border Region

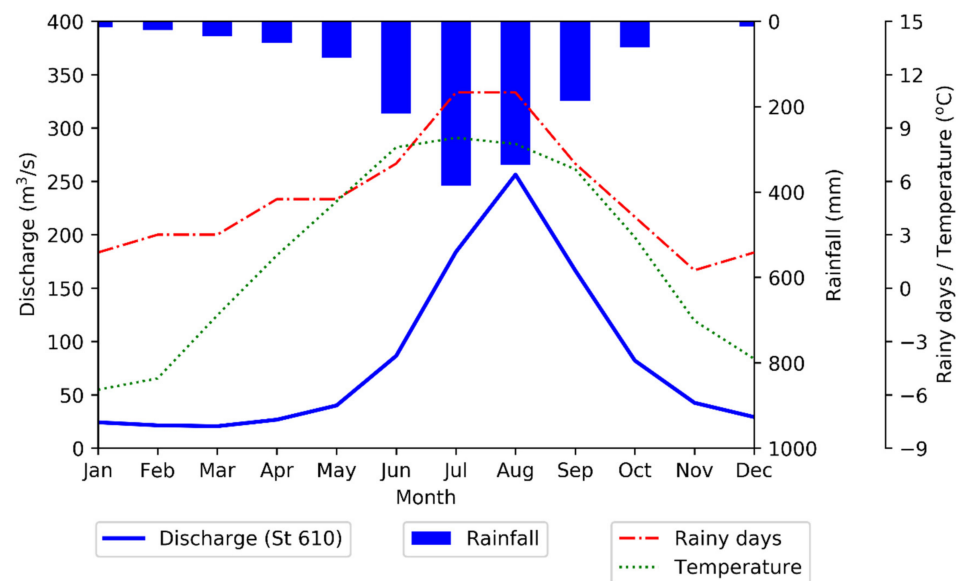
Figure 5. Mean monthly discharge at Bahrabise station (Station no.: 610) and basin-averaged mean monthly rainfall (inverted y-axis at right), and rainy days and average temperature (offset right axis) of the study area. Monthly discharge data for Bahrabise station is computed from the data maintained by the Department of Hydrology and Meteorology (DHM), basin-averaged rainfall and rainy days are computed from the CHIRPS data using 94 grid points and basin-averaged temperature is computed from the WorldClim data.

The hydrological characteristics of the study area are shown in Figure 5. The spatially averaged values of the mean monthly climatic variables (rainfall, rainy days, and temperature) clearly show significant intra-annual variability. In particular, a strong seasonality in rainfall could be observed, with almost 80% of the average annual rainfall being received during the rainy season. Due to a large altitudinal variation across the study area, there are significant temperature differences between the highest temperature (over 23 °C) at lower regions during July and the lowest temperature (below −20 °C) at upper region of the study area during January. An average of 30 °C variation of temperature could be seen across the study throughout the year. The river valley is warmer and drier compared to the hill slopes. The monthly rainfall is above 350 mm (rainy days ~11 days) during July and August, accompanied by the highest air temperature (about 8 °C, varying from −4.5 °C in the upper region to 23 °C in the lower region). Generally, the heaviest rainfall is accompanied by the greatest average temperature. The monthly variation of the river discharge at Bahrabise shows a peak value during August. July and August are the two months when a peak instantaneous discharge could happen upon heavy rainfall upstream of the study area. We found that 10–13% of the annual rainfall is contributed by a single day's rainfall, which clearly indicates high-intensity, short-duration rainstorm events are recurrent across the study area. Considering the maximum consecutive seven-day rainfall for every year between 1981–2019, this study finds that about 20% of the total annual rainfall occurred during the consecutive seven-day period. Under such a scenario, the soil of the hillslopes becomes completely saturated, and there are high chances of the failure of unstable slopes. After the 2015 Gorkha earthquake, more than 2000 landslides (small to large) occurred along the corridor of Bhotekoshi–Sunkoshi River [53].

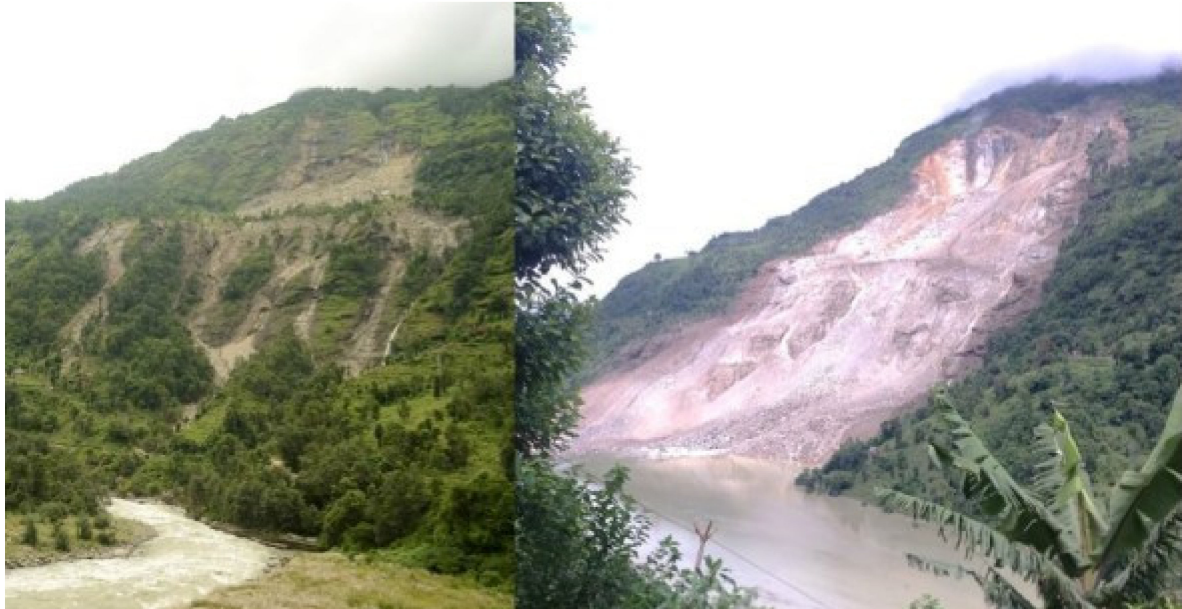
Figure 10. Jure landslide site. The photo on the left (Image credit: Narendra Khanal) shows the site after a small movement of earth in June 2013. On the right, the same site after the devastating landslide on 2 August 2014. The lake formed by the landslide dam can be observed in right image.

The Jure landslide, which occurred in the early hours of 2 August 2014, is one of the massive landslides in Nepal. The landslide mass (rock and debris) completely blocked the Sunkoshi River and created a landslide dam (Figure 10). The river also showed nil discharge for the first nine hours, and an outlet was opened at around 2 pm (almost 12 h of damming) by experts from government agencies and the Nepali Army [61]. After 37 days of the formation of the landslide dam and artificial lake, the dam breached on 7 September 2014, predominantly due to overtopping. During the landslide, there was no rainfall, as evidenced by the rainfall observing station at the Bahrabise gauging station located ~3.7 km upstream, which showed zero rainfall reflecting the causes behind the huge mass movement, not the exact measurement of the rainfall. However, the rain that infiltrated along the cracks and into the loose soil layer during the monsoon (rainy season) might have saturated the unstable mass. Shrestha and Nakagawa [61] reported that satellite images acquired in September 2013 showed the area had experienced landslides and several scars, revealing the existence of an unstable mass along the mountain slope. Ao et al. [62] also

revealed that the upper part of landslide had long become unstable before the collapse. Further, the expansion of nonengineered road construction is promoting shallow landslides or reactivating old landslides.

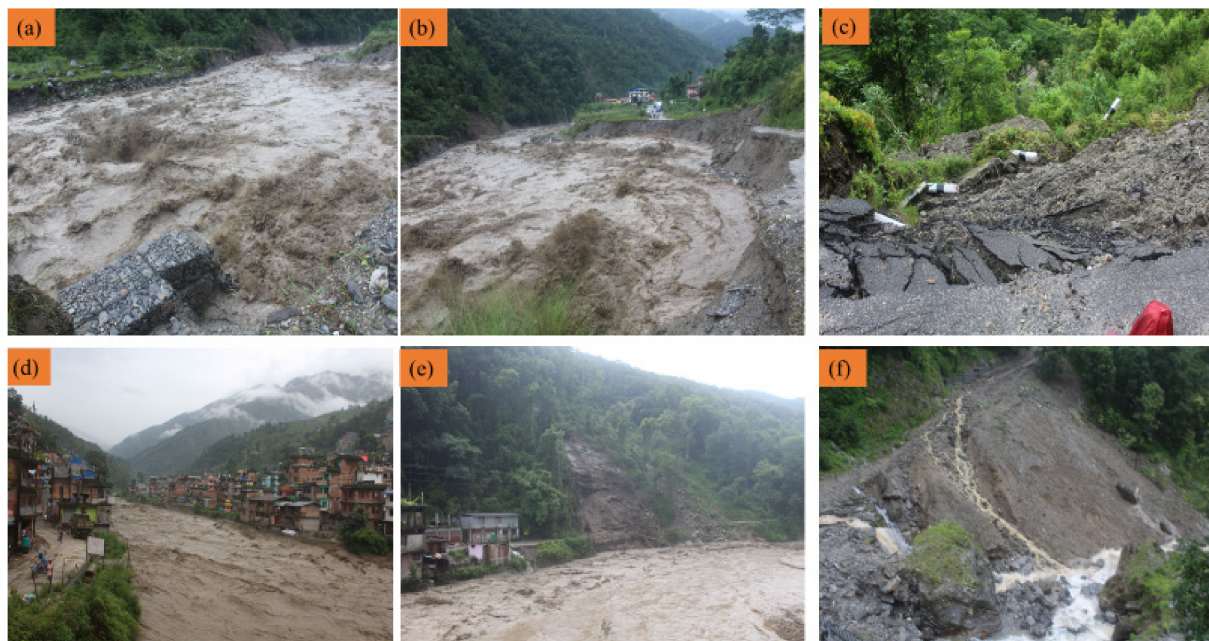
Figure 12. Effects of flooding and debris flow: (a) toe cutting and subsequent damage to protection structure by Sunkoshi River, (b) mass movement and slope failure due to toe bank erosion, (c) highway section damaged due to debris flow, (d) flooding in Bahrabise neighborhood, (e) obstructed road section due to slope failure, (f) slope failure across a gorge.

The debris flow and the flooded Sunkoshi River significantly affected communities and infrastructures, as shown in Figures 12 and 13. For instance, toe cutting was observed along the river stretch that threatened several settlements and damaged retaining structures. Nearly 700 m of the highway was swept away by the debris flows and toe cutting. Two people were confirmed dead and 17 others were reported to be missing. Meanwhile, 16 houses were damaged by the debris flows. Apart from this, a bridge (Purkutte bridge) collapsed due to the flooding that occurred in the Bhotekoshi River. The Middle Bhotekoshi

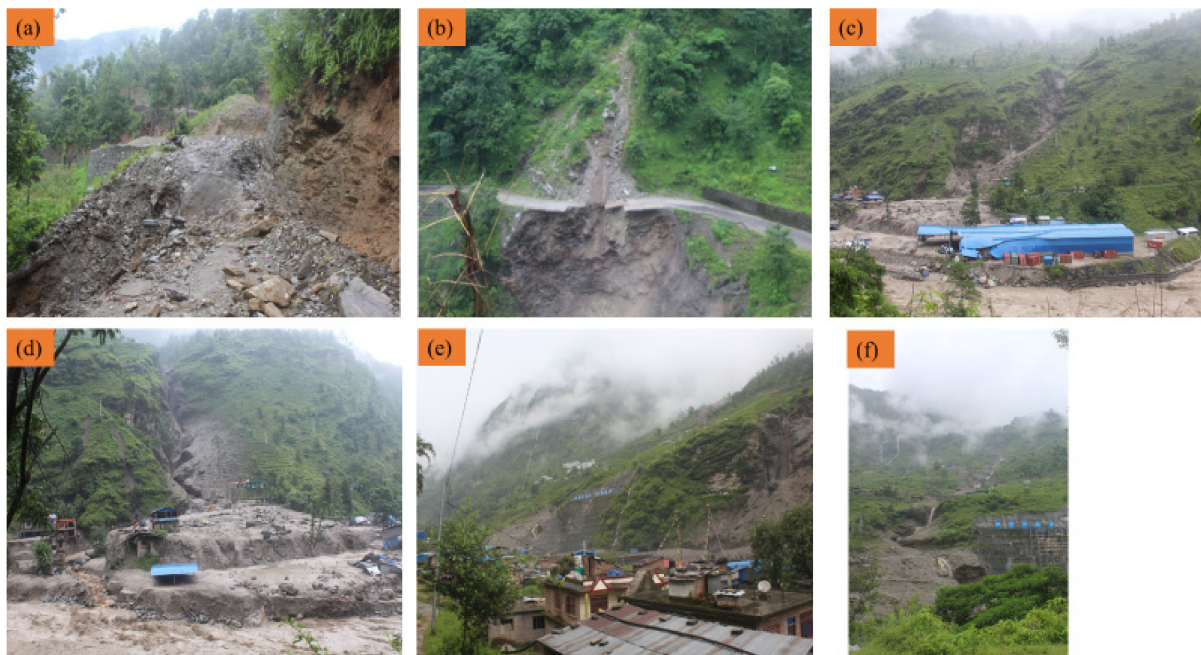
Figure 13. (a) Rural road section wiped out by debris flow, (b) highway section damaged by debris flow, (c) damage to warehouse, (d) completely destroyed Jambu neighborhood by debris flow, (e) damage to Middle Bhotekoshi Hydropower Project, (f) widening of debris flow along the gorge.

Hydropower Project was also affected by the debris flow on its intake side. The debris flow also affected the warehouses of the project.

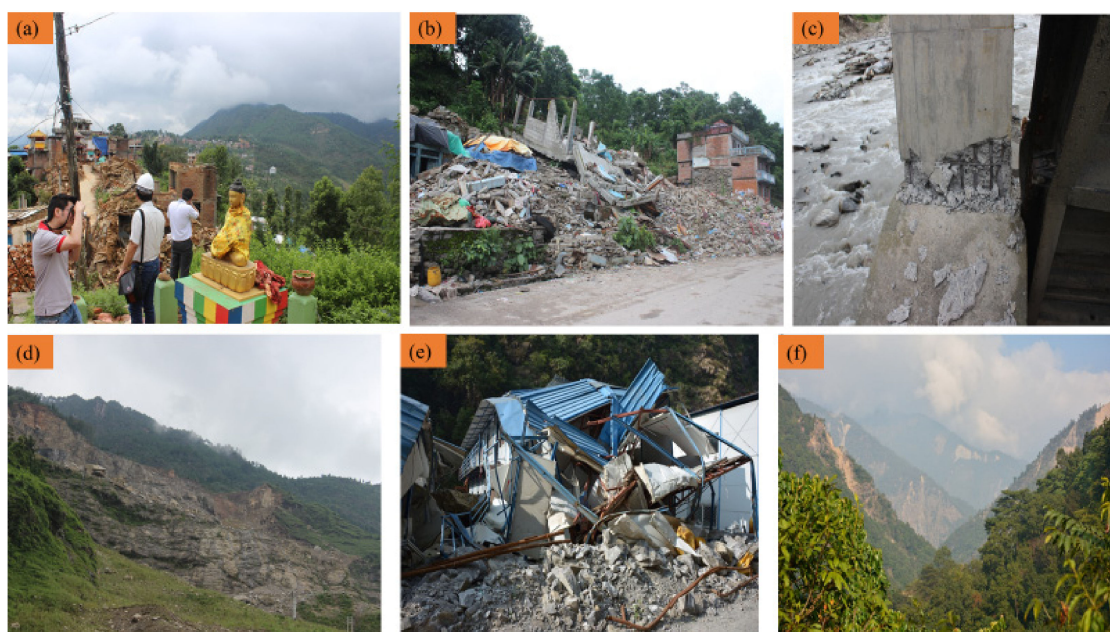
Figure 15. (a) Damaged settlement across a ridgeline in Sindhupalchowk district, (b) destroyed settlement along the Arniko Highway in Sunkoshi–Bhotekoshi watershed, (c) damaged pier of the Sunkoshi hydropower project reservoir site, (d) reactivated Jure landslide due to the earthquake, (e) damage to water supply infrastructure, (f) landslides triggered in the mountains across the Bhotekoshi–Sunkoshi watershed.

Some notable evidence displayed by the 2015 Gorkha earthquake in Sindhupalchowk is presented in Figure 15. Figure 15a shows a dense settlement at the ridge collapsed by the earthquake. Similarly, the entire settlement across the Bhotekoshi–Sunkoshi corridor was destroyed by the earthquake, as shown in Figure 15b. The earthquake also caused extensive damage to the infrastructure. Figure 15c shows the damage to a pier of the bridge at the reservoir location of the Sunkoshi hydropower project. An important piece of cascading evidence was displayed in the Jure landslide area, as shown in Figure 15d. The landslide was again triggered. Due to the reactivation of the landslide, large boulders and debris flow occurred that blocked the Arniko Highway. Similarly, the water supply infrastructure was affected by the earthquake in Sindhupalchowk. Figure 15e shows the damage caused by the earthquake in Melamchi Water Supply Project headwork site. The earthquake triggered many landslides across the Bhotekoshi–Sunkoshi watershed. However, the size of landslide was not uniform, as shown in Figure 15f.

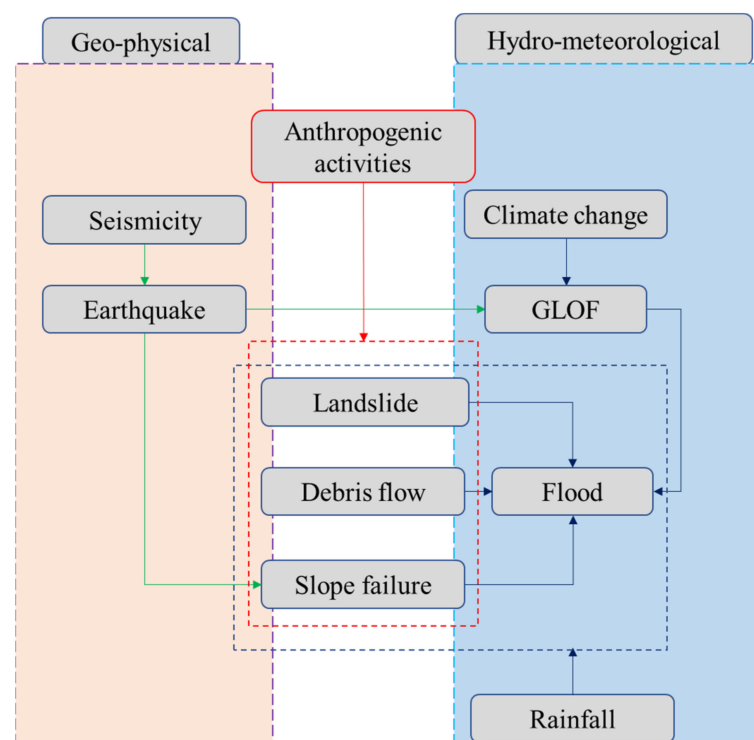
Figure 17. Cause and consequence matrix for multiple independent and cascading hazards for Bhotekoshi–Sunkoshi watershed.
