**Determination of Mangrove Adequacy as Natural Coastal Defence Against
Wave Dynamics Using Remote Sensing Analysis for Southern Kedah Coastline**

Bachelor of Engineering (Hons) Civil

September 2017

Universiti Teknologi PETRONAS

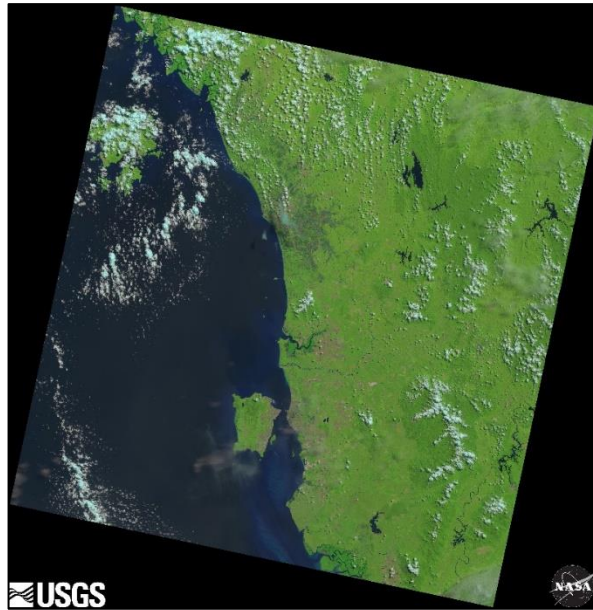
Figure 3.2: Satellite Images of Landsat 8 OLI which covers the whole Kedah's coastline

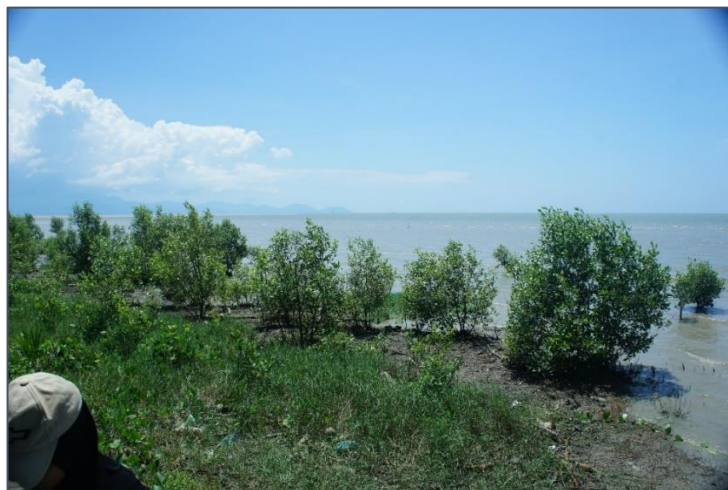
Figure 4.1: Young mangrove trees of *Sonneratia* genus spotted at Kota Kuala Muda coastlines.

Kota Kuala Muda, Kedah was one of the area affected by tsunami that was chosen as one of the study area. Based on observations and assessment made on the study site, the mangrove species identified came from the *Sonneratia* genus. Most of the trees were about the same height which also means they were about the same age. Based on rough estimation, these mangroves were replanted less than 10 years back as the plant was considered young. The mangrove plants that were more seaward were much smaller which could be explained due to their exposure to the waves breaking.

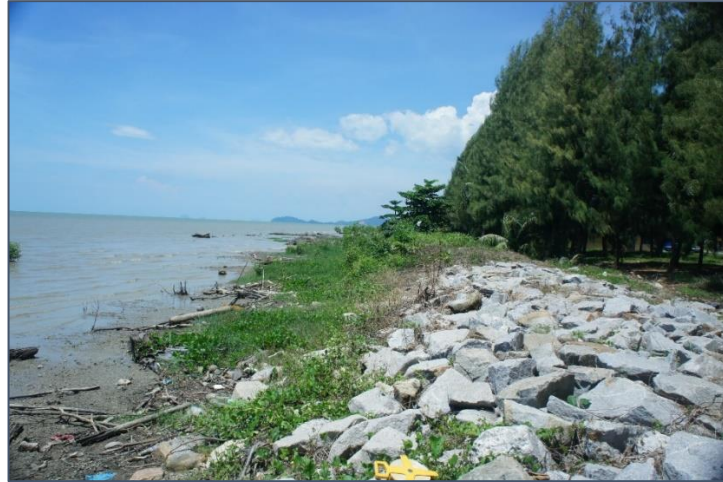
Figure 4.2: Existing rock revetments protecting Kota Kuala Muda from wave actions.

The mangroves were live on the mud which was in front of the existing rock revetment as shown in Figure 4.2. These mangroves need to grow up and became mature enough

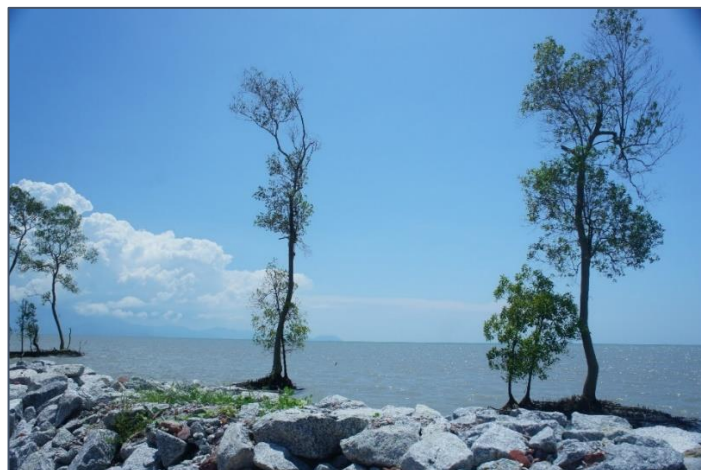
Figure 4.3: Remaining *Sonneratia* tree in front of rock revetments.

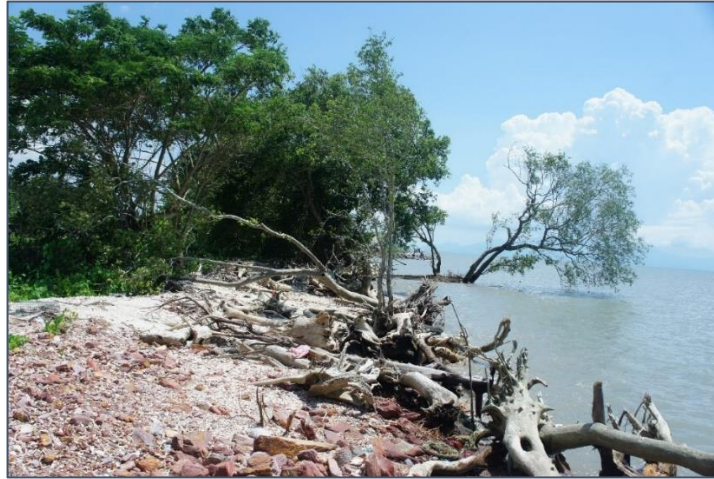
Figure 4.4: Degraded mangrove trees (forest) at Kampung Padang Salim's shoreline.

Based on the condition of the deteriorating sparse forest, these mangroves can no longer dissipate waves effectively and protected the shore as how it used to.

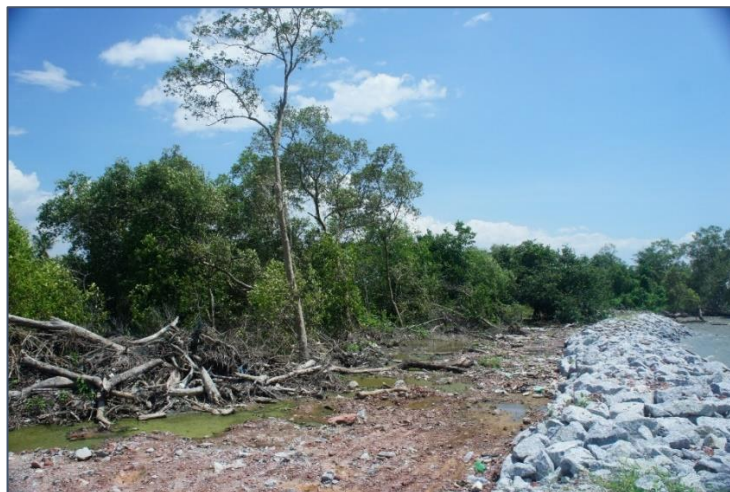
Figure 4.5: Constructed rock revetment to protect the shoreline from wave actions.

Plus, the wave actions were eroding the muddy soil which was very important for the mangrove survivability. Therefore, the last protection of the shore was applied which was the construction of the rock revetments which was reported by the villagers, recently build by the DID Kedah.

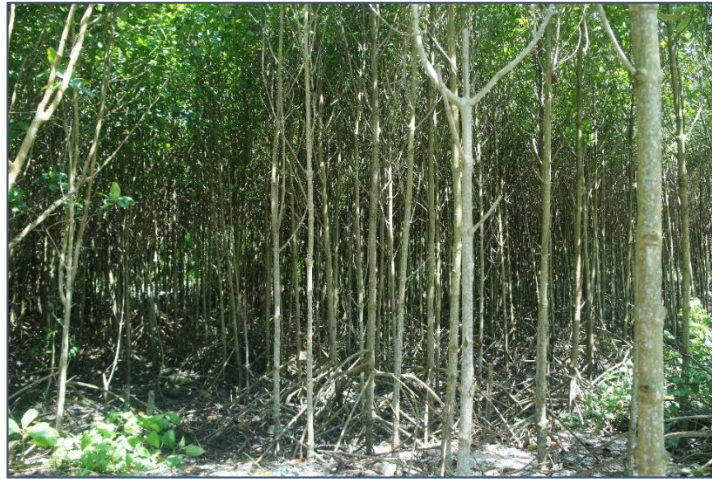
Figure 4.6: Replanted mangrove forests of *Rhizophora Apiculata* and *Rhizophora Mucronata* in Sungai Yu.

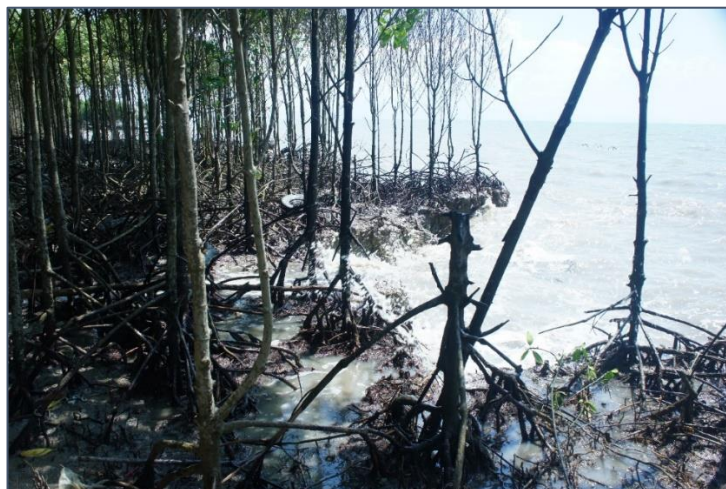
Figure 4.7: Wave actions eroding the muddy soil during high tides.

The forest was quite dense with density 0.64 tree/m² and maximum band width of 60 meters. However, there was evidence that this forest was affected by rough wave actions especially during high tides as shown in Figure 4.7. This forest would eventually degrading as the wave actions keep eroding the muddy soil in the shoreline.

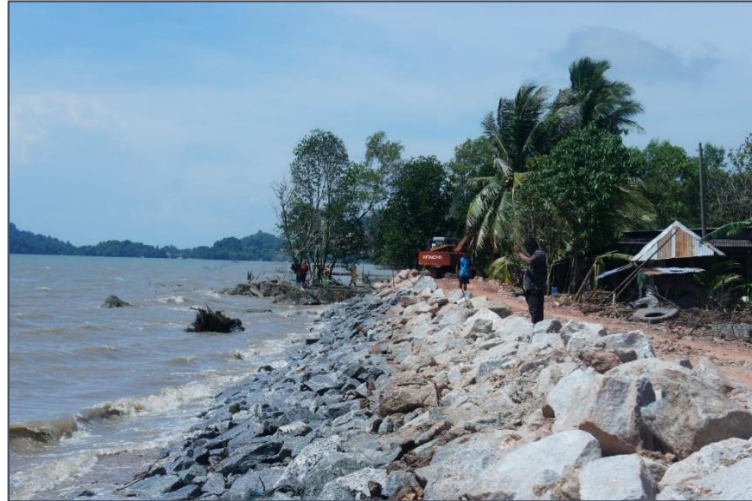
Figure 4.8: Recently constructed rock revetments to protect the coastline.

At the edge of this replantation forest, there were not enough mangroves to protect shoreline. To avoid the wave actions from eroding the shore further landward and affecting the closest resident, DID Kedah decided to put the protection measure to address this problem from worsening as shown in Figure 4.8.

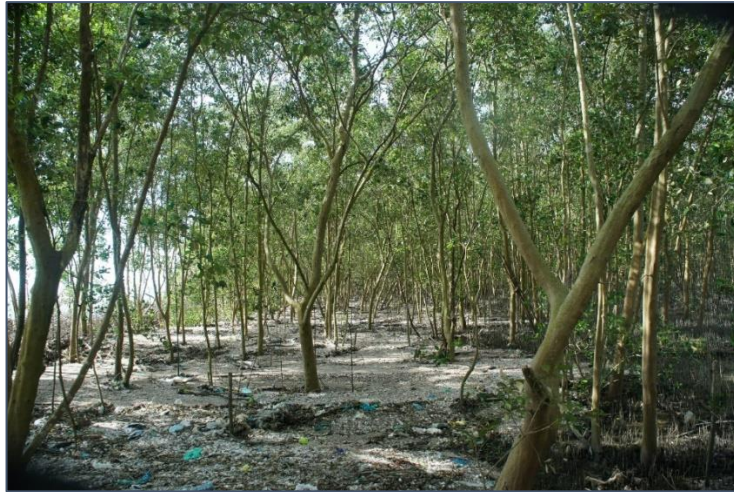
Figure 4.9: Mangrove forest of *Sonneratia* genus and *Rhizophora Apiculata* species

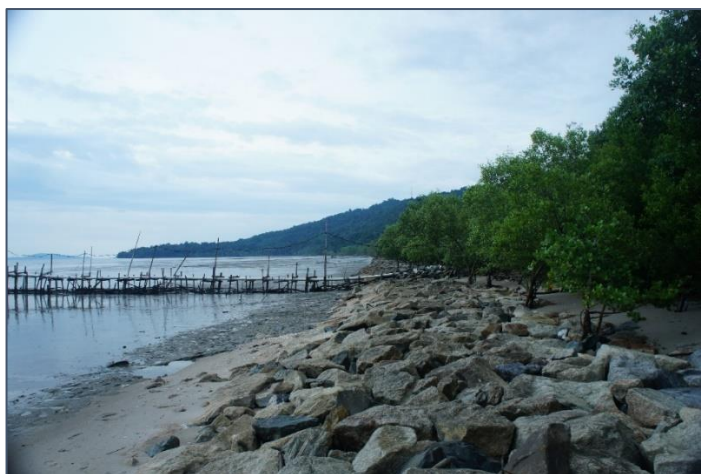
Figure 4.10: Rock revetments extended from the breakwater to the shoreline.

Sungai Singkir Laut, Kedah has a rock revetment extended to the shore as it was attached with the breakwater nearby fishermen's navigation channel. Mangroves tree were found to be behind (landward) of the revetments. There were quite number of species found on the mangroves such as *Bruguiera Sexagulata* species and few species from the *Sonneratia* genus. These trees were matured and expected had age of 15 to 10 years and above. Presence of sediments were found behind the revetments and this sediment has covered most of the mangrove roots and makes it quite challenging to identify the species based on the roots. These mangrove forest were quite dense, and it extend north from the navigation channel. However, it was difficult to assess further due to presence of shrubs and thick grass.

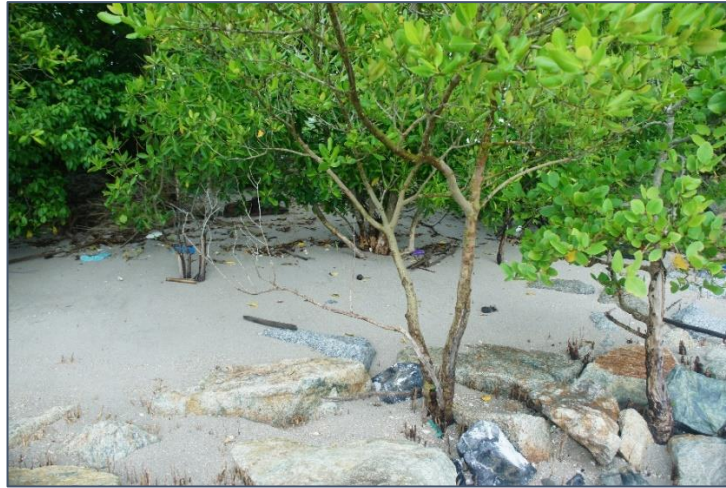
Figure 4.11: Sediments covered the roots of the mangrove trees.

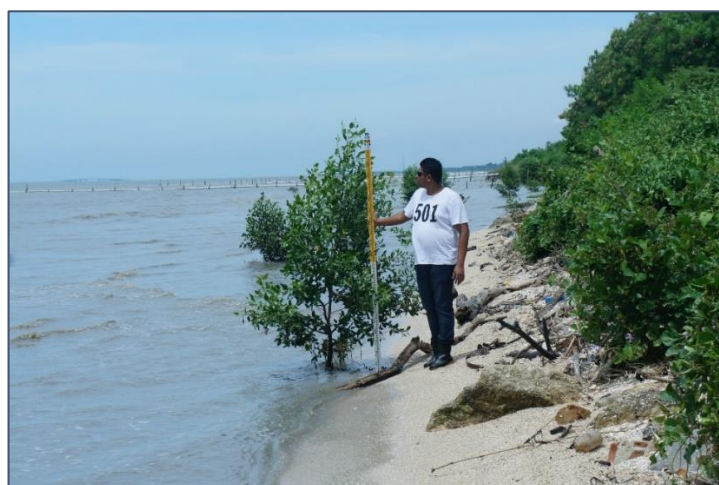
Figure 4.12: Measuring the height of the *Sonneratia*.

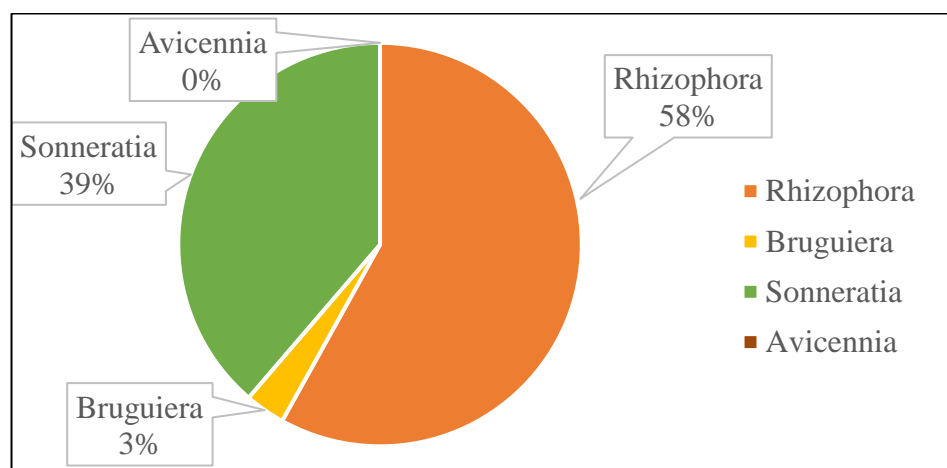
Figure 4.13: Overall Species Distribution in the Study Area

From the assessment made on the study area, 35 mangrove trees were identified which was the mix of both matured and unmatured tree from various species. Most of the species found on site were *Rhizophora Apiculata* and *Rhizophora Mucronata*. Table 4.1 present the mangrove species found on the coastline of the study area while Figure 4.13 illustrates the species distribution of the mangrove species. The dominating species that were found in the site were *Rhizophora*, followed by *Sonneratia* species and *Bruguiera*. From the site assessment, the *Avicennia* species was not found.

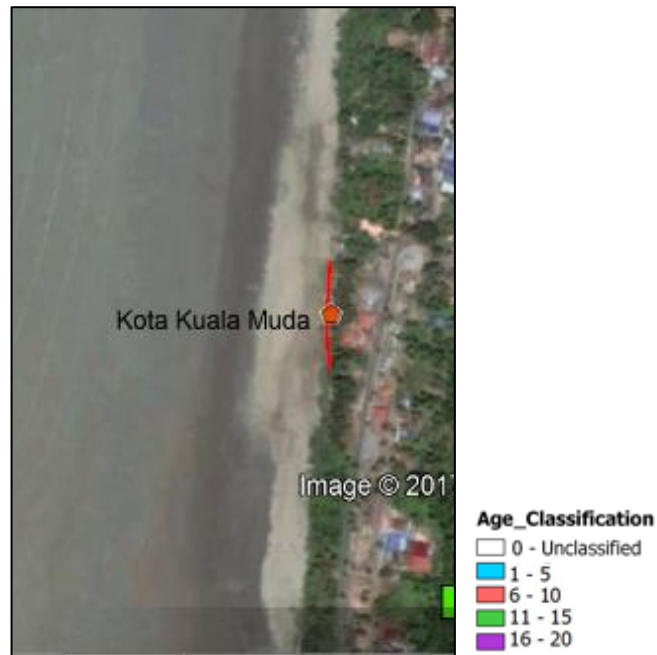
Figure 4.18: No *Rhizophora* species found in Kota Kuala Muda

Accurately, there was no *Rhizophora* tree found in the area where site assessment was conducted at about 100 meters stretch of coastline. The only species found was *Sonneratia* species which was quite young and sparse in density. According to Mazda et al, 2006, *Sonneratia* forest of 100 meters wide able to reduce the wave energy by 50%. However, these young and less dense *Sonneratia* species has a band width of about 10 meters.

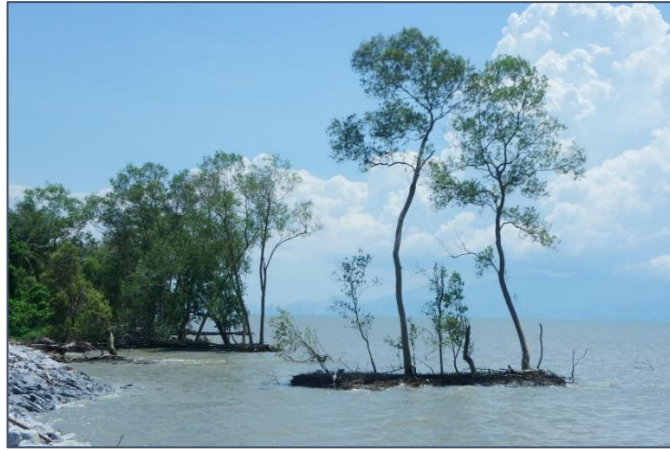
Figure 4.19: Mangrove trees survived in the remaining mud.

Even though the mangrove of *Sonneratia* species found in Kampung Padang Salim were grown and matured, it was undeniable that the whole forest was degrading. The mud on the coastline were washed away by the wave actions. Only the tree with harder mud materials able to sustain themselves in such conditions but soon they would also be affected by the waves. The authorities took immediate action by layering the shoreline with rock revetments to stop the land from retreating due to wave actions. This was concluded that the mangrove forests in Kampung Padang Salim (restricted to study area only) were no longer able to attenuate waves effectively. Moreover, the decreasing amount of muddy soil on the shore also affecting the planning of any mangrove rehabilitation program in future.

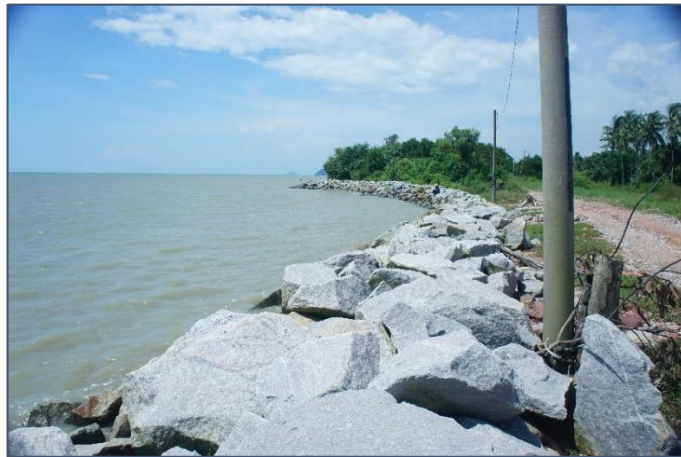
Figure 4.20: Rock revetments installed on the coastline as protection.

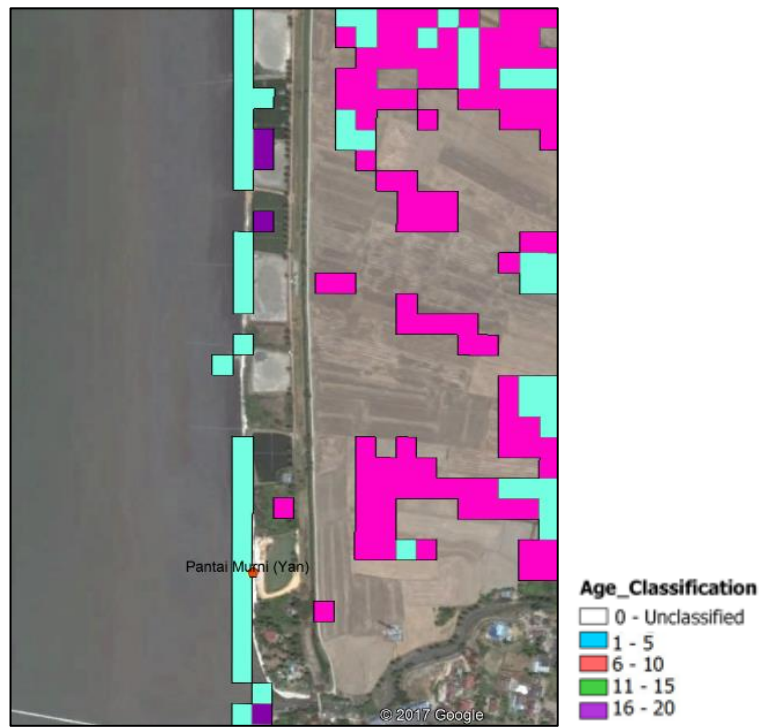
Figure 4.25: Age classification of *Rhizophora* species at Pantai Murni

Based on remote sensing analysis, Pantai Murni has mangrove of young *Rhizophora* species (age 1-5 years old) with band width of 10 meters. This forest needed extra band of mangroves so that it capable to reduce more wave energy and act as the shoreline defence against wave actions effectively.

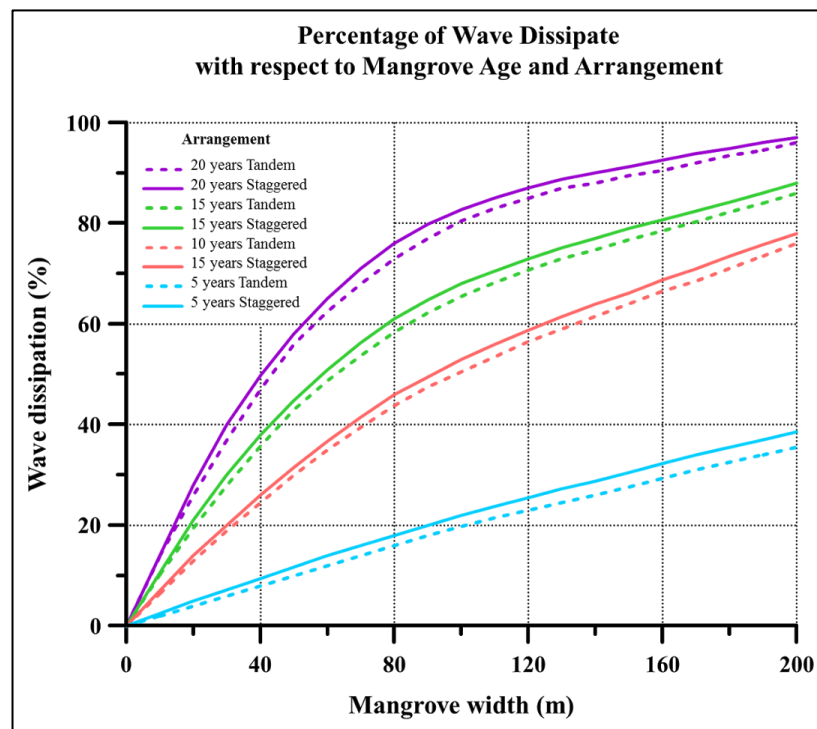
Figure 4.26: Percentage of Wave Dissipate Respect to *Rhizophora*'s Age and Arrangement.

The proposed rehabilitation mangrove belt for the coastlines was derived based on the findings as in previous discussions. Based on research made by Mohammad et al., 2014, they ranked the Peninsular Malaysia has very low vulnerability index with coastal significant wave height lower than 0.5 meter. Therefore, this research derived rehabilitation initiatives based on suggestion to reduce the average significant wave height of 0.523 meters of the study area to 50% lower. The graph shown in Figure 4.26 below was derived from few researchers' findings on the relationship between the *Rhizophora* species' age, arrangement, band width and the percentage of wave dissipation (Hashim et al. 2013).
