**Characterization of annulus well cement
quality to estimate the leakage potential
in cement well barriers**

PhD Thesis UiS No. 676 - December 14th

Katherine Beltrán Jiménez

Faculty of Science and Technology
Department of Petroleum Science and Engineering

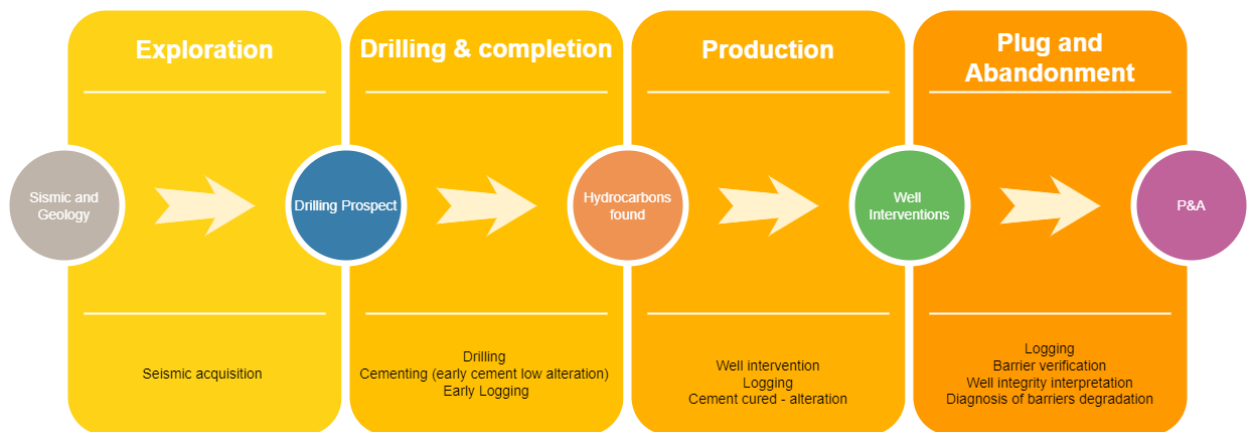
Figure 2.1: Well phases and verification of cement integrity at different times along the well life cycle

Annular cement is present in most of the well stages from drilling to P&A, it is normally exposed to changes in temperature and pressure, penetration of fluid and its quality directly affects the well integrity. Fig. 2.1 shows the well construction stages highlighting occurrence of some typical well operations.

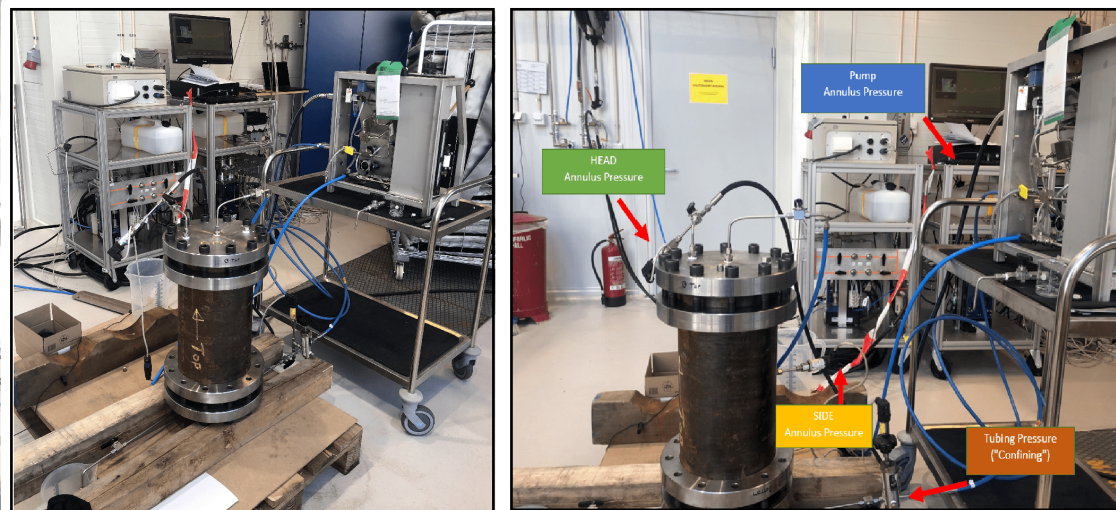
Figure 3.5: Picture of instrumentation and rig up for testing for the uniform debond cell

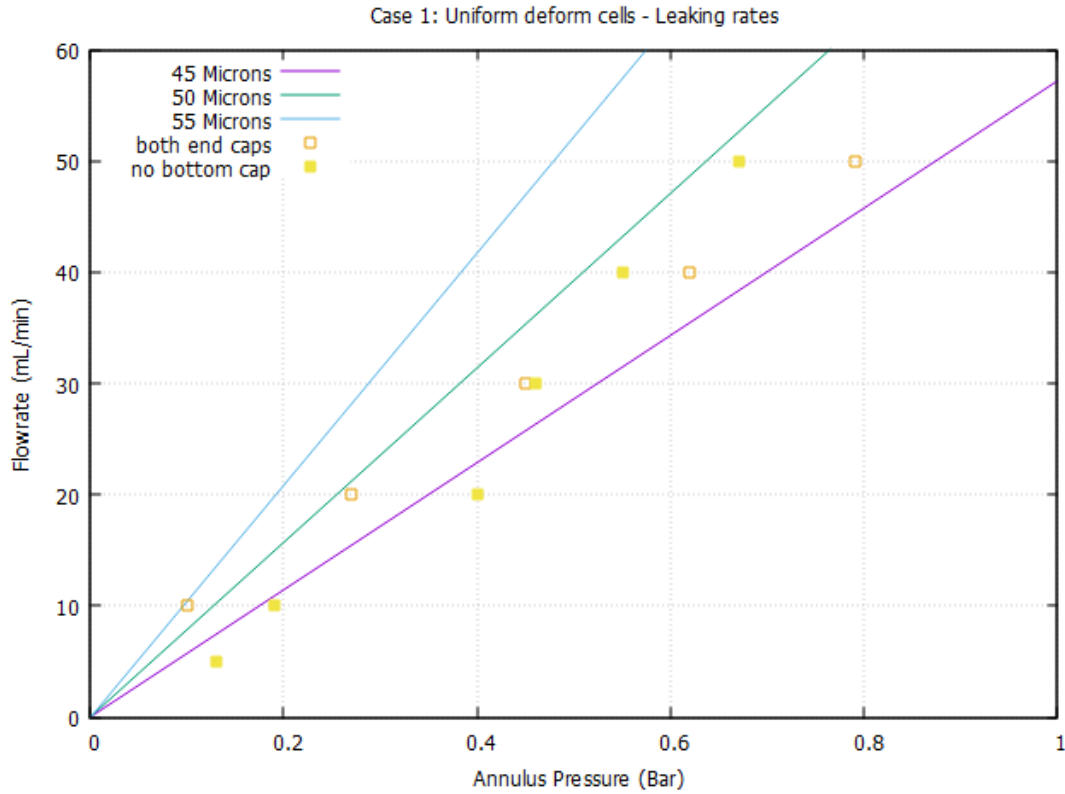
Figure 3.6: Flow rate and pressure measured for Uniform debonding cell

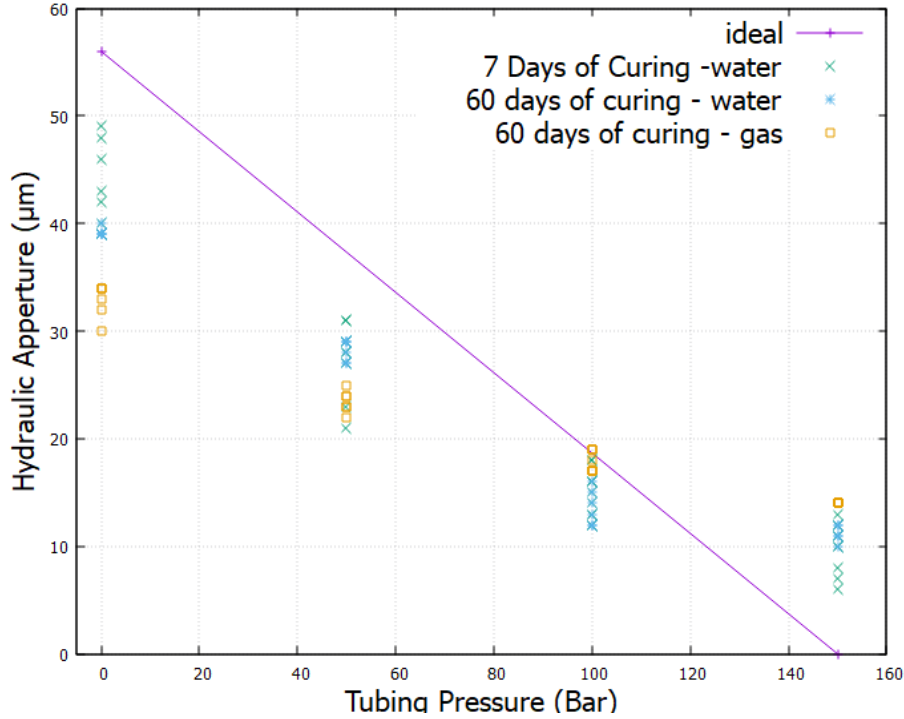
Figure 3.8: Results of equivalent hydraulic aperture when varying confining pressure at 7 days and 60 days of curing

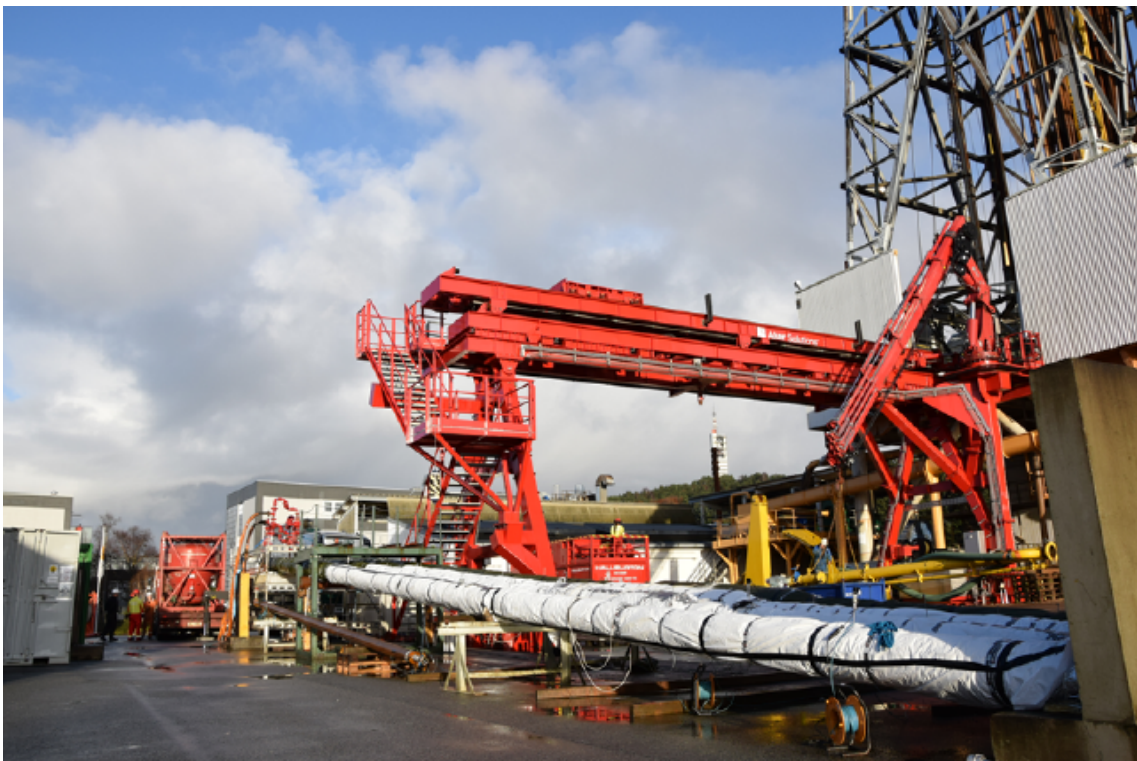
Figure 3.9: View of the four test assemblies draped in insulation and plastic covers.

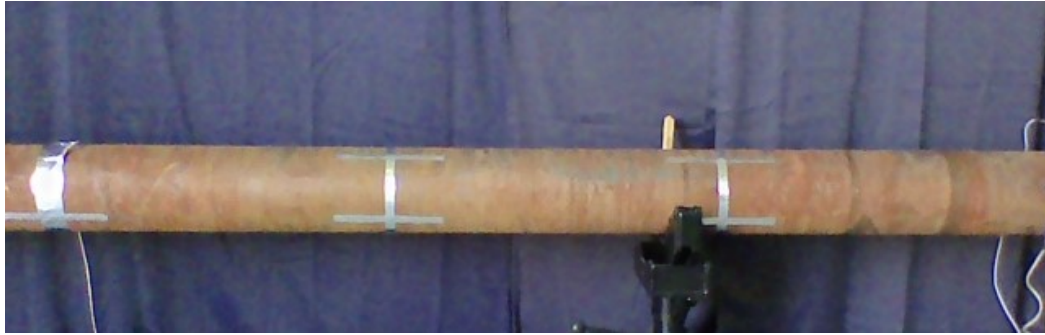
Figure 3.10: Warm water (40) injection in assembly C6. Water is injected from right to left. a) Picture of the interval between 0.0 m and 3 m after 30 minutes since the start of injection. b) Detail of a part of the assembly rotated by 90° showing that surface heating was limited to the region of the migration channel.

a) Test section C6 with metallic tape for position identification.

b) Initial stage of warm water (40) injection. Picture was taken 3 minutes after start of injection.

c) Final stage of warm water (40) injection. Picture was taken 30 minutes after start of injection.

d) Final stage of cold water (10) injection. Picture was taken 10 minutes after start of cold water injection.

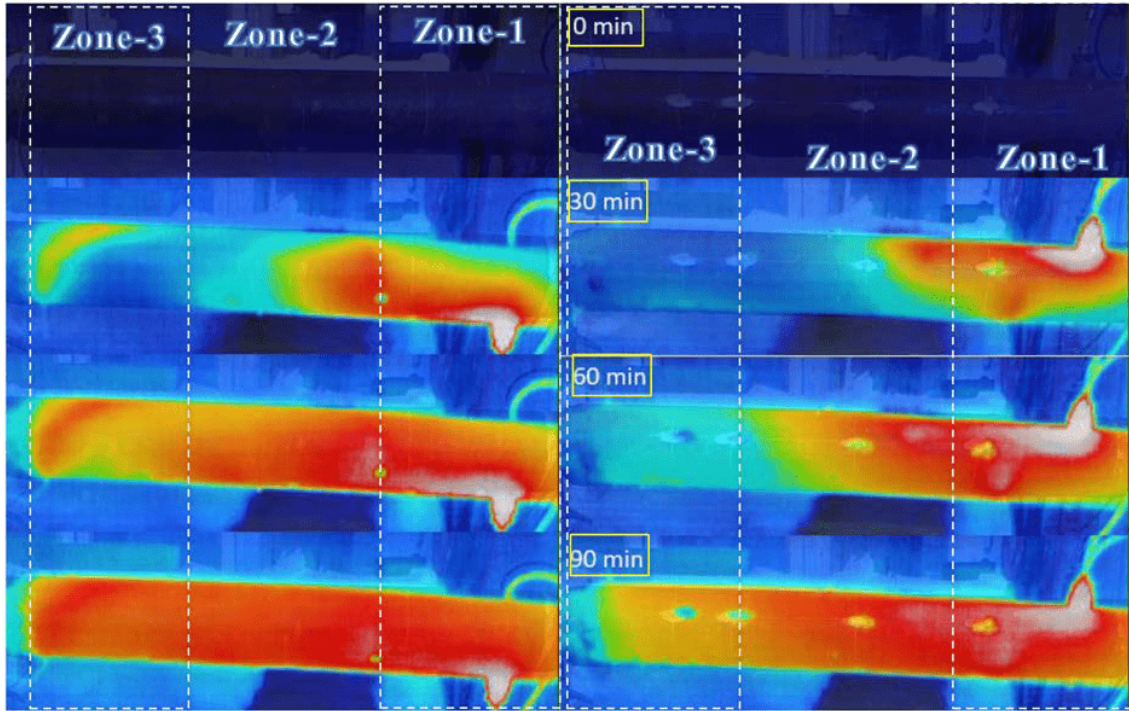
Figure 3.18: Thermal imaging sequence recorded in micro annuli cell when injecting hot water from left to right (using ports P1 as injection point and P3 as outlet)

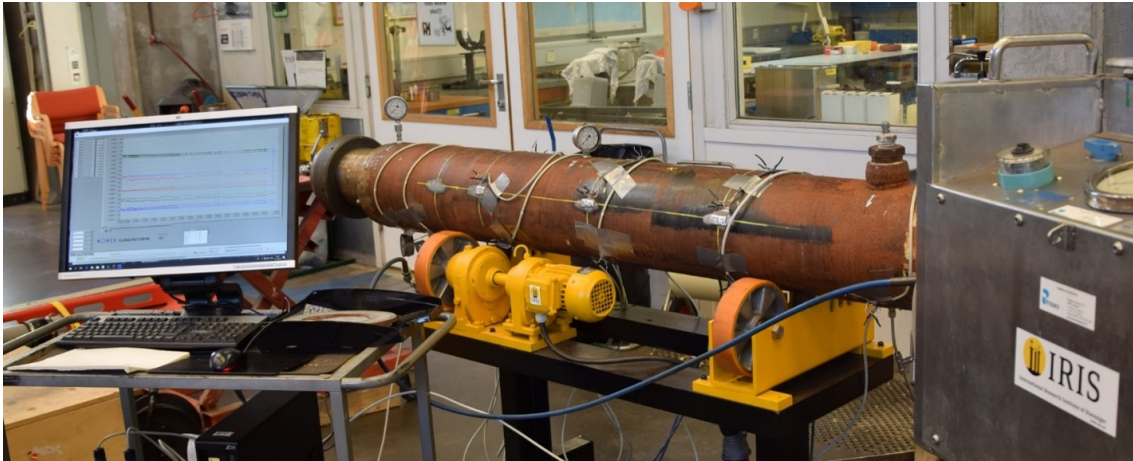
Figure 3.19: Initial instrumentation for testing in 2018

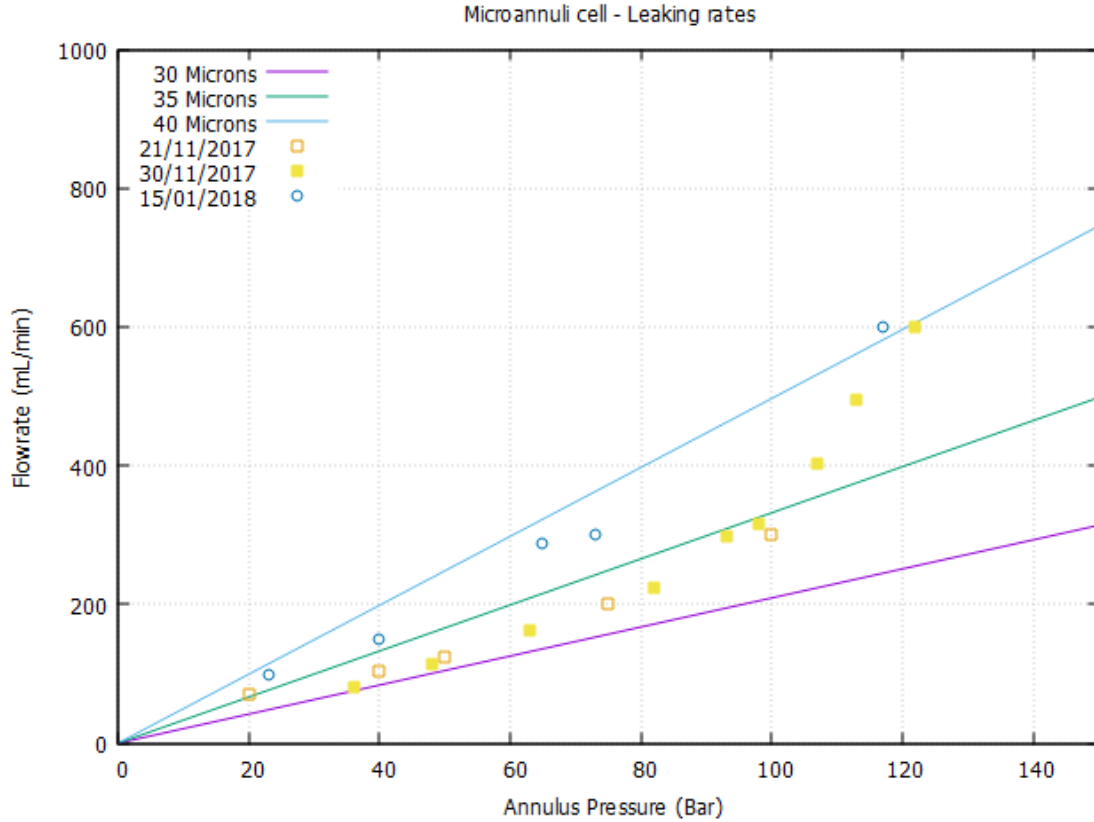
Figure 3.20: Flowrate obtained during experiments in 2017 and 2018. Inlet port P1, outlet port P3

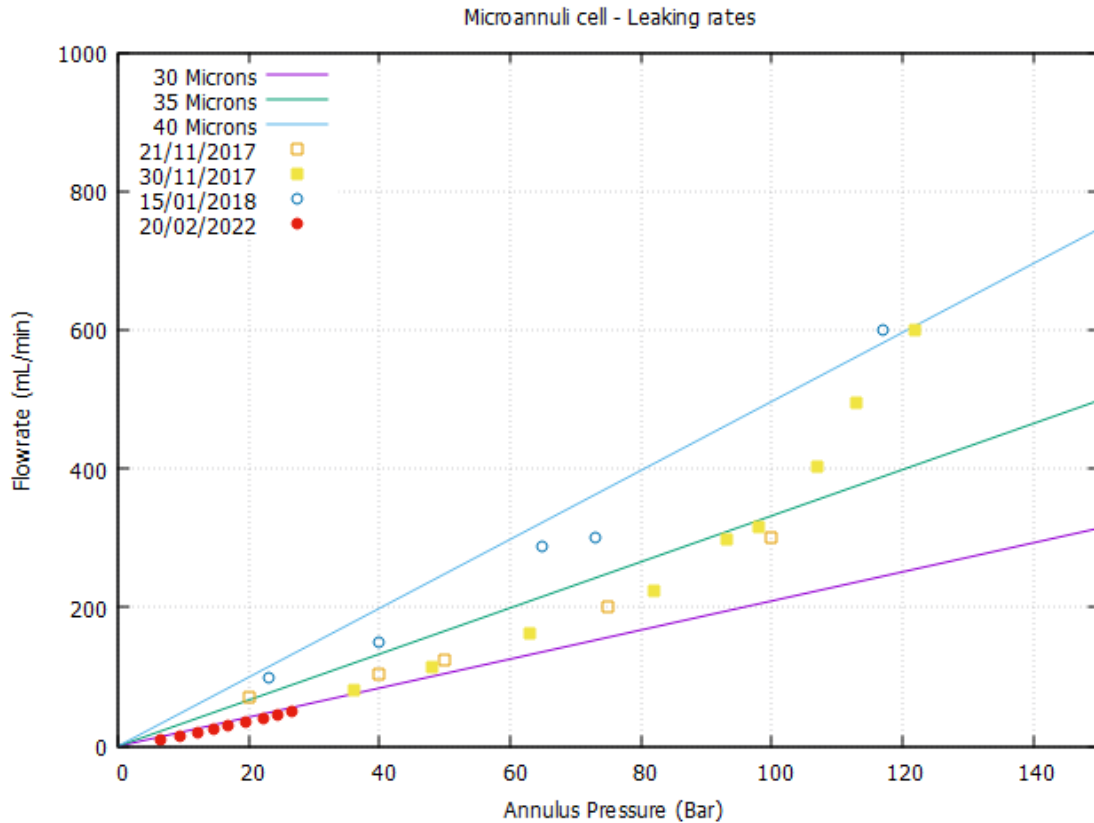
Figure 3.22: Flow rate obtained during experiments in 2017 and 2018

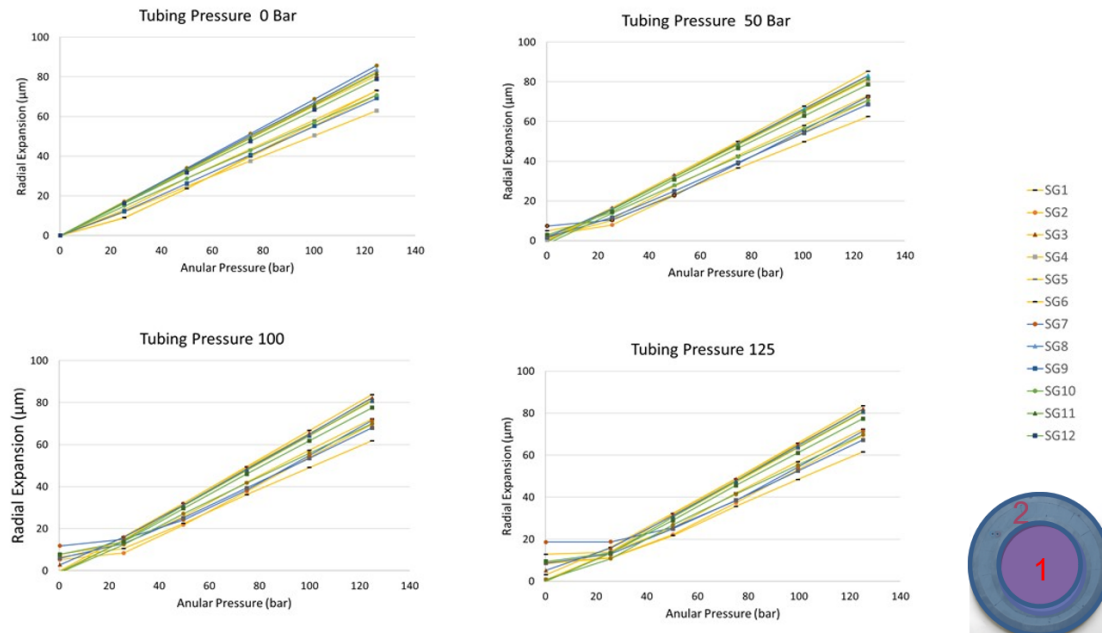
Figure 3.24: response of strain gauges when confining pressure in the tubing and annular pressure is increase.

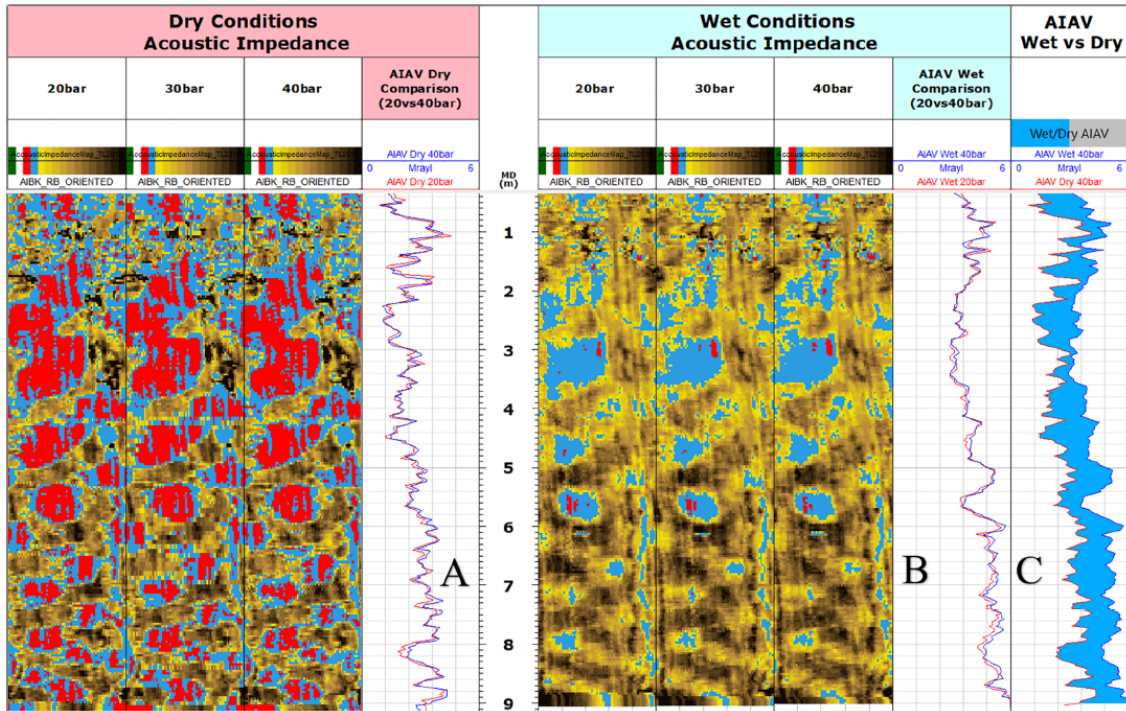
Figure 3.29: High resolution log for Transition Joint, collected on surface for dry and wet conditions. Log shows acoustic impedance and AIAV [4]

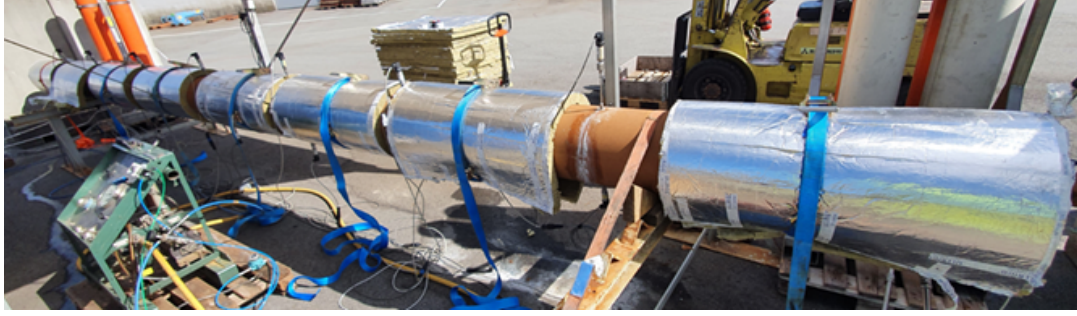
Figure 3.31: Typical instrumentation during leak testing on Transition Joint.

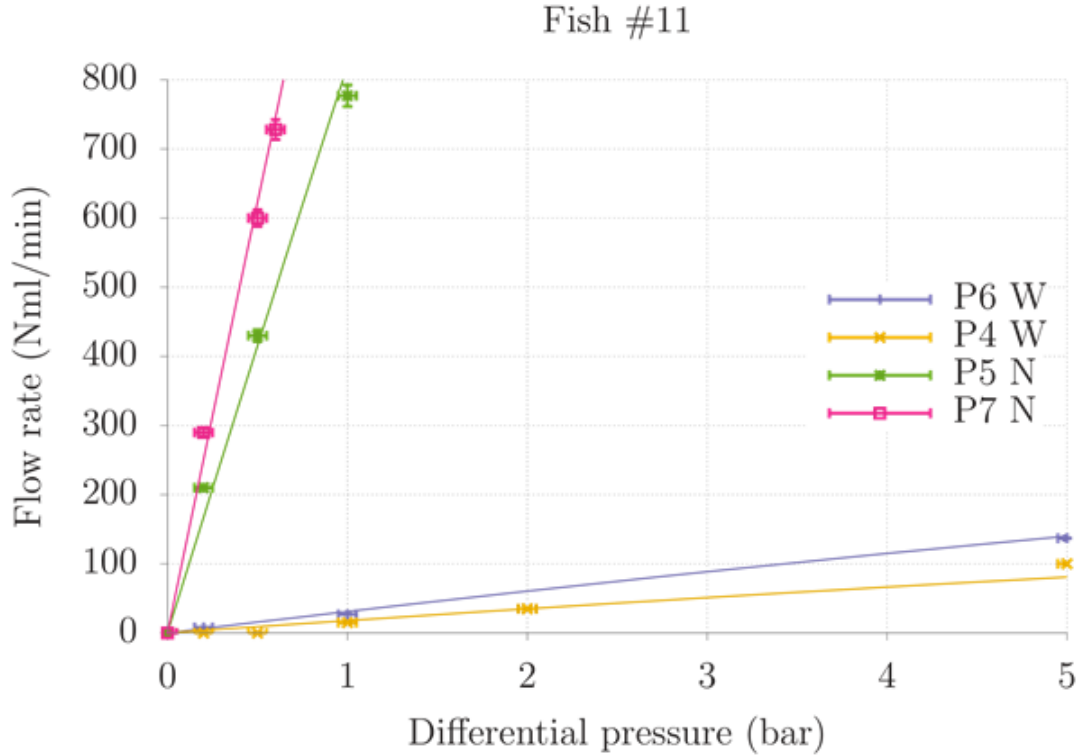
Figure 3.32: Measured, normalized gas seepage rates through the annulus of Fish #11 to different outlet ports

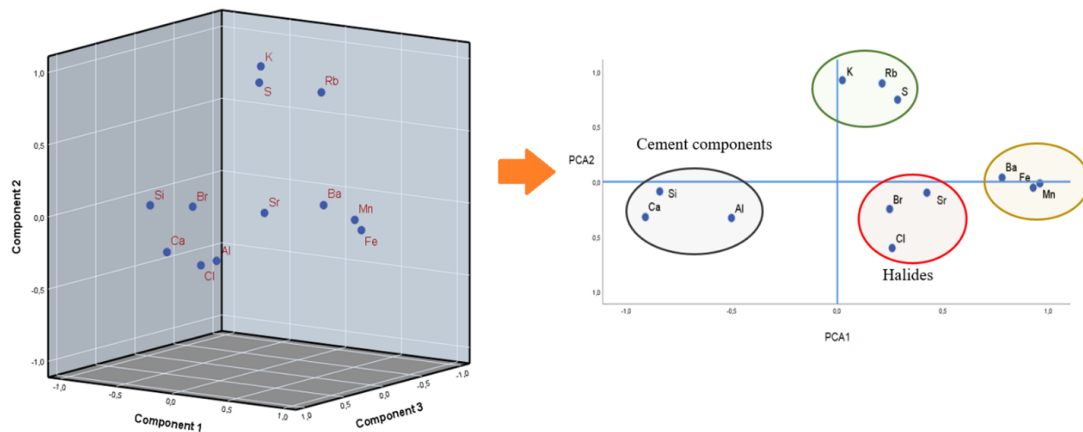
Figure 4.14: 3D and 2D visualization of the 3 and 2 main components for the PCA analysis based on XRF dataset

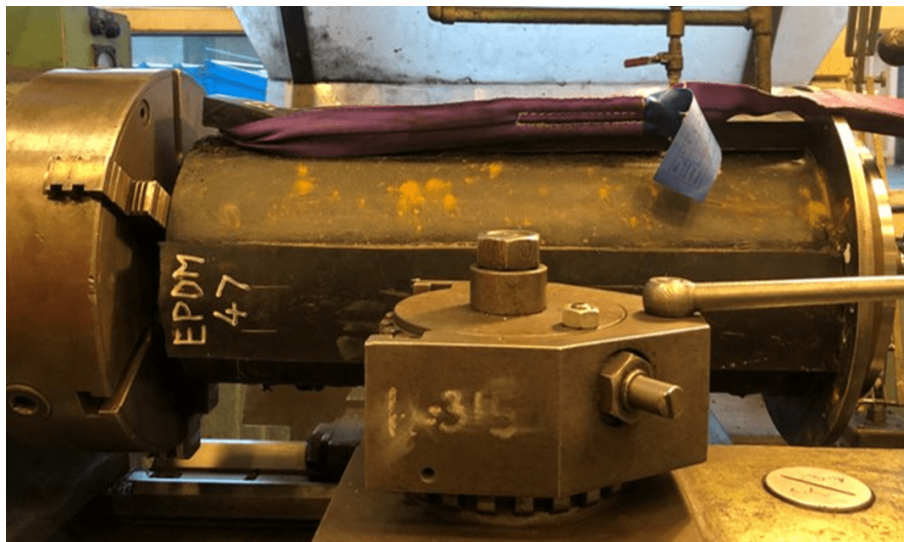
Figure 5.6: Crude test to evaluate the adhesive bond between the rubber materials and casing surface.
