SCANNING ELECTRON MICROSCOPY AND X-RAY MICROANALYSIS OF THE CONDITION OF CONCRETE STRUCTURES OF A CHEMICAL ENTERPRISE WITH LONG-TERM CORROSION IN A SULFATE ENVIRONMENT

Abstract: Long-term operation of premises in aggressive environments of chemical enterprises affects the surfaces of concrete structures and leads to the formation of destructive processes.

The aim of the study was to determine changes in the structure and mineral composition of concrete during long-term operation in an aggressive sulfate environment at a chemical plant for the production of titanium dioxide using the sulfate method to predict the service life of concrete structures.

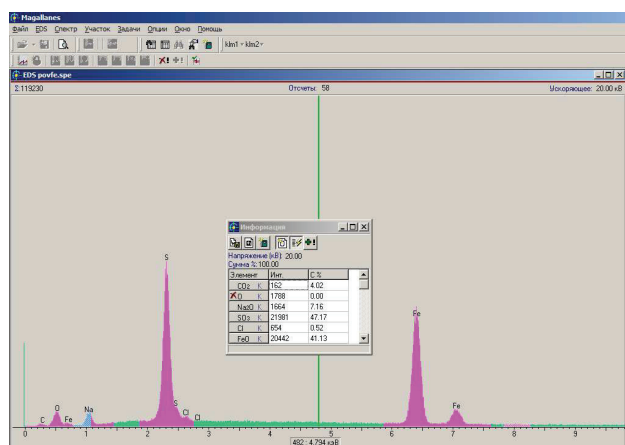
Fig. 5. The spectra of X-ray energy dispersive analysis are averaged from the microfield

In some of the samples, the concrete surface had a reddish color, typical for iron (III) compounds. The surface microstructure is loose, with signs of corrosion (Fig. 4, a). The penetration depth of iron sulfates into the concrete thickness is about 50 μm (Fig. 4, b). X-ray microanalysis from the surface microfield indicates the presence of sulfur and iron oxides (Fig. 5).
