**Three-dimensional numerical study on the batter
instability mechanism of Maddingley Brown Coal
Open Pit, Victoria, Australia using PLAXIS 3D**

This thesis is submitted in total fulfilment of the
requirements for the degree of Doctor of Philosophy

School of Science, Engineering and Information Technology
Federation University Australia
University Drive, Mt Helen,
Victoria 3353
Australia

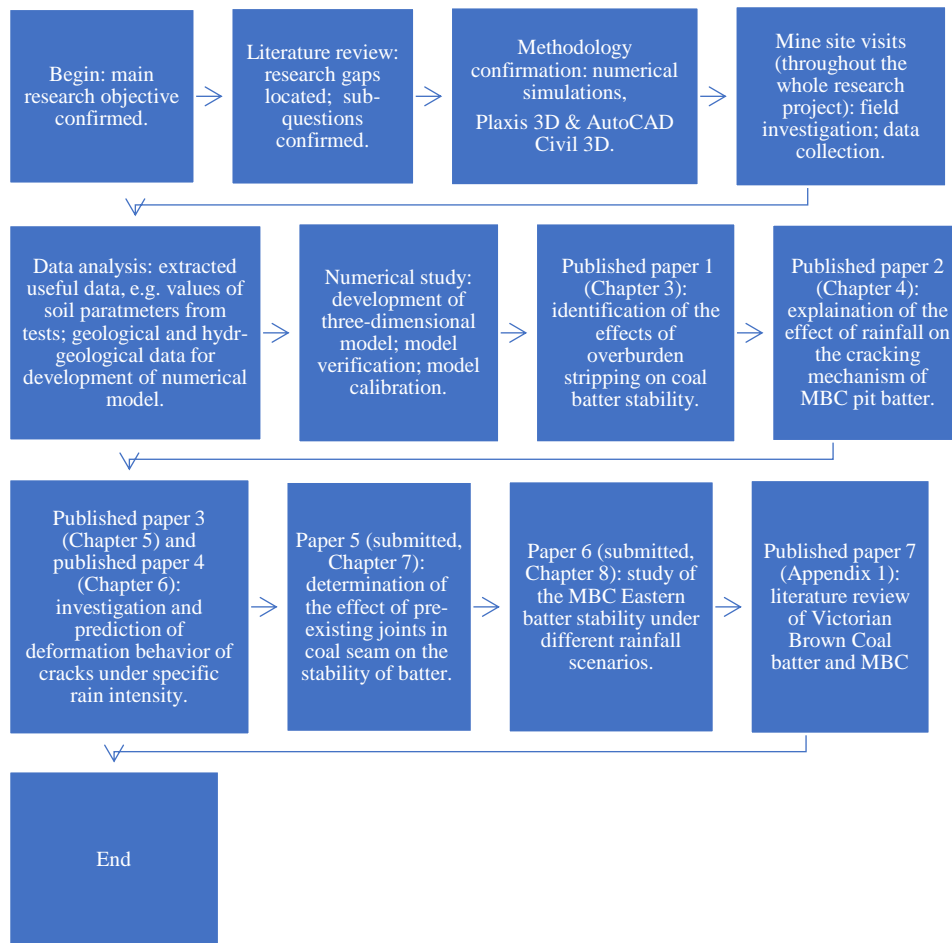
Figure 1.13 Flowchart to achieve the objectives of the research project

Steps followed for achieving those research objectives are presented in the block diagram below (Fig. 1.13).

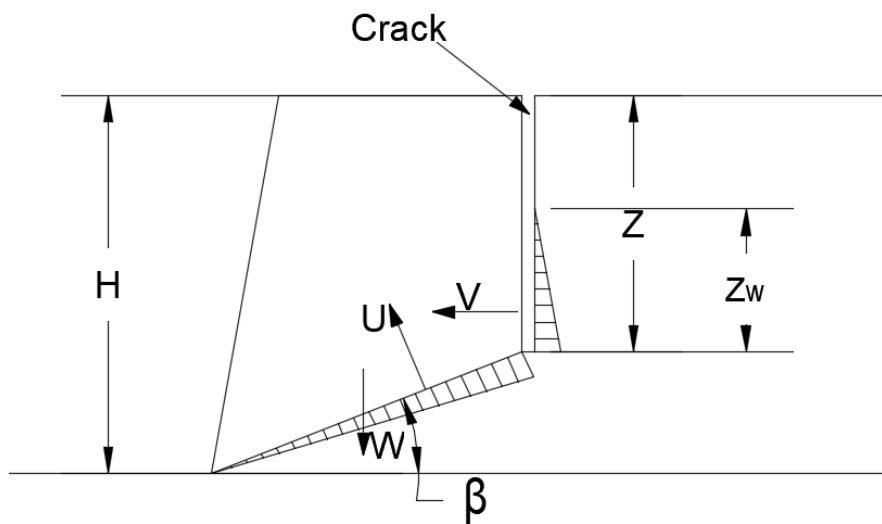
Figure 2.11 Block sliding mechanism (Raghuvanshi, 2019)

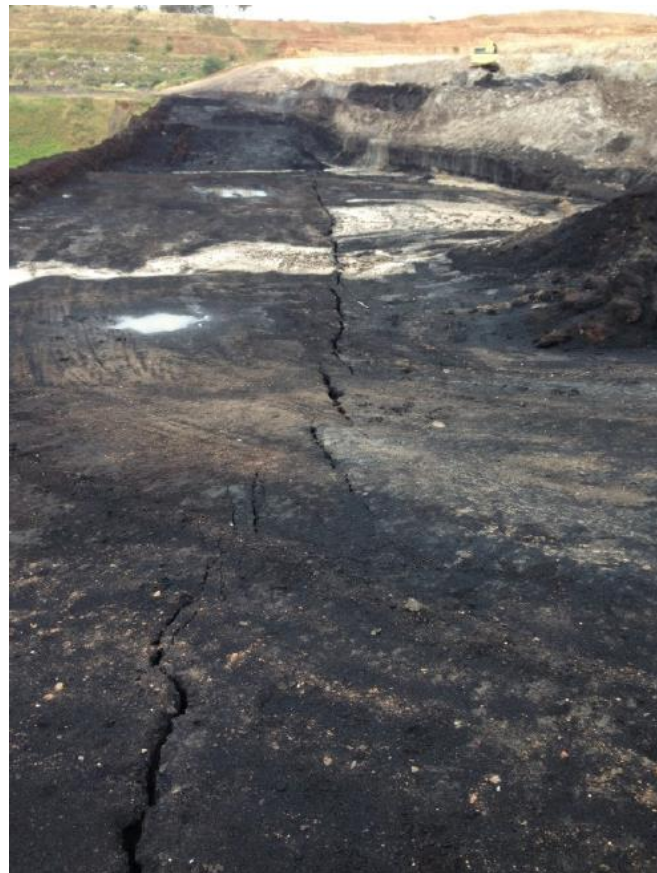
Figure 3.3 Crack on the coal seam (URS Australia, 2013a, b)

In November 2013, an east-west striking crack was observed on the top of coal seam approximately 20 m from the crest of the coal face (Department of State Development, Business and Innovation, 2013). The aperture varied from trace to 150 mm wide (Fig. 3.4) extended 50m and terminated 10 m away from the access road on the eastern side (URS Australia, 2013). The aperture was wider in the east (bottom in Fig. 3.3) than in the west (top in Fig. 3.3). The less horizontal movement in the west would benefit from the toe buttress (Department of State Development, Business and Innovation, 2013). A number of survey markers were installed on north batter on 19 November 2013 to monitor the displacements of the batter moving upwards, eastwards and northwards. The monitored results had been reporting weekly (Golder Associates, 2014).

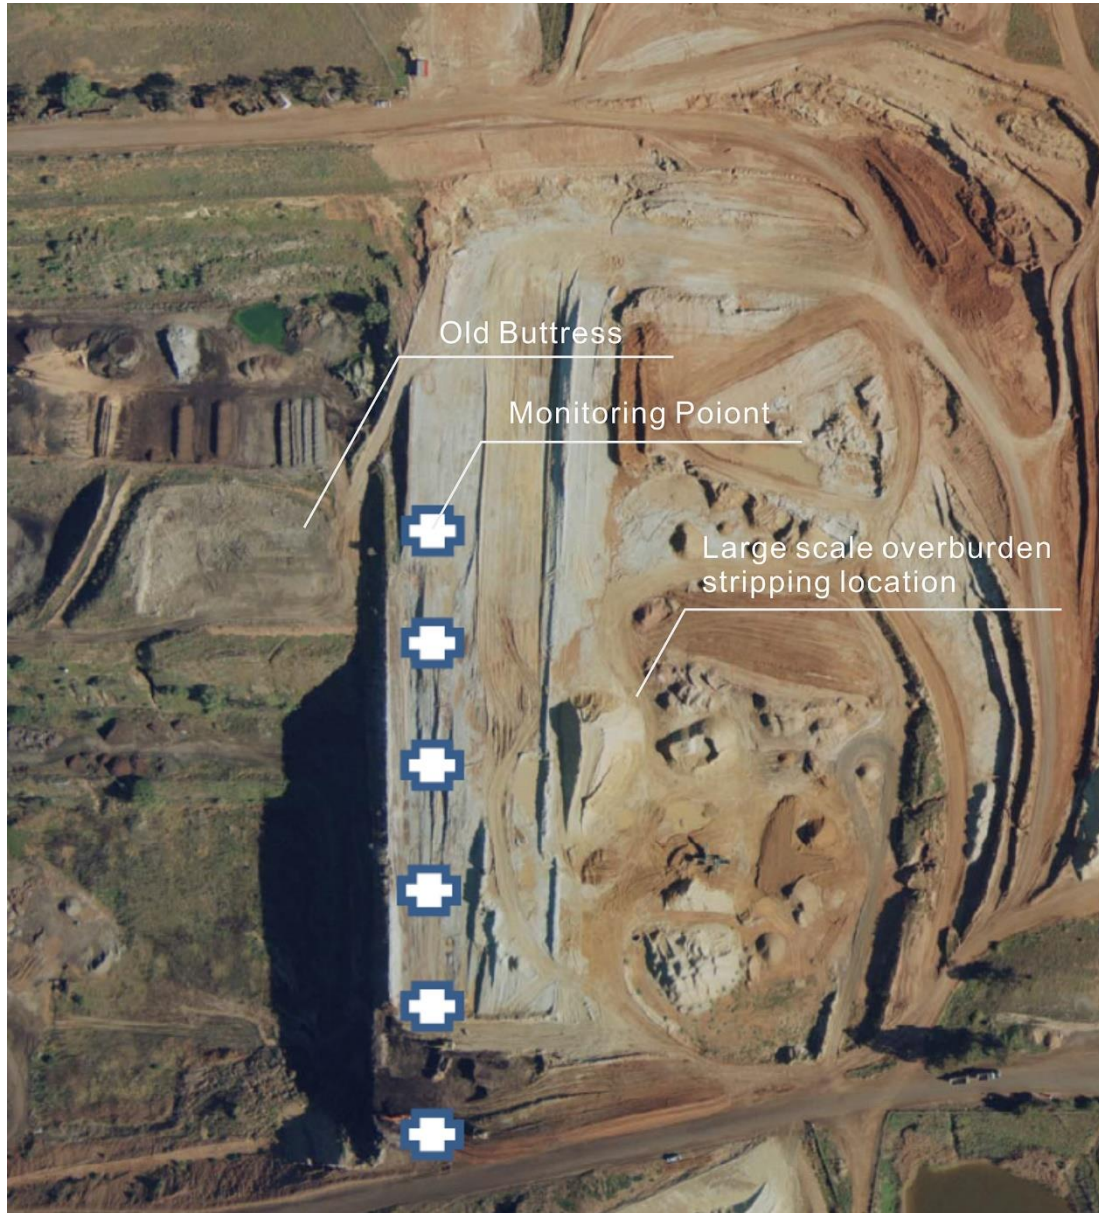
Figure 4.1 North batter coal face with the monitoring system established immediately after the observation of crack

The northern batter of MBC had been stable for many decades without any mining activities until in early 2013 when the overburden stripping activities commenced. The overburden was stripped ahead of the northwards coal mining. The north coal batter was approximately 25 m high in a single bench, at a slope angle $> 80^\circ$. There was an old 5 m high toe buttress (brown coal) providing support to the bench at the western end of the coal bench (Fig. 4.1).

A number of survey markers were installed on north batter on 19 November 2013 (Fig. 4.1) to monitor the displacements of the batter. This monitoring result was reported weekly till the early 2014 when the survey markers were destroyed by mining activity. The movements of the crack were shown in Figs. 4.4–4.6. Fig. 4.4 shows the northward (positive) and southward (negative) movements; Fig. 4.5 illustrates the eastward (positive) and westward (negative) movements; Fig. 4.6 demonstrates the upward (positive) and downward (negative) displacements. The southward movement and upward heave were the dominant deformations (see Figs. 4.4 and 4.6, respectively).

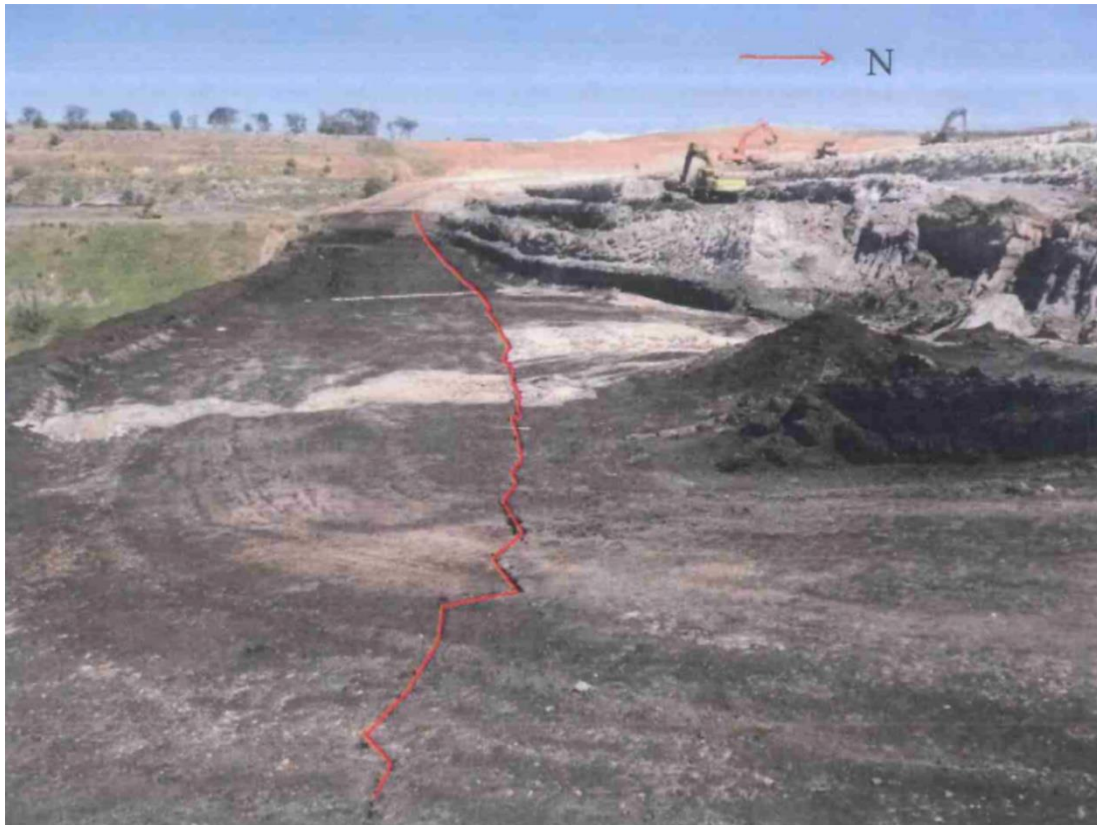
Figure 4.2 Crack on the coal seam (looking towards west)

On 8 November 2013, east-west striking cracks were observed on the top of coal seam approximately 20 m from the crest of the coal face. The opening of the cracks varied from trace to 150 mm wide at about 20 m back from the coal face and extended for approximately 50 m on the eastern side and terminated 10 m away from the access road on the eastern side (Fig. 4.2).

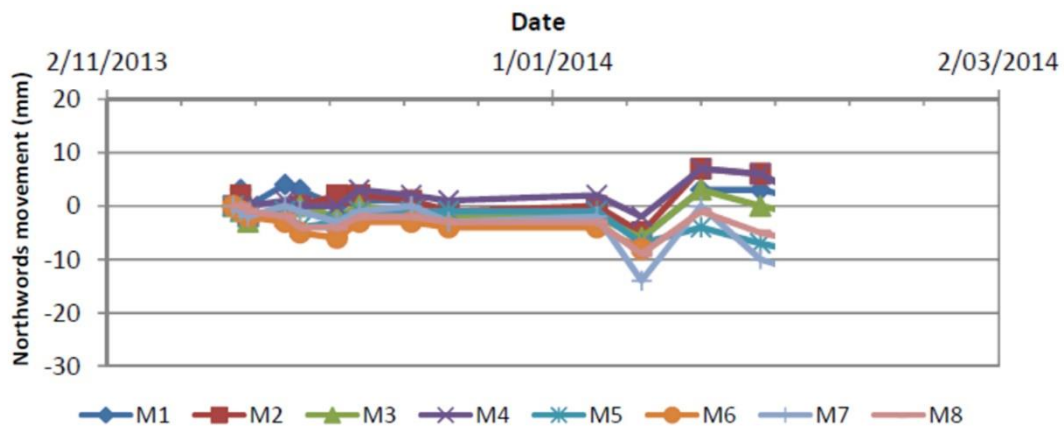
Figure 4.4 Northward movements of cracks

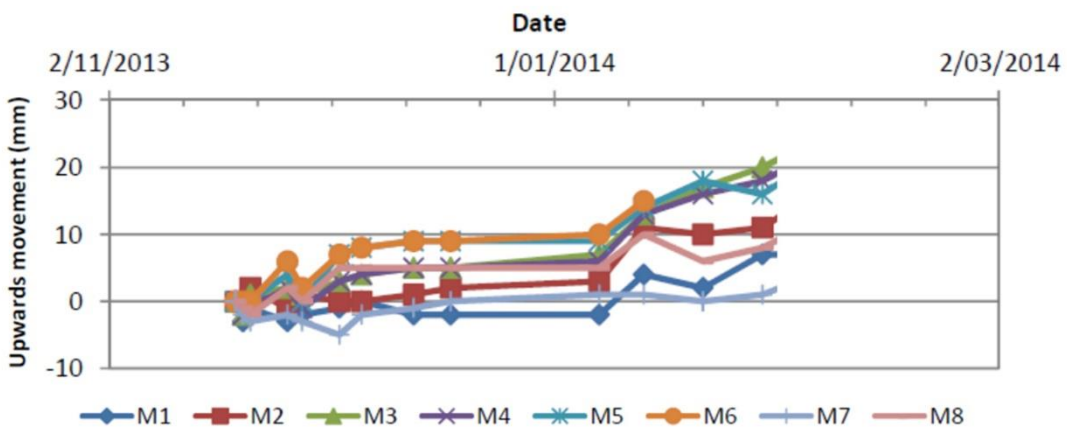
Figure 4.6 Upward movements of cracks

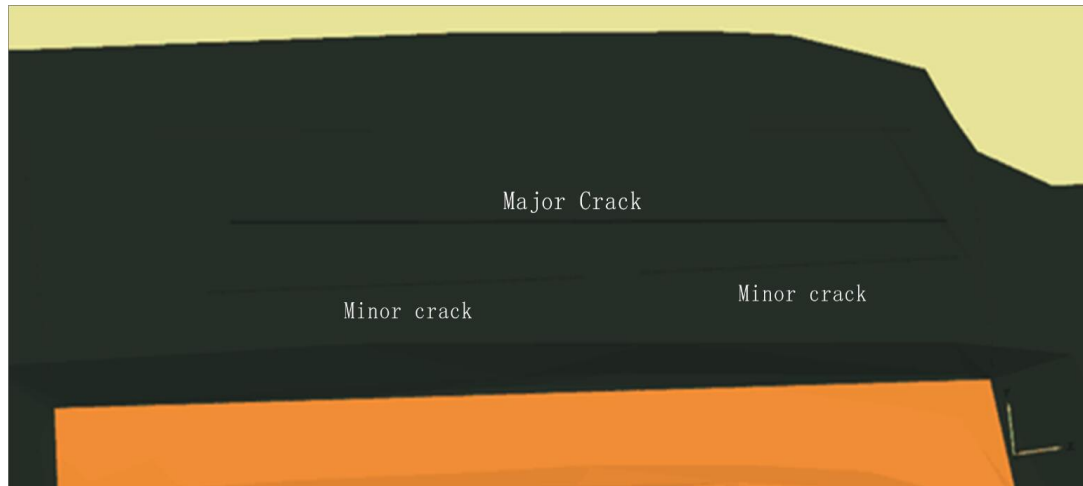
Figure 5.6 Aerial view of cracks on north batter surface

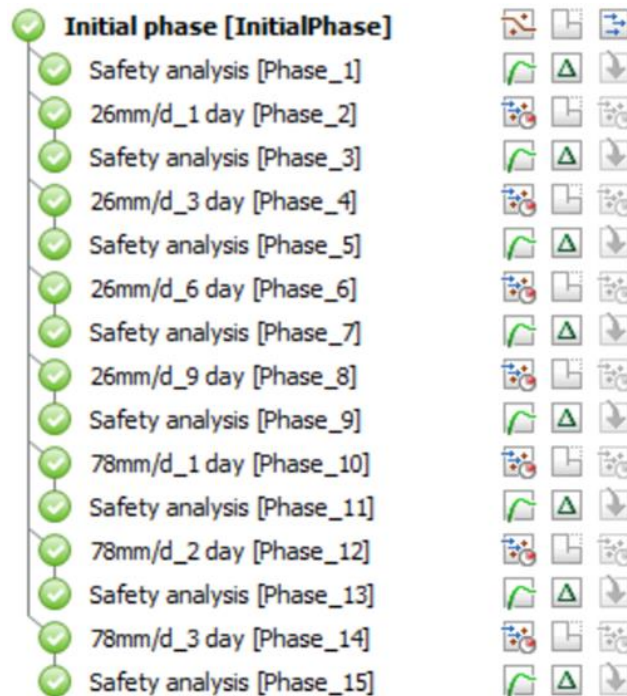
Figure 6.7 Designed calculation phases

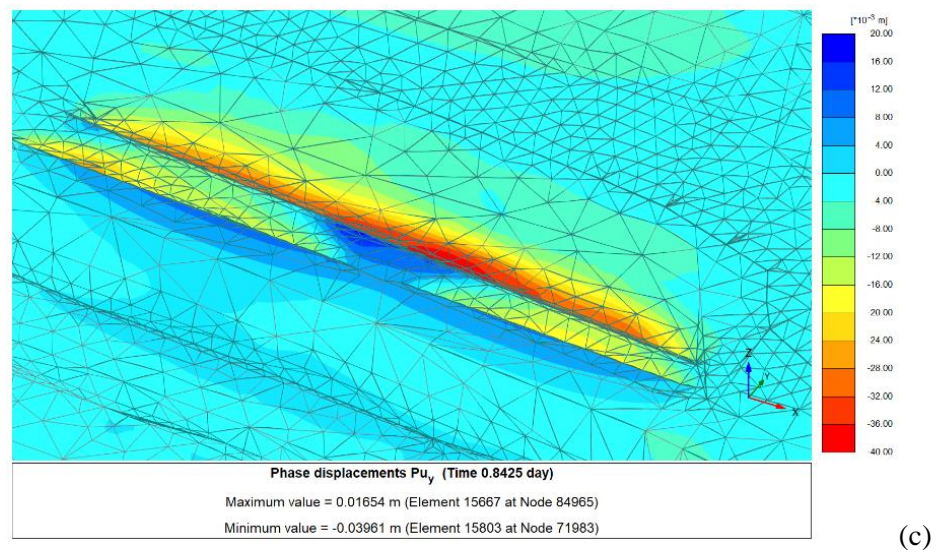
Figure 6.12 Deformation of cracks at: a. 0.2425 day; b. 0.5425 day; c. 0.8425 day

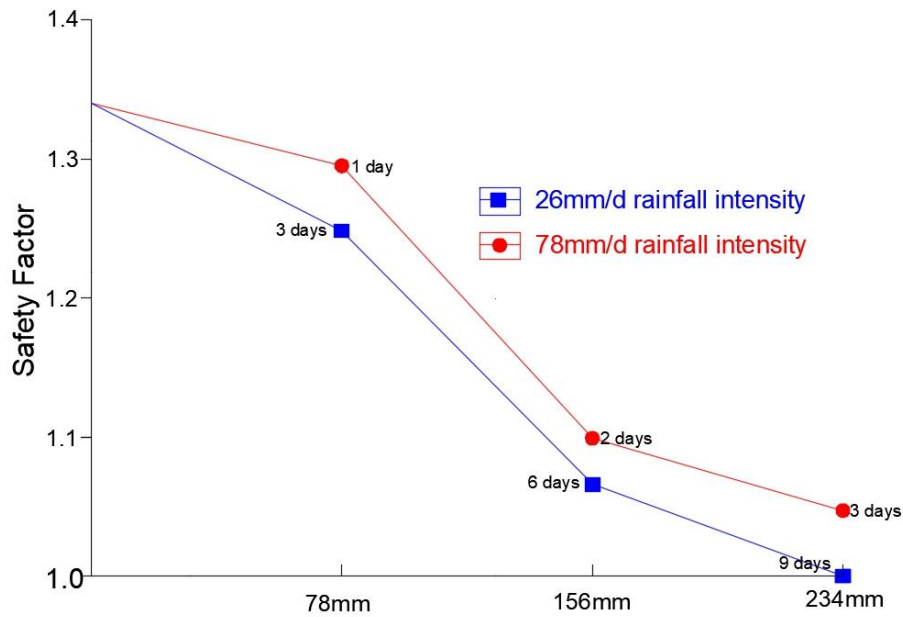
Figure 6.14 Relation between safety factor and accumulated precipitation of 26 mm/day and 78 mm/day in 9 days
