Reda, A., Rawlinson, A., Sultan, I. A., Elgazzar, M. A., & Howard, I. M. (2020). Guidelines for safe cable crossing over a pipeline. *Applied Ocean Research*, 102.

Guidelines for Safe Cable Crossing over a Pipeline

This paper documents a recent case study of damage of a field joint coating at a crossing of an existing pipeline by a 132 kV subsea cable of 191 mm outside diameter. Investigation of the damage on site revealed that it was caused by lateral movement of the cable under the influence of hydrodynamic forces.

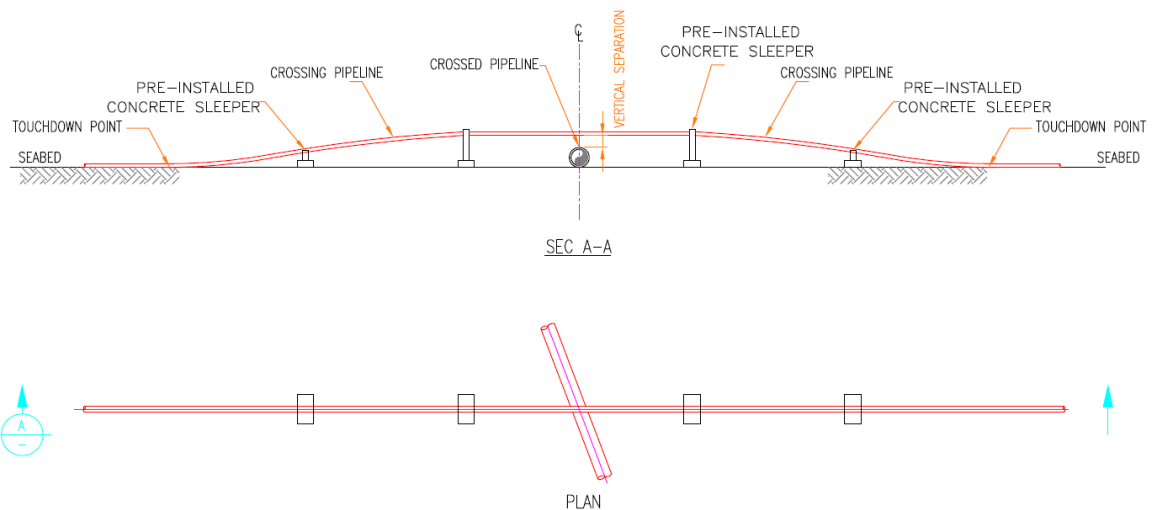
Figure 2: Discrete supports

It should be noted that the crossing angle shown in Figure 2 is less than 90 degrees. Many pipeline industry sources recommend the included angle between the crossing and crossed pipelines be at a minimum of 30°. This is not based on technical integrity concerns but rather to simplify the construction of the crossing.

If the crossing design concept uses discrete supports or a ramp as shown in Figure 2, a geotechnical survey is also required at the crossing point to enable characterisation of the soil type and its shear strength parameters. However, this survey is not required if the design is based on articulated padding, since the positive separation is maintained irrespective of the settlement of the crossing configuration.

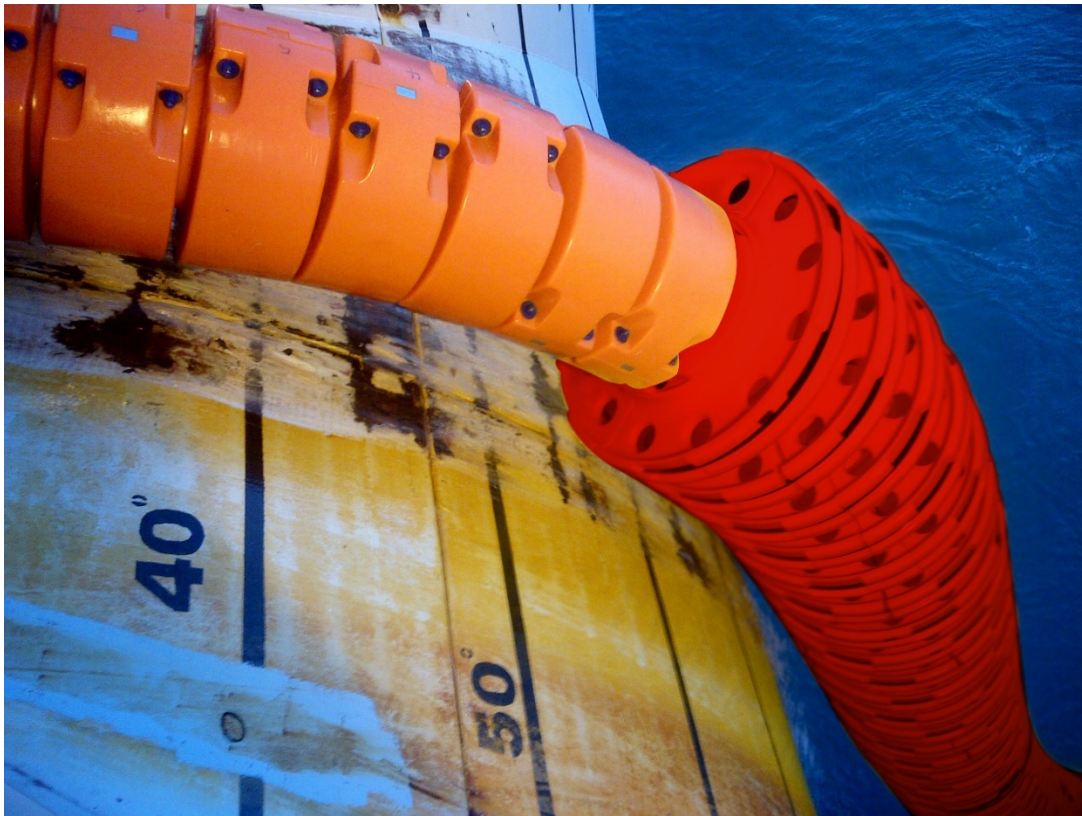
Figure 7 shows deployment of the articulated padding system during the cable installation.

Figure 7 Deployment of the articulated padding

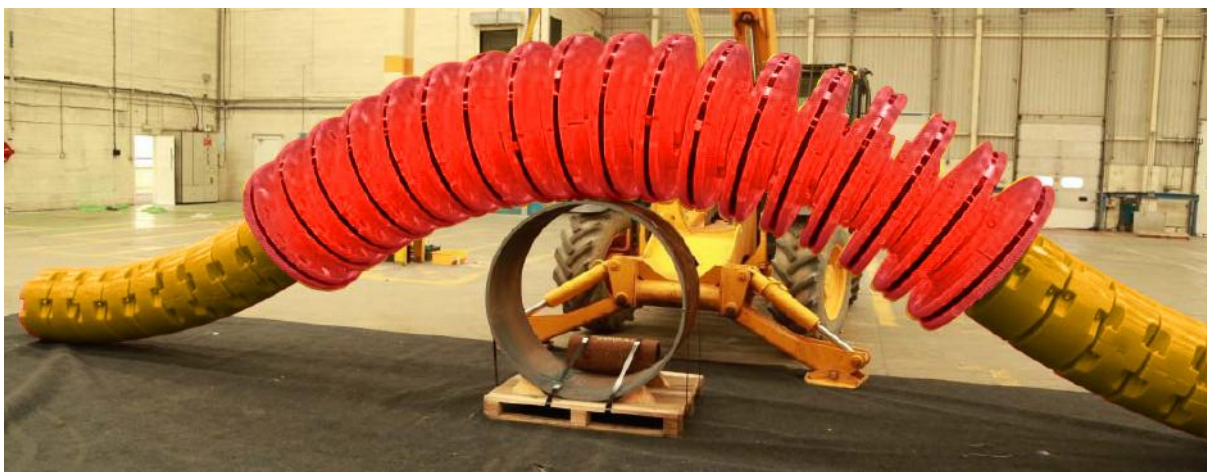
Figure 8 shows the mock-up trial undertaken on the articulated padding and bend restrictors. The mock-up test was performed to ensure efficiency of the offshore installation procedure during the actual operation.

Figure 8: Mock-up test undertaken at the factory.

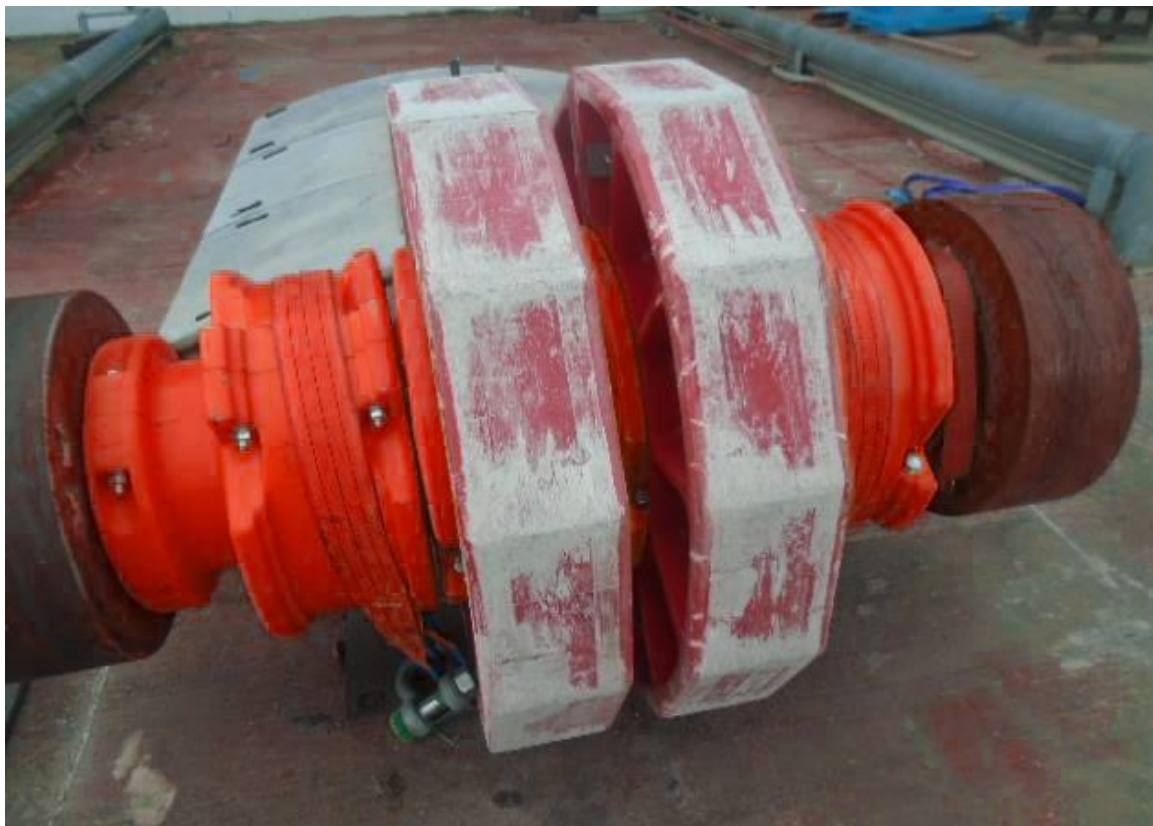
- An abrasion test (see Figure 11) was conducted to ensure that the material loss due to abrasion of the articulated padding will comply with the design life of the cable. Value of the span length between the two cable touchdown points will be such that in-line or cross-flow VIV will not take place as per the criteria given in DNVGL-RP-F105 [Ref. [12]] and Ref.[14]. VIV refers to Vortex induced vibration.

Figure 11 Abrasion Test outcome

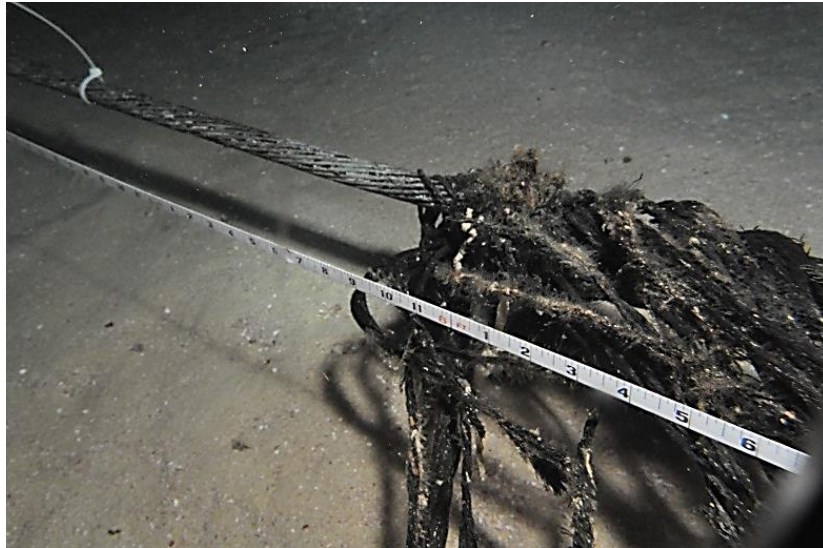
- Excessive and repeated lateral movement of the cable that could lead to abrasion to the outer sheathing of the cable, as shown in Figure 13. Once the outer sheath is abraded, the galvanized armour will also gradually abrade, and consequently the armour will corrode. Abrasion of the subsea cable takes place due to relative motion of the cable against rough surfaces such as a rocky seabed. [Ref. [16]] explained that cable abrasion over time, associated with the lateral movement, will inevitably lead to cable failure as shown in Figure 14. It is indicated by [Ref. [16]] that abrasion of the outer sheath of the cable could possibly lead to fibre failure and a cable break.

Figure 13: Outer sheathing damage and armour exposure due to instability

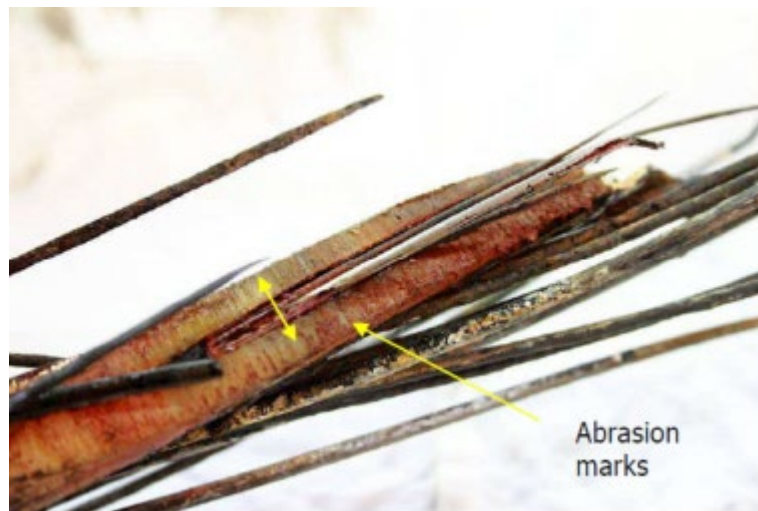
Figure 14: Example of cable break due to abrasion [Ref.16]

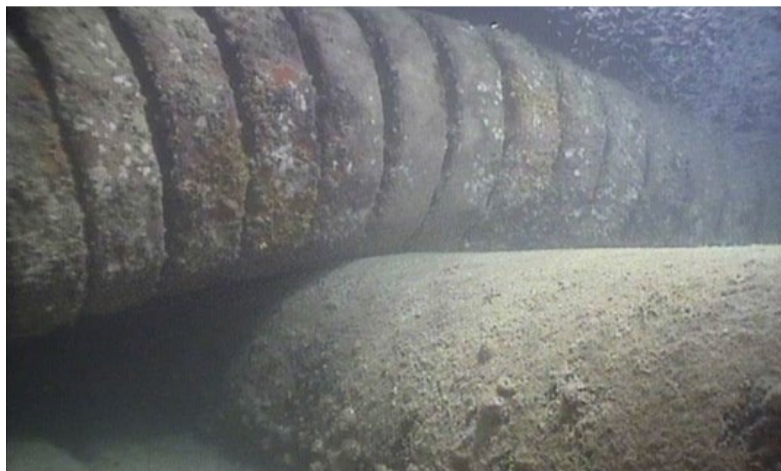
Figure 16: ROV Survey at the crossing locations- Note the articulated padding installed on the crossed pipeline away from the field joint

A post-installation survey was undertaken one year after the cable installation. The survey included three dozen crossing locations similar to that shown in Figure 16. Visual inspection revealed that coating damage had occurred in the pipeline field joint at two crossing sites.

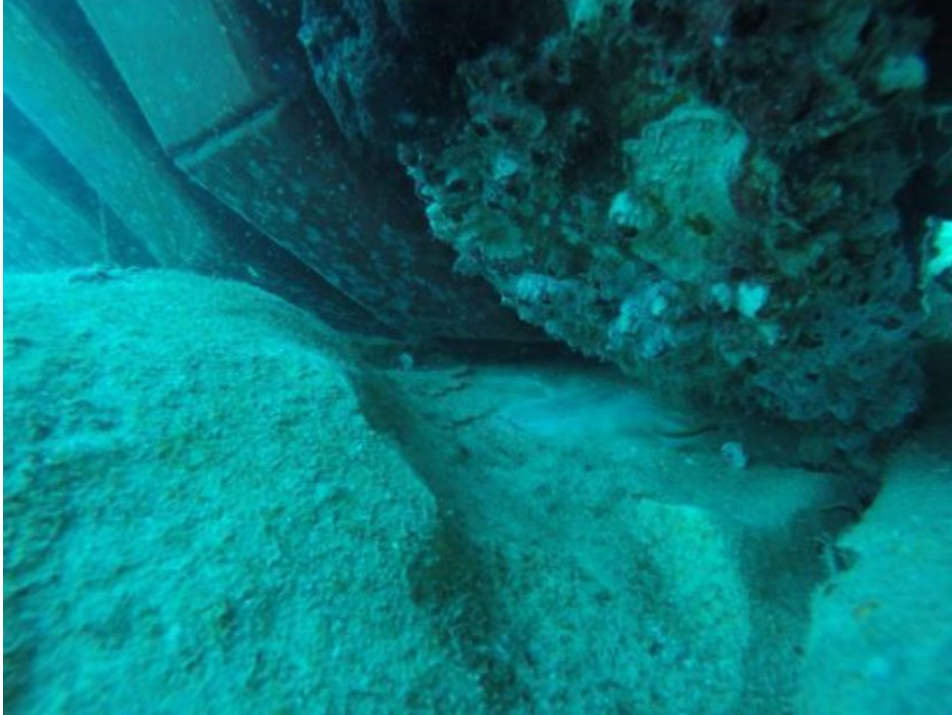
Furthermore, Figure 17 and Figure 18 show damage in the concrete weight coating cutback. This indicates that the cable/padding was moving laterally and the concrete cutback acted as a stopper (to some extent).

Figure 17: Damaged Field Joint Coating-Pipeline # 1. Note that the cable is not yet lifted for the purposes of inspection in this photograph.

The damage occurred along the entire width of the field joint coating (approximately 0.8 m), confirming that the damage spread across both sides due to cyclic lateral movement.

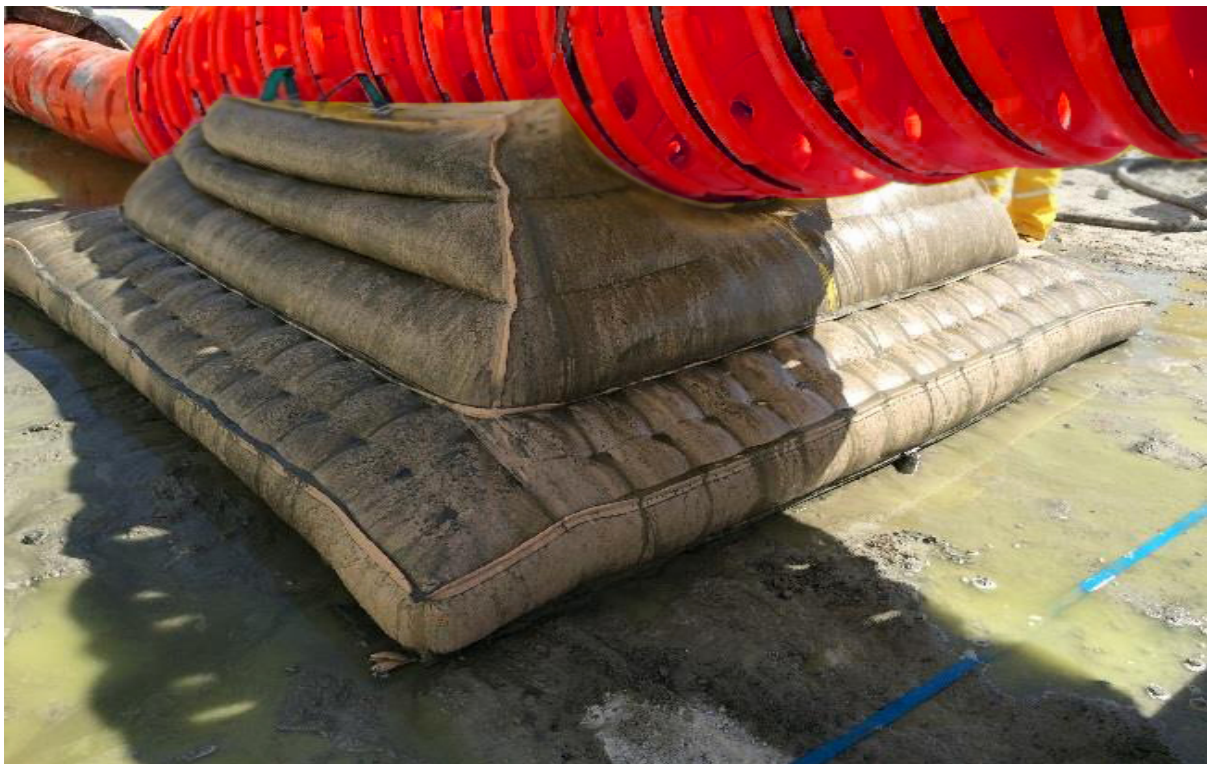
Figure 25: Mock-up trial for the cradle support

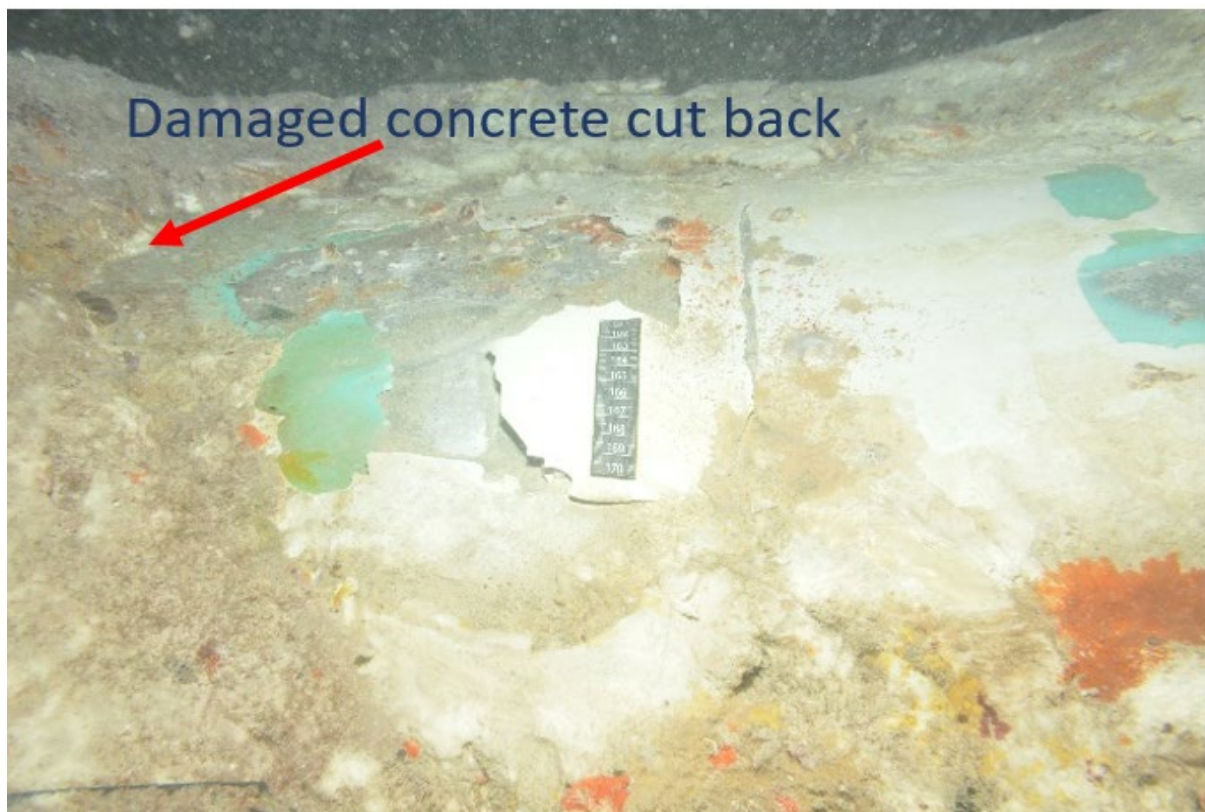
Dynamic loads due to rolling or sliding of the articulated padding across the rough surface of the round pipeline are difficult to quantify, because of the complexity of the lateral motion and involvement of many unknown force components. However, the damaged concrete at the cutback area shown in Figure 26 appears to have resulted from significant rolling and sliding loads.

Figure 26: Damaged concrete cut back

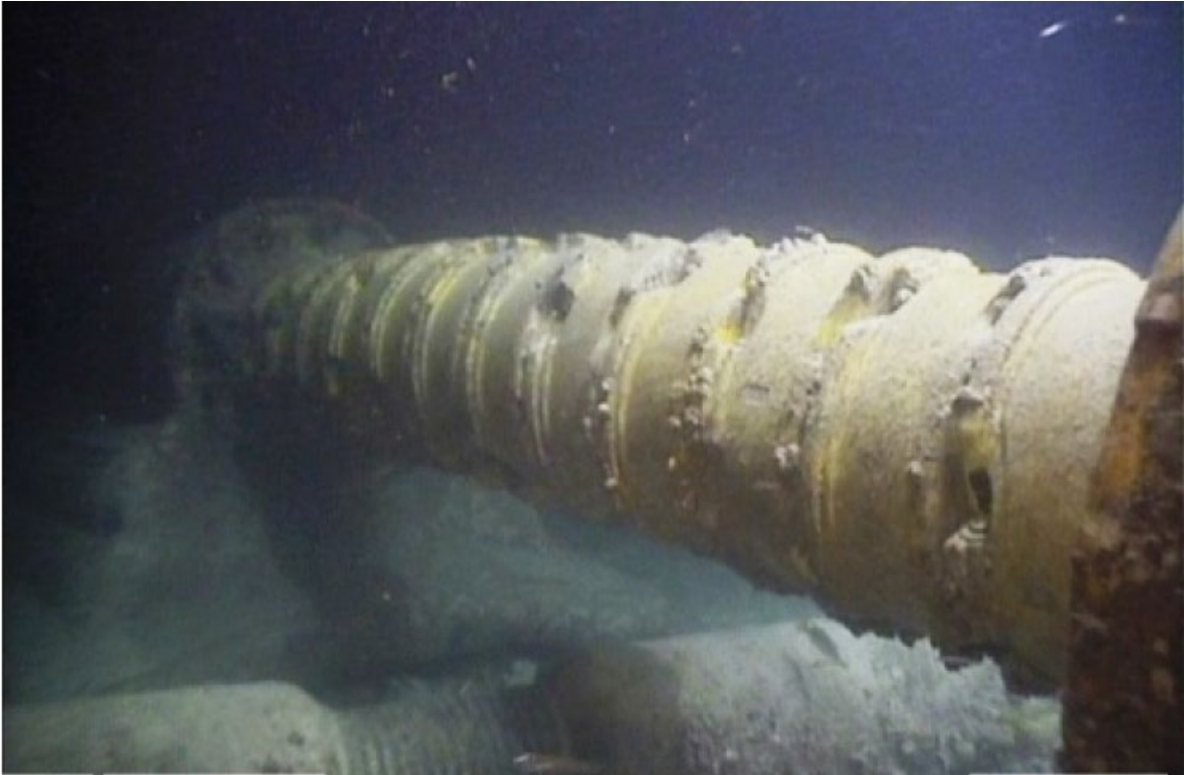
Figure 32: ROV survey for the cable and the bend restrictor

It is evident from Figure 32 that the bend restrictor is intact and still preventing the cable from sagging at the crossing point and the vertical separation between the bottom of the bend restrictor to the top of the crossed pipeline is maintained.

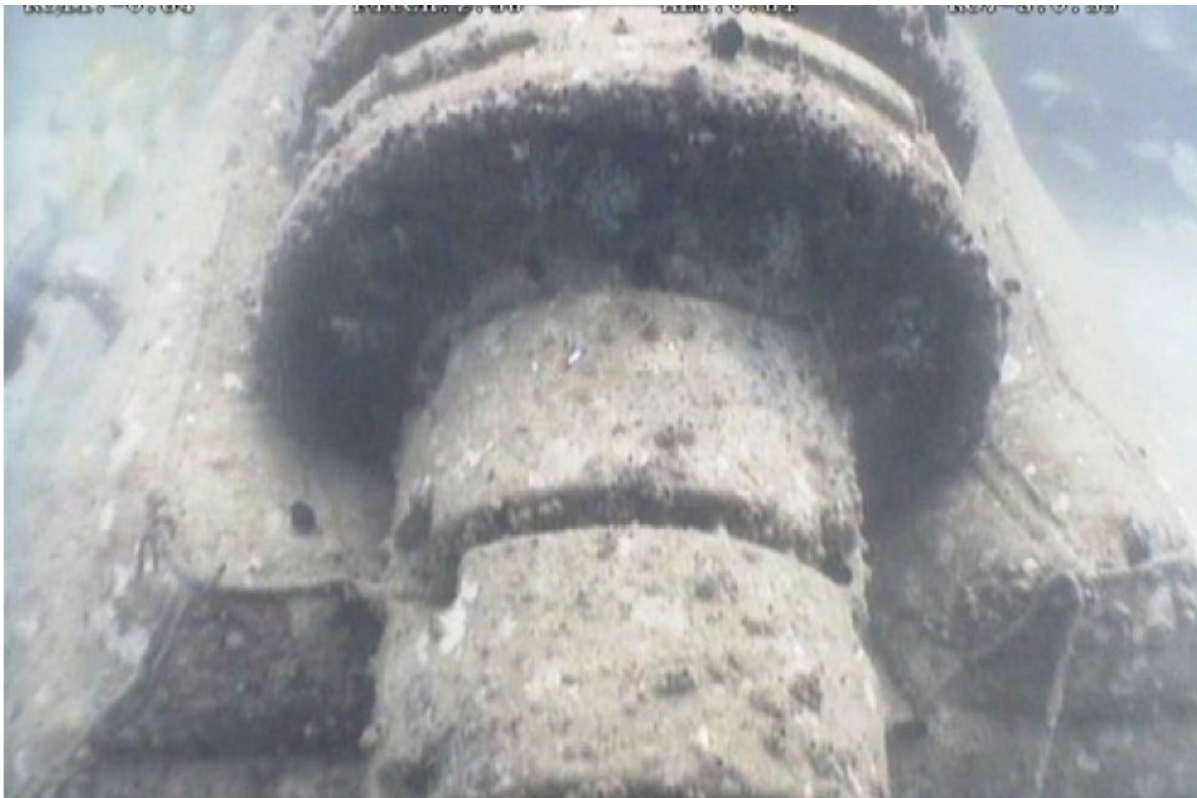
Figure 33: ROV survey for the cable and the cradle support.

Figure 33 demonstrates that the discs rest on the cradle and the discs are restrained by the cradle. There is no sign that the discs broke through the cradle. Furthermore, there is no sign of damage of the cradle.

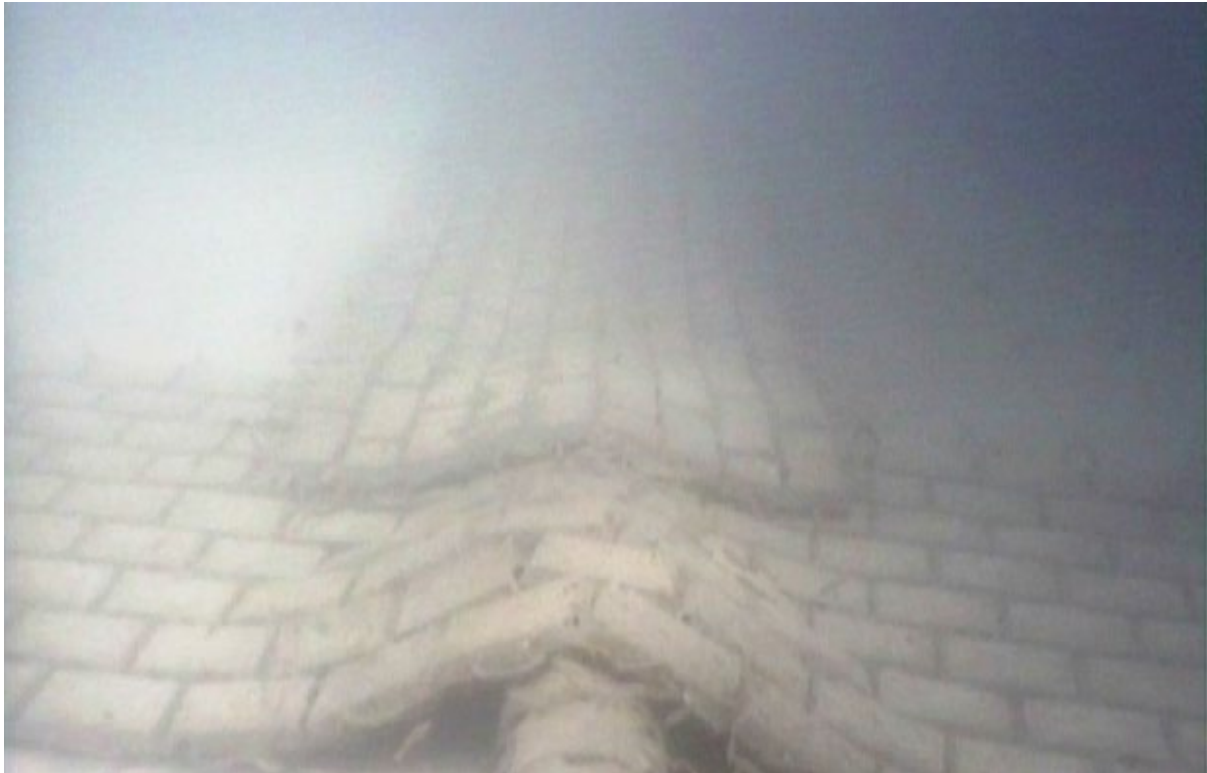
The ROV survey also covered the mattresses at the touchdown point to investigate if the cable was washed away from the mattresses. This is shown in Figure 34.

Figure 34: ROV survey showing the mattresses at the touch point.
