Cycles and trends in the dynamics of a leaning tower. Eight years of geometric monitoring with surveying techniques

This paper presents the methodology and results of the geometric monitoring of a leaning tower (Santa María la Blanca church in Agoncillo, La Rioja, Spain) with surveying techniques. Throughout the period 2007-2014, two types of variations in the geometry of the building have been tracked: those due to a seasonal cycle (winter-summer) and those caused by the progressive increase in the leaning of the tower. The text describes the distribution of the control points, the fieldwork, the computation strategy and the way to ensure that the results are significant. By way of conclusion, this work discusses the applicability of these techniques to the monitoring of historic buildings.

The church of Santa María la Blanca of Agoncillo (La Rioja, Spain) was built in ashlar masonry during the 17th and 18th centuries. It is a three nave construction with chapels. The ground surface of the main edifice is around 12 by 30 meters by 20 meters high. Although it holds some remarkable pieces of furniture and sculpture, out of the canon of art historians, the building is mainly known

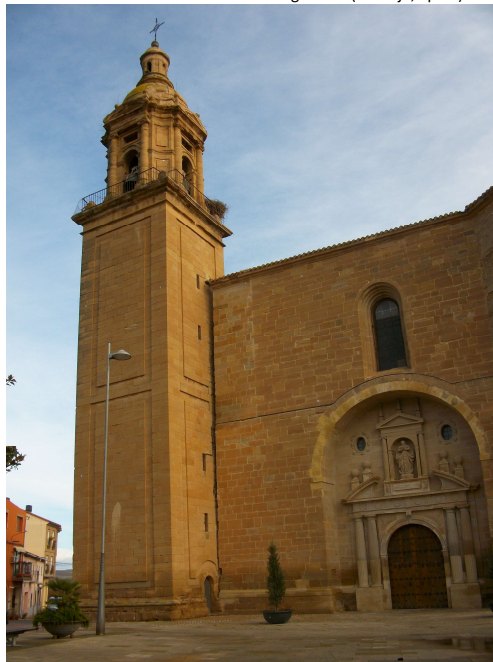
Figure 1. Leaning tower of Santa María la Blanca church in Agoncillo (La Rioja, Spain). Source: self-elaboration.

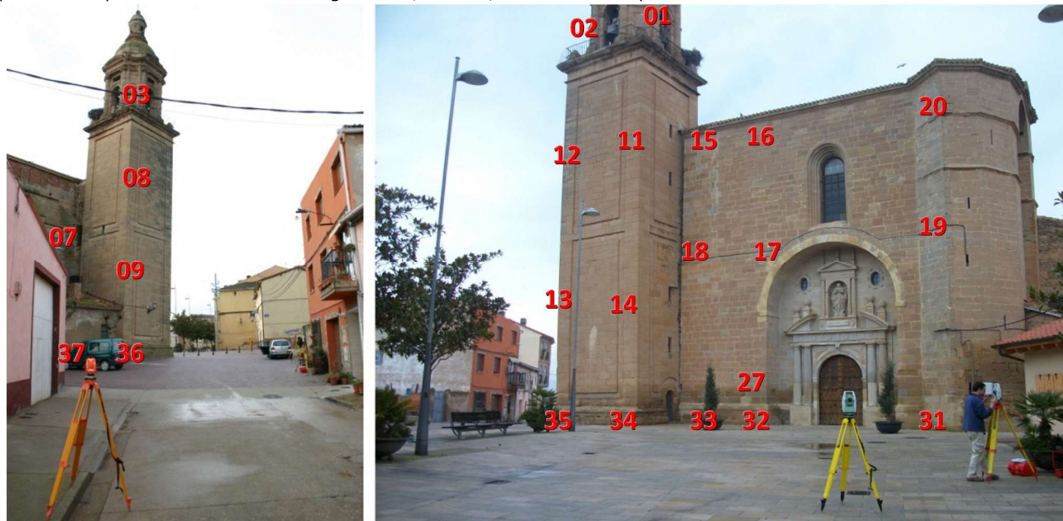
The measurements with total station were done from the square in front of the main façade (to the west) and the vacant lot (to the north). Figure 2 shows these two spaces as well as the location of the control points on the building. For the majority of these locations, two markers were placed very close to each other, both were measured and computed independently in order to detect observation mistakes and remove them from the calculations, in addition, by resorting to a redundant signalling system, any possible detachment or movement of the points (not linked to the movement of the walls) can be more easily spotted. The computation of the coordinates of these targets was done by means of least squares adjustment of the angular intersections and reached an accuracy of 2 mm (established by the semi-major axis of the 95% confidence ellipses provided by the adjustment at each point).

Figure 2. Open spaces around the tower from which the survey observations were carried out. The numbers on the pictures indicate the location and codes of the control points. Total station was arbitrarily set up by resection in eight positions at each epoch, the coordinates of the stationing points were auxiliary and valid only for that specific epoch since the points were not marked on the ground and, therefore, could not be reoccupied. Source: self-elaboration.

35 and 27 in figure 2 were selected. Then, all the epochs for the period 2007-2009 were recalculated in relation to this new system, in such a way that their values could be cross-checked with the measurements made in 2014.

In order to describe the results, let us have a look at locations 1, 2 and 3 (see figure 2), the ones situated at the top of the tower since they show the differences more clearly. As there are two control points for each location, we have six samples of the difference among epochs (indicated as “C01”, “D01”, “C02”, “D02”, “C03” and “D03”). Figure 4 displays the charts corresponding to all six points. For each point, four positions with their uncertainties are drawn: average for winter 2007-2009 (dark red), average for summer 2007-2009 (dark blue), winter 2014 (light red) and summer 2014 (light blue). In the charts, position is represented by the centre of the ellipse and uncertainty by the ellipse itself.

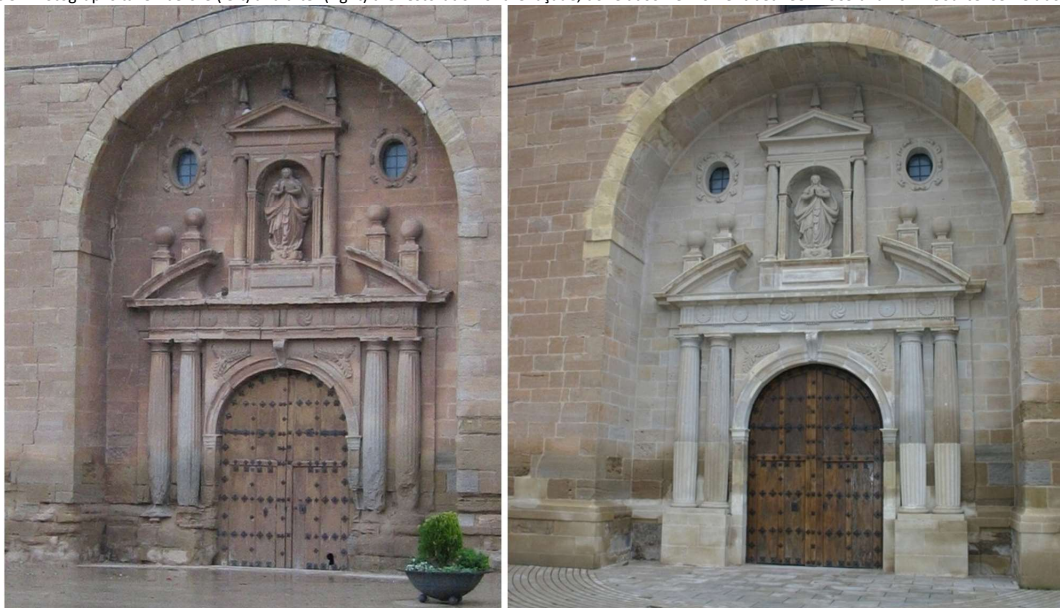
Of special relevance for our study was the restoration of the main façade that we found in 2014. In that work, cracks were covered and degraded stones replaced, especially at the base of the building and near the entrance (Figure 3). Four markers were removed as a result of this intervention, including many of the ones placed at the bottom of the building (in particular, locations 31, 32 and 33 in figure 2) and, even worse, one that had been used to define the reference system relative to which the measurement of the leaning was calculated. Furthermore, several surrounding buildings had also been restored or rebuilt during the time span of our study with the resulting loss of some external markers. Consequently, previous to the observation of new measurements it was necessary to place new control points in the empty areas.

Figure 3. Photographs taken before (left) and after (right) the restoration of the façade, done at some moment between 2009 and 2014. Source: self-elaboration.

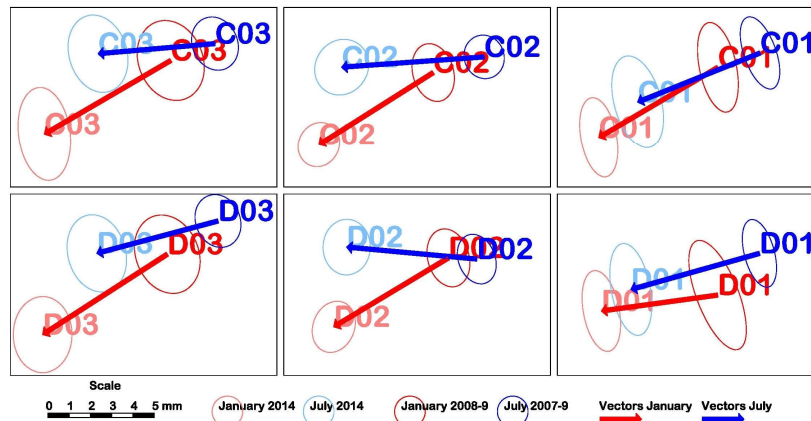
Figure 4. Ellipses corresponding to the XY position and uncertainty of the six control points located on the belfry. The representation shows the average values for the campaigns of winter and summer during the period 2007-2009 and the values obtained in 2014. The figure also shows the vectors of the displacements for the period 2009 to 2014. Source: self-elaboration.

To begin with, figure 4 shows that, except for “D01”, the error ellipses corresponding to the coordinates of the control points computed for the campaigns of January and July 2014 (light ellipses) are clearly separated, thus confirming the existence of the seasonal cycle already detected in the campaigns of the period 2007-2009 (dark ellipses).

As far as the accumulative movements are concerned, figure 4 shows the vectors corresponding to the displacements between the positions of January and July after the five elapsed years. The direction of these vectors is consistent with an increase in the leaning angle with respect to the church, the average length being 6 mm. If it is assumed that this displacement is the result of a movement with constant speed in progress throughout all the time, the speed of the aforesaid movement can be estimated in around 1.2 mm/year.

According to the values in table 1, over a five-year period and considering an uncertainty of 2 mm for the coordinated of each epoch, the error with which the speed can be determined is 0.6 mm/year, which means that the resulting value (1.2 mm/year) is significant. What is more, this estimated speed is in line with the result obtained after the analysis of the campaigns 2007-2009, when the conclusion was reached that, if accumulative movements exist, their speed should be under 1.4 mm/year.

As told before, the interpretation of both the cycle and the accumulative movement as due to the increase in the leaning of the tower is also supported by the rest of the control points placed at different heights on the tower (21 points in total), which show vectors along the same direction but with lengths that are progressively smaller as the markers are closer to the ground. As the speed 1.2 mm/year was measured for the control points on the belfry (located around 25 meters above the ground), this variation can be also expressed as an angular increase in the leaning of the tower in the order of 10” (sexagesimal seconds) a year.
