**Analytical tools applied to  
the evaluation of the influence  
of different marine environments  
on the conservation state of  
building materials**

**Héctor Morillas Loroño**  
**September 2015**

This PhD Thesis has been developed in the Analytical Chemistry Department from  
the University of the Basque Country  
(Faculty of Science and Technology, Leioa, Spain)

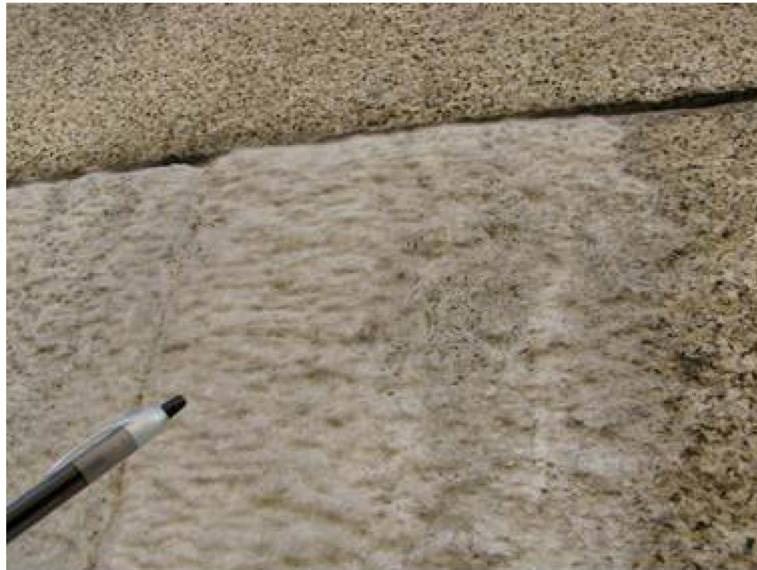
**Figure 1.3.** Example of white crust formed over building surface.

The white crusts are usually carbonate-rich coatings and its presence is influenced by diverse factors such as building design, mortar composition and its water content. These white crusts can be formed on diverse building materials such as limestones, igneous rocks, concrete, tiles and even glasses [25]. Although a priori the white crusts look like crusted efflorescence, they cannot be considered efflorescences. Its main feature lies in its stability over time (see Figure 1.3). The white crusts do not suffer dissolution/crystallization cycles related to moisture regimes, they are not easily removed by rain-wash and they are also difficult to clean [26].

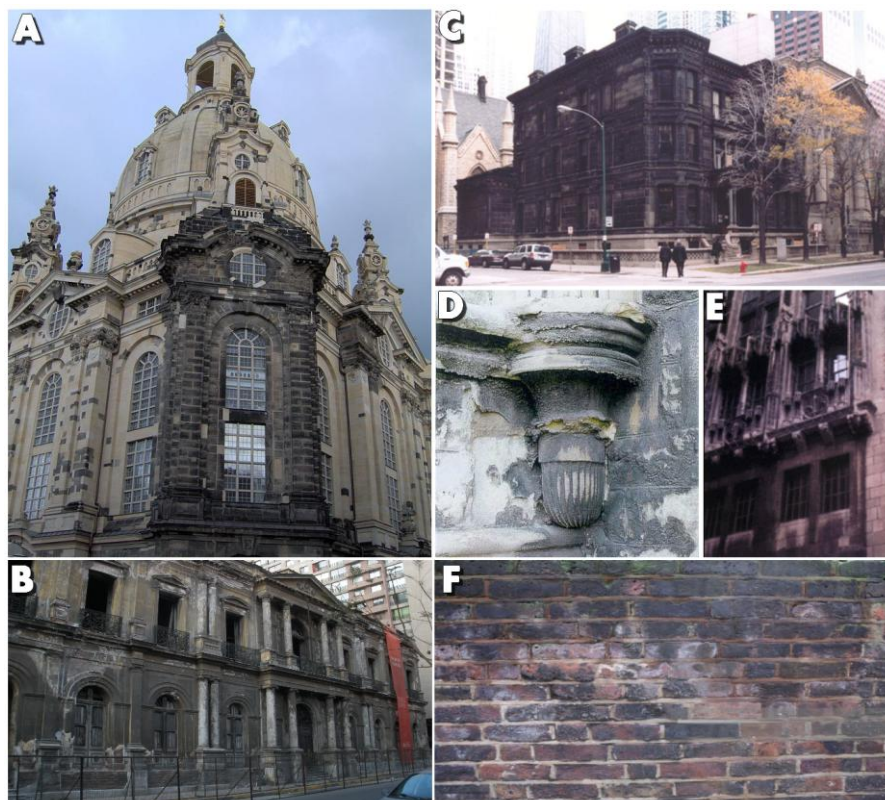
**Figure 1.4.** Examples of black crusts formed over A) limestone building surface in Germany, B) limestone building surface in Chile, C) sandstone building surface in U.S.A, D) limestone building corner surface in United Kingdom, E) sandstone building surface in France, F) brick wall.

Figure 1.4 shows different examples of black crusts. The chemical composition of these black crusts can vary depending on the building geographic location. Thus, black crusts on buildings close to the sea will have different chemical composition than others located in rural or urban areas, depending on the compounds present in the atmosphere, which can be trapped in the porous matrix of the black crust. Although a priori, a location close to the sea can be free of pollutants, if in the surrounded environment, industry and ships traffic are present, these pollutants can be potentially accumulated on the black crusts. In the recent years because of the increased use of diesel fuels, a considerable increase of  $\text{NO}_x$  in the atmosphere has been registered. The acid aerosol can react with the primary particles emitted to the atmosphere, giving rise to nitrate particles as secondary particles, which can be also deposited and accumulated in the black crusts.

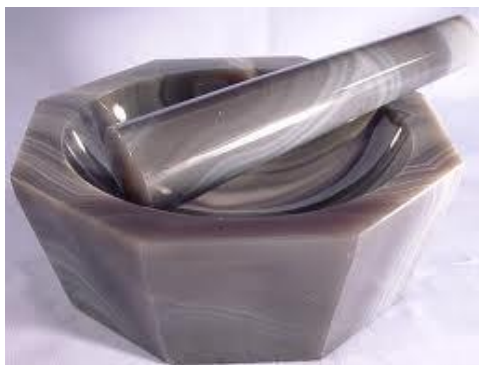
**Figure 3.1.** Agate mortar with pestle.

The samples used for quantitative analysis (Ion Chromatography and ICP-MS) and for XRD analyses were homogenized in an agate mortar with pestle. This step is very important in order to obtain homogenized samples with lower particles size (See Figure 3.1).

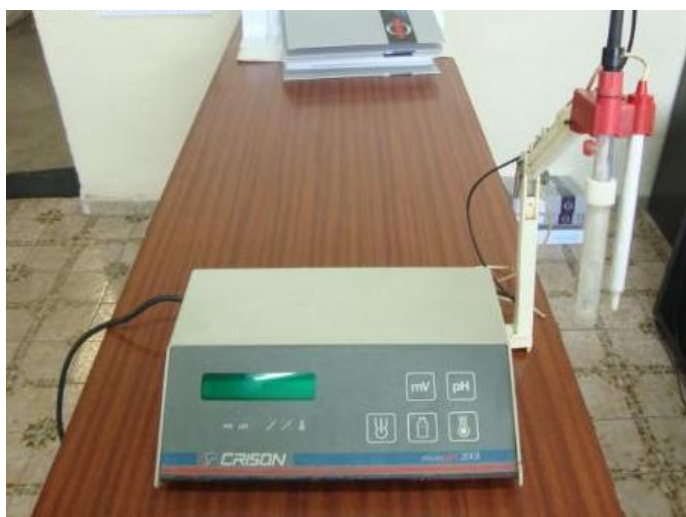
**Figure 3.3.** pH meter / VoltMeter Crisonmicroph 2000.

In this PhD Thesis, for the analysis of pH and redox potential of the rainwater samples (see Chapter 5), a Crison microph 2000 (Crison Instruments S.A. Alella, Barcelona, Spain) instrument was used (see Figure 3.3). In this instrument, depending on the variable to be measured (pH or redox potential), the measuring electrode was selected. On one hand, for the calibration of pH meter, a diary calibration using two buffer solutions was carried out. Firstly the pH 7.00 buffer solution (Crison pH 7.00 @ 25°C buffer solution CRI9464.99) was used. Secondly the pH 4.01 buffer solution (Crison pH 4.01 @ 25°C buffer solution CRI9463.99) was used. Both of them were measured at 25°C. On the other hand for the calibration of the voltmeter, a diary calibration using a Hamilton Redox Bufer 475± 5mV which is certified traceable to N.I.S.T and P.T.B (N.I.S.T: National Institute of Standards and Technology, USA and P.T.B: Physikalisch-Technische Bundesanstalt, Germany) was used.

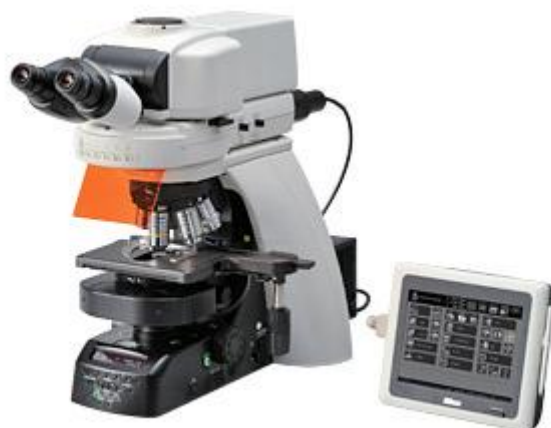
**Figure 3.4.** Nikon Eclipse 80i Phase Contrast Microscopy

A Nikon Eclipse 80i PCM (Phase Contrast microscope) provided with 20×, 40×, and 60× objective lenses was used to obtain microphotographs of the red biofilm from Chapter 6 (see Figure 3.4). For the preparative process of the sample, special tweezers were used to sample the main colonizer from the red biofilm, under the view of a microscope. After the extraction of the main colonizer, it was placed on a slide and a drop of oil was also added to avoid spherical aberration with the highest numerical aperture lenses, promoted by the different indexes of refraction of the specimen and the objective lenses.

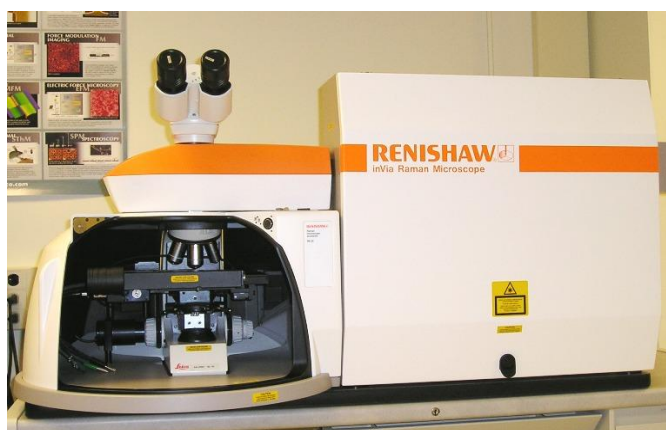
**Figure 3.7.** The Renishaw inVia confocal Raman microscope.

source are 50 mW and 350 mW for each of the laser beam, and at the samples 20 mW and 150 mW respectively), and a Peltier cooled CCD detector (-70°C) (see Figure 3.7).

The spectrometer is coupled to a DMLM Leica microscope (Bradford, UK) and for visualization and first focusing 5x PLAN (0.12 aperture) objective and 20x N PLAN EPI (0.40 aperture) lens were used. The spectra were acquired using 50x PLAN (0.75 aperture, lateral resolution of 2  $\mu\text{m}$ ) and 100x (lateral resolution of 1  $\mu\text{m}$ ) long-range objectives. At high magnifications, the laser spot was reduced to around 1  $\mu\text{m}$ . The microscope implements a Prior Scientific motorized XYZ positioning stage with a joystick and is equipped with a micro-camera. The spectra were acquired between 100-4000  $\text{cm}^{-1}$  with a resolution of 1  $\text{cm}^{-1}$  using the Wire 3.2 software (Renishaw, Gloucestershire, UK).

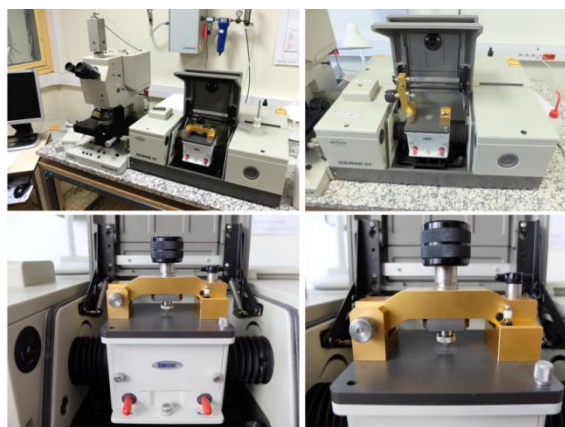
**Figure 3.8.** Bruker Equinox 55 spectrometer (top) and ATR unit from Golden Gate (bottom).

The infrared spectra were acquired using a Bruker Equinox 55 FTIR spectrometer in Attenuated Total Reflectance (ATR) mode (see Figure 3.8). The infrared source of this instrument is a heated silicon carbide filament that emits radiation in the mid infrared. The ATR measurements were performed using a Golden Gate (Specac, Kent, U.K) ATR unit equipped with a diamond crystal (refractive index of 2.4 than  $1000\text{ cm}^{-1}$ ), with incidence angle of  $45^\circ$ . A system of zinc selenide (ZnSe) mirrors and lenses focuses the infrared beam on the diamond crystal which is transmitted to the sample. The detector used is a DTGS (acid sulfate Triglycine deuterated). The sample is placed in contact with the crystal by a sapphire anvil on which is applied a maximum pressure of 0.1 GPa. The area analyzed on the samples is about  $0.8\text{ mm}^2$ . The spectra were acquired between  $600\text{--}6500\text{ cm}^{-1}$  (narrow spectral range to low wavenumbers due to the presences of ZnSe lenses), with a standard resolution of  $4\text{ cm}^{-1}$  and each spectrum accumulated 16 times.

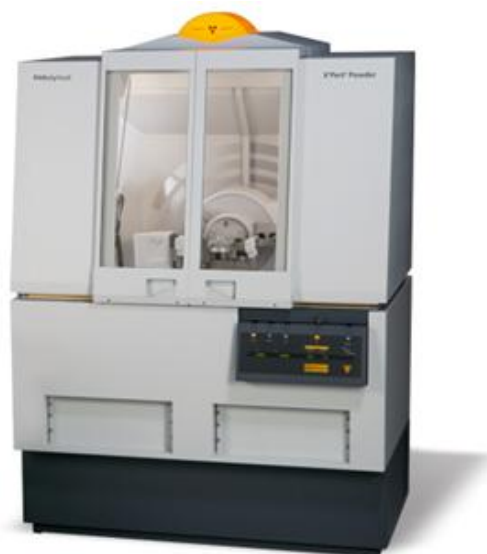
Figure 3.9. PANalyticalXpert PRO powder X-ray diffractometer

To contrast, confirm and complement the information given by Raman and infrared spectroscopies, XRD analyses were carried out on the X-ray Service from SGIker of UPV/EHU. Previous to the analyses each of the samples was powdered and homogenized manually using an agate mortar. The XRD analyses were performed using a PANalytical Xpert PRO powder diffractometer equipped with a copper tube ( $\lambda_{\text{Cu}_{K\alpha\text{media}}} = 1.5418 \text{ \AA}$ ,  $\lambda_{\text{Cu}_{K\alpha1}} = 1.54060 \text{ \AA}$ ,  $\lambda_{\text{Cu}_{K\alpha2}} = 1.54439 \text{ \AA}$ ), vertical goniometer (Bragg–Brentano geometry), programmable divergence aperture, automatic interchange of samples, secondary graphite monochromator, and PixCel detector. The operating conditions for the Cu tube were 40 kV and 40 mA, with an angular range ( $2\theta$ ) scanned between 5 and 70° (see figure 3.9). The treatment of the diffractograms and the identification of the mineral phases present were carried out using the specific X'pert HighScore (PANalytical) software in combination with the specific Powder Diffraction File (PDF2) database (International Centre for Diffraction Data – ICDD, Pennsylvania, USA).

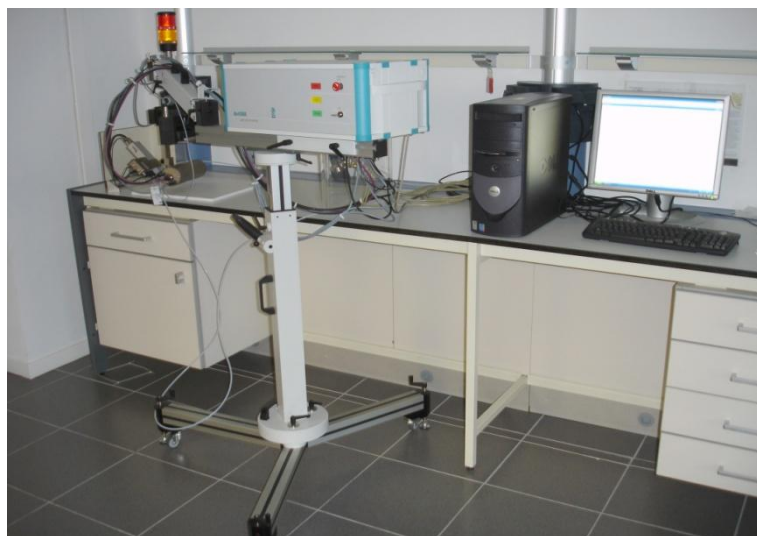
**Figure 3.10.** Artax  $\mu$ -XRF portable instrument by Röntec (currently Bruker).

In this PhD Thesis, apart from point-by-point analyses, elemental maps were also acquired using a lower lateral resolution ( $650\ \mu\text{m}$ ) thanks to the use of a lower diameter collimator implemented in a second  $\mu$ -ED-XRF instrument, the portable ARTAX  $\mu$ -ED-XRF from Röntec (currently Bruker Nano GmbH, Berlin, Germany). Each elemental map was constructed according to the net areas of XRF lines. This spectrometer implements a low-power metal-ceramic-type MCBM 50 X-Ray tube with molybdenum target as excitation source. The molybdenum anode spot size in the instrument is  $70 \times 50\ \mu\text{m}$ , and it can be used at a maximum voltage of 50 kV and at a maximum current of  $700\ \mu\text{A}$  (maximum power of 35 W). The radiation-protecting tube housing is equipped with an electrical shutter and safety functions externally controlled by a PC. The X-Ray Fluorescence radiation is detected by means of an electro-thermally cooled Xflash® detector, which is a silicon drift detector with high-speed low-noise electronics. The detector has an active area of  $5\ \text{mm}^2$  and a  $8\ \mu\text{m}$ -thick Dura-beryllium window. The geometry between primary beam, sample, and detector is fixed at  $0^\circ/40^\circ$  relative to the perpendicular of the sample surface. The X-Rays were collimated by a tantalum collimator with a diameter of 0.65 mm and the beam diameter in the sample surface is around  $200\ \text{mm}^2$ . An integrated CCD camera provides an image of the sample region under investigation ( $8\ \text{mm} \times 8\ \text{mm}$ ). In the vibration-damped swivel arm from the instrument, a motor-driven XYZ positioning stage is directly mounted, which consists of three equal modules with a maximum travel of 50 mm in each direction. This motor unit allows focusing on different parts of the sample

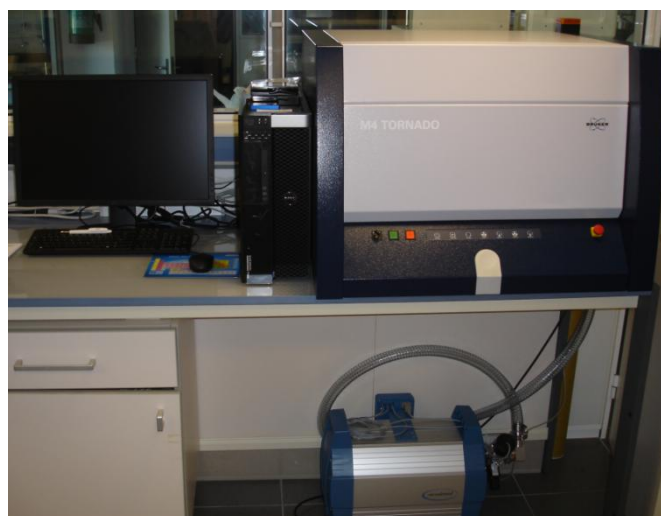
**Figure 3.11.** M4 Tornado  $\mu$ -EDXRF by Bruker.

For the measurements in the millimeter scale, the M4 Tornado (Bruker Nano GmbH, Berlin, Germany)  $\mu$ -ED-XRF instrument was used (see Figure 3.11). With this instrument punctual measurements, line scans and HyperMaps were acquired. The X-Ray tube implemented in this instrument is a micro-focus side window Rh tube powered by a low-power HV generator and cooled by air. Thanks to the implemented collimator, spot sizes of 1 mm were measured. The X-ray tube can work at a maximum voltage of 50 kV and at a maximum current of 700  $\mu$ A, which were the conditions considered for the spectra acquisition in this work. The detection of the fluorescence radiation was performed by an XFlash® silicon drift detector with 30 mm<sup>2</sup> sensitive area and energy resolution of 145 eV for Mn-K $\alpha$ . In order to improve the detection of the lightest elements ( $Z > 11$ ), filters were not used and measurements were acquired under vacuum (20 bar). To achieve the vacuum, a diaphragm pump MV 10 N VARIO-B was used. The live time used for each punctual measurement was 200 seconds. For the focusing of the area under study, two video-microscopes were used, one of them to explore the sample under a low magnification (1 cm<sup>2</sup> areas), and the other one to perform the final focusing (1 mm<sup>2</sup> areas). Apart from punctual measurements and line scans, HyperMaps were also acquired. The elemental maps showed in this PhD manuscript were obtained after a previous assignation of the elements, deconvolution and application of Fundamental Parameters based-method regarding the quantitative information of each element on each point from the mapped area. The spectral data acquisition and treatment was performed using the M4 TORNADO software and the quantification was done thanks to the M-Quant software package

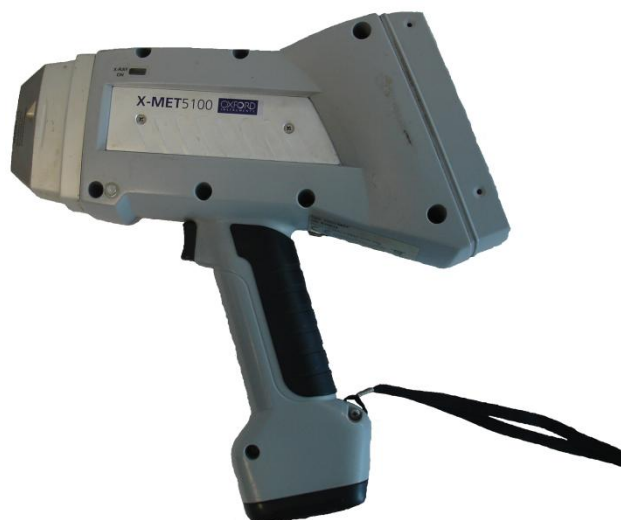
**Figure 3.14.** Handheld ED-XRF XMET5100 (Oxford Instruments, UK).

A hand-held ED-XRF XMET5100 spectrometer (Oxford Instruments, UK) equipped with a Rh tube as X-Ray source was used (see Figure 3.14). This device can work at maximum of 45 KV and the size of the emitted radiation X-Ray beam is 9 mm. The analyzer includes a silicon drift detector (SDD) of high resolution that is able to provide an energetic resolution of 150 eV (calculated for the Mn K $\alpha$  line at -20 °C) and a spectral resolution of 20 eV. The analyzer contains a PDA to control the spectrometer and also to the obtained spectra and the semi-

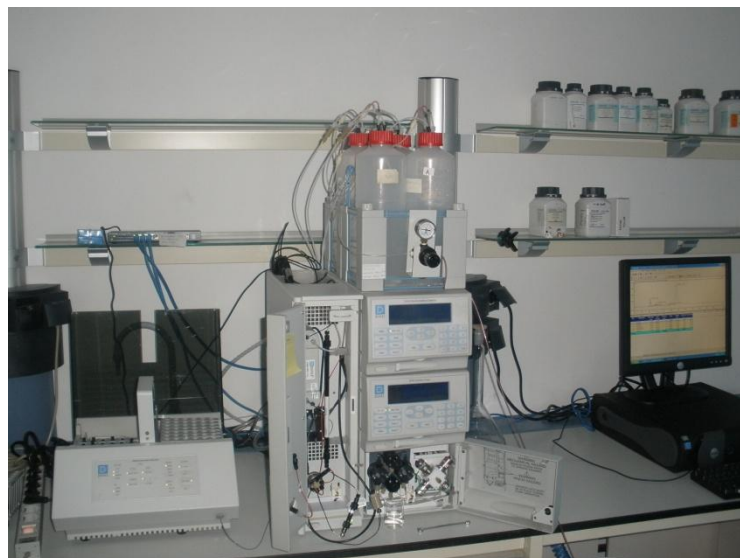
**Figure 3.17.** Ion chromatograph coupled to a conductimetric detector with postcolumn suppression and AS 40 autosampler (Dionex).

In all situations, cations and anions involved in each soluble salts were quantified by means of a Dionex ICS 2500 ion chromatograph connected to a conductimetric detector (ED50 Dionex conductimetric detector) with postcolumn suppression (Dionex Corporation, Sunnyvale, California, USA) (see Figure 3.17).

The chromatograph is coupled to an autosampler AS40 from Dionex which makes possible an automatic analysis of sample series. The acquisition and data-handling was performed using the Chromaleon 6.60-SPIa software (Dionex Corporation).

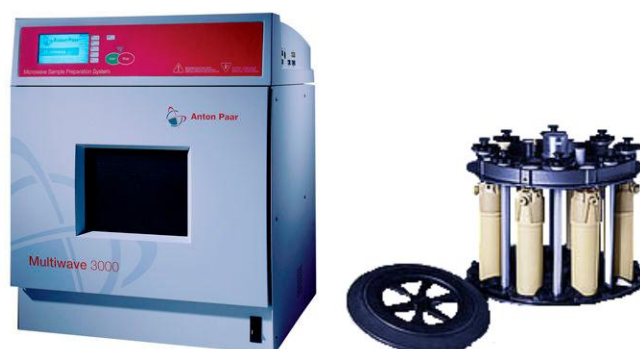
**Figure 3.18.** Multiwave 3000 microwave (Anton Paar, Graz, Austria) and Teflon vessels for digestion.

The extraction of non-siliciclastic compounds was performed using a microwave assisted acid digestion in a Multiwave 3000 (Anton Paar, Graz, Austria) system provided with an 8XF-100 digestion rotor and 100 mL fluorocarbon polymer (PTFE) microwave vessels (see

Figure 3.18). Powdered 0.5 gr dried sample (constant weight verified using the Mettler-Toledo balance AJ150 model,  $\pm 0.0001$  g) were weighed in each Teflon vessel and subjected to acid digestion using 12 ml of 3:1 HNO<sub>3</sub> (69%) : HCl (36%). The acids were added and allowed to react for a few seconds before closing the vessels.

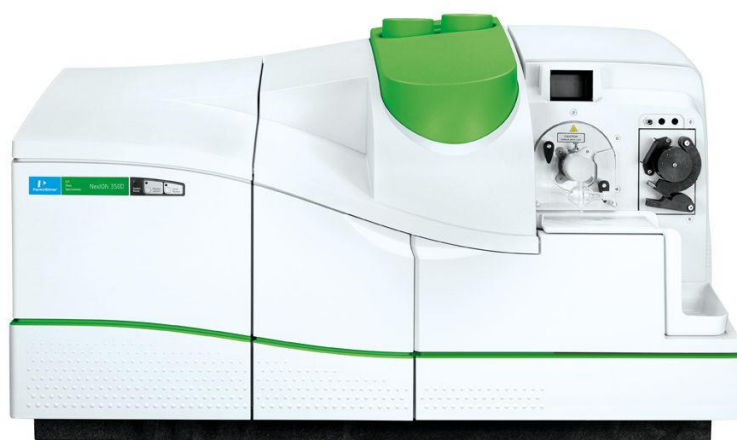
**Figure 3.19.** ICP-MS instrument (NexION 300, Perkin Elmer).

Prior to the elemental measurements, the acid concentration of the acid extracts was reduced to less than 1% HNO<sub>3</sub> using Milli-Q water. In addition, a solution containing 10 µg.L<sup>-1</sup> of Be, Sc, Ge, In, Re and Bi was added as internal standard. The internal standards and ICP-MS calibration standards solutions were prepared from 1000 mg.L<sup>-1</sup> stock solutions of Alfa Aesar (Specpure®, Plasma standard solution, Germany) inside a class 100 clean room. All solutions were prepared using Milli-Q quality water. PL 20-200 µL and PL 500-5000 µL micropipettes (Eppendorf, Hamburg, Germany) with an calibration standards and samples dilutions were prepared using analytical balance model Mettler-Toledo XS205 (Columbus, OH, USA) with accuracy of ± 0.00001 g. The elemental analysis of the extracts was performed by ICP-MS (NexION 300, Perkin Elmer) in a class 100 clean room (see Figure 3.19). The argon used was supplied by Praxair (99.995%, Madrid, Spain).<sup>27</sup>Al, <sup>44</sup>Ca, <sup>88</sup>Sr, <sup>98</sup>Mo, <sup>114</sup>Cd, <sup>120</sup>Sn, <sup>121</sup>Sb, <sup>138</sup>Ba, <sup>184</sup>W, <sup>202</sup>Hg and <sup>206+207+208</sup>Pb isotopes were determined in standard mode and <sup>23</sup>Na, <sup>24</sup>Mg, <sup>39</sup>K, <sup>47</sup>Ti, <sup>51</sup>V, <sup>52</sup>Cr, <sup>55</sup>Mn, <sup>56</sup>Fe, <sup>59</sup>Co, <sup>60</sup>Ni, <sup>65</sup>Cu, <sup>66</sup>Zn, <sup>75</sup>As, <sup>78</sup>Se, <sup>111</sup>Cd isotopes were determined in collision mode with He with in order to eliminate possible polyatomic interferences.

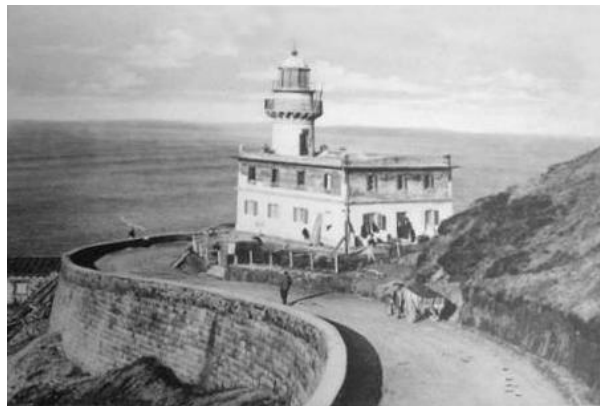
**Figure 4.3.** Historical photograph of Igueldo Lighthouse at the beginning of 20th century.

As San Sebastian needed a lighthouse that would elevate the category of the city, which was very important in that time, and taking advantage of the expansion which was taking place at the port of San Sebastian, it was decided to build a new lighthouse in 1855. Initially, it was thought to recover the lighthouse in its original location, but considering that its initial position caused problems, this option was rejected. For this reason, Manuel Peironcelly was commissioned to design the new lighthouse. He built the new one at a lower altitude in the slope of Igueldo Mount, to avoid problems with fog. Therefore, the new Igueldo Lighthouse was placed at an altitude of 134 meters instead of 184 meters. During years, the new lighthouse has undergone many structural renovations. In 1911, it was decided to improve and renew its lighting. In 1918, the electrification project was performed. Later, in 1929, the installation was renewed and in 1934, the lighthouse inner rooms were coated with tiles (see Figure 4.3).

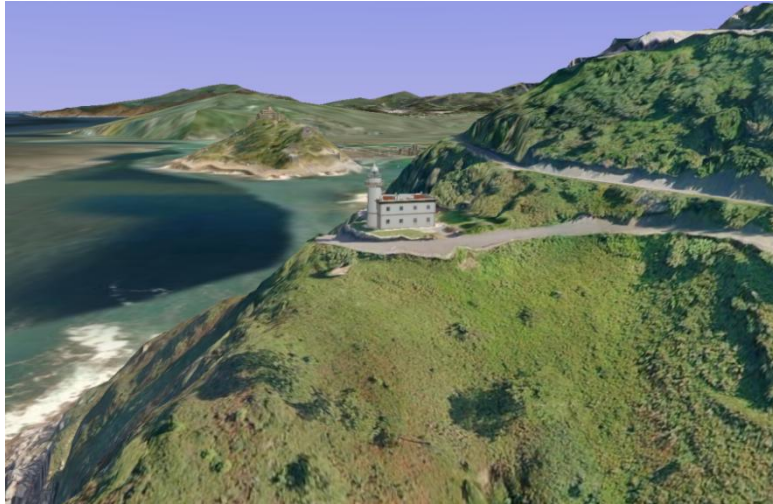
**Figure 4.5.** Orography of the Igueldo Lighthouse surroundings.

proportional to the wind speed. In our case the orography of Igueldo area is relatively complex (see Figure 4.5), because the lighthouse is located in a karstic area, full of cliffs, which includes additional variables that hinder the simulation.

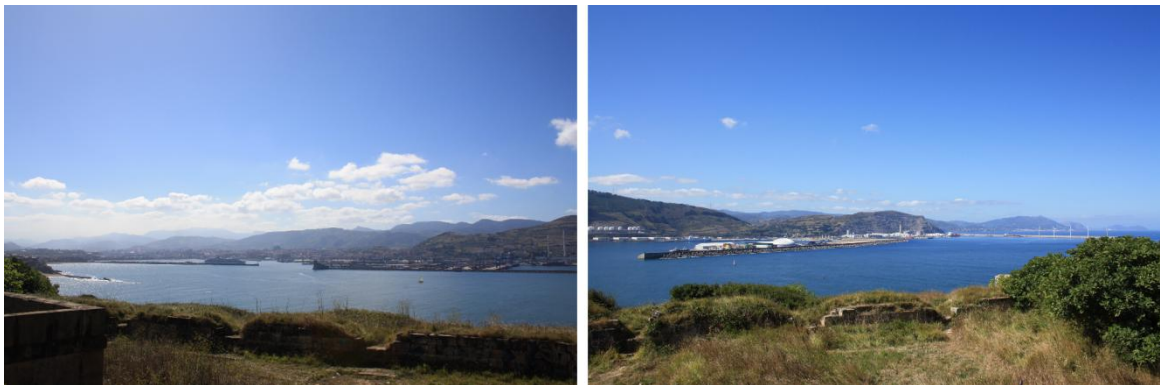
In this chapter, the direct influence of both marine aerosol and environmental stressors coming from urban-industrial environments on a specific construction will be evaluated. The selected building was La Galea Fortress (Getxo, Basque Country, north of Spain). As it will be explained in the research articles, this building undergo the direct influence of the Primary and Secondary Marine Aerosol particles, crustal particles, acid aerosol depositions, metallic airborne particulate matter depositions, etc. As it can be observed in Figure 6.1, many industries (e.g. steel industries) and the port of Bilbao are placed in front of the fortress. Apart from this, as it can be also observed in the Figure 6.1, La Galea Fortress is located just on a cliff (50 m high) in the coast.

**Figure 6.1.** Views from La Galea Fortries, showing the location, directly influenced by the marine aerosol and an urban-industrial area.

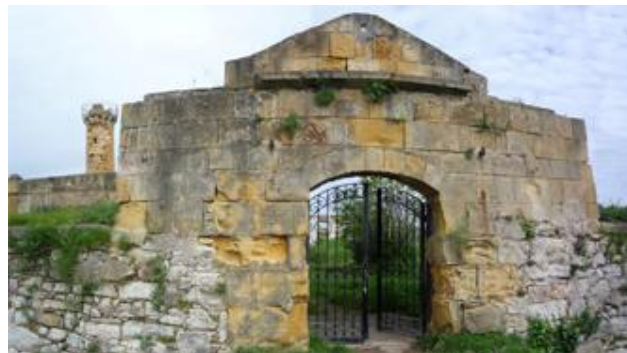
- [105] D. Barca, V. Comite, C. M. Belfiore, A. Bonazza, M. F. La Russa, S. A. Ruffolo, G. M. Crisci, A. Pezzino, C. Sabbioni, Impact of air pollution in deterioration of carbonate building materials in Italian urban environments, *Applied Geochemistry* (2014) 48: 122-131.

The entrance of the fortress was located on the South-southeast orientation. It is built using sandstone ashlar. The entrance has an arch appearance that opens inwardly in a wide vault. Its outside dimensions are 1.80 meters wide and 2.12 meter high; while the interior size is 4.38 x 2.50 meters (see Figure 6.3).

At the top of the entrance arch, the front wall appears with small access as completely smooth truncated pyramid, without any decoration excepting the stones themselves. This facade originally had a small slightly protruding stone, that nowadays it is almost completely lost. On the inside of this structure the voids of the wooden bar designed to strengthen the closing of the door is still preserved, although none of these elements (bar and door) have been not preserved until today.

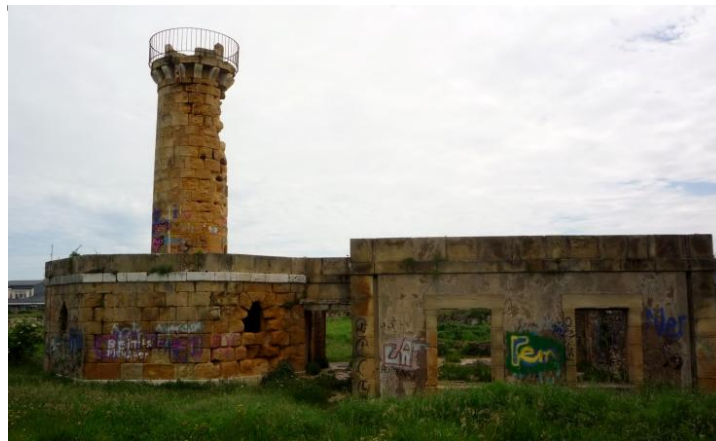
[111] <http://www.emerisda.eu/about-project/project-description/summary/> [last accessed 11 July 2015].

Inside the enclosure, it can identify a total of three buildings linked historically with the tower. The first one is the Lighthouse Tower, being the oldest. The second one belongs to a building used to house the lighthouse keeper. Finally, a small building, the one constructed in the 20<sup>th</sup> century is also preserved nowadays (see Figure 6.4). The tower is a building with

circular and cylindrical ground and performed with sandstone blocks. The diameter of the tower base is 3.30 meters reaching 2.95 meters at the top, being the walls thickness 0.60 meters. Its total height is 10.85 meters (originally with flashlight, the tower reached a full wingspan of 12.35 meters). At the top, the tower is topped by a projecting cornice which bears on a series of monolithic limestone corbels and currently is crowned by a balcony with iron railings. As referred in the chronicles of that time, originally this building was completely whitewashed and white painted. Today nothing remains of it except a few white scraps on the ground floor. Inside the tower, several vains to provide illumination to the narrow and steep spiral staircase that allows the ascent to the top of the building were destined. This staircase was performed by large sandstone blocks, and now has lost in two different sections several steps. To this staircase accessed from a lintel vain opened at the base and whose jambs appear slightly chamfered, where his initial gap (95 cm wide and 1.74 cm high) narrowing slightly until being reduced to 77 cm. In its base, this tower is surrounded by a single building octagonal floor executed in a similar way to the tower by sandstone ashlars. The only decoration is presented in the cornice and plinth area with a horizontal band performed by limestone blocks which protrude slightly from the facade line and chromatically contrasting with the rest of the wall by its whitish color. Furthermore the tower has four openings vains and the dimensions are of 8.60 meters each side and a height until the cornice of 4.05 m. Nowadays is formed by a formwork bricks, cement and a cement mortar layer with large stones volumes which in the mid-1950s were replaced to the original cover.

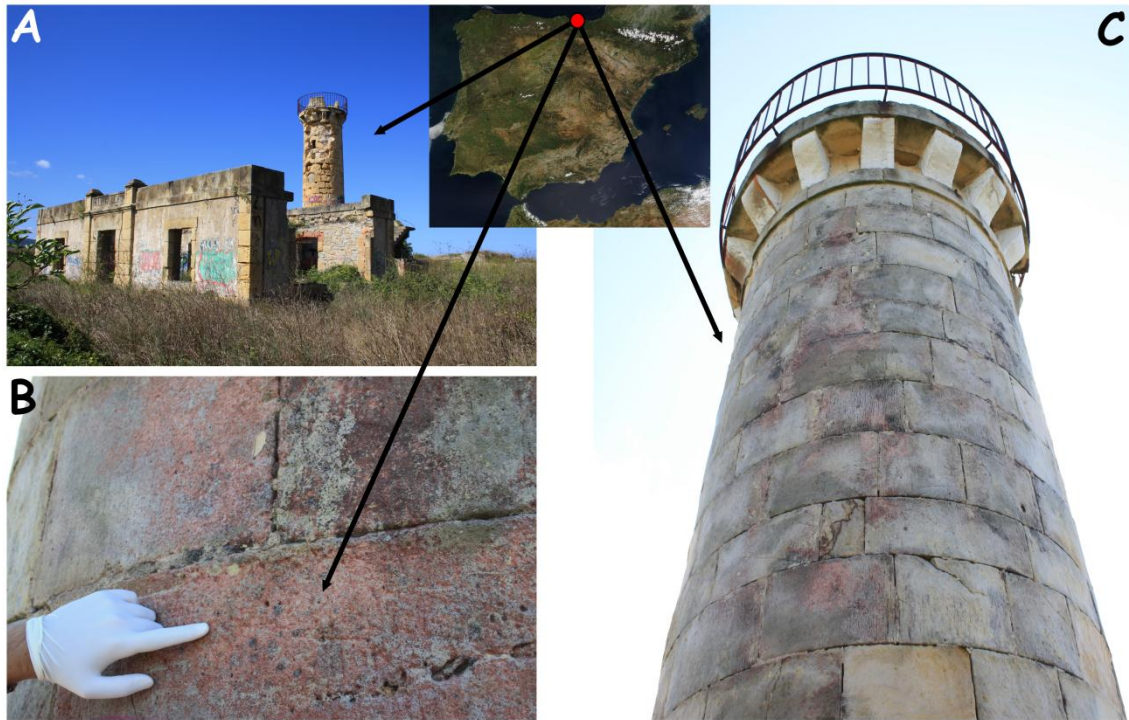
**Figure 1.** (A) General view of La Galea Fortress, (B) red biofilm colonizing the sandstone from the Northwest side of the Fortress tower and (C) general view of the Northwest side of the tower showing the red biofilm on the sandstone blocks.

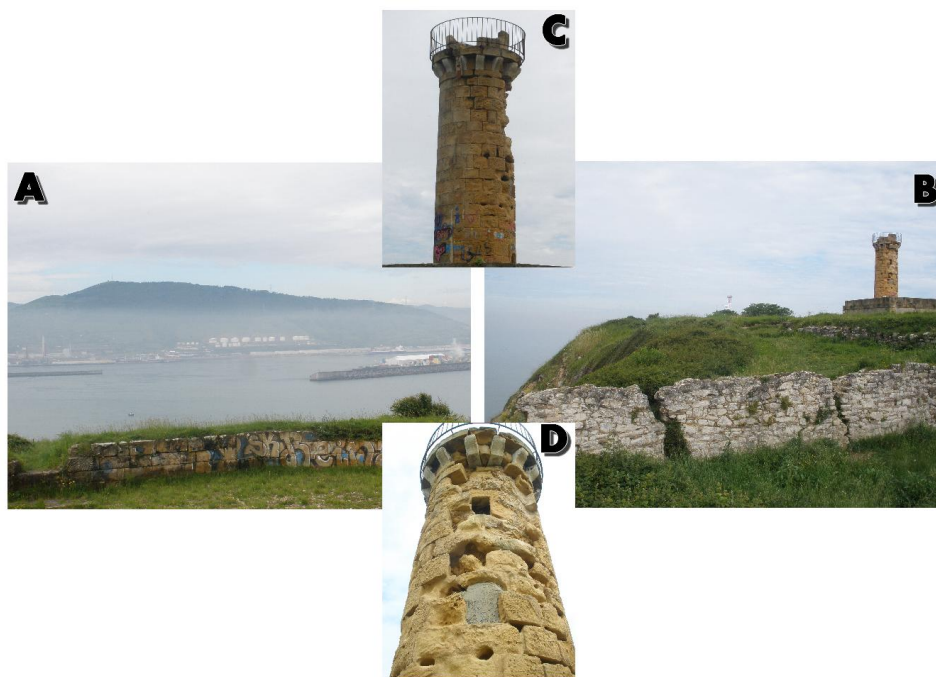
In order to demonstrate the influence of the dry deposition of secondary marine aerosol (SMA) particles on the conservation state of the sandstone from La Galea Fortress, sandstone samples from the tower were analyzed. As it can be seen in Figure 7, this building which dated back to 1742, is just on a cliff with the direct exposure to the marine aerosol and the emissions of surrounded industry and ships traffic (see Figures 7 A and B). It is necessary to remark that La Galea Fortress tower is in a very poor conservation state, since the tower is suffering a losing process of its sandstone (see Figures 7 C and D).

**Figure 7.** Location and views from La Galea Fortress, showing A) and B) the direct influence of the marine aerosol, surrounded industry and ships traffic C) and D) evidences of the poor conservation state of La Galea Fortress tower.
