BOISE STATE UNIVERSITY

IMPACT OF CLIMATE CONDITIONS ON THE USE
OF INFRARED THERMOGRAPHY FOR THE
INSPECTION OF COATED AND UNCOATED
UNREINFORCED CONCRETE SAMPLES

Aitor Hernández Alonso

2019

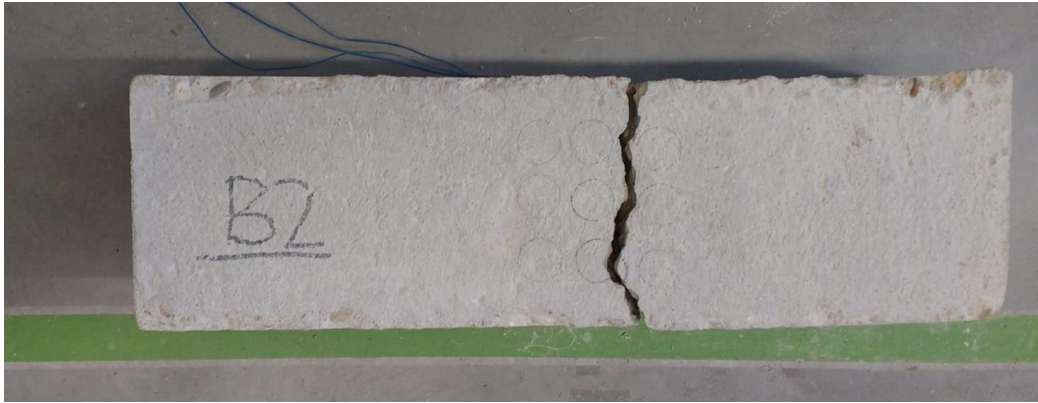
Figure 1: Uncoated Concrete Specimen

This is a regular concrete sample with a crack and will be a studied specimen.

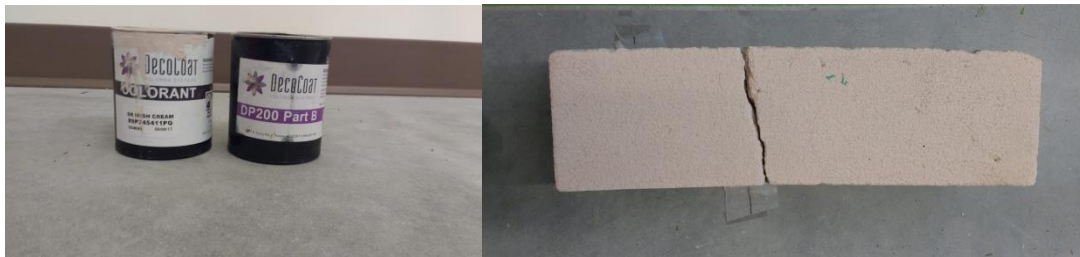
Figure 2: DecoCoat product and coated concrete block

In this case, we have a concrete specimen but DecoCoat SR Irish Cream product was applied on top of the concrete surface. According to the company this product uses special technology designed to cool high-traffic areas and reduce urban heat island effect and the temperature of asphalt surfaces while resisting UV damage and degradation of asphalt to create a more comfortable environment. [2]

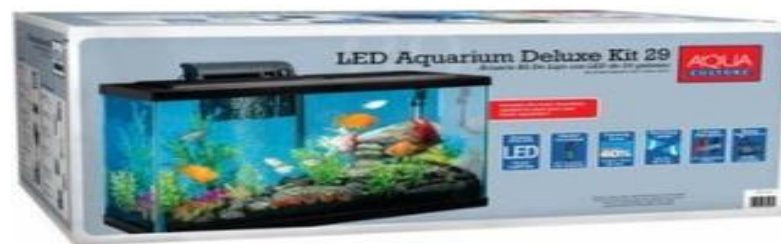
Figure 3: Glass container

- **Glass Container:** All the tests have been performed inside this container in order to keep required heat/wind/humidity conditions for our tests. The glass container dimensions are 48'' Length, 13'' Width and 20''Height.

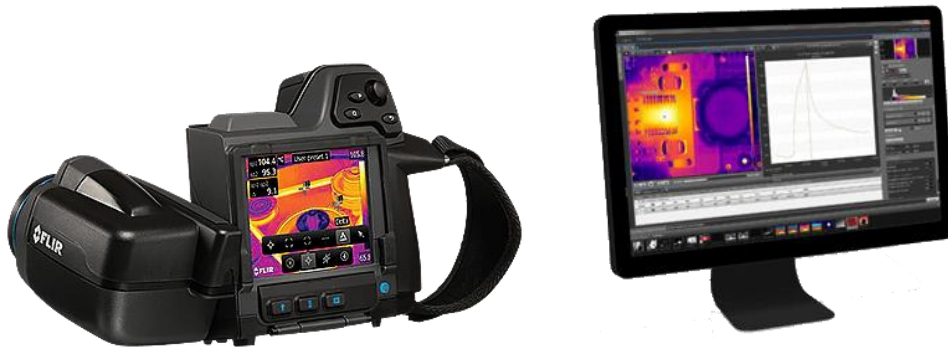
Figure 4: FLIR camera and software (Images retrieved from www.flir.com)

- **Thermal camera:** FLIR model camera, model T430sc to capture image data. Object distance was set at 0 to 1 meter and atmospheric temperature was set at 20 degrees Celsius (similar to lab temperature). Relative humidity is considered around 50 percent and emissivity was set at default, that is, 0.95. The wavelength range of the camera is between 7 and 14 Microns. Integration time in the camera for our study is 12 milliseconds. [1]
- **FLIR ResearchIR Software:** This software is a powerful and easy to-use thermal analysis software package for FLIR cameras. It provides camera control,

highspeed data recording, image analysis, and data sharing. The ResearchIR software connects directly to FLIR Research and Science cameras via USB. [9]

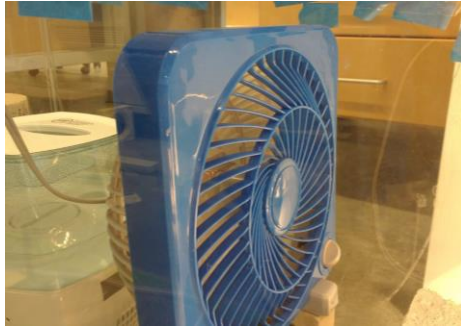
Figure 6: Fan installed on test

- **Fan:** This element is used for simulating wind conditions that could take place in the field.

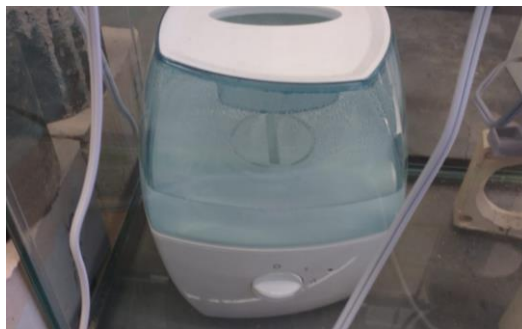
Figure 7: Humidifier installed on test

- **Humidifier:** This element was used for simulating humidity conditions that could take place in the field, for example on a rainy day. The humidity was being kept between 80-85%. In case the humidity exceeded 85% the humidifier was disconnected until it reached again the desired range.

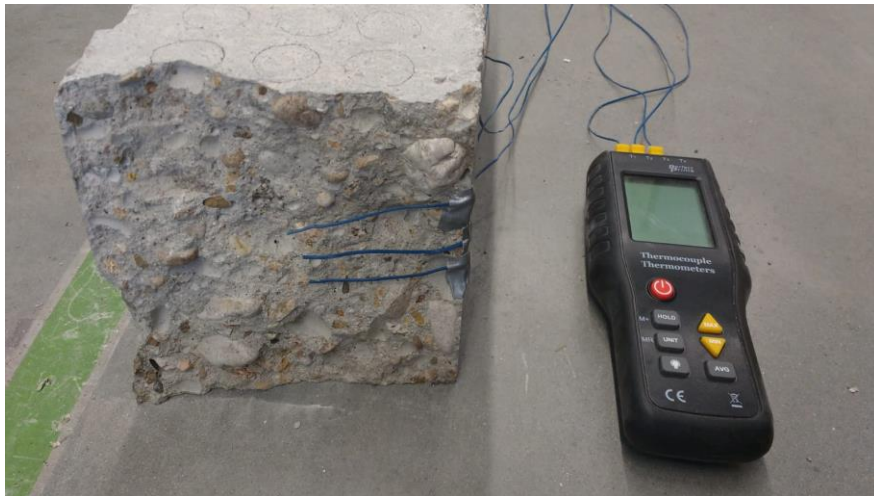
Figure 8: Thermocouples on specimen

- **Thermocouples:** Thermocouples measured the temperatures at different depths of the specimen. Three thermocouples were installed on each specimen before starting the test. The sensors are located 3 inch inside the specimen and each thermocouple is located at a different depth.
 - ✓ Thermocouple 1 was located at a depth of 2 inches from the top surface of the specimen.
 - ✓ Thermocouple 2 was located at a depth of 3 inches from the top surface of the specimen.
 - ✓ Thermocouple 3 is located at a depth of 4 inches from the top surface of the specimen.

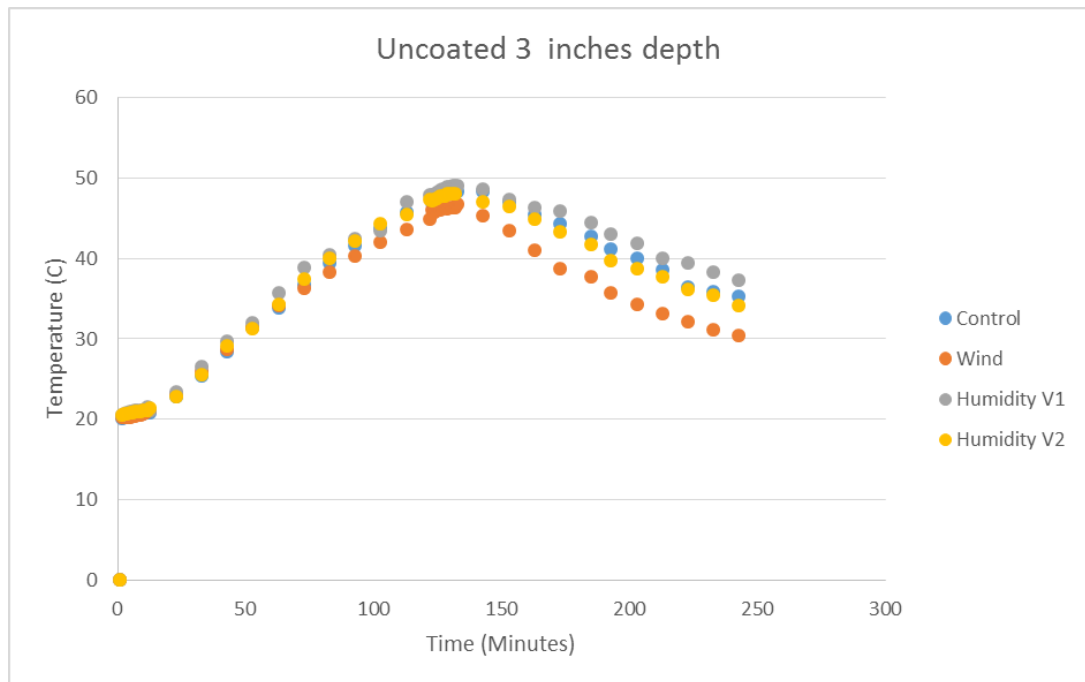
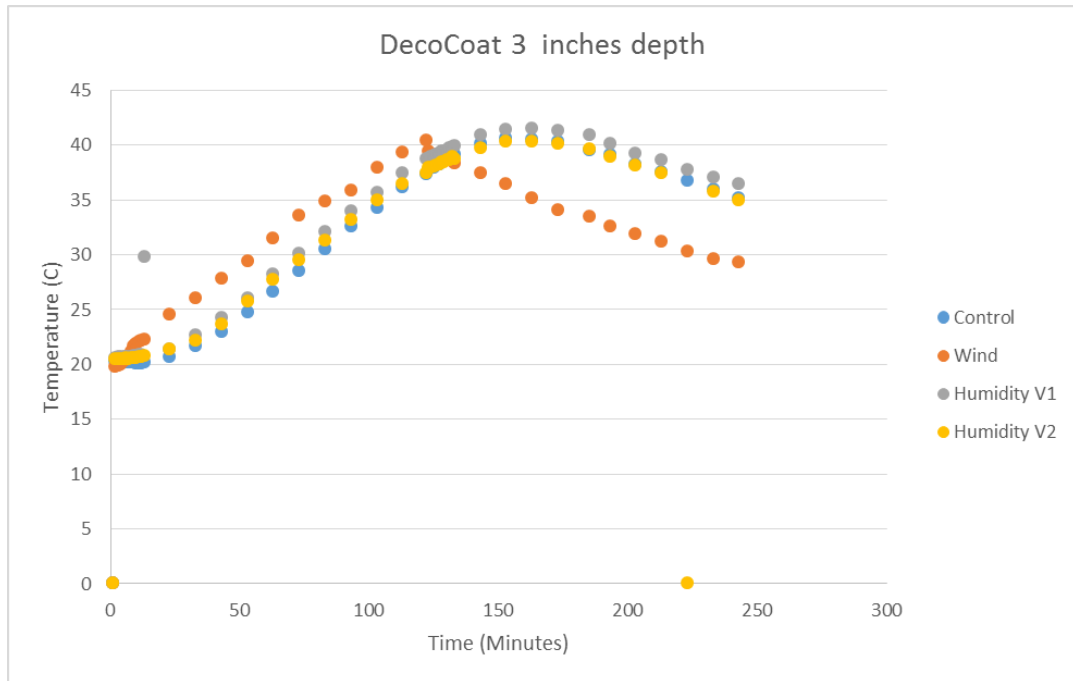
In this graphs the different climate conditions are analyzed. The four different colors represent the four different tests that have been carried out on each specimen. (See legend on the right side of graphs). In the graph both heating (120 minutes) and cooling are represented (120 minutes) and both stages are clearly defined by the slopes of the graphs.

Evaluating data for the three thermocouples would have been time-consuming and would overload this project. Therefore, all the data used for the graphs of this section has been taken from the readings of the thermocouple located at 3 inches depth, which is the one that is located in the middle, thus it can be more representative than the other ones. The aim of this very first section is not to compare data between the two different concrete samples, but to compare data between the different climate conditions (control, humid, humidity V1 and humidity V2). Future sections will compare the specimens.

First of all, during cooling process the wind curve is the one that has the deepest slope of the four climate conditions for both graphs, which means that heat dissipation rate is higher than the other curves. This is due to the wind capacity to reduce the ambient temperature through ventilation, which causes faster heat dissipation in the crack, reducing its temperature much faster than the other test. This is because both systems (ambient and crack) are in thermal equilibrium, therefore if the ambient temperature is reduced, more heat from the crack will be released to the ambient causing a temperature reduction in the crack.

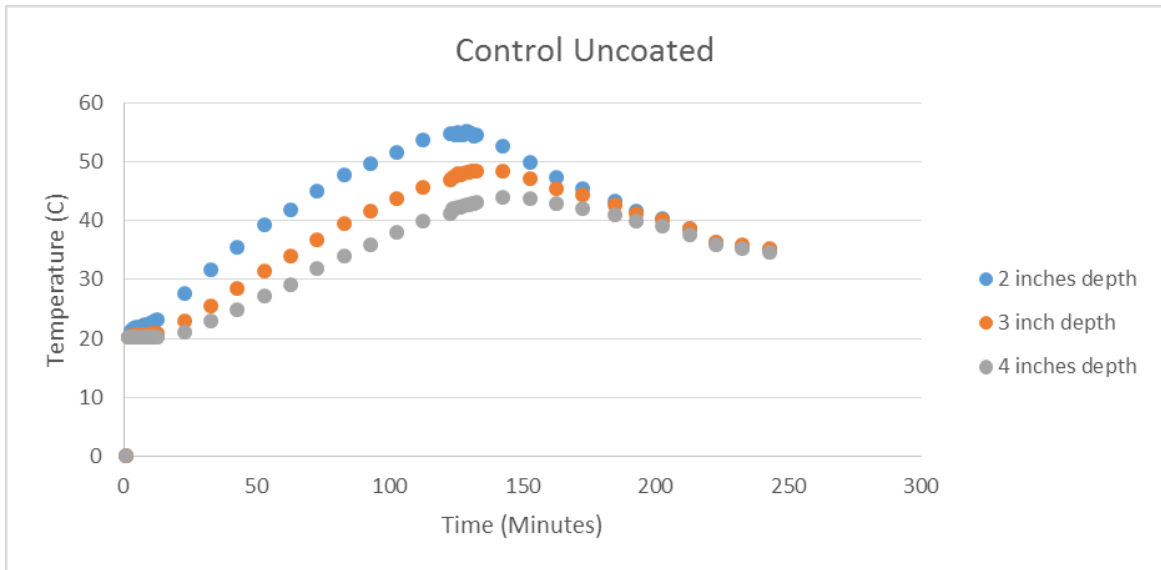
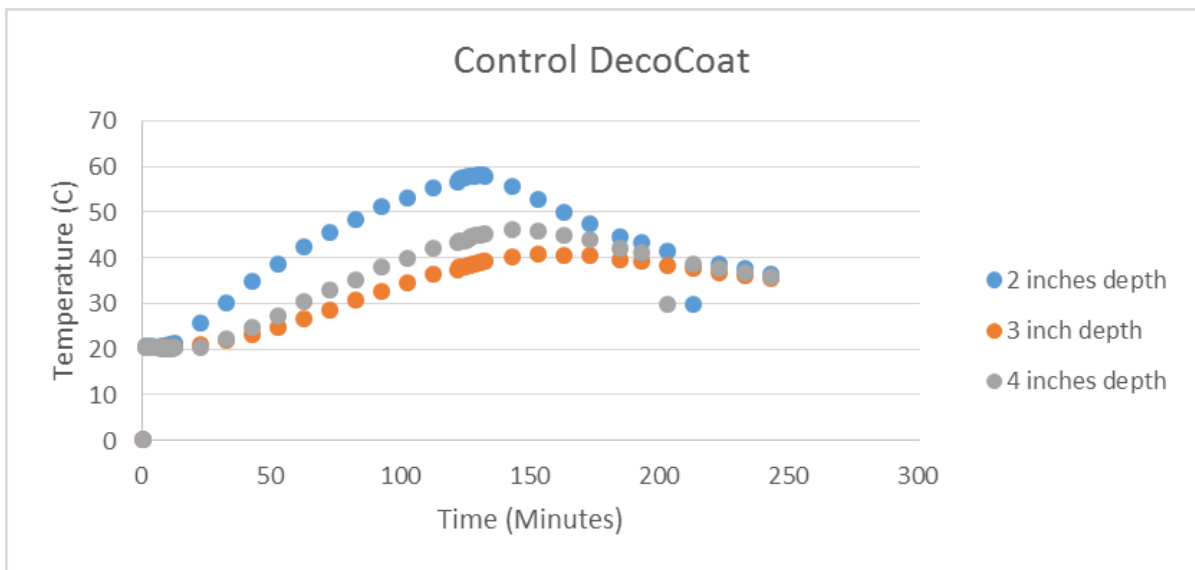
In this graphs we can see the results of the control test. It can be observed in both graphs that during the heating process, the top edge of the crack (2 inches depth) has a higher temperature than the others (3 inches depth and 4 inches depth). The 2 inches curve has a more marked slope than the other two. This is because the thermocouple located at 2 inches depth is closer to the heating source than the other two thermocouples. By logic,

Regarding the cooling process, the thermocouple located at 2 inches depth has the fastest cooling speed. This is because this one is the closest to the concrete surface; therefore it can release heat to the ambient air in an easier way than the other ones.

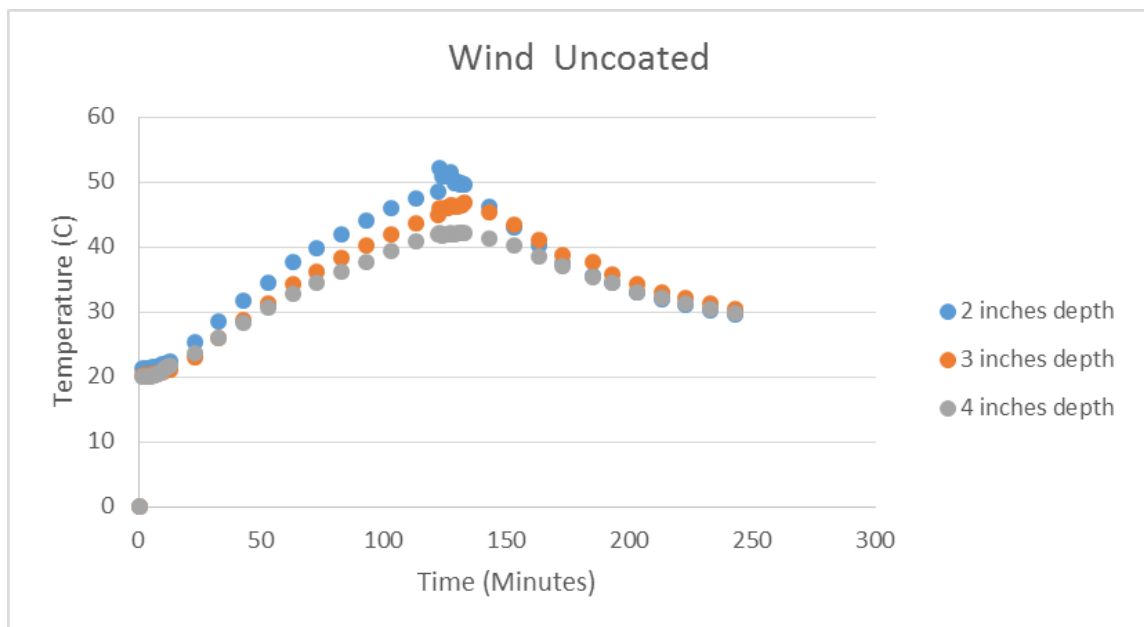
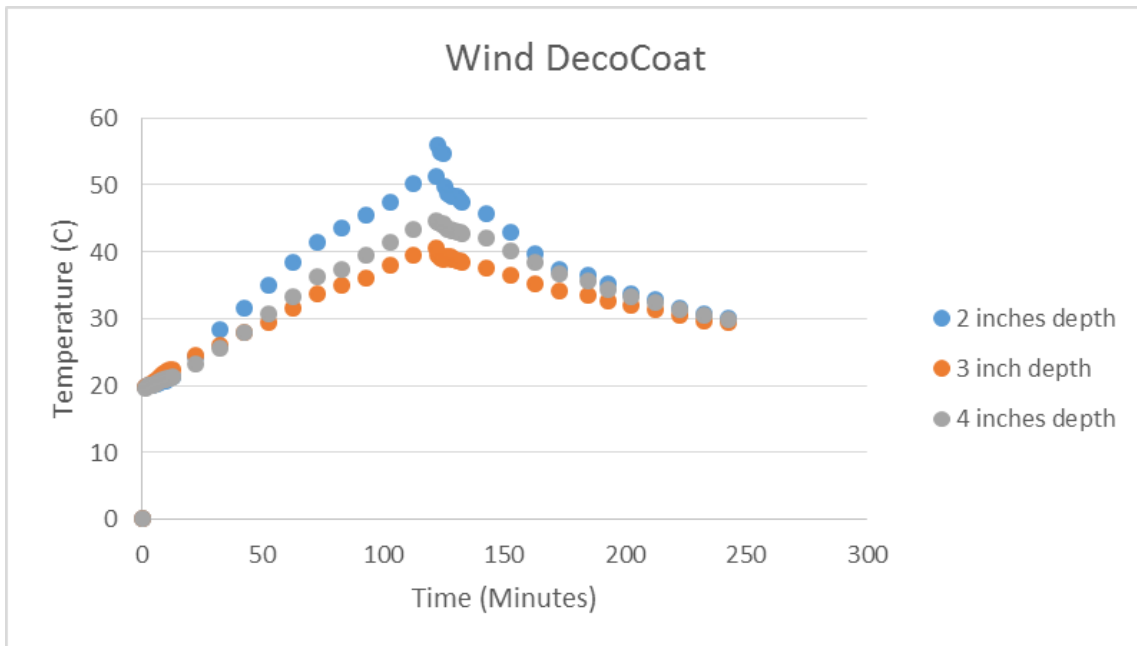
In this section the wind graphs are plotted. At first glance, it can be seen that during the heating process, now the difference between 2 inches curve and the other curves is not as noticeable as the control case. This means that, even being the closest thermocouple to the heat source, it is being continuously ventilated by the fan, which produces a remarkable decrease of temperature. This, along with an almost lack of ventilation for the thermocouples located at 3 and 4 inches depth make the three curves (2, 3, 4 inches) more similar to each other compared to the control case.

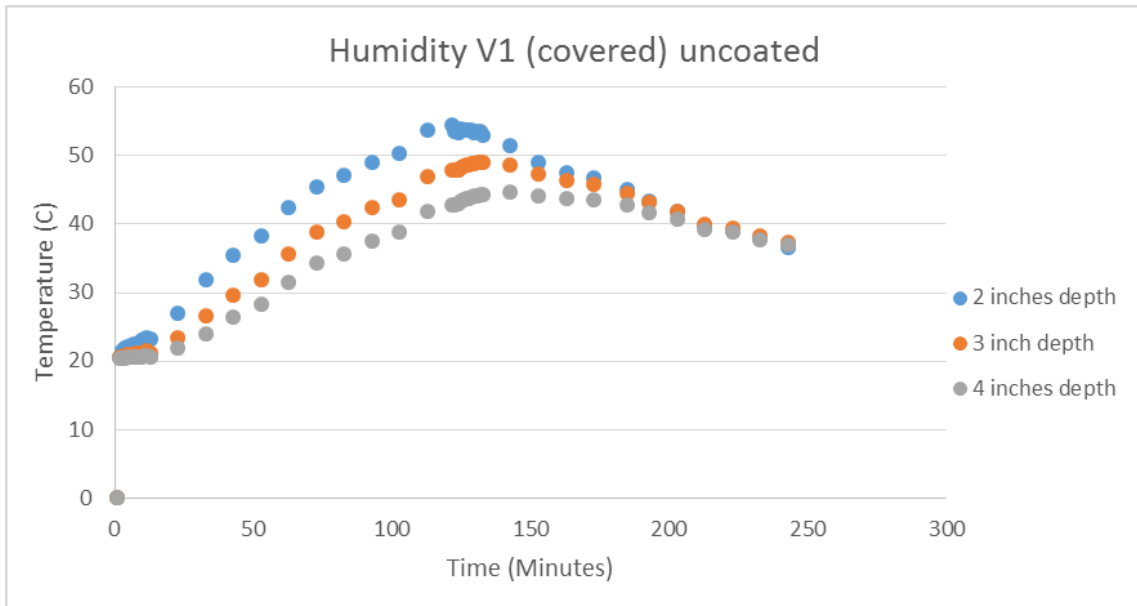
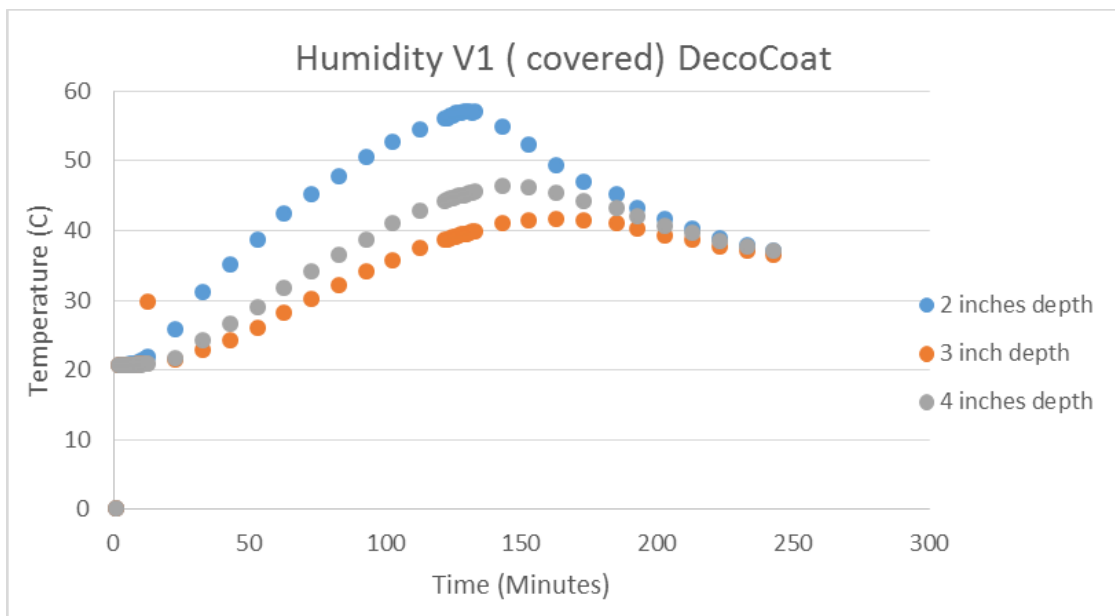
In this graphs we can see for the entire humidity test the comparisons for the thermocouples located at different depths. Only humidity V1 will be studied, where the humidity is kept high. From this graph it should be mentioned that for the coated specimen the 2 inches depth thermocouples has a significant higher temperature. This

may be because the already explained reason. The coating reduces the heat absorption of the concrete and increases the heat of closest thermocouple from the surface, which is the 2 inches depth one.

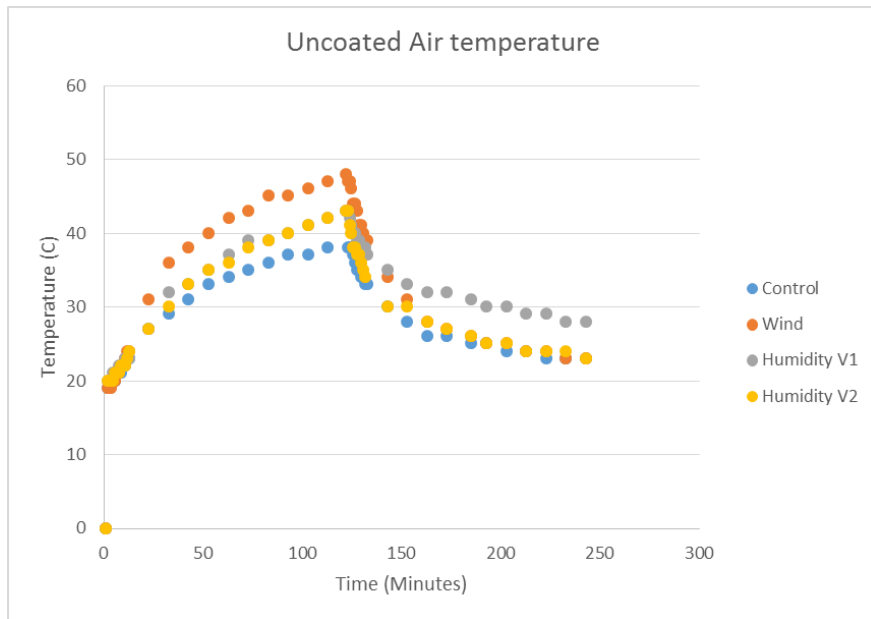
As it can be seen on the uncoated specimen graph during the cooling process, for humidity V1 (75-85% of relative humidity) the ambient air heat dissipation rate is slower. The slope of humidity V1 is less steep than the rest of the curves. As showed in the following graph, control and wind graphs have a humidity of around 20% during cooling, whereas humidity V2 is between 50-55%.

However, this does not seem to affect the ambient air temperature for humidity V2 during the cooling. Therefore, it seems that this slower heat dissipation rate of ambient air heat produce by high humidity is only given when the ambient humidity is exceeding a certain value around 70%.

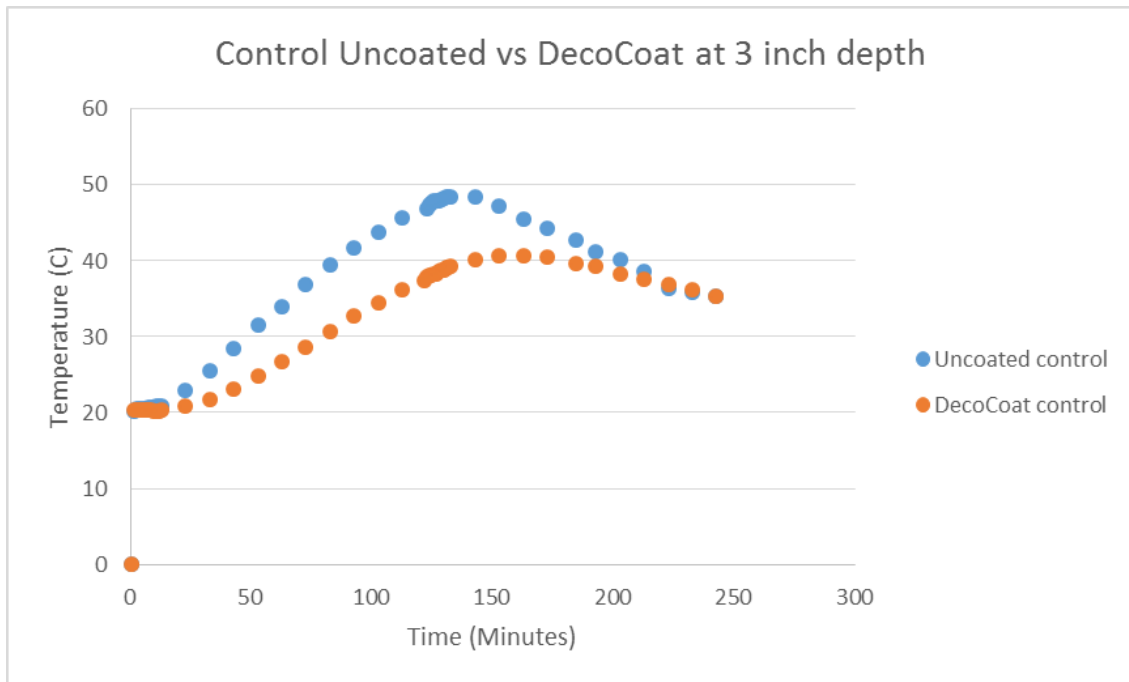
Graph 13: Control Uncoated vs. DecoCoat at 3 inches depth

The control graph is shown. We can observe that whereas for the uncoated specimen the maximum temperature that is reached at 3 inches depth is almost 50 °C, for the coated specimen it is around 40°C. Therefore, a high temperature difference exists during the whole heating process which makes bigger when time passes. This means that the coating reduces the temperature of the crack.

Besides, it should also be mentioned that the coated sample crack has a very low cooling rate compared to the fast cooling rate of the uncoated sample crack. The latter, even being 10°C higher at the end of the heating process, it reaches a slightly lower temperature than the coated specimen crack, which denotes a significant cooling rate. The final temperature for both is around 30°C.

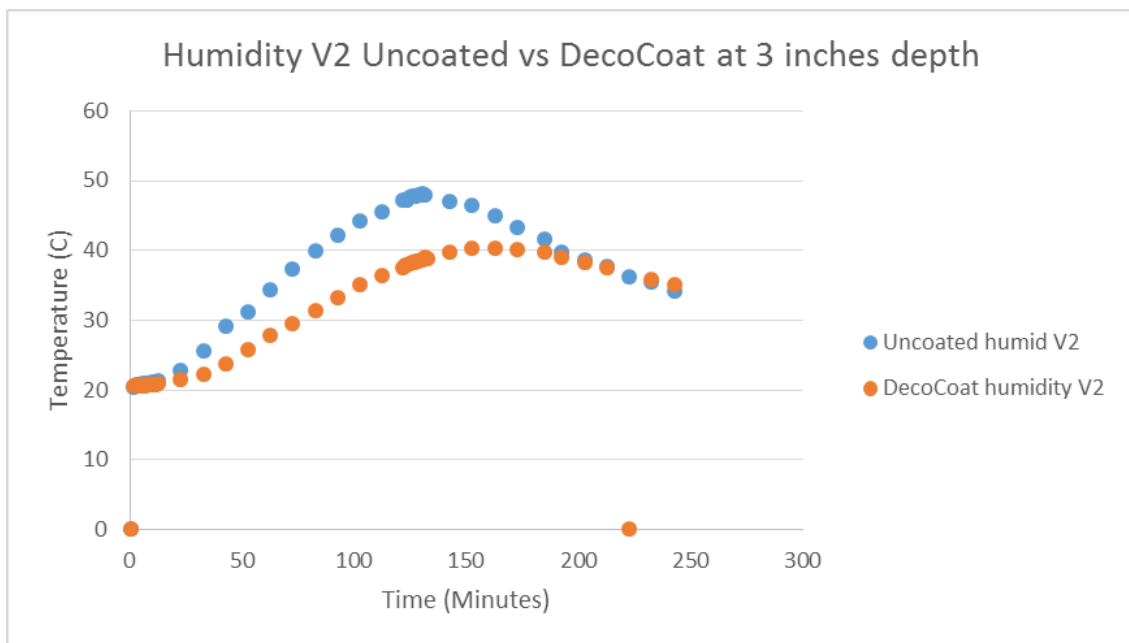
In these two graphs, we can see the comparison of the humidity test for both samples. We can see that the maximum temperature reached by the uncoated sample crack is around 50 °C and for the coated one is 40 °C. It can be observed that throughout the test, the behaviour of the curves is very similar to the explained for the control test.

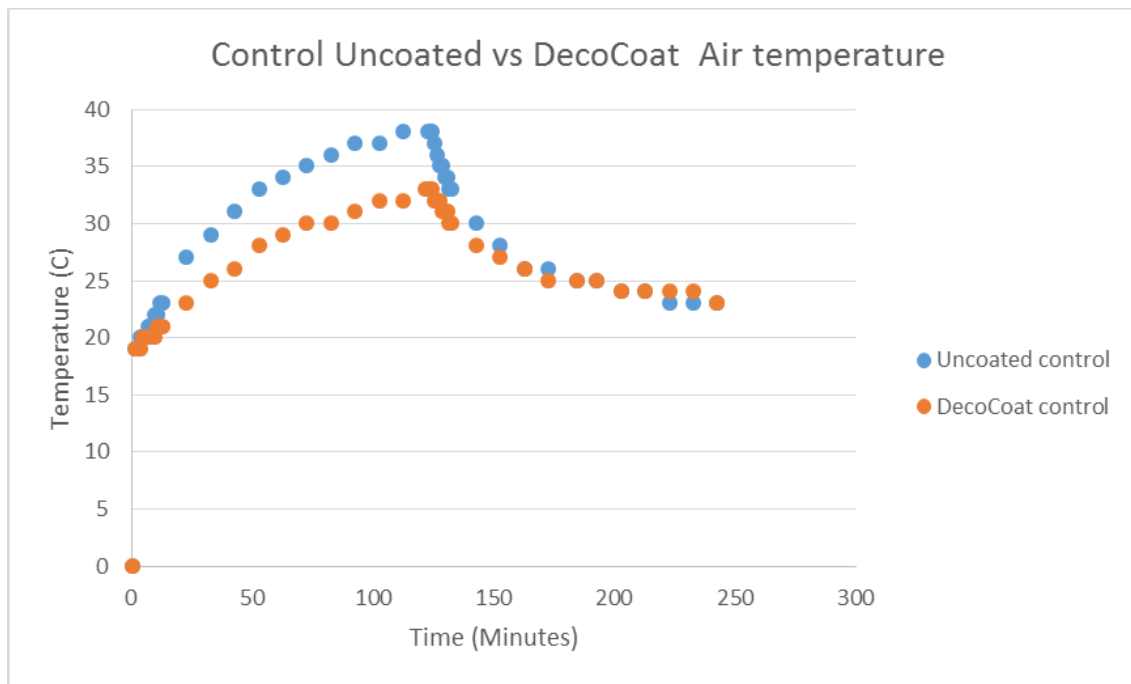
Graph 17: Control Uncoated vs. DecoCoat Air temperature

Regarding air temperature during the control test, it can be observed that during the heating process the air temperature is much higher for the uncoated experiment than for the coated one. The former generates a maximum air temperature of 38 °C, whereas the latter generates a maximum air temperature of 33°C.

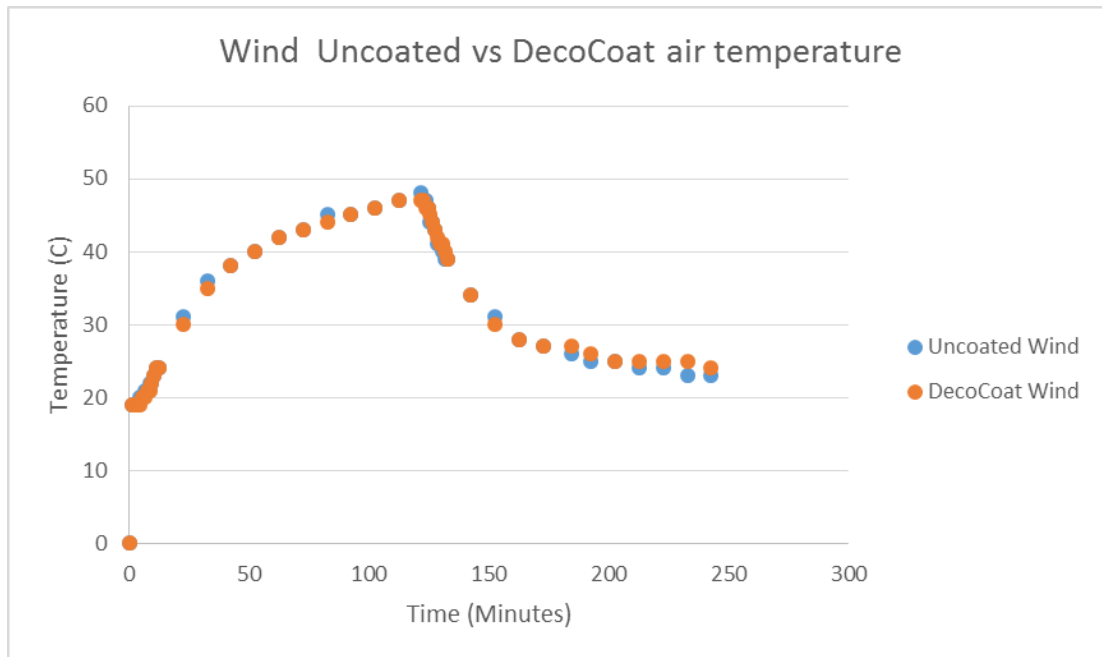
Graph 18: Wind Uncoated vs. DecoCoat Air temperature

For the wind test, it can be appreciated that there are not significant differences between the air temperature for the coated and uncoated samples. If we extrapolate this result to the outdoors, it will mean that in windy days this type of coating will probably not be useful for reducing the ambient air temperature of the surrounding, thus it cannot prevent urban heat island effect.

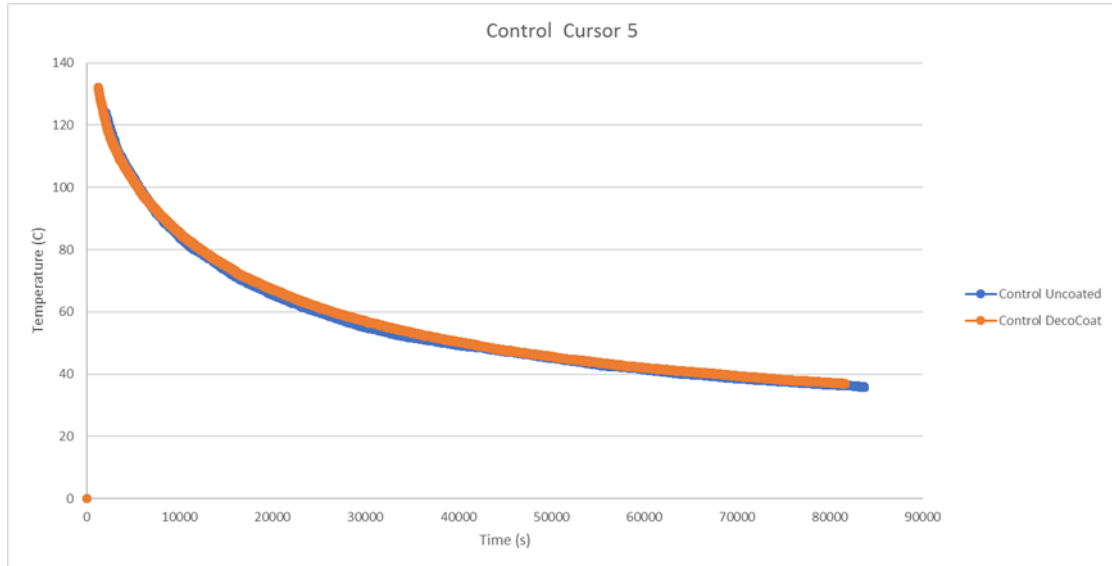
Graph 24: Surface temperature: Control cursor 5

Regarding the control test it can be seen that both curves have a very similar pattern and there are no differences between them. The only relevant difference is the initial surface temperature which is higher for the DecoCoat (136 °C) than for the uncoated (128°C). This means that the coating produces a higher surface temperature than the uncoated sample, about 8 °C more. This is not positive if we want to maintain the surface temperature as low as possible in order to extend the life cycle of the concrete.
