Effect of Modified Septic Tank on Groundwater Quality around Federal University of Agriculture, Abeokuta, South-west Nigeria

Kofoworola Olatunde*, Modupe Sarumi, Sadiq Abdulsalaam, Babatunde Bada, Funmilola Oyebanji

Department of Environmental Management and Toxicology,
Federal University of Agriculture Abeokuta, Nigeria

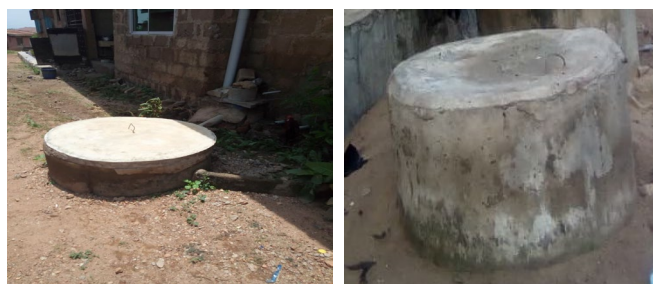
Figure 1 Examples of modified septic tank units within study area.

In a desperate effort to reduce construction cost, coupled with the poor regulation of construction activities by urban and town planning authorities in Nigeria, recent years have witnessed homeowners constructing septic tank units which do not meet specifications as opposed to an ideal septic tank which is a sedimentation tank consisting of a minimum of two chambers with dimensions about 1.5 m wide x 2.5 m long x 1.8 m tall [4]. These modified septic tanks consist of a circular pit or concrete ring above or below the

ground with a diameter and depth both approximately a meter (in most cases) (Figure1). The walls are lightly lined with concrete and the floor is left unlined to allow for easy percolation [5]. These septic tanks units are not fit for sewage management in terms of volume, depth, required safeguards and distance from ground water sources especially when the surrounding soil is highly porous. Unfortunately, once groundwater is polluted, it is usually very difficult and costly to remediate [6]. Waste in septic tanks contains germs and pathogens which pose real threat of contamination to underground water and can serve as a vehicle for the spread of water borne diseases such as cholera, dysentery, schistosomiasis, lymphaticfilariasis, parasitic and viral infections [7].
