Ecological and environmental effects of urban transformation: An example in Turkey

Abstract

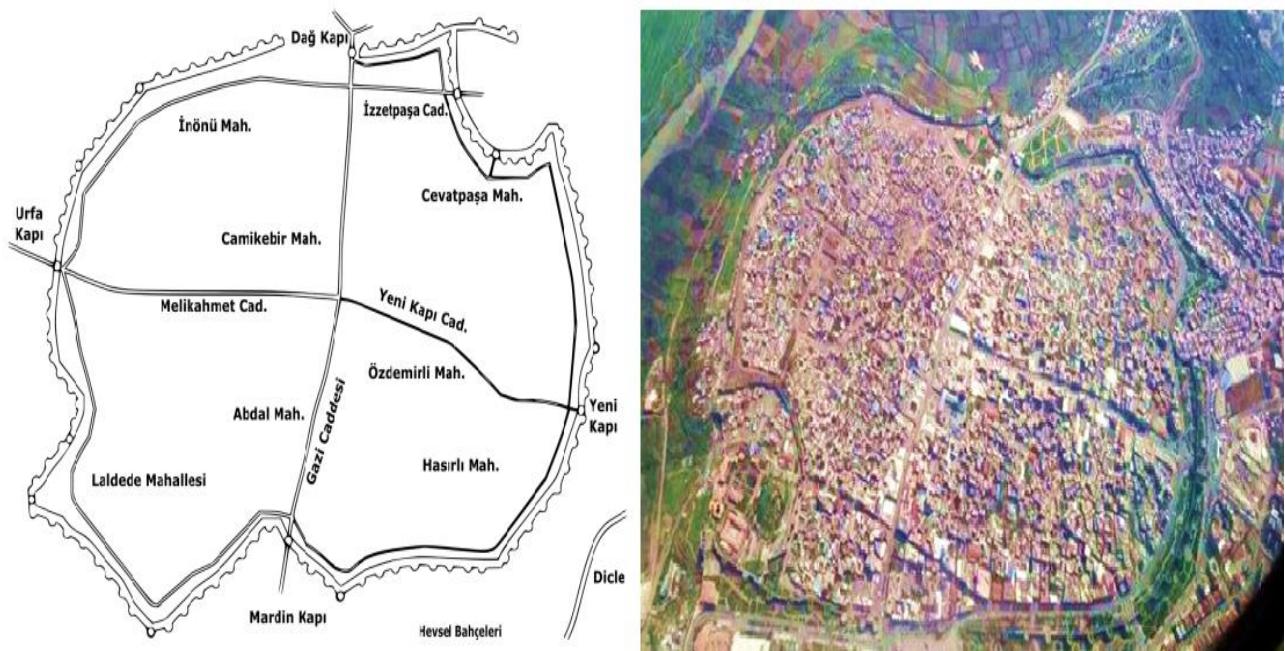
In this study, a fortification action plan was prepared for the transformation works in the Suriçi region, as seen in Figure 2. Data before and after the transformation were obtained from institutions, supported by tables and graphs, and necessary comparisons were made.

Figure 2. Action plan map and risky area satellite image in Suriçi [14]

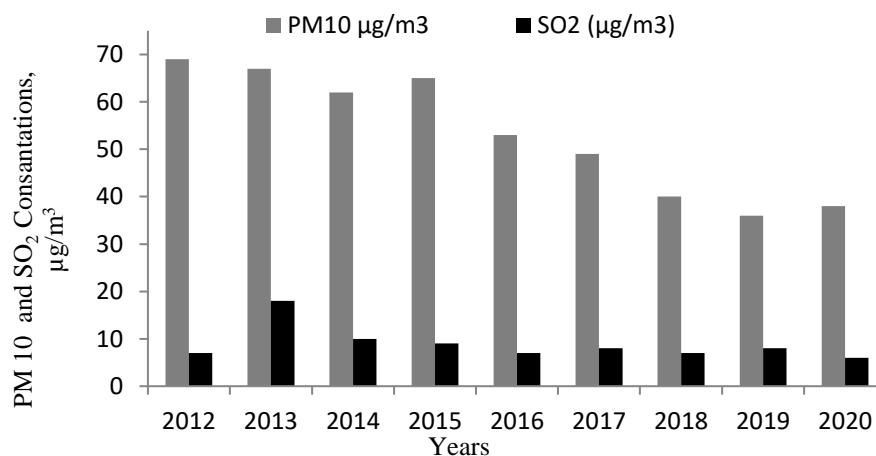
As seen in Figure 3, while the amount of SO₂ have exchanged in the range of 7 $\mu\text{g}/\text{m}^3$ in 2012, 18 $\mu\text{g}/\text{m}^3$ in 2013, 10 $\mu\text{g}/\text{m}^3$ in 2014, 9 $\mu\text{g}/\text{m}^3$ in 2015 before urban transformation, after the urban transformation have exchanged in the range of 7 $\mu\text{g}/\text{m}^3$ in 2016, 8 $\mu\text{g}/\text{m}^3$ in 2017, 7 $\mu\text{g}/\text{m}^3$ in 2018, 8 $\mu\text{g}/\text{m}^3$ in 2019, 6 $\mu\text{g}/\text{m}^3$ in 2020. It is seen that the amount of SO₂ in years before urban transformation is higher than in years after urban transformation

Figure 3. Change of SO₂ and PM10 in Sur District by years [15]

The reasons for this were the poor-quality coal used before the urban transformation, the lack of natural gas and air pollution caused by unhealthy buildings and constrictions. Since the buildings were fixed to suit for using natural gas after the urban transformation, natural gas was provided and thus, using of the wood, coal and waste has minimized. Ruined, scattered and irregular structures which causes dust have been reduced. Also, green areas have been increased. Therefore, a reduction in SO₂ data has been achieved after urban transformation. It can be said that the decrease in the amount of SO₂ in 2016 and later is the result of the positive effects of urban transformation on environment.

Similarly, before urban transformation, while the amount of pm have exchanged in the range of 69 $\mu\text{g}/\text{m}^3$ in 2012, 67 $\mu\text{g}/\text{m}^3$ in 2013, 62 $\mu\text{g}/\text{m}^3$ in 2014, 65 $\mu\text{g}/\text{m}^3$ in 2015, after urban transformation have exchanged in the range of 53 $\mu\text{g}/\text{m}^3$ in 2016, 49 $\mu\text{g}/\text{m}^3$ in 2017, 40 $\mu\text{g}/\text{m}^3$ in 2018, 36 $\mu\text{g}/\text{m}^3$ in 2019, and 38 $\mu\text{g}/\text{m}^3$ in 2020. Since

the region was an irregular and slum area, some citizens were engaged in livestock breeding. There was high rate spread of dust emission from the hay storages using for the animals into the atmosphere. However, after the urban transformation, this situation disappeared. In addition to increase to green areas, dust, smoke, etc. Pollutions which cause to increase of PM such as hay, waste on street and avenues have decreased. In addition, PM originating from bread ovens was minimized after urban transformation.

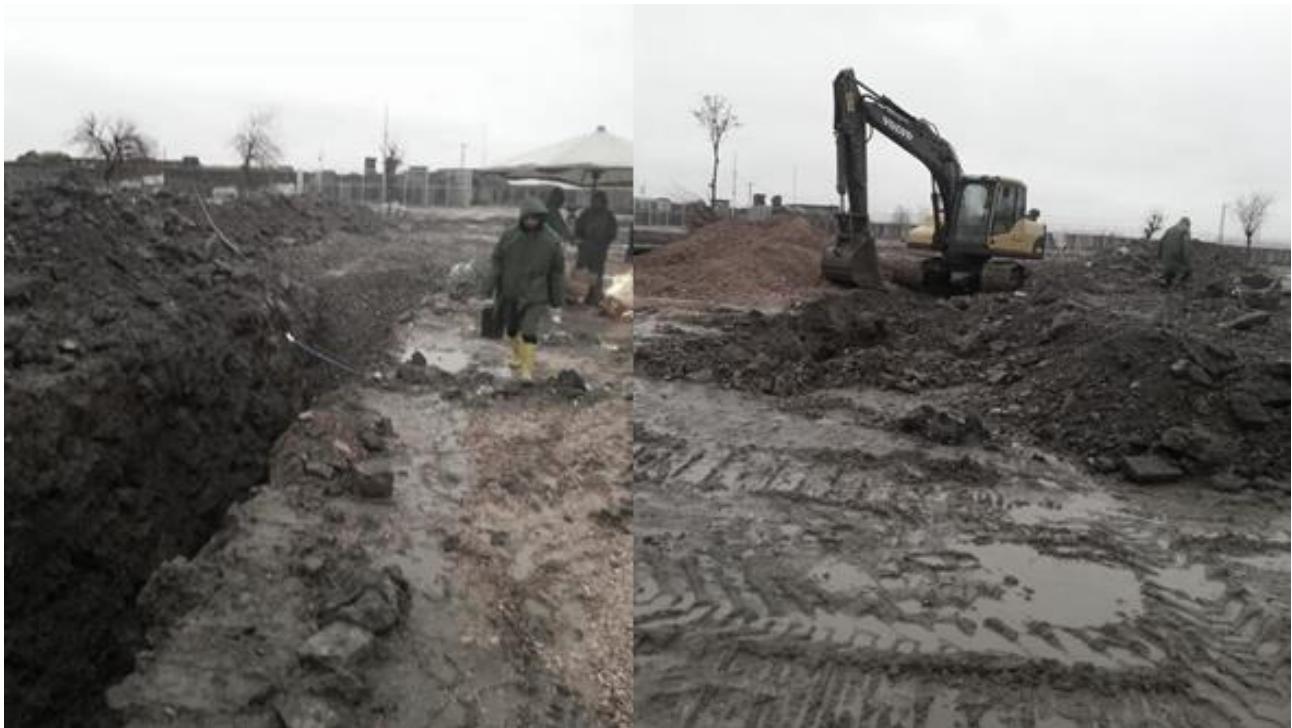
In urban transformation, protection of water quality it is essential, to prevent water pollution and safely transmit clean drinking water from its source to the user. As seen in Figure 4A, during the 2015 terrorist incidents in the Sur region, the drinking water pipes in the city were damaged as a result of the ditch digging incidents in the region and the water in the city. Damaged water pipes brought many negativities. The waters were heavily polluted and many diseases (typhoid, nausea, etc.) have emerged. As can be seen in Figure 5, 25.686 meters of drinking water line has been laid in the region with the urban renewal works and the drinking water problem has been solved.

Figure 5. Images from the drinking water line laying Suriçi after urban transformation (2018) [14]

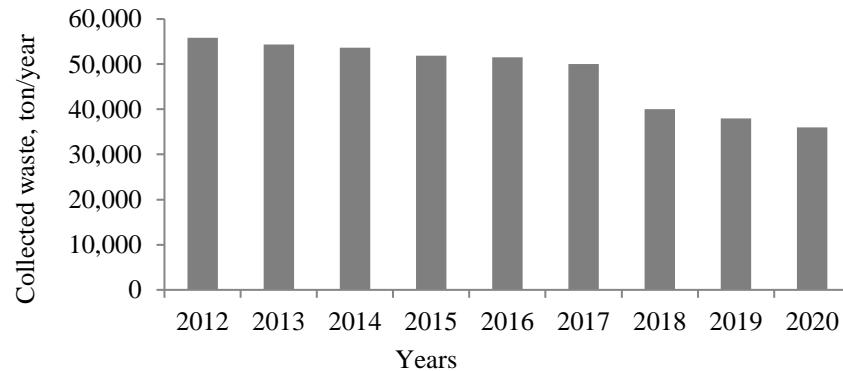
When Figure 6 is examined, the waste distributions were obtained to as 55.878 tons in 2012, 54.347 tons in 2013, 53.659 tons in 2014, 51.873 tons in 2015, 51.503 tons in 2016, 50.000 tons in 2017, 40,000 tons in 2018, 38,000 tons in 2019, 36,000 tons in 2020.

Figure 6. The amount of garbage collected by years in sur district [16]

It is seen that the amount of garbage in 2013, 2014, and 2015, especially in 2012, is higher than in 2016, 2017, 2018, 2019, and 2020. Before the urban transformation, the population was high and the amount of solid waste was relatively high, however it was not collected efficiently. Because the streets were narrow, vehicles could not enter. After the urban transformation, the waste was slightly decreased. This decrease was due to the decrease in population. Normally, the number of solids per population has varied a lot. But the ugly images have disappeared. Wider and regular streets and avenues ensured a more regular collection of solid waste.

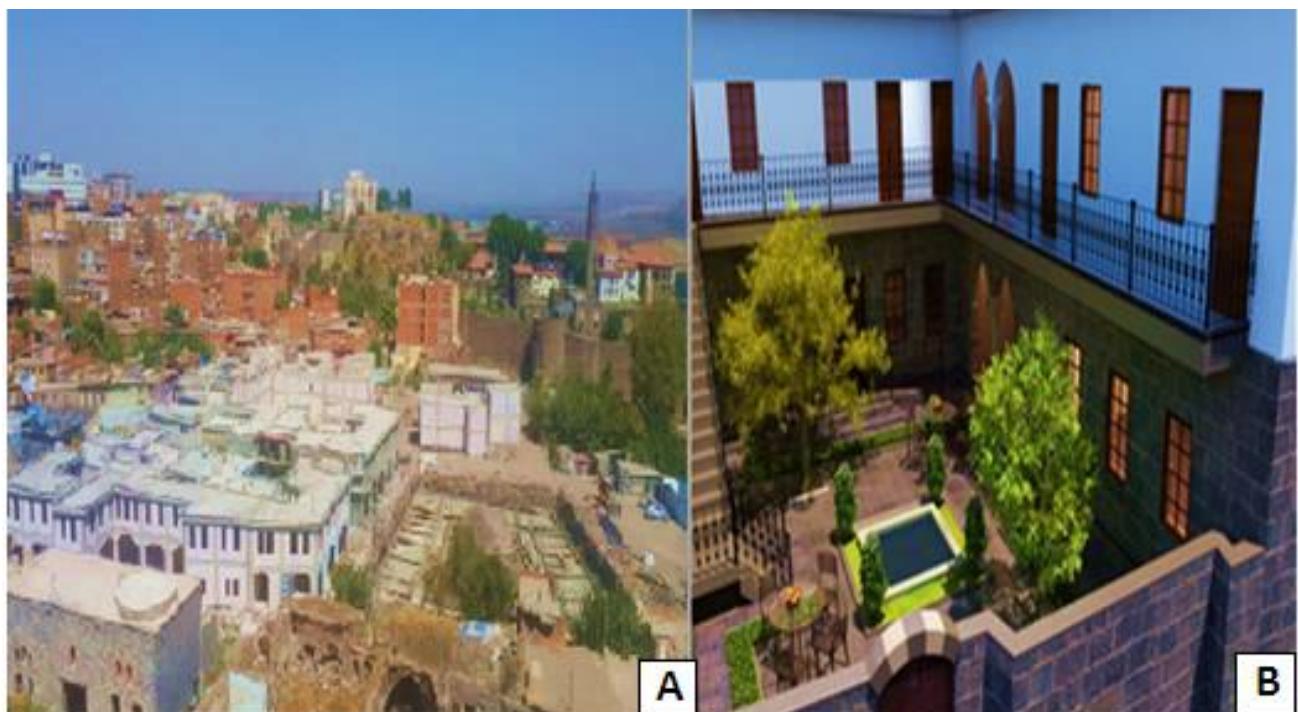
Figure 7. A view of the newly built houses before and after the urban transformation (2018) [14]

As seen in Figure 7. A, there was a historical texture in old traditional houses. But the structures had a complex and overlapping appearance. There was almost no green space around traditional houses. As can be seen in Figure 7. B, although the new buildings do not exactly reflect the old historical texture, the renovation works have brought a new breath to the city. People's quality of life has risen to higher levels. Traditional architectural structures predicted a healthier and more economical life in houses. Natural a situation had reflected. However, newly made buildings are designed to take into account more current needs. In general, when the renewing evaluation, especially in terms of environment and health, the architectural structure of the houses is considered more favorable. The evaluated data showed that in terms of architecture and history is a negative effect; in terms of general supplies and current need, reception is positive effects.

Numerous buildings in Sur district were damaged. Damaged buildings were renovated with urban transformation. Care has been taken not to lose the historical and cultural texture of the buildings reconstructed here. However, the originality of the historical missions and architectural forms of these structures has also been lost. The houses built covered an area of 13.000 square meters. Reconstructed houses were kept small in square meters. The reason for this situation is, while crowded families lived in the past, there are small families now. Bathroom, kitchen, and living room on the ground floor of the two-story houses, bedrooms, and bathrooms are built on the first floor. Basement floors are planned to be used as warehouses.

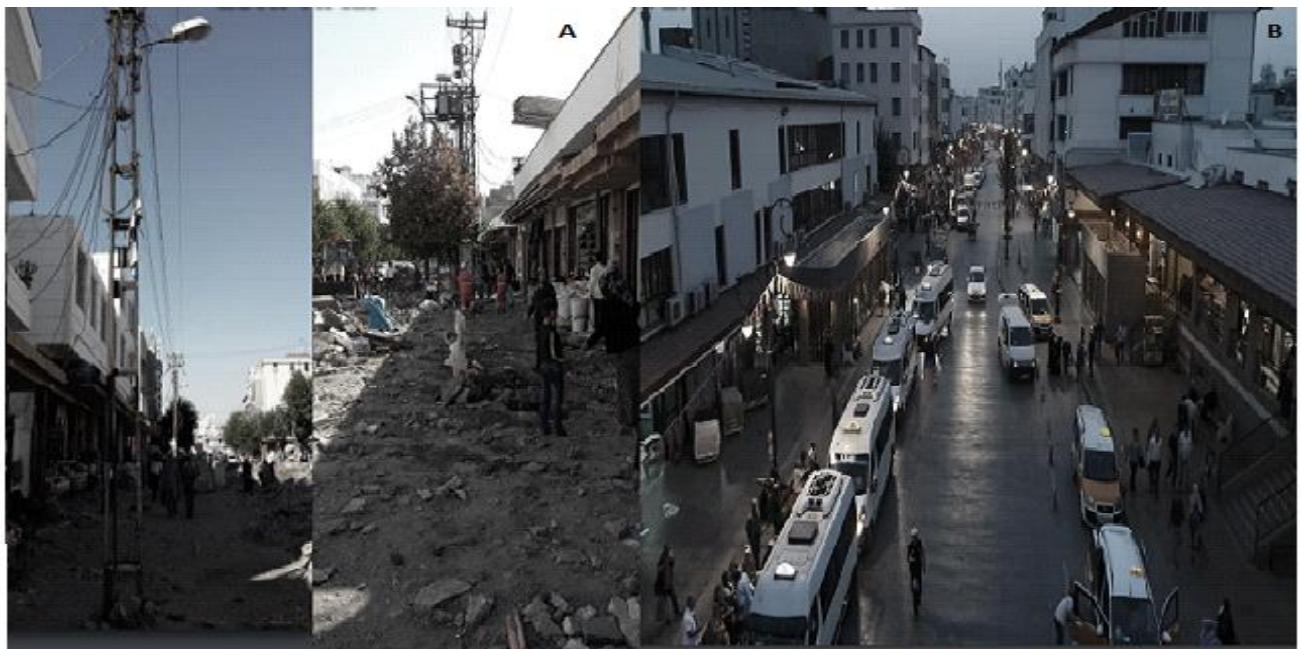
their houses. Since the Sur region was the heart and busiest place of Diyarbakir, people met all their shopping needs from here. As can be seen in Figure 8. People could not walk comfortably because the streets were narrow and walking areas were difficult. After the urban transformation, as seen in Figure 8. B, the streets have been widened compared to the past and vehicle passages have become easier. It was concluded that urban transformation made a positive effect on traffic and transportation.

Figure 8. A view from Gazi Street in Sur District before and after urban transformation (2018) [14]

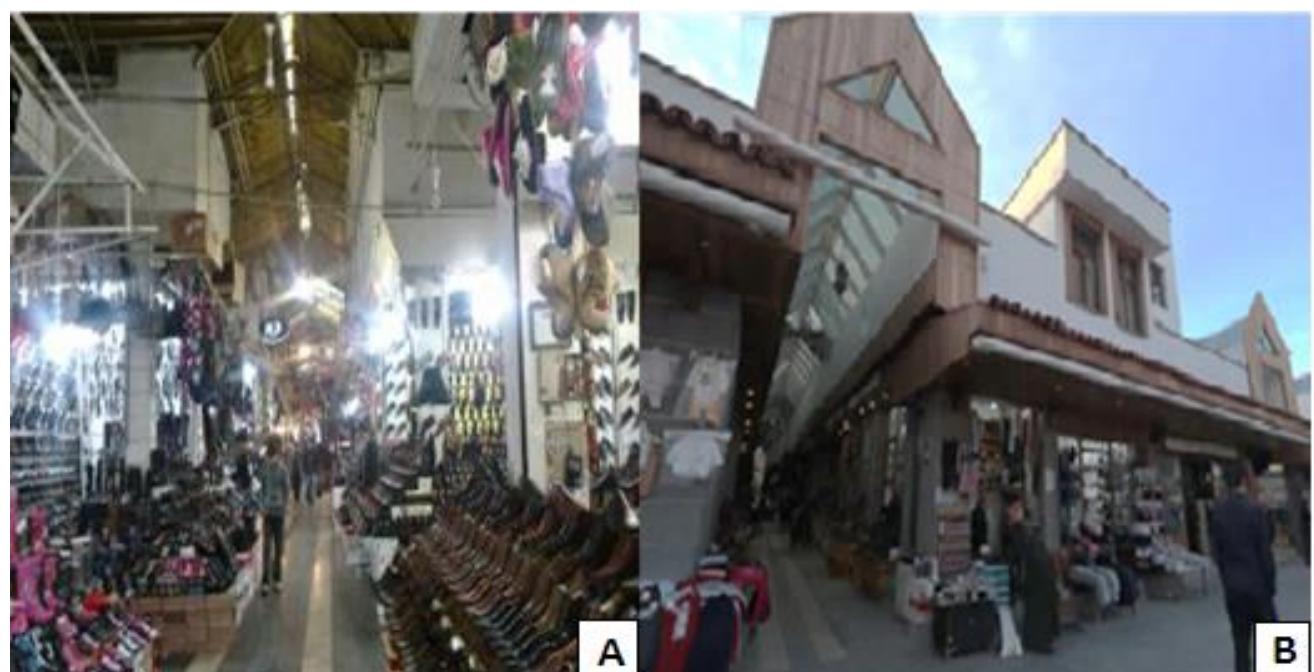
The garbage could not be collected regularly because of the narrow streets in the Sur region. There were old and dirty buildings images and unregular workplace signs. These caused the formation of undesirable odor and images in the environment. The sign and shape of the shops in the bazaar had been spoiled the aesthetic image. As can be seen in Figure 9. The shop signs of the bazaar have become quite complex and customers could not identify that they belong to any name. Along with the urban transformation, as seen in Figure 9. B, the signboards of the shops in the district were renewed with a wooden appearance.

Figure 9. A view from the burned bazaar facade cladding works before and after the urban transformation [14]

In this case, the signboards of the shops were changed with the urban renewal works, wooden signboards were made that appeal to the eye and make the shops attractive. At the same time, garbage collection problems have been removed. Old and dirty buildings were renewed. So, the urban transformation was determined to made positive effect on aesthetic pollution removing and image
