The trend of collapse of buildings in concrete materials in Lagos State, Nigeria (2013-2019)

To cite this article: Anthony N. Ede *et al* 2021 *IOP Conf. Ser.: Earth Environ. Sci.* **655** 012078

Anthony N. Ede^{1,*}, Akpabot I. Akpabot¹, Solomon O. Oyebisi¹,
Oluwarotimi M. Olofinnade¹, Chukwueloka A. Okeke¹, Kehinde D. Oyeyemi²,
Emmanuel I. Ugwu³, Fiyin Gambo¹

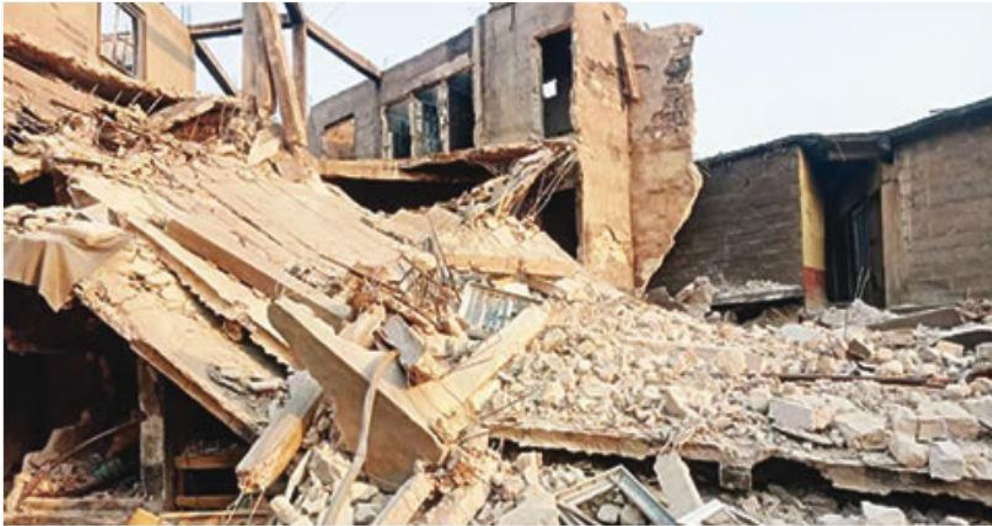
Figure 1: A collapsed plaza in Lagos state. Source: [16]. The Punch, <https://punchng.com/nigeria-recorded-43-building-collapse-cases-in-2019-report/>

Lagos State is located in the south-western area of Nigeria. It holds the status of being the smallest yet possessing the most populous conurbations in the world. It is Nigeria's largest urban area, with 20 local government areas (LGA) and 57 local council development area (LCDA). Researchers in[27]while assessing the building collapse cases in Nigeria between 2009-2019 noted that the Southwest had 34 cases of building collapses making it the highest number of failures (60% of total failures within the period) with 132 deaths (64% of entire death within the study period). The debris of a collapsed plaza is shown in Figure 1, while Figure 2 shows a typical rescue operation taking place at a collapsed site at Lagos Island.

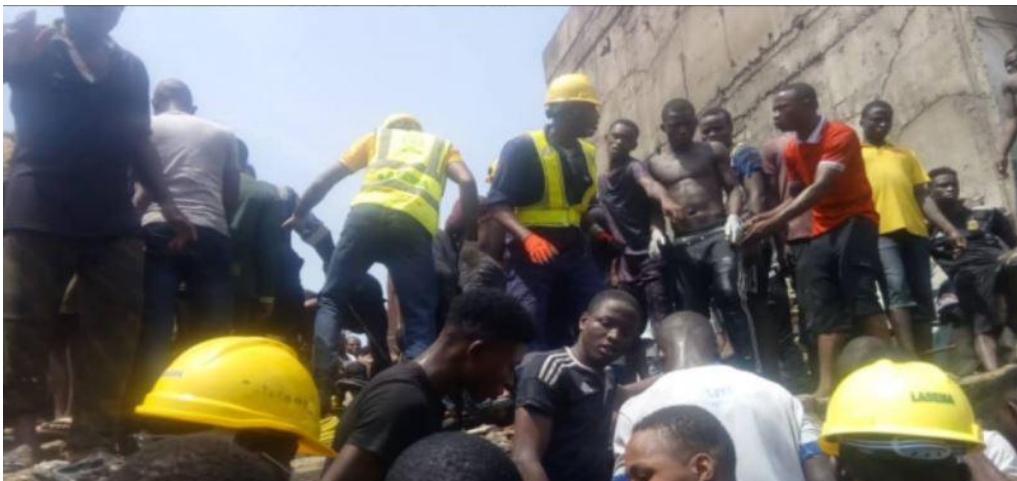
Figure 2: Rescue workers at scene of collapsed building at Lagos Island. [19], The Punch newspaper, <https://punchng.com/36-000-potential-collapses-waiting-to-happen-says-building-collapse-prevention-guild/>
