Cultural Resources Management Plan: Black Mesa Ranger Station

A Thesis

Master of Science

in Cultural Resource Management

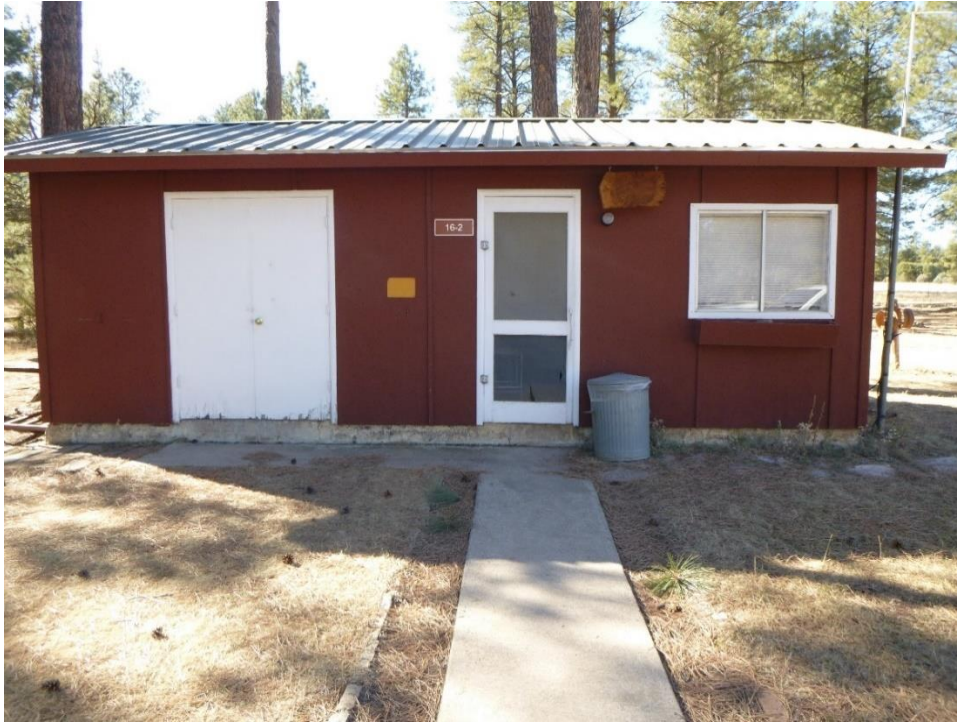
The helibase building is a wood frame structure situated on a concrete slab foundation (*see Figure 11*). The exterior is covered using plywood style sheets with some one-inch wide wooden strips providing detail. The exterior is painted in the red color of the Forest Service with white painted doors and trim around the windows. The roof is a light brown ridge, sheet metal. A poured concrete sidewalk extends from the front door east along the side of the building to a secondary, double door entry and extends from the front door to the fence on the north side of the building. A row of bricks run parallel along either side the sidewalk extending to the fence with some additional six by six-inch pavers located along the north side of the building. A radio antenna, used to operate the radio base station in the building, is mounted to the northwest corner of the building and is embedded in the ground.

Figure 11. Helibase building (16-2), view south.

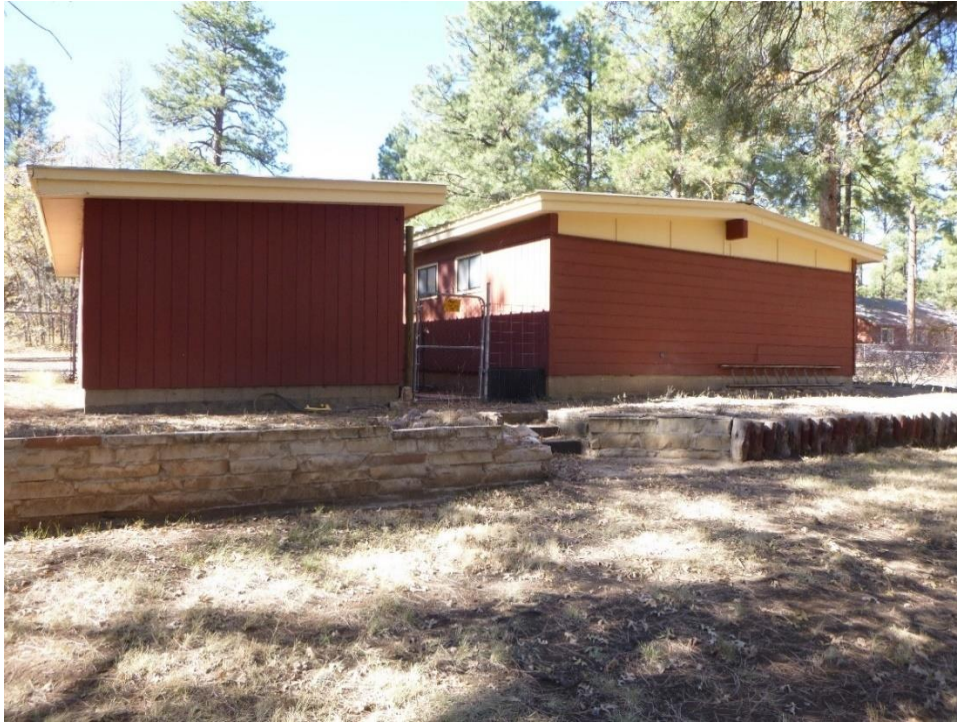
The east side of the yard has a raised terrace upon which the building sits that is constructed out of faux rock bricks and wooden timbers. The terrace also wraps partially around to the south and north sides of the yard. The entire yard is fenced by a chain link fence with gates on the south side of the garage, at the end of the walkway between the house and garage, on the north side of the yard, and on the west side of the yard. A clothesline is present along the south side of the garage within the fenced yard. The storage shed that was put in by a past resident of the house sits in the southeast corner of the yard and is a prefabricated structure made from plywood. The shed is a single room used to store yard equipment and miscellaneous personal items by the residents and has a wooden awning extending off the east side for covered firewood storage.

Figure 17. Ranger House exterior (11-40), view east.

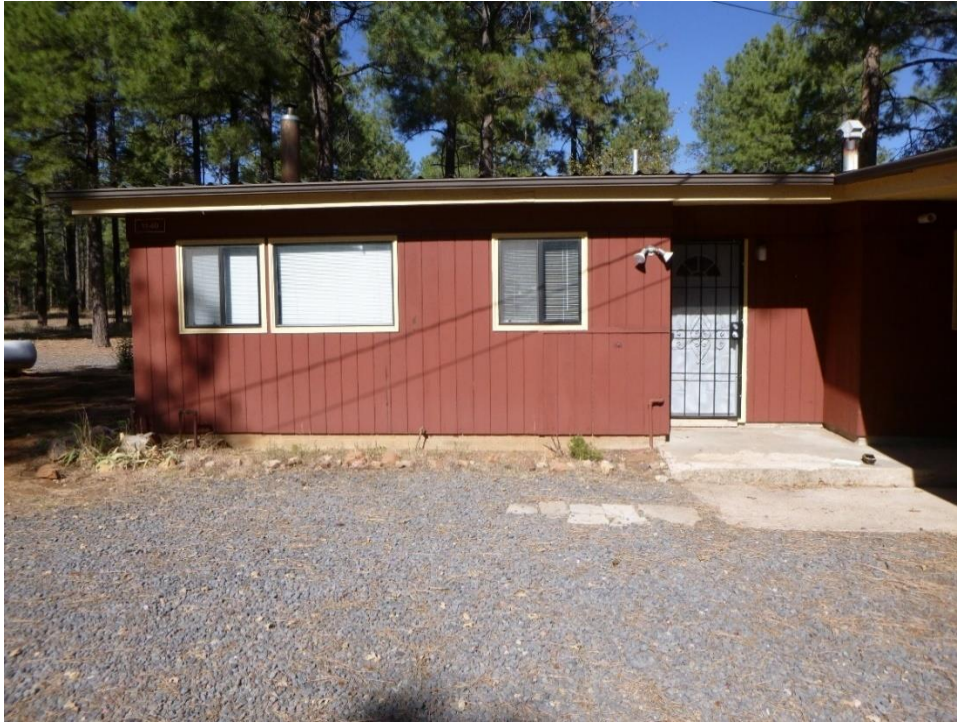
Modifications to the structure include modern double paned windows, modern hollow metal and screen security doors, sheet metal roof, faux wood laminate flooring, modern appliances, wood stove insert, modern bathroom hardware (including sink and toilet), chain link fence, storage shed, and extension/modification to the front porch.

Figure 18. Ranger House exterior (11-40), view north.

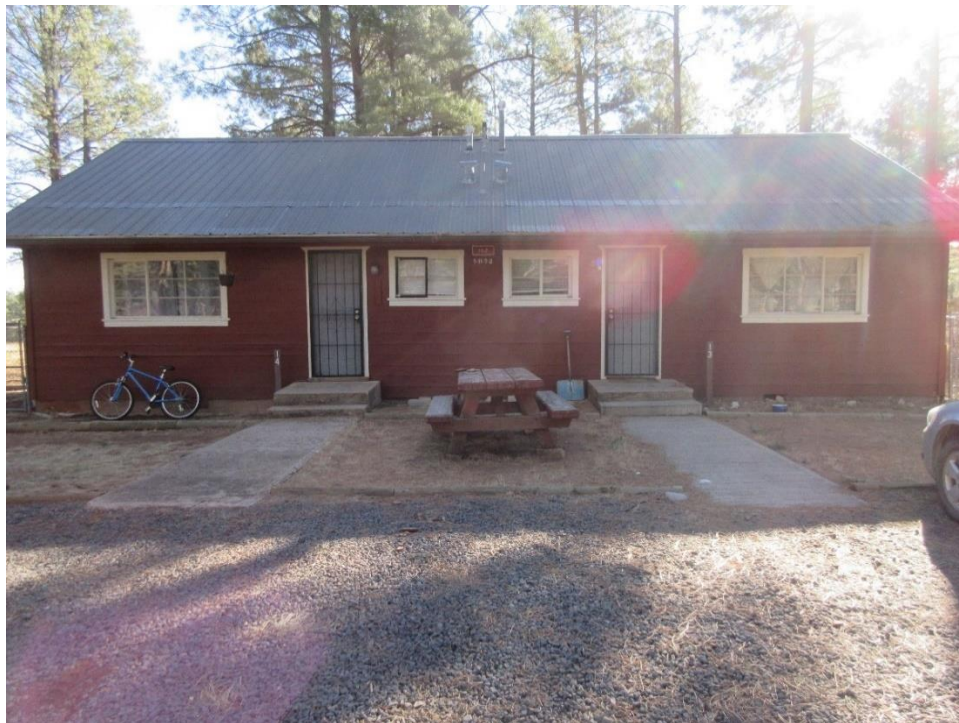
the parking area. The roof is covered in a corrugated green sheet metal with a metal gutter located along only the front of the building. The exterior entrances each have a metal security door on the outside with lightweight, hollow aluminum entry doors. Three quarters of the building is surrounded by a yard that is fenced with a chain link fence. Each duplex has a side entrance with a set of poured concrete steps and small wooden awning covering the side entrance. The building is built on a cinder block stem wall foundation with a crawl space underneath.

Figure 19. Old Duplex building (11-7), view east.

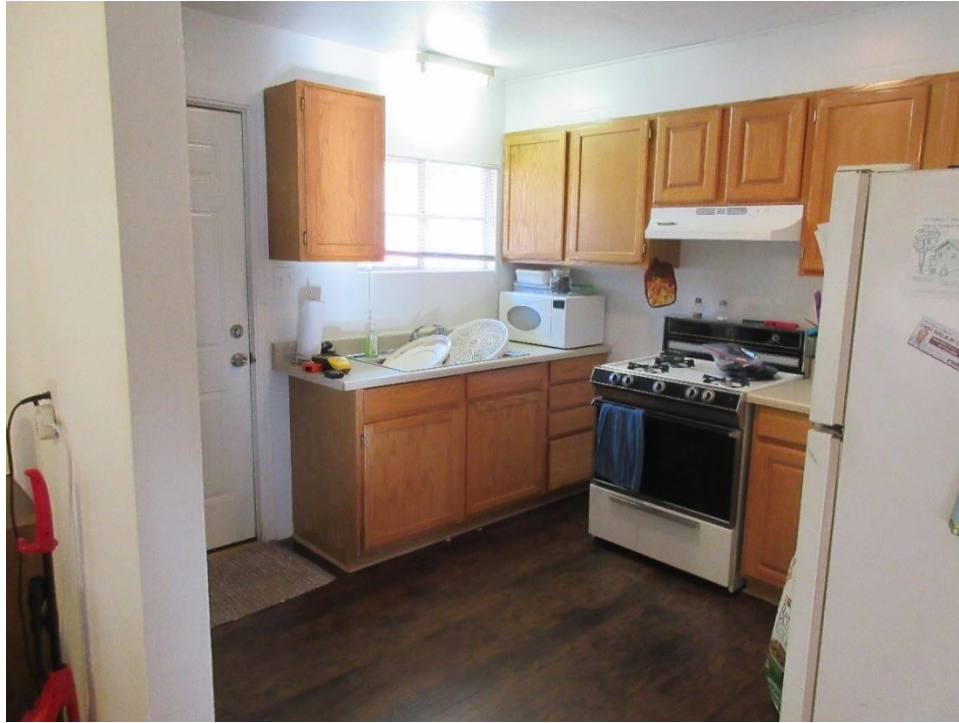
Modifications include hollow metal exterior doors, metal screen security doors, faux wood laminate flooring, modern kitchen cabinets and appliances, modern bath vanity, sink and toilet, modern double paned windows, removal of wooden stove, chain link fence, and sheet metal roofing.

Figure 20. Kitchen interior of Old Duplex (11-7), view from living room.

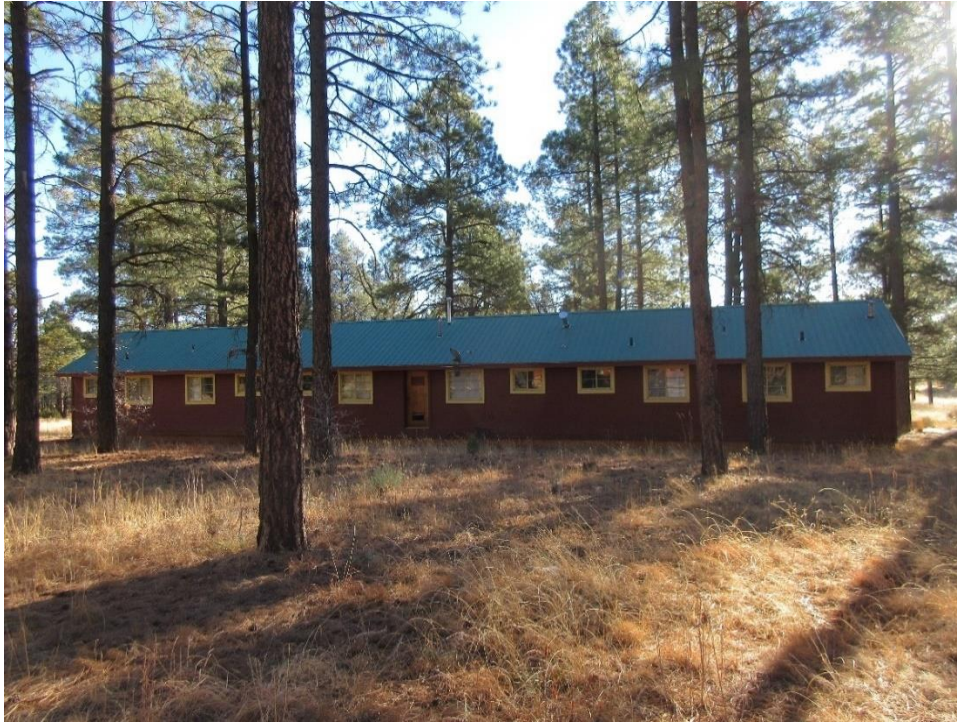
The exterior of the building is constructed in the same manner as the Old Duplex with a rustic channel style siding painted in the Forest Service red with white trim (*see Figure 21*). The roof is covered by green, corrugated sheet metal roofing material. The building is constructed on a stem wall foundation with poured concrete porches/stairs at each entrance to one of the units. The exterior entrances each have a metal security door on the outside with lightweight, hollow aluminum entry doors. On the backside of the building there is one hollow veneer wooden door that opens into a single room containing hot water heaters for the building. There are parking areas situated off a circle drive for the employees living in quarters to utilize. In the center, grassy area of the circle drive are the remains of plumbing pipes from a washhouse which used to be situated across from the Engine Quarters. This wash house was associated with the Hotshot crew quarters (a building that is no longer present) and possibly with the Engine Quarters as the Hotshot crew quarters did not contain bathroom amenities and the wash house would have provided further bath amenities for those housed in the Engine Quarters.

Figure 21. Engine Quarters building (11-60), view east.

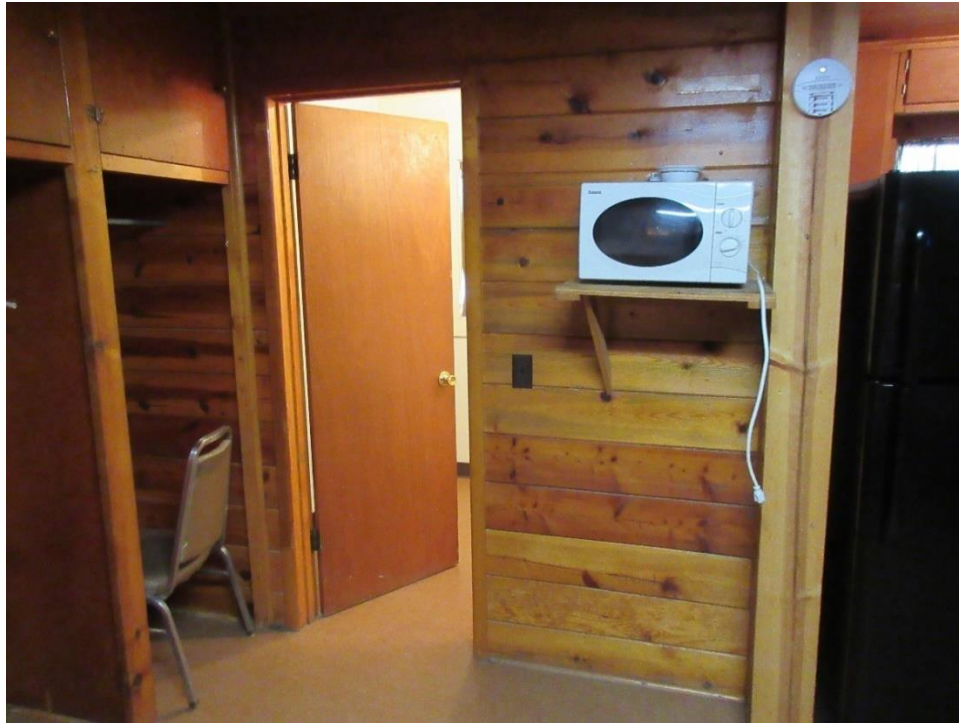
the units were recently replaced with new metal, sliding windows in place of the original metal, single paned hand crank windows.

Figure 22. Interior view towards bathroom in northernmost unit, view from living area.

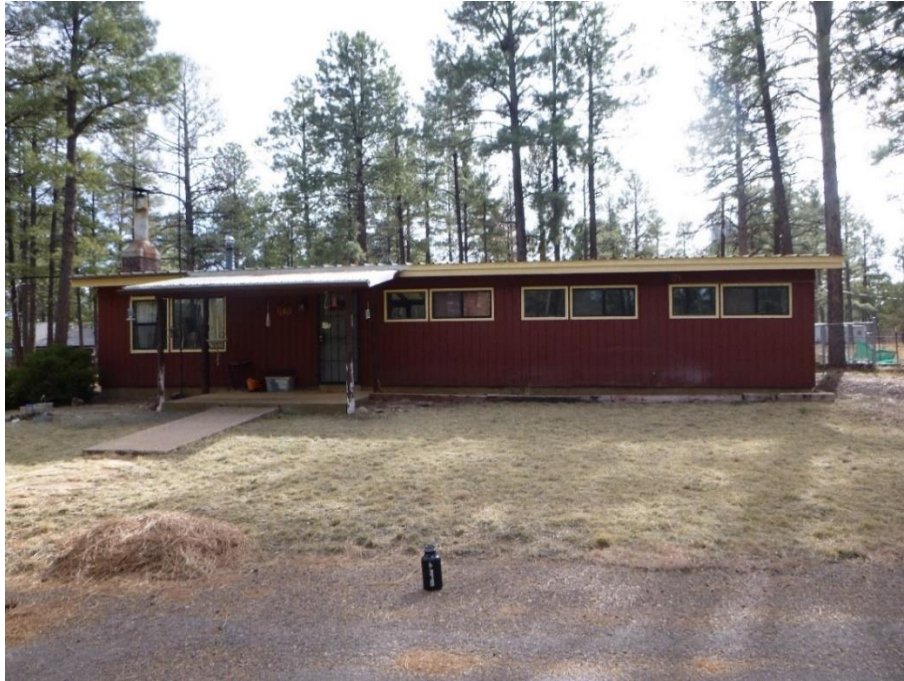
This house is called the Range House by ranger station staff due to its location next to the building known as the Range Barn. This building is a mirror image of the Ranger House (11-40) with the only difference noted between the two being in general condition and decoration done by the residents (*see Figures 24 and 25*). The house was built in 1964, same as the Ranger House, and is present on the historic map of the station from 1963 as a proposed building (*see Appendix A, Figure A.6*). The house is located towards the center of the ranger station in the center area of the road that loops through the ranger station.

Figure 24. Range House exterior (11-38), view east.

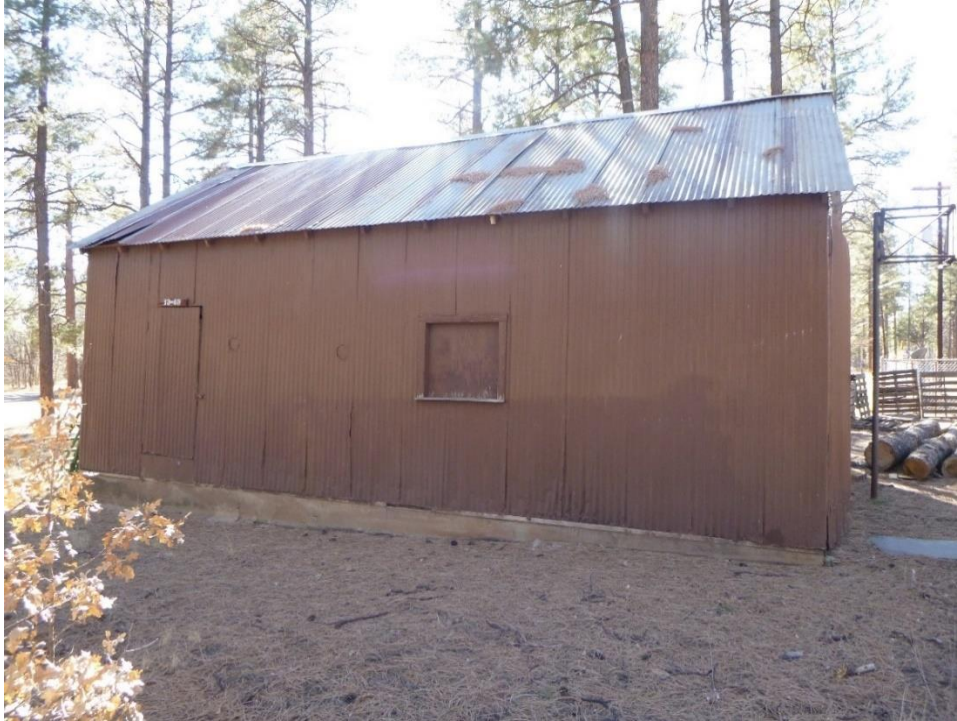
Figure 26. Exterior of Barn (13-69), view south.

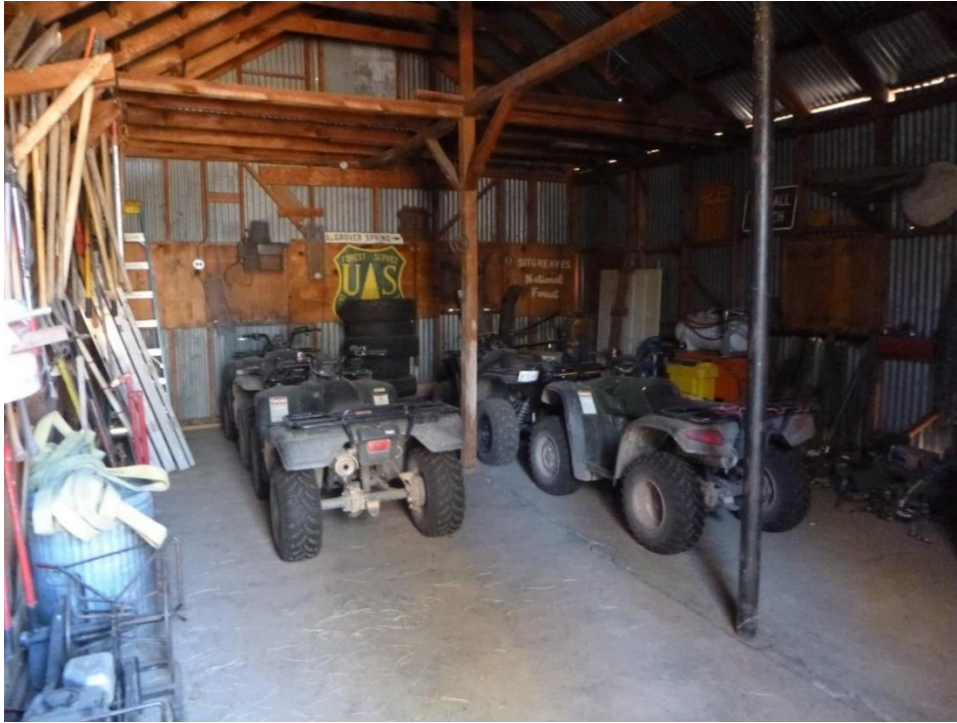
openings exist in the upper level on the east and west walls. It appears that a loft may have been present in the building at some point as rafters still exist in the back portion of the barn.

Figure 27. Interior of Barn (13-69), view from door.

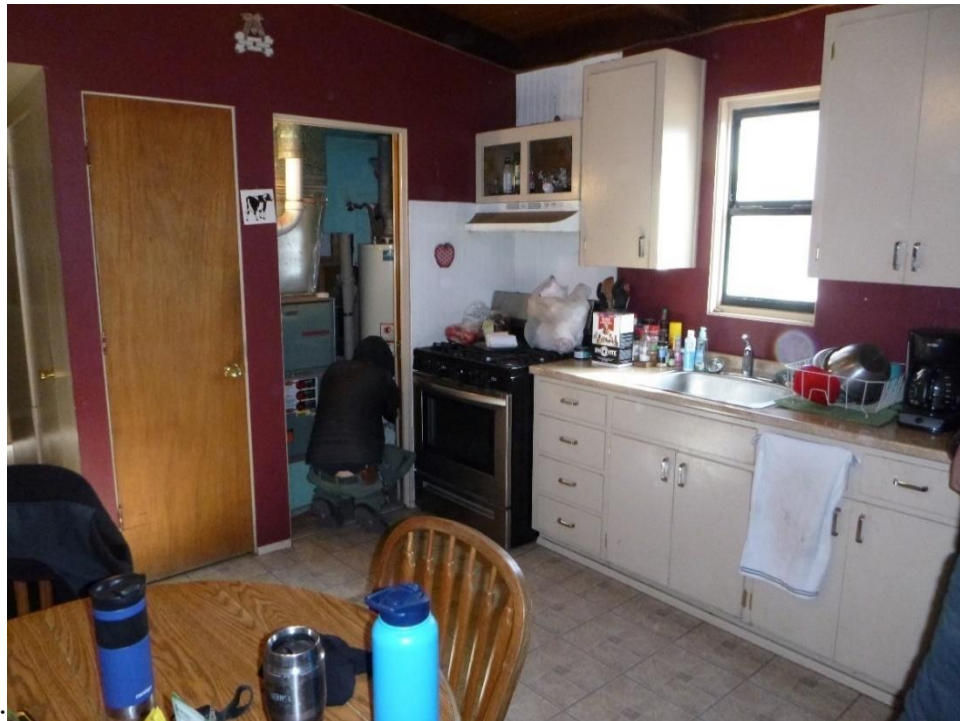
The interior of each duplex unit contains two bedrooms, bathroom, living room, hallway, hallway closet, and kitchen. The flooring throughout the units is a mix of carpet in the bedrooms, living room, and hallway while the kitchen and bathroom areas have a laminate tile floor (*see Figure 29*). The windows in each unit are single paned, metal framed windows. Most of the windows are fixed with no means of opening while some of them are sliding windows. In the living rooms, a freestanding wood burning stove is present on a faux stone platform with a faux stone façade extending up the wall behind the stove.

Figure 29. Kitchen of north unit of the Duplex (11-85), view from double doors.

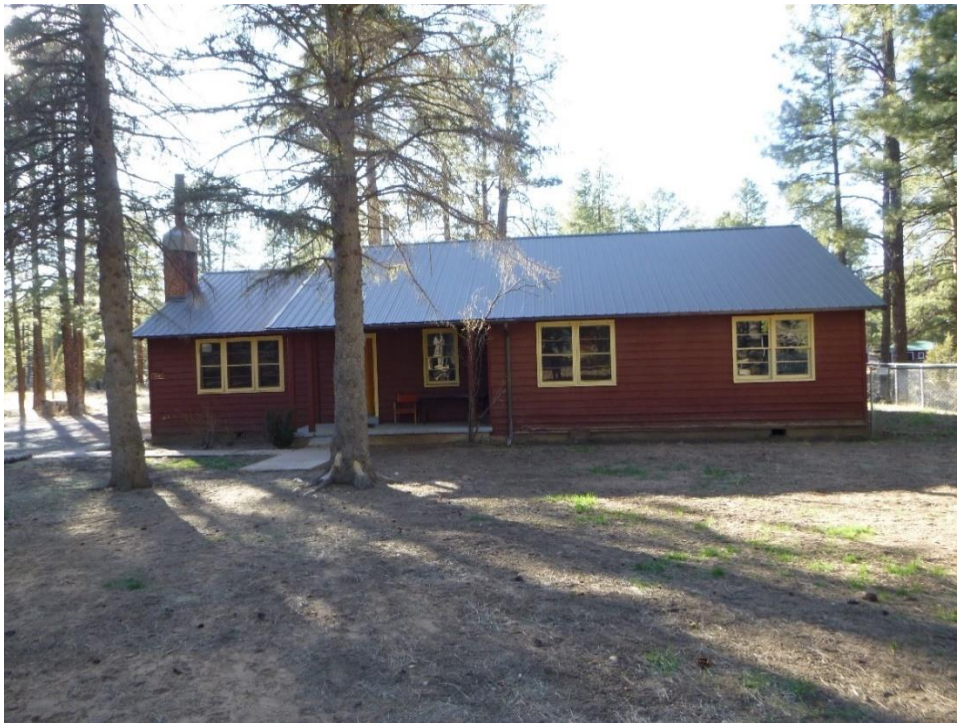
of the building as this sidewalk is in a severe state of decay as the surface has extensive damage. On the south side of the building is the chimney for the fireplace constructed from red brick. The west side of building has the backdoor from the kitchen with a set of poured concrete steps that lead down to a poured concrete pad. The roof is covered in brown corrugated sheet metal. A fenced yard is situated along the west and north sides of the building. The fence surrounding the yard is a chain link fence. Just outside of the fence to the west of the building is a wooden shed and the remains of the original septic tank that are associated with the house. The shed is a wooden structure with an unknown date of construction and has a dirt floor that has begun to fill in within the shed. The septic tank is a made of concrete with an open top that is partially covered by a piece of metal. The septic tank is no longer in use by the building as it is now connected to the modern sewer system running through the entire ranger station.

Figure 30. Weight Room building (11-54), view west.

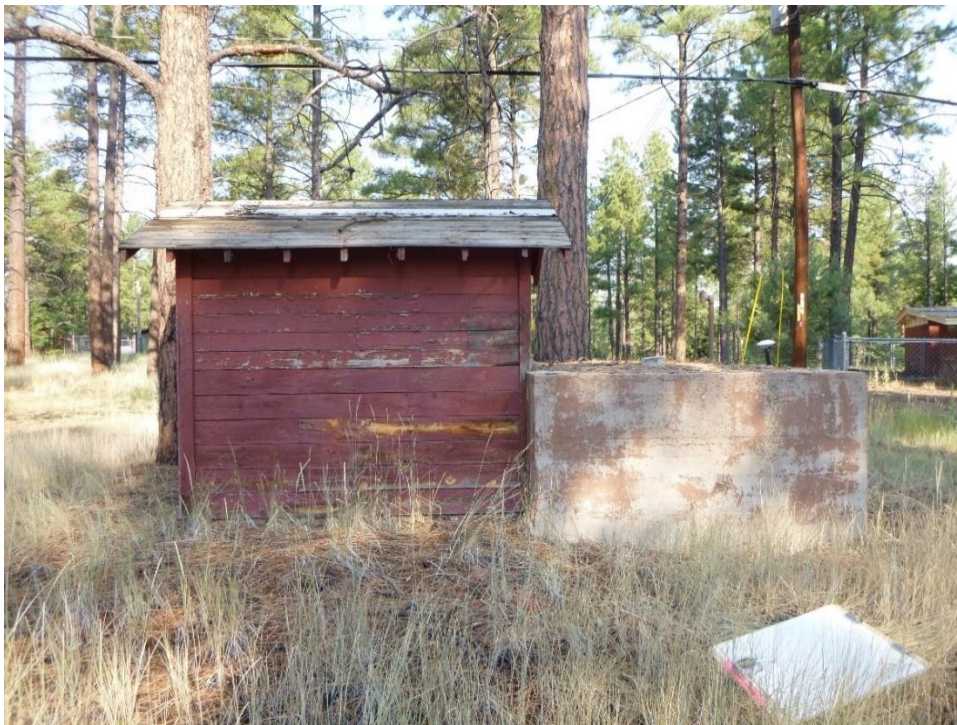
building is sided in the rustic channel style siding (wooden board type siding with small grooves in between) such as used on several other of the buildings on the station built in the mid-1960s. The building is painted in the Forest Service red color but has no trim painted in white. The paint is faded and worn on the wooden siding and several boards have water damage and rot. The building is a wooden frame structure built over a set of poured concrete steps which descend down into a poured concrete box that is partly submerged. The roof of the building has lost almost of its roofing materials, which are asphalt shingles, and the wooden roof substructure is visible.

Figure 32. Exterior of Old Well House (16-71), view west.

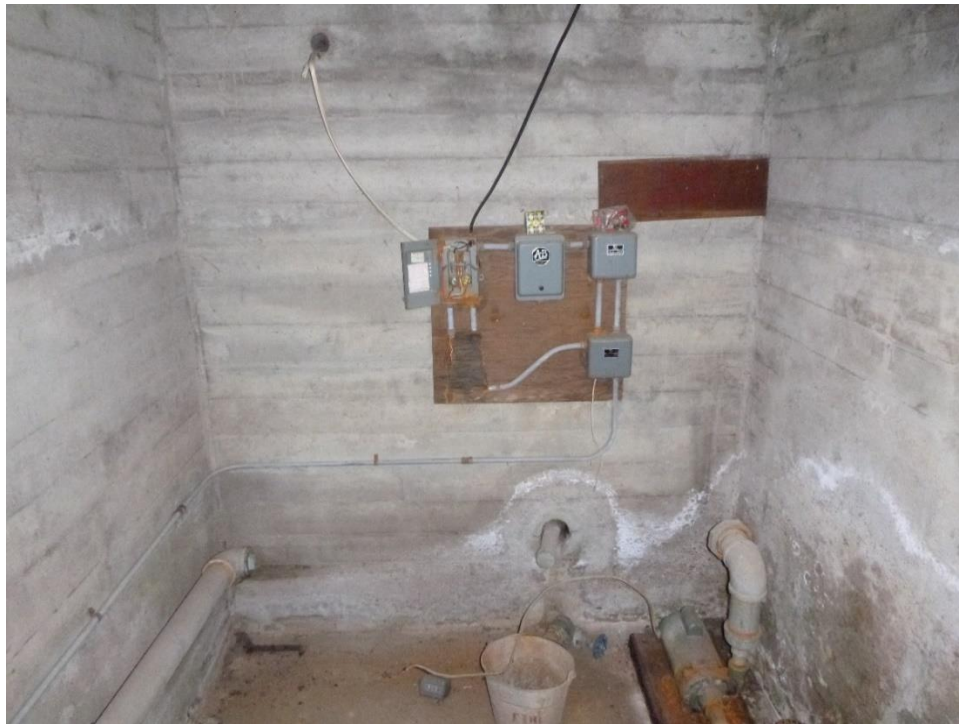
remains of plumbing and the pump for the well (*see Figure 33*). At the entrance to the building a simple wooden frame door is present with the exterior painted red. Within the building two artifacts were noted: a fire extinguisher mounted to the west wall of the building by the door that was manufactured in the 1960s and last inspected in 1969 and an aluminum bucket with the word “FIRE” stenciled on it. There appear to be no modifications to this building.

Figure 33. Interior of Old Well House (16-71) at base of the stairs, view from stairs.

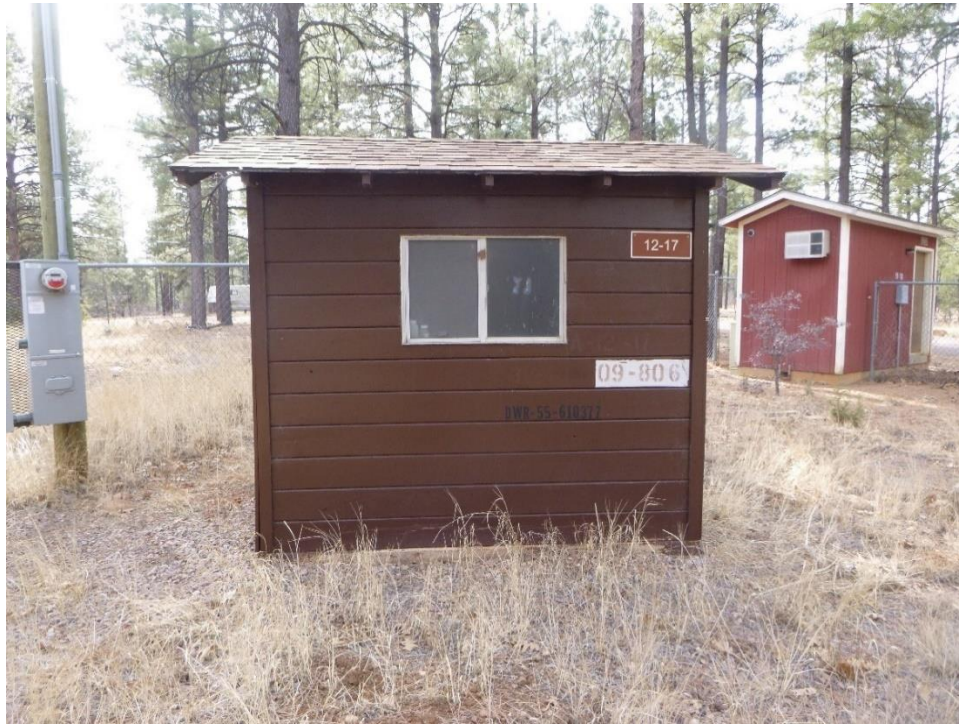
house to treat the water as it was pumped from the Old Well House (16-71) to the water tower that used to exist next to the building. This building now houses all the well pump and water treatment for the water supply to the entire station.

Figure 34. Chlorine/Pump House (12-17), view east.

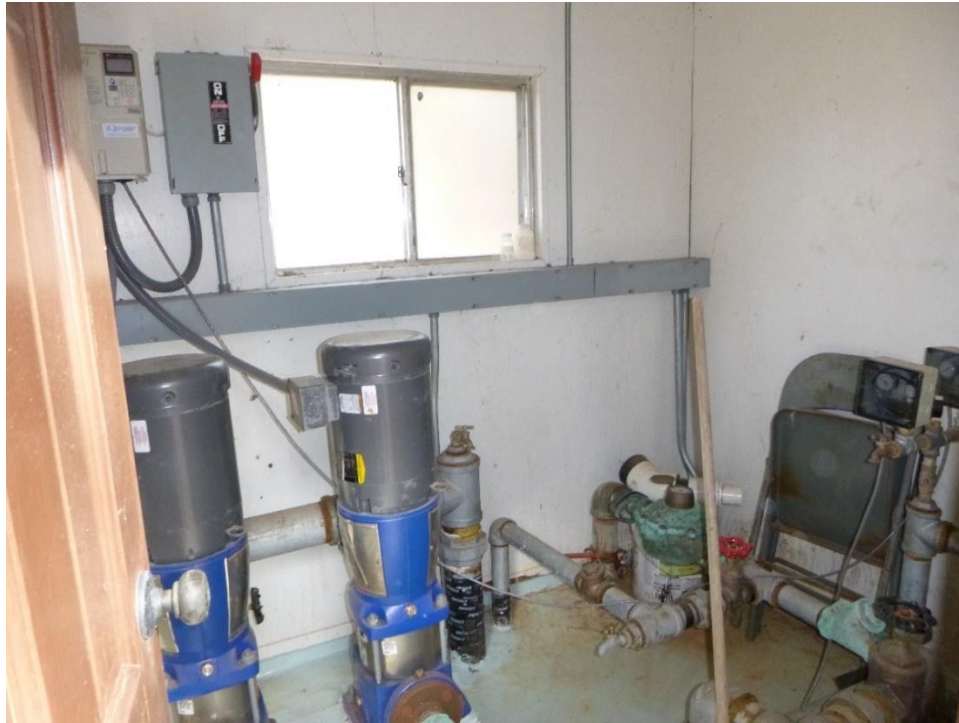
structure itself while some of the pumps and water pipes as well as the electrical hardware have been updated.

Figure 35. Interior of Chlorine/Pump House (12-17), view from doorway.

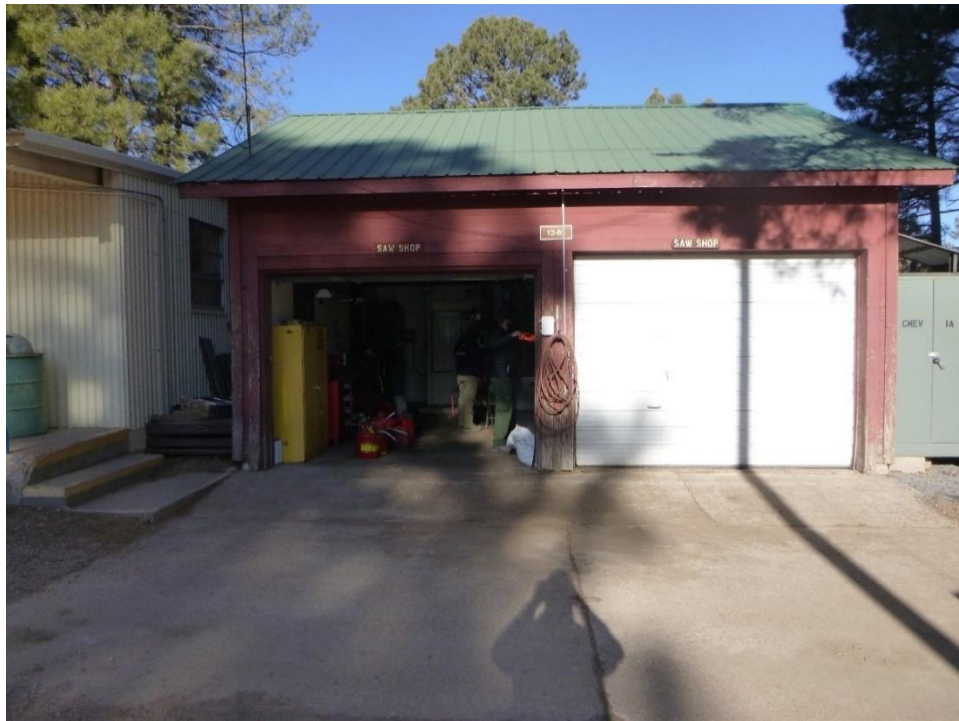
wooden frame construction situated on a poured concrete foundation. On the south side of building there is a door to a small attic space, however, the exterior staircase that used to provide access to the door is no longer present. The staircase was removed in the early 2000s due to safety concerns as the staircase and attic space fell into disrepair (Nathan Maurer and Curtis Smith, personal communications). The front of the building has two modern roll up, metal garage doors that provide access to the interior. In between the doors a hole was drilled to provide access for an air compressor hose which is fed through the wall and hung on a hose rack on the exterior wall. A concrete pad extends out from the front of the building that provides a ramp into the building. Siding and trim along the base of the building has some damage and wear from water. The roof is covered in a green corrugated sheet metal.

Figure 38. Front of Saw House (13-65), view west.

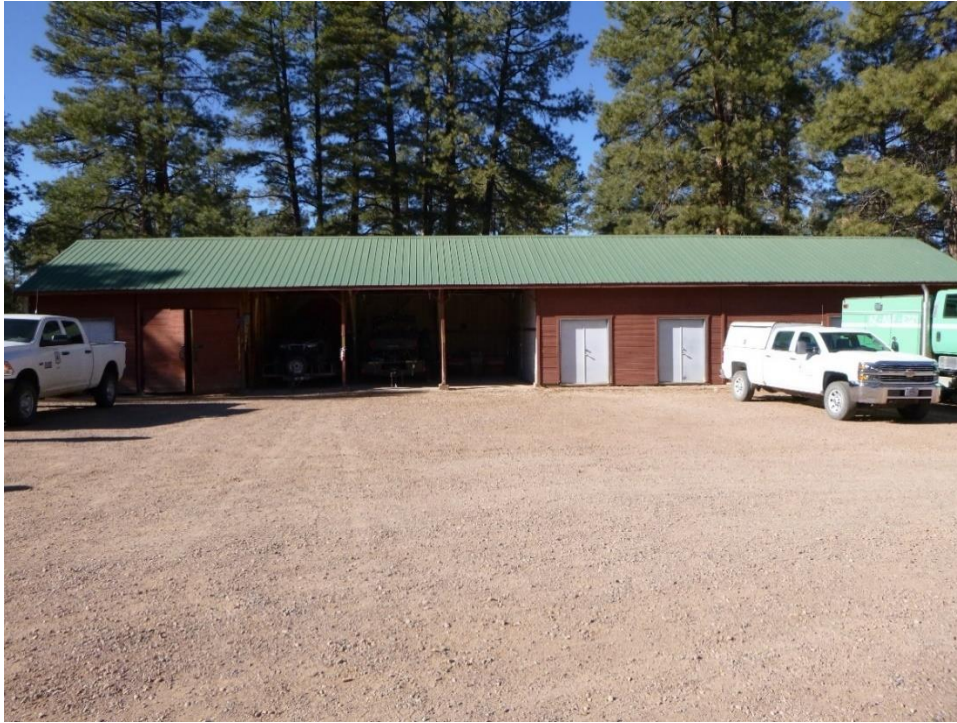
The exterior of the building is sided in the wooden rustic channel style siding that is painted in the same red as used across the station on other buildings (*see Figure 43*). The front of the building consists of two storage areas on the east side, then three open bay areas, and then four additional enclosed storage areas on the west side. The siding on the front of the building was redone within the last 15 years as the original wooden siding had deteriorated. The secured storage areas have had modern hollow metal, double doors installed at their entries. One of the storage areas on the east side that is not secured has large wood framed double doors with wood siding on them. This storage area was originally another open bay area that was closed in by the fire crew so that miscellaneous yard equipment could be stored (Daniel Ruebush and Curtis Smith, personal communications). On the backside of the building there is one single door that provides a secondary entry into one of the storage areas. The entire building is wood frame construction on top of a concrete foundation which has some damage and deterioration.

Figure 42. Fire Cache & Equipment Storage (13-30), view south.

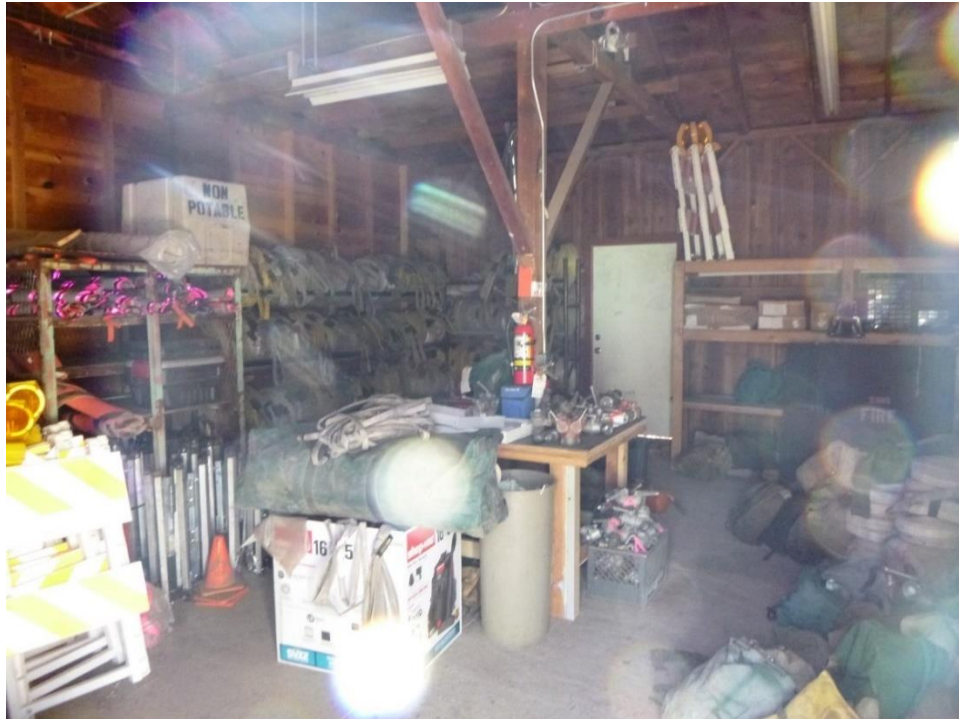
part of the original layout of the building. Storage rooms were constructed using plywood walls by the fire crews with only the exterior west wall and the wall separating the open bay area from one of the storage rooms appearing to be part of the original structure. Two of the storage rooms have had lofts built into the back of the rooms to provide for more storage.

Figure 43. Interior of one storage room in the Fire Cache & Equipment Storage building (13-30), view from entry door.

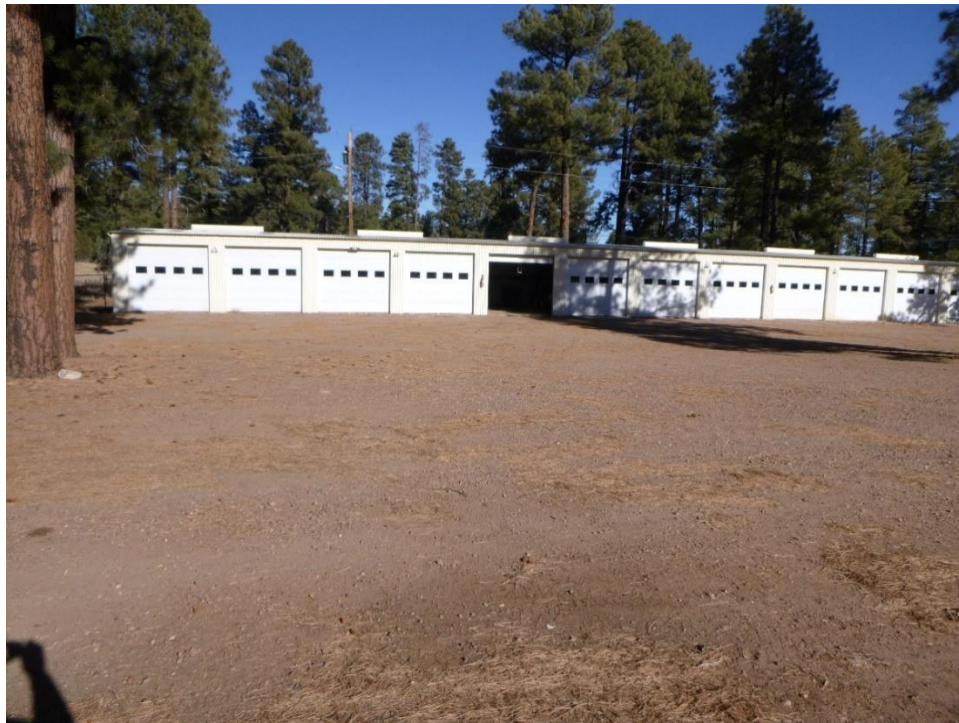
The building is constructed on a poured concrete foundation from prefabricated metal “I” beams and tan corrugated sheet metal (*see Figure 44*). The ground surface was built up slightly to provide a level surface for the construction of the building. The entire building, both interior and exterior, is made using corrugated sheet metal bolted to metal framing materials. None of the walls are insulated or completely framed in (*see Figure 45*). There are 12 roll up garage doors located on the east side of the building for vehicle access and storage while a single hollow, metal door is present on the south side of the building for additional entry. The building has no windows, but a few pieces of opaque plastic roofing are present in the roof to provide semi-transparent skylights. No modern modifications are apparent on this structure.

Figure 44. Garage 12 Bays (13-91), view west.

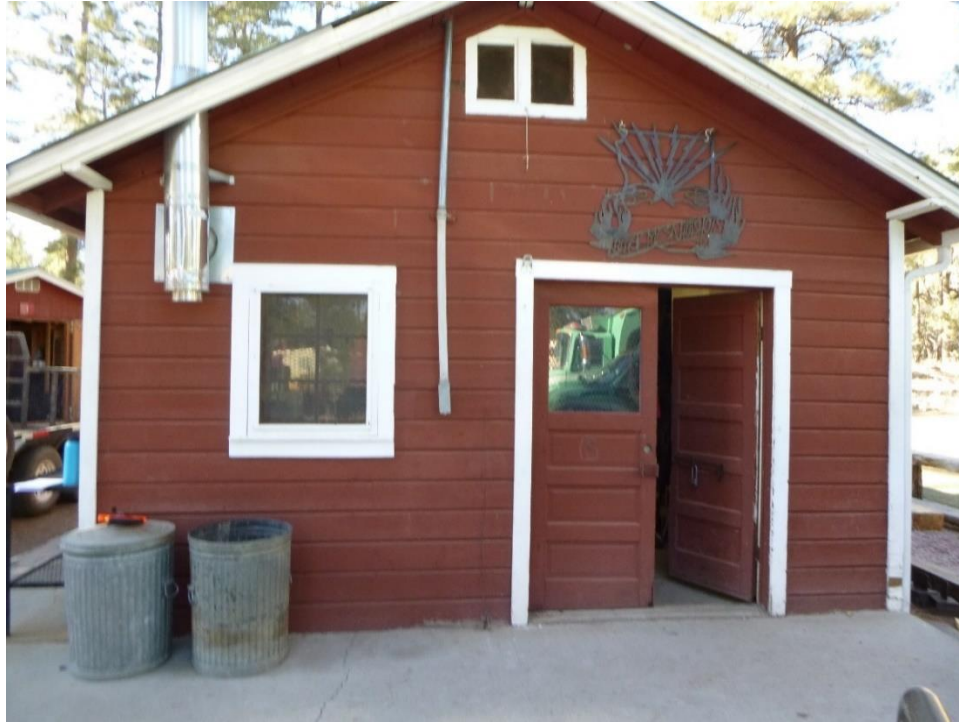
The building is constructed using a wooden frame method with a modern poured concrete, slab foundation (*see Figure 46*). The exterior is covered in a channel rustic style siding that is painted in Forest Service red with white trim. Several modifications to the exterior have occurred over the years to enhance its use for the Hotshots. Modifications include the following: installation of a stove pipe through the front exterior wall and up through the roof to accommodate a wood burning stove, a poured concrete sidewalk that spans the front of the building and then wraps around to the east side, new corrugated green metal roof, boarding up of a side entrance on the east wall, metal gutter system, addition of a small storage room on the southeast corner of the building to house an air compressor, and the addition of a cement paver patio area and wooden awning covered work area along the south side of the building.

Figure 46. Hotshots building (13-63), view south.

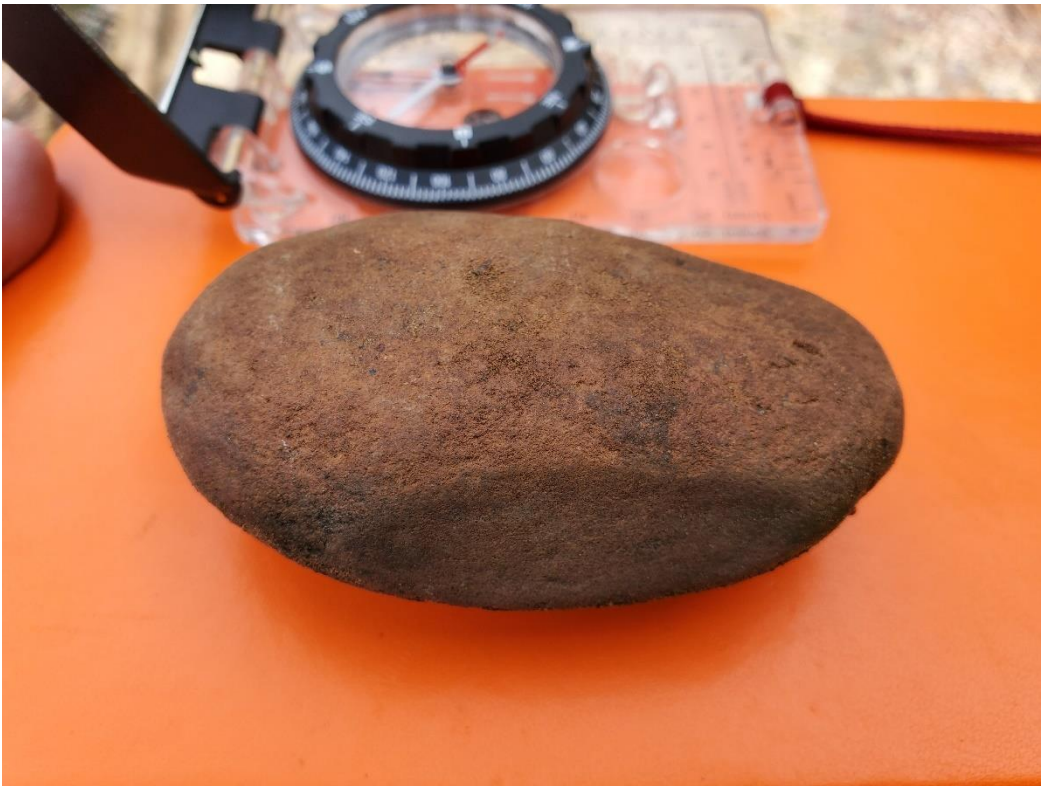
Figure 51. Groundstone tool in AC # 1, Tool 1 (T1).

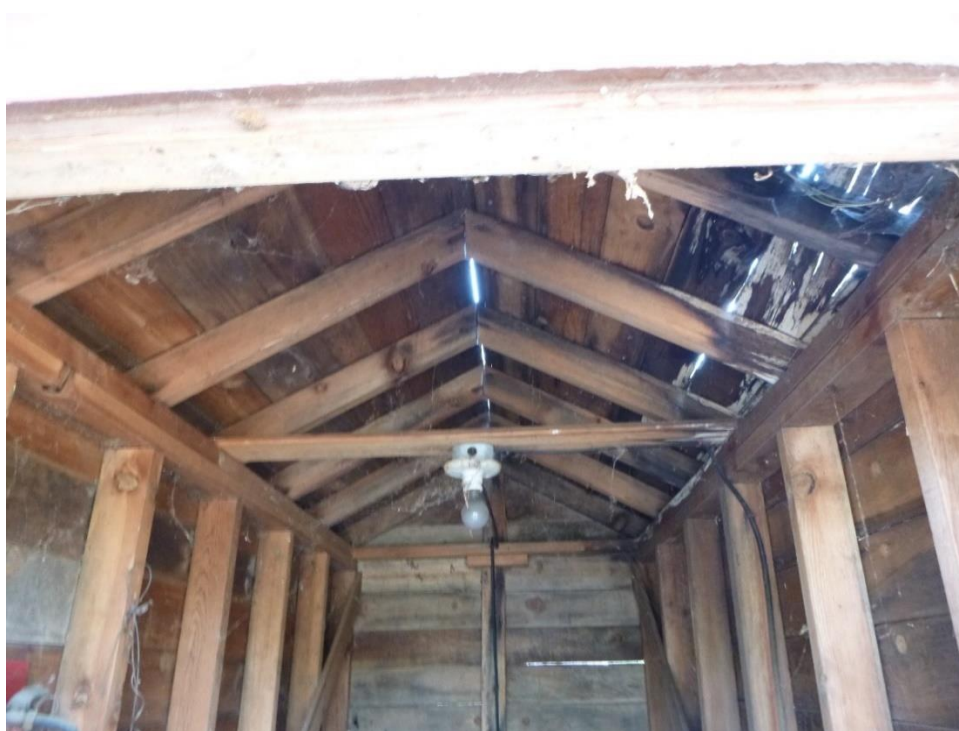
Figure C.48. Wooden structure of Old Well House (16-71).
