Article

Influence of Composite Thickness on Ultrasonic Guided Wave Propagation for Damage Detection

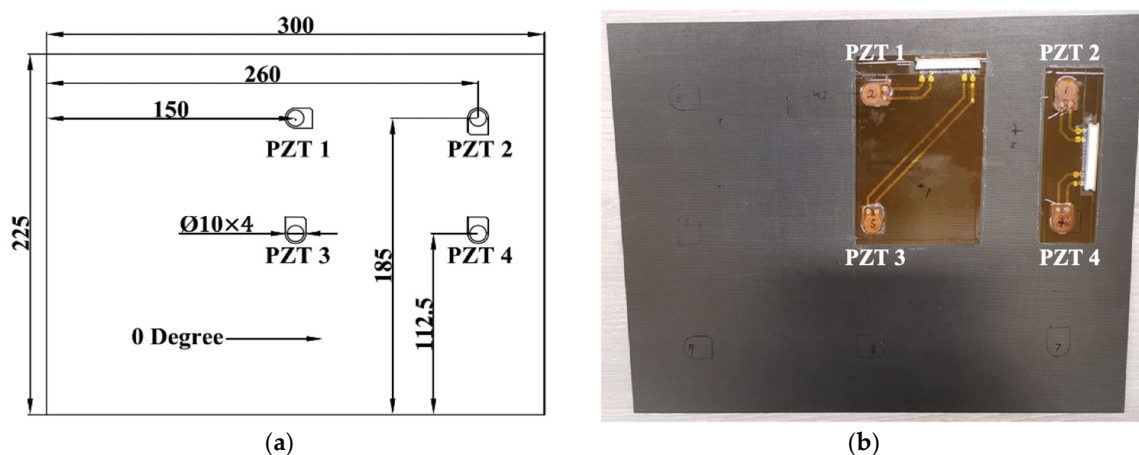
Figure 1. (a) Drawing of the specimen; (b) example of the composite panel with PZT transducers.

To compare the thickness effect on UGWs, three different composite panels with thicknesses of 2 mm, 4 mm and 9 mm were fabricated. The reason for choosing these numbers was that thicknesses of 2 mm and 4 mm are typical of fuselage skin and the thickness of 9 mm is representative of a composite frame in the fuselage or other high-load-bearing parts on an aircraft wing. Unidirectional carbon fibre prepregs (Hexply® IM7/8552) were chosen, and the average thickness of each cured ply was 0.125 mm. The quasi-isotropic stacking sequence for the lay-up was $[(0^\circ/45^\circ/-45^\circ/90^\circ)_n]_s$, where n was 2, 4 and 9 for each panel, respectively. The general drawing of these panels and locations for each PZT transducer is shown in Figure 1a. After curing, those panels were inspected by a DolphiCam ultrasonic camera.

To compare the amplitude of guided wave signals of each panel, the configuration of path 3–4 with two PZT transducers is shown in Figure 1a. A National Instrument (NI) PXI-5412 arbitrary signal generator and a NI PXI-5105 digitizer were used for signal generation and recording guided wave signals, respectively. The actuation amplitude and the sampling frequency were 6 V and 100 MHz, respectively. Path 3–4 with two PZT transducers is shown in Figure 1a, together with 5 cycles of Hanning-windowed tone-burst signals at 50 kHz and 250 kHz, as shown in Figure 5.

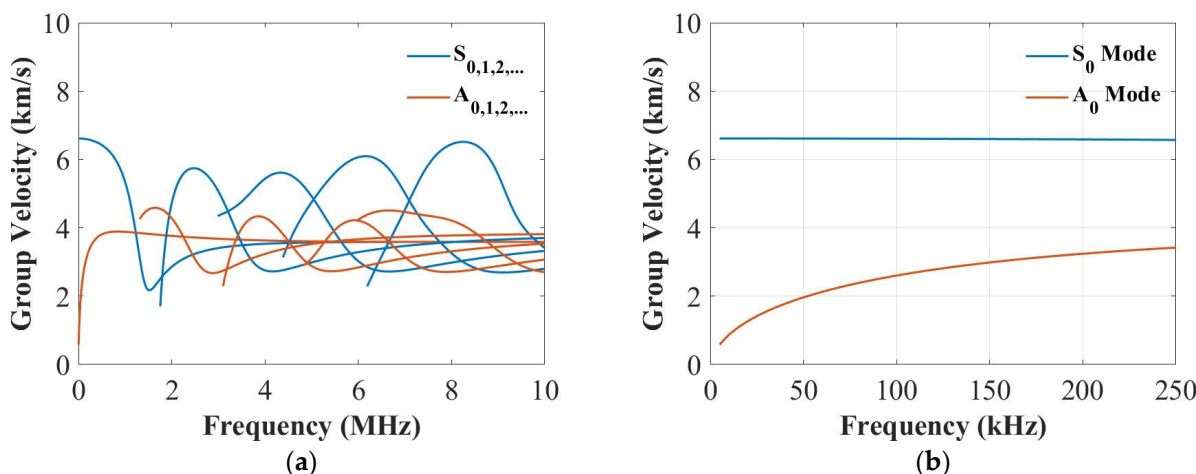
Figure 2. Dispersion curves for the group velocity from 0 to 10 MHz (a) and from 0 to 250 kHz (b) for the 2 mm thick panel.

In this section, the dispersive curves based on the analytical method [41] were plotted to study the thickness influence on the group velocities of the S_0 and the A_0 modes. Figures 2–4 plot the dispersion curves of quasi-isotropic panels for the 2 mm, 4 mm and 9 mm thick panels at 0° , respectively. According to these figures (Figures 2a, 3a and 4a), the shapes of these curves look similar, and the only difference is their frequency range. Figures 2b, 3b and 4b show the dispersion curves from 0 to 250 kHz, which clearly showed the group velocity of the A_0 and the S_0 modes at 250 kHz became closer when increasing the thickness. This means the thickness greatly affected the group velocity of the S_0 mode at 250 kHz.

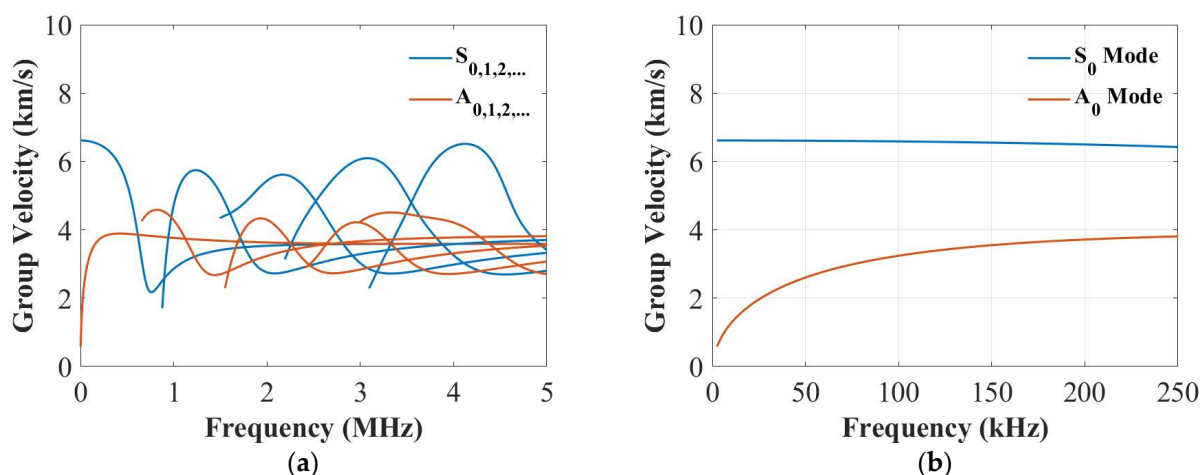
Figure 3. Dispersion curves for the group velocity from 0 to 5 MHz (a) and from 0 to 250 kHz (b) for the 4 mm thick panel.

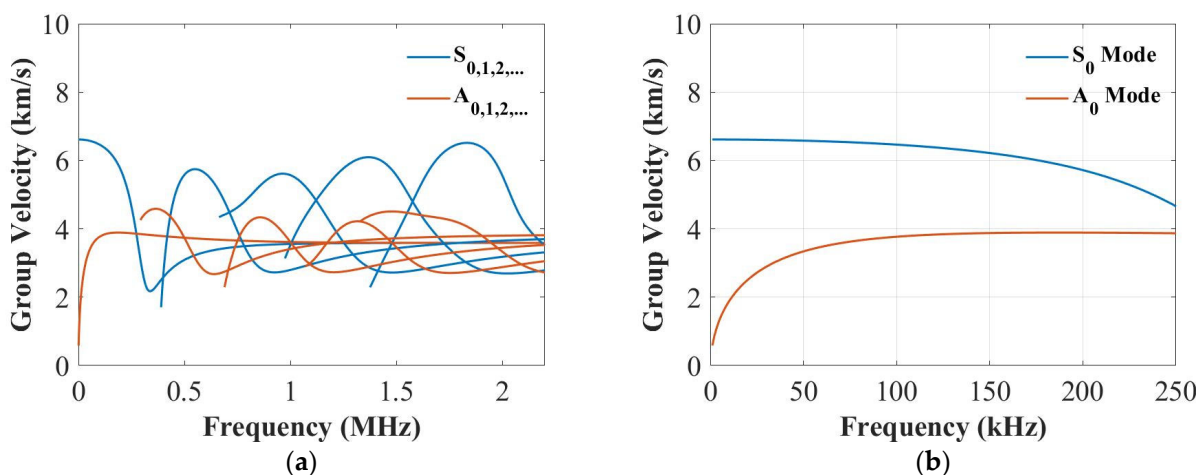
Figure 4. Dispersion curves for the group velocity from 0 to 2.5 MHz (a) and from 0 to 250 kHz (b) for the 9 mm thick panel.

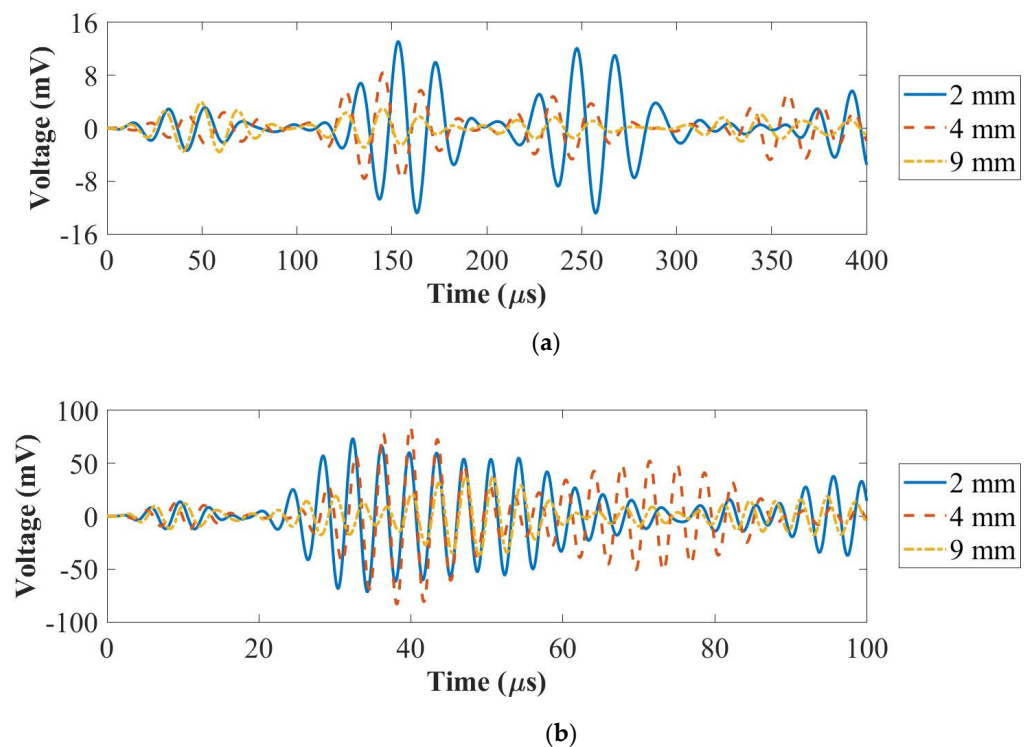
Figure 5. UGW comparisons for the panels with the thicknesses of 2 mm, 4 mm and 9 mm at 50 kHz (a) and 250 kHz (b).

As is shown in Figure 5a, the amplitude of the first wave packet (A_0 mode) for the 2 mm thick panel was higher than that of the 4 mm and the 9 mm thick panels at 50 kHz. In Figure 5b, the amplitude of the first wave packet for the 2 mm thick panel was lower than that of the 4 mm thick panel and higher than that of the 9 mm thick panel at 250 kHz. In conclusion, the amplitude of the first wave packet for the A_0 mode reduced with the increased thickness. The group velocity of the A_0 mode increased with the panel thickness increased from 2 mm to 4 mm and then to 9 mm. In addition, the amplitude of the first wave packet for the S_0 mode increased first and then reduced. The group velocity of the S_0 mode decreased when the panel thickness increased from 2 mm to 4 mm and then increased with the increased panel thickness from 4 mm to 9 mm.

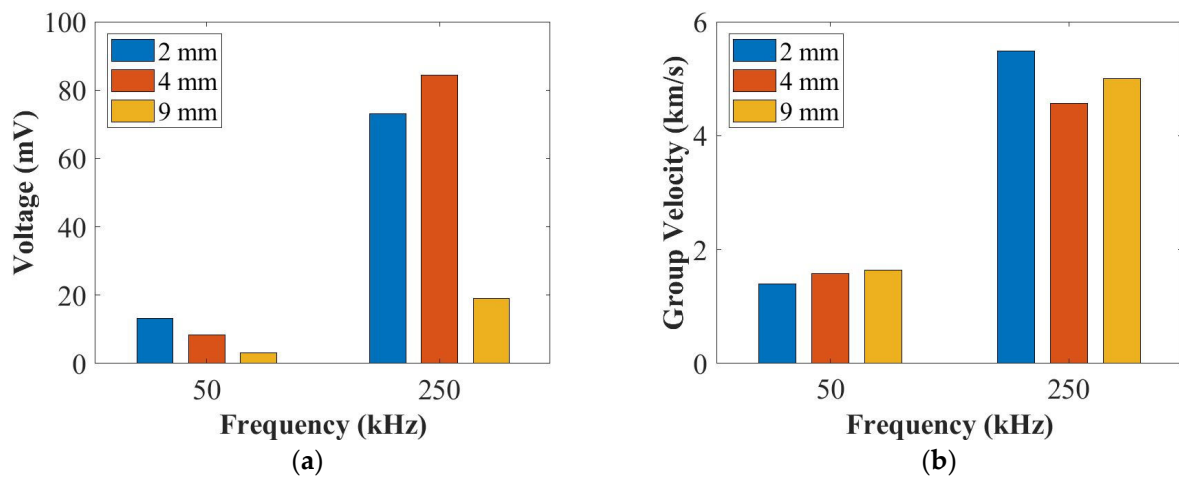
Figure 6. The summary of the amplitudes (a) and the group velocities (b) of UGWs for the panel thicknesses of 2 mm, 4 mm and 9 mm at 50 kHz and 250 kHz.

Figure 6 summarises the amplitude and the group velocity for the panel thicknesses of 2 mm, 4 mm and 9 mm at 50 kHz (A_0 mode) and 250 kHz (S_0 mode). The peak amplitude was computed by choosing the peak amplitude of the measured envelope signals by using the Hilbert transform. The group velocity was computed by the distance between the actuator and the sensor divided by the times of arrival of their envelope signals. As can be seen in Figure 6a, the amplitude of the A_0 mode was influenced more than that of the S_0 mode by the thickness. This is because the A_0 mode was an out-of-plane motion and the S_0 mode was an in-plane motion. In Figure 6b, the group velocity of the A_0 mode increased with the increased thickness at 50 kHz, which was affected by the thickness. Furthermore, the group velocity of the S_0 mode for the 9 mm panel was faster than that of the 4 mm thick panel and slower than that of the 2 mm thick panel, which was not affected by the thickness.

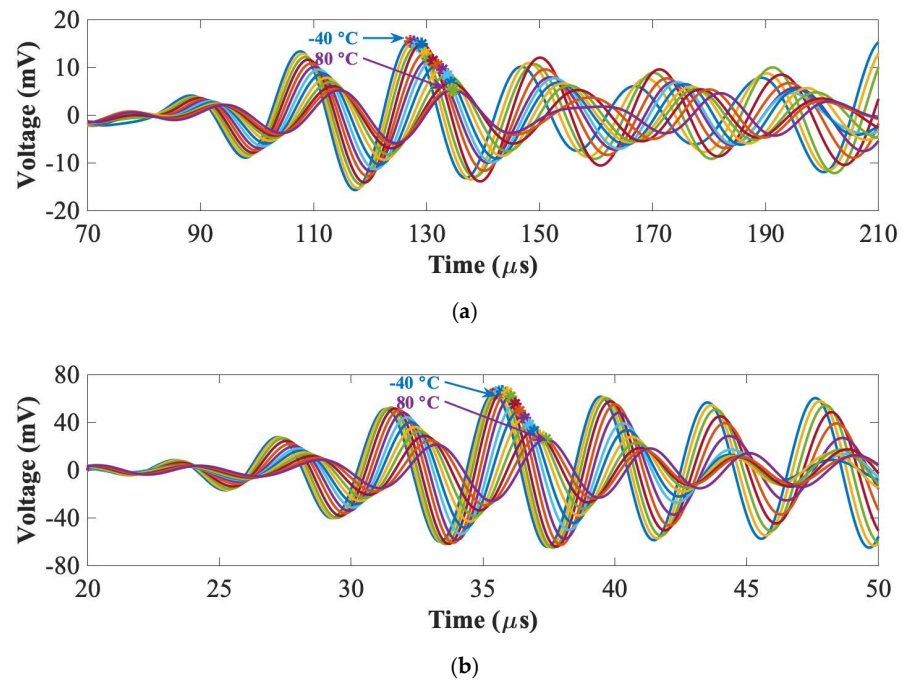
Figure 7. UGWs with peak amplitudes under varying temperatures at 50 kHz (a) and 250 kHz (b) for the 2 mm thick panel.

Temperature change affects UGWs in two ways: change in phase and change in amplitude, both of which can significantly compromise the reliability of the diagnosis if not compensated. There are several detailed investigations into the effect of the temperature on guided wave signals for thin composite plates [42]. However, no research has reported the temperature effect in thick composites and whether there is any dependency on the thickness which then should be taken into account when using temperature compensation algorithms. Therefore, in this section, the temperature effect on the peak amplitude of the first wave packet of UGW signals was evaluated. The three panels were placed into an environmental chamber, and the temperature was varied from $-40\text{ }^{\circ}\text{C}$ to $80\text{ }^{\circ}\text{C}$ with a step of $10\text{ }^{\circ}\text{C}$. The PZT transducer path 3–4 shown in Figure 1a was measured by 5-cycle Hanning-windowed tone-burst signals at 50 kHz and 250 kHz. Figure 7 plots an example of UGWs for the 2 mm thick panel at 50 kHz and 250 kHz. The peak amplitudes of the first wave packets under each temperature were computed automatically to measure the amplitude reduction and the phase shift.

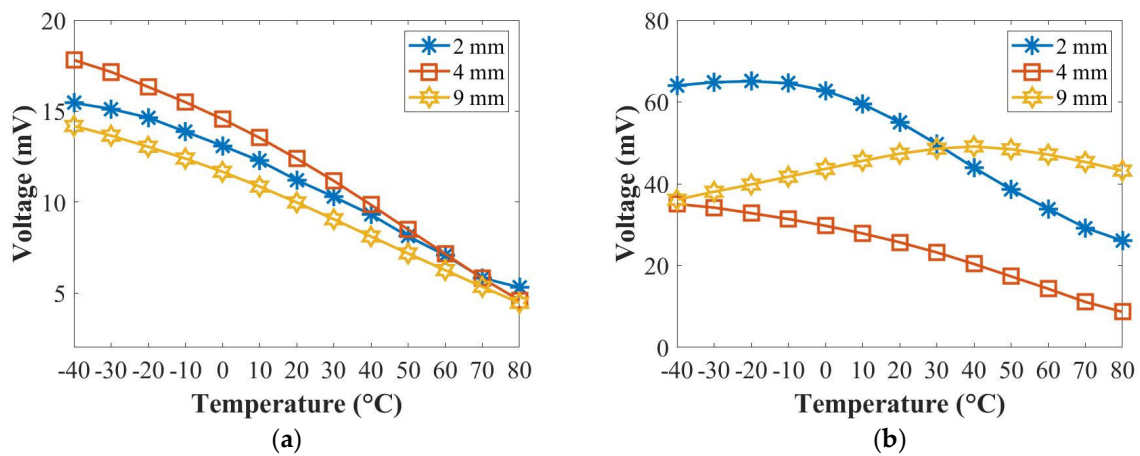
Figure 8. Relationships of the temperature with the peak amplitude at 50 kHz (a) and 250 kHz (b).

Figures 8 and 9 summarise the relationships of the temperature with the amplitude and the time-of-flight (ToF) at 50 kHz (A_0 mode) and 250 kHz (S_0 mode) for the panel thicknesses of 2 mm, 4 mm and 9 mm. The amplitude value was chosen from the peak amplitude of the first wave packet of each signal, and the ToF value was the difference between the time at the peak amplitude of the first wave packet and the half of the actuation signal. In Figure 8a, the amplitudes of the A_0 mode for the panel thicknesses of 2 mm, 4 mm and 9 mm decreased at 50 kHz. In Figure 8b, the amplitude of the S_0 mode for the 2 mm thick panel decreased and that for the 4 mm thick panel increased slightly first and decreased, while that for the 9 mm thick panel increased from $-40\text{ }^{\circ}\text{C}$ to $40\text{ }^{\circ}\text{C}$ and then decreased from $40\text{ }^{\circ}\text{C}$ to $80\text{ }^{\circ}\text{C}$ at 250 kHz with the increased temperature. In Figure 9a,b, the ToFs of both the A_0 mode and the S_0 mode increased for the panel thicknesses of 2 mm, 4 mm and 9 mm with the increased temperature at 50 kHz and 250 kHz.

Overall, the amplitude of the A_0 mode reduced with the increased temperature for all panels, which was not dependent on thickness, while that of the S_0 mode had different trends for panels of different thicknesses. In addition, the group velocities became slow for both the A_0 and the S_0 modes for all those panels with the increase in temperature, which were not dependent on thickness.

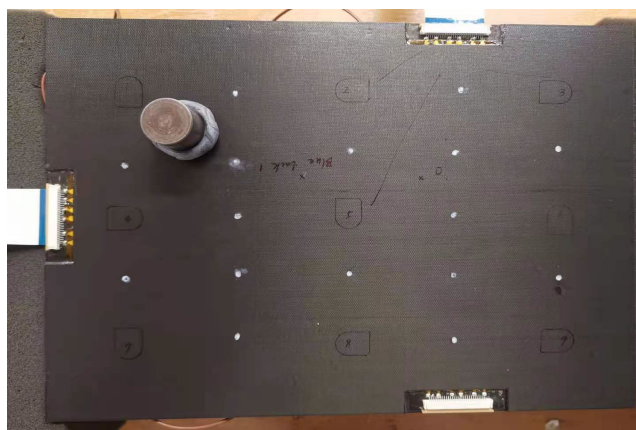
Figure 10. Photo of the surface-mounted artificial damage on the surface of the opposite side of the PZT transducers for the 2 mm thick panel.

In this section, a weighted Blu Tack was closely placed on the surface of the composite panel to simulate the type of surface-attached damage. To verify the thickness effects on damage detection and localisation for the PZT transducers, the Blu Tack was placed on the composite surface of the opposite and the same side (off-centre) of PZT transducers for each panel, and the schematic of the surface-mounted artificial damage (a weighted Blu Tack on the surface of the opposite side of the PZT transducers) can be seen in Figure 10.

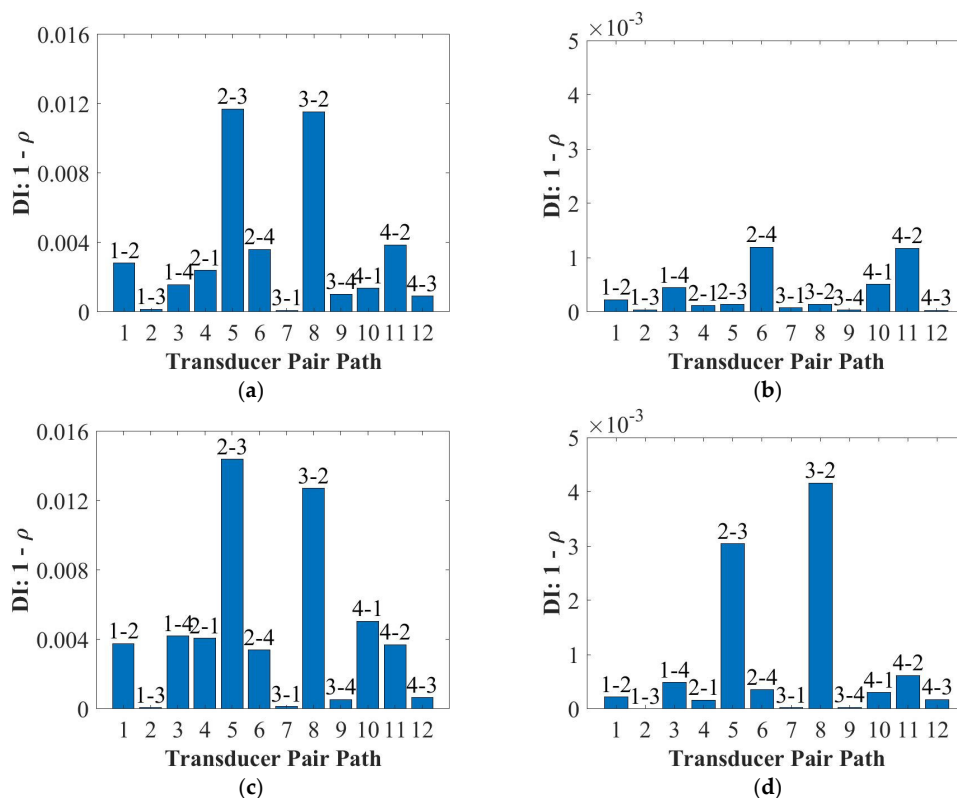
Figure 11. Damage detections for the 9 mm thick panel at 50 kHz (a) and 250 kHz (b) for the opposite side of the Blu Tack and at 50 kHz (c) and 250 kHz (d) for the same side of the Blu Tack.

Since the DI and the DAS algorithms can accurately detect and locate the surface-mounted artificial damage for the 2 mm and 4 mm thick panels (Figures A1 and A2 in Appendix A), the results for the 9 mm thick panel were reported in this section. Figures 11 and 12 plot the results of damage detections and localisations at 50 kHz and 250 kHz when the damage was closely attached on the opposite and same sides of the PZT transducers for the 9 mm thick panel. As can be seen in Figure 11, the surface-mounted artificial damage (added mass) can be detected by the DI for the panel thickness of the 9 mm, when the weighted Blu Tack was attached on both the opposite and same sides of the PZT transducers. Meanwhile, the DI results showed that the A_0 mode had a better detection of the surface type of damage (weighted Blu Tack) than the S_0 mode.

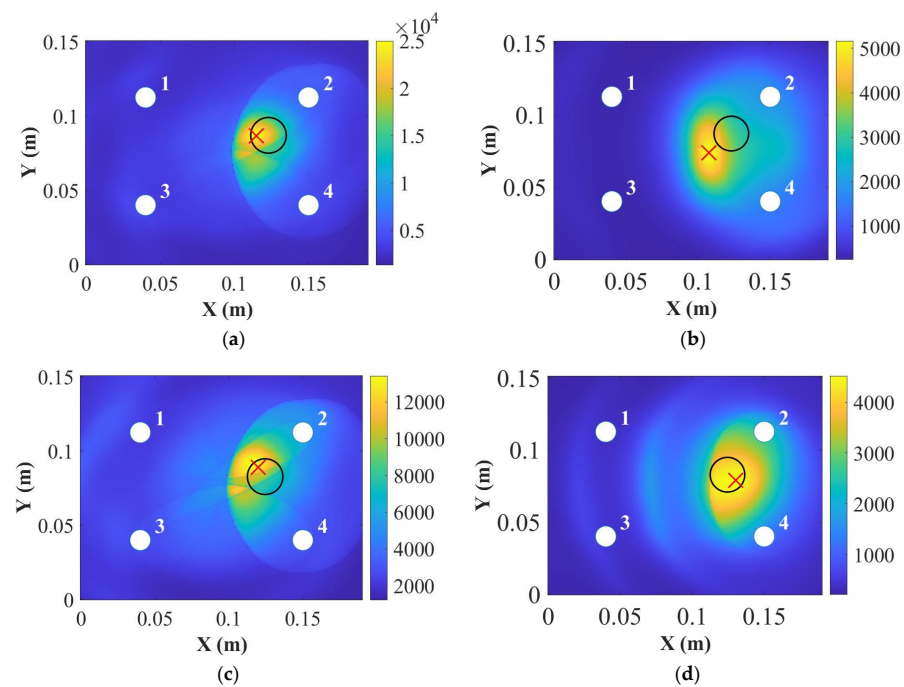
Figure 12. Damage localisations for the 9 mm thick panel at 50 kHz (a) and 250 kHz (b) for the opposite side of the Blu Tack and at 50 kHz (c) and 250 kHz (d) for the same side of the Blu Tack (where “○” is the position for real damage and “×” is the position for predicted damage).

In addition, the DAS algorithm showed this type of damage cannot be located accurately for the S_0 mode in the 9 mm thick panel at 250 kHz shown in Figure 12b. These can be related to the dispersion curve shown in Figure 4. The group velocities of the A_0 and the S_0 modes were closer, which may affect the results of damage localisation. However, when the surface-mounted artificial damage was attached on the same side of the PZT transducers, the damage was located accurately at 250 kHz for the 9 mm thick panel, as shown in Figure 12d. This may be because the S_0 mode was less sensitive for thick composites, so that the accuracy of the DAS algorithm was affected. Next, the panels were impacted to cause damage, and the appropriateness of the different modes for detection was investigated.

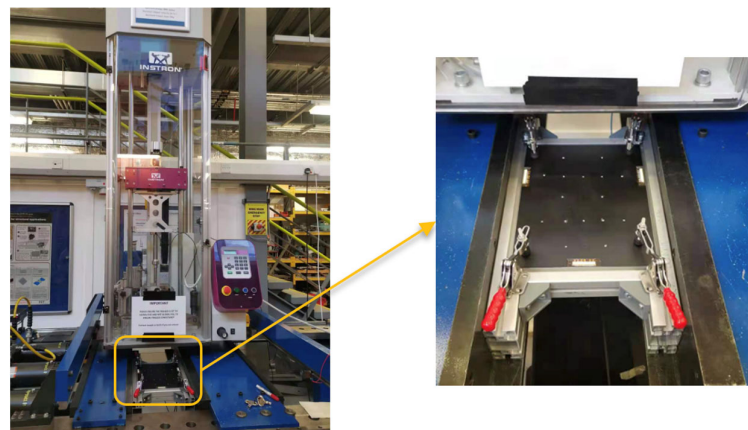
Figure 13. INSTRON CEAST 9350 drop tower for the impact test.

To study the real impact damage, impact tests were conducted on the above 2 mm, 4 mm and 9 mm thick panels. Barely visible impact damage (BVID) was considered in these tests. A drop tower INSTRON CEAST 9350 was used for these impact tests, as is shown in Figure 13. The impact position for each panel was on the opposite side of the PZT transducers and was the same as one of the positions for the surface-mounted artificial damage. The impact energy started from a low level and then increased step by step until a suitable damage area was detected by a DolphiCam C-scan (CF08). The hemisphere diameter of the impactor was 20 mm. For the 2 mm thick panel, a 22 kN load cell was used with a 3 kg additional mass. The impact energy was 15 J, and the impact velocity was 3.53 m/s. For the 4 mm and 9 mm thick panels, a 90 kN load cell was used with a 3 kg additional mass. The impact energy and velocity were 20 J and 2.72 m/s for the 4 mm thick panel, respectively, and were 57 J and 4.59 m/s for the 9 mm thick panel, respectively. After the impact, the surface cracks were visible on these panels.

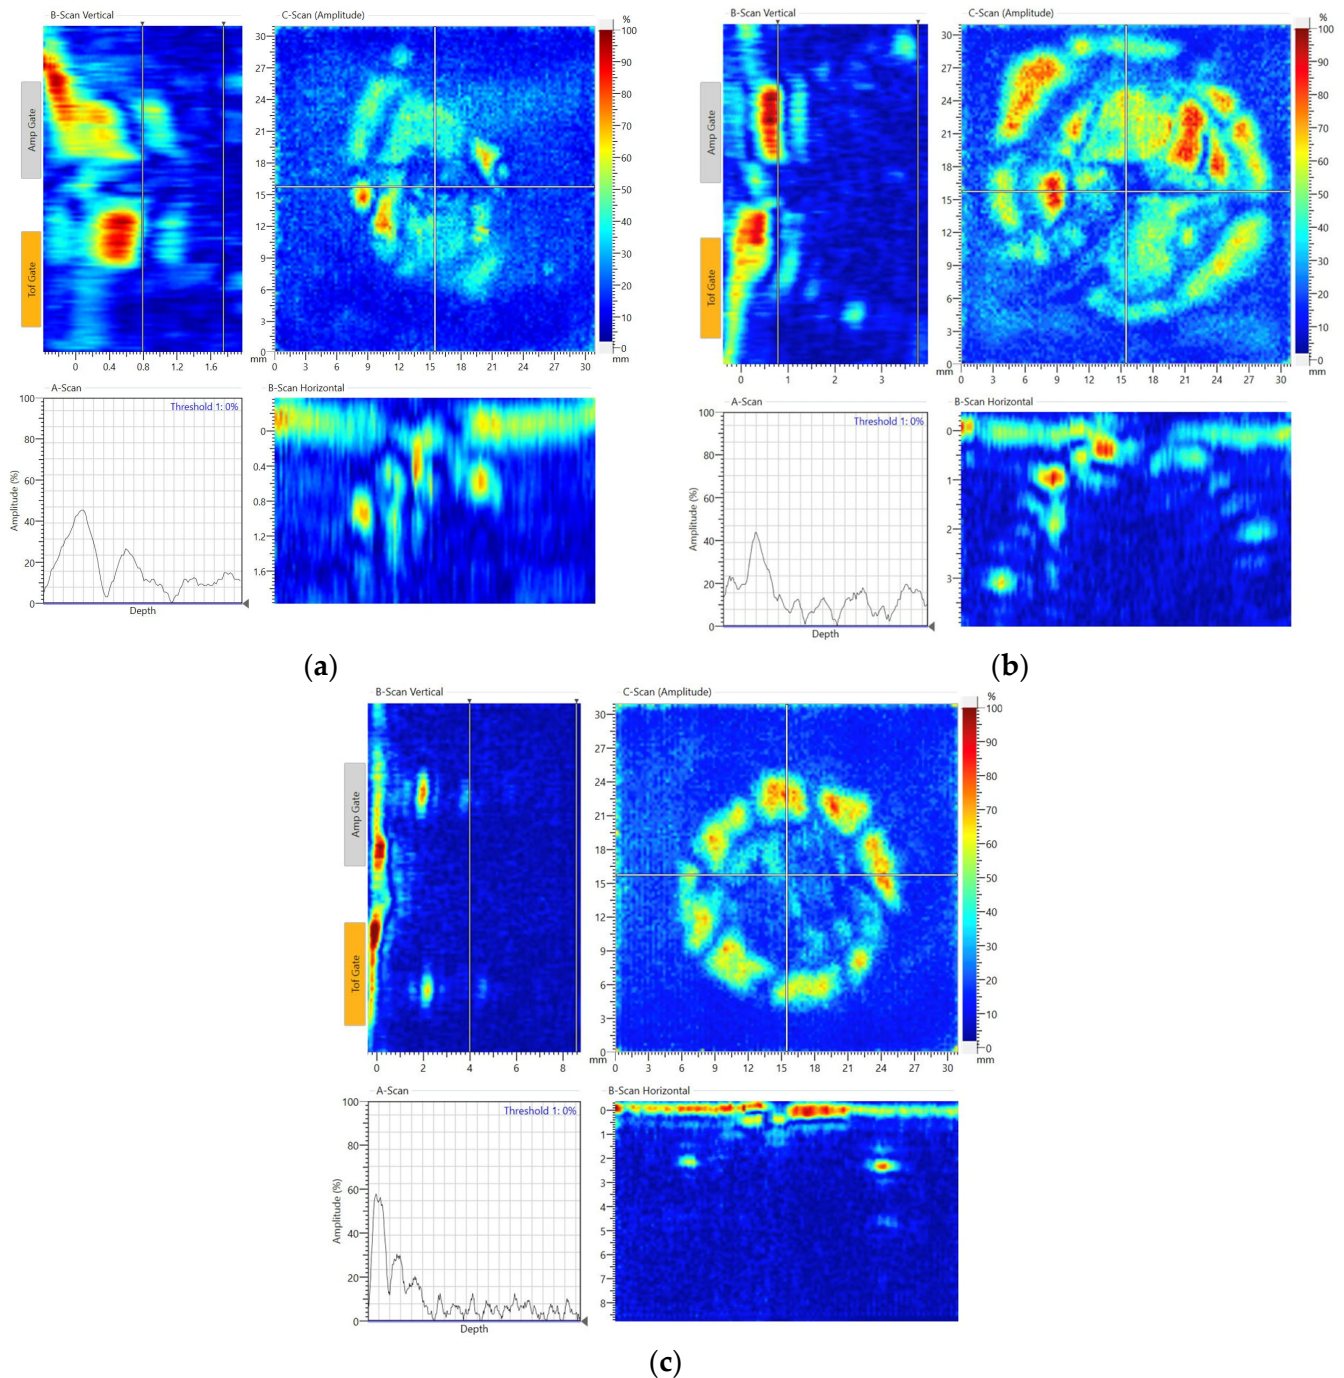
Figure 14. The C-scan results of the impact damage at 15 J for the 2 mm thick panel (a), 20 J for the 4 mm thick panel (b) and 57 J for the 9 mm thick panel (c).

Figure 14 shows C-scan results for the impact damage of each panel. In Figure 14a, the detected damage area was about 176 m^2 , and the delamination occurred from the 9th ply to the top surface according to the horizontal and vertical B-scans for the 2 mm thick panel. In Figure 14b, the detected damage area was about 452 mm^2 for the 4 mm thick panel, and the damage was from the 24th layer to the top surface according to the horizontal and vertical B-scans. As shown in Figure 14c, the detected damage area was about 254 mm^2 for the 9 mm thick panel. The delamination occurred from the 8th layer to the top surface according to the horizontal and vertical B-scans.

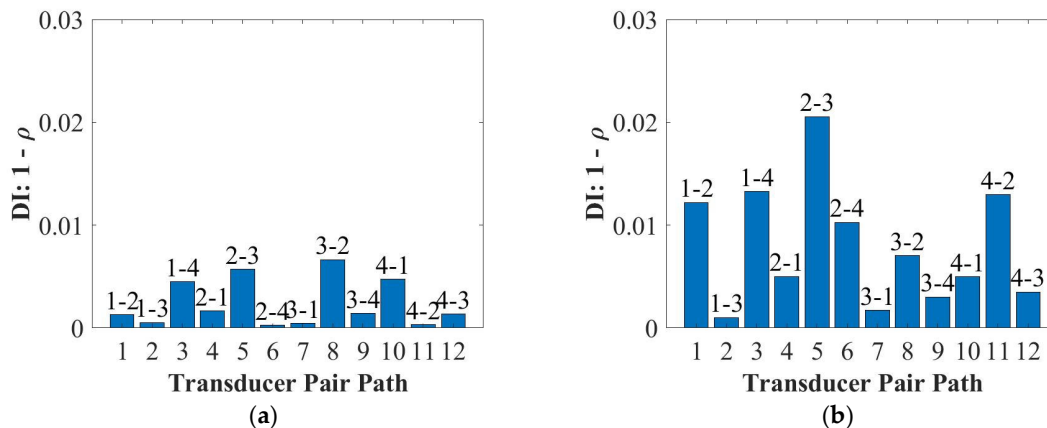
Figure 15. Damage detections for the 9 mm thick panel at 50 kHz (a) and 250 kHz (b).

In this section, the results of detection and localisation of the impact damage at 50 kHz and 250 kHz for the 9 mm thick panel were shown in Figures 15 and 16, respectively. As can be seen in Figures 15 and 16, the damage index can detect the impact damage, but the DAS algorithm cannot locate the impact damage accurately.

For the 9 mm thick panel, neither of the frequencies showed robust and reliable results of detection and localisation, which is attributed to the small severity of the damage as shown in Figure 14c. The extent of damage can be hardly noticed in the C-scan through the thickness; therefore, the damage reflected waves were of small amplitude and fell mainly within the noise level (very small DI values). Therefore, the damage should be extended for reliable detection. Another important factor is that for the delay-and-sum results usually guided waves are chosen in their non-dispersive zones. As can be seen in Figure 14b, the thickness greatly affected the group velocity of the S_0 mode at 250 kHz. In addition, the group velocity for the 9 mm thick plate at 250 kHz was dispersive, which caused the S_0 and the A_0 modes to interact with each other. Therefore, the localisation results were not accurate as was also noticed here.

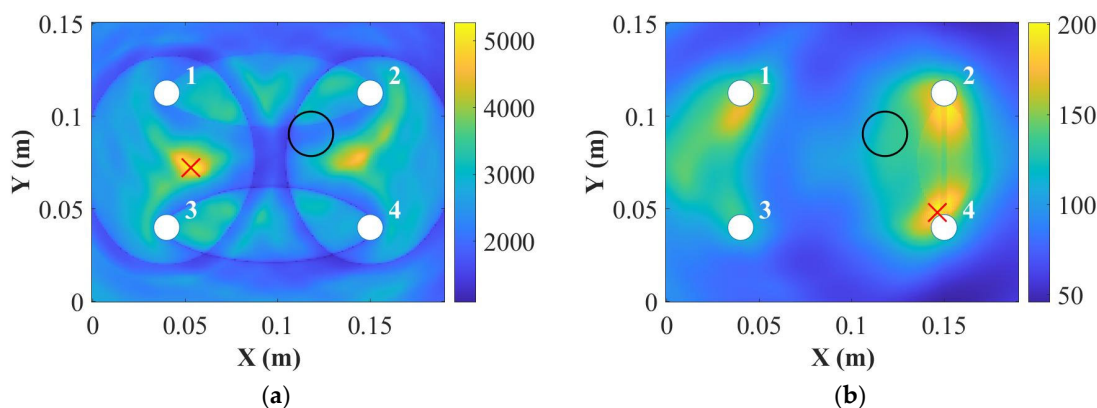
Figure 16. Damage localisations for the 9 mm thick panel at 50 kHz (a) and 250 kHz (b) (where “○” is the position for real damage and “×” is the position for predicted damage).

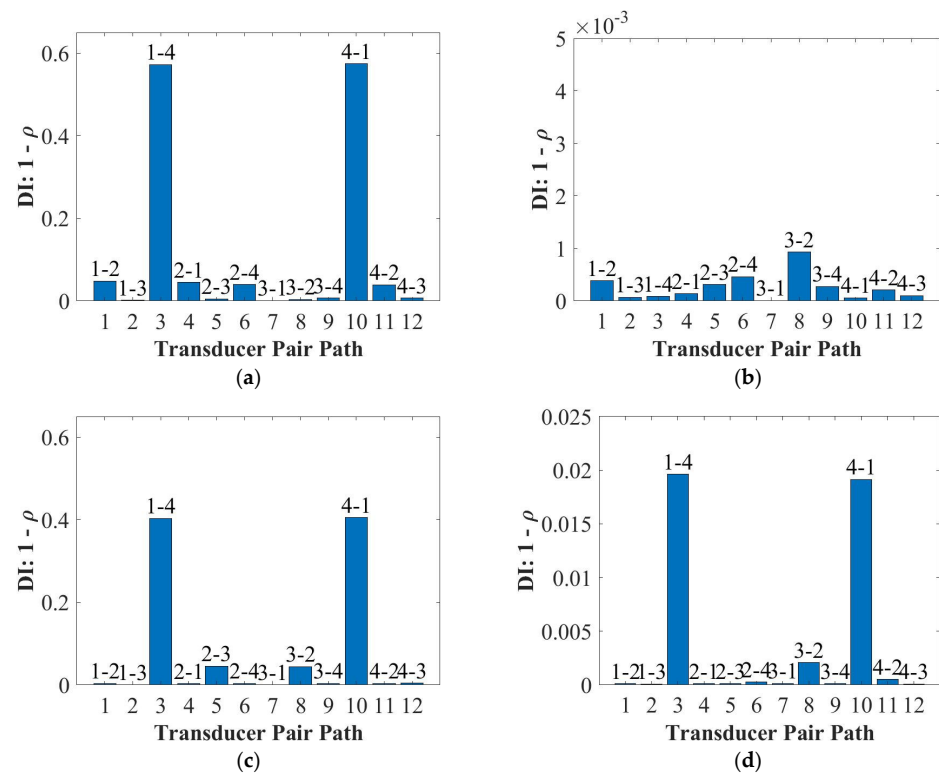
Figure A1. Damage detections for the 2 mm thick panel at 50 kHz (a) and 250 kHz (b) and for the 4 mm thick panel at 50 kHz (c) and 250 kHz (d).

In this section, the surface-mounted artificial damage was closely placed on the opposite surface of the PZT transducers for the 2 mm and 4 mm thick panels. Figures A1 and A2 plot the results of damage detections and localisations at 50 kHz and 250 kHz. As can be seen in these figures, the surface-mounted artificial damage (added mass) can be detected by the DI for the panel thicknesses of 2 mm and 4 mm. Meanwhile, the DI results showed that the A_0 mode had a better detection of the surface type of damage (Blu Tack) for the

2 mm and 4 mm thick panels. In addition, the DAS algorithm shows this type of damage can be located accurately at 50 kHz and 250 kHz.

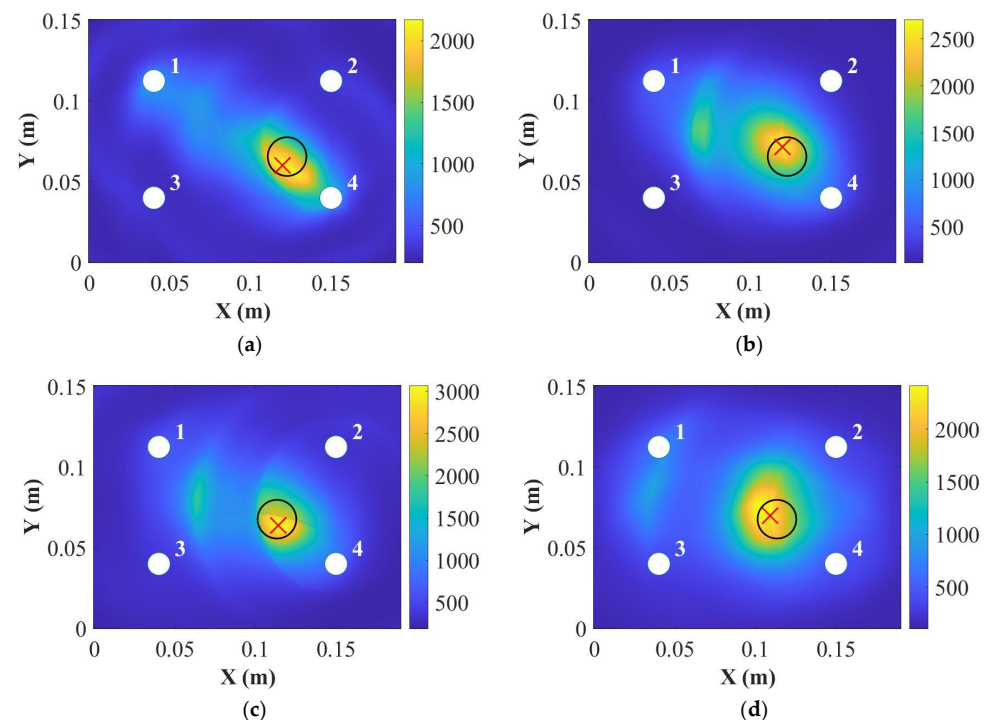
Figure A2. Damage localisations for the 2 mm thick panel at 50 kHz (a) and 250 kHz (b) and for the 4 mm thick panel at 50 kHz (c) and 250 kHz (d) (where “○” is the position for real damage and “×” is the position for predicted damage).
