Effect of rock weathering, clay mineralogy, and geological structures in the formation of large landslide, a case study from Dumre Besi landslide, Lesser Himalaya Nepal

Amar Deep Regmi¹, Koki Yoshida¹, Megh Raj Dhital² and Krishna Devkota³

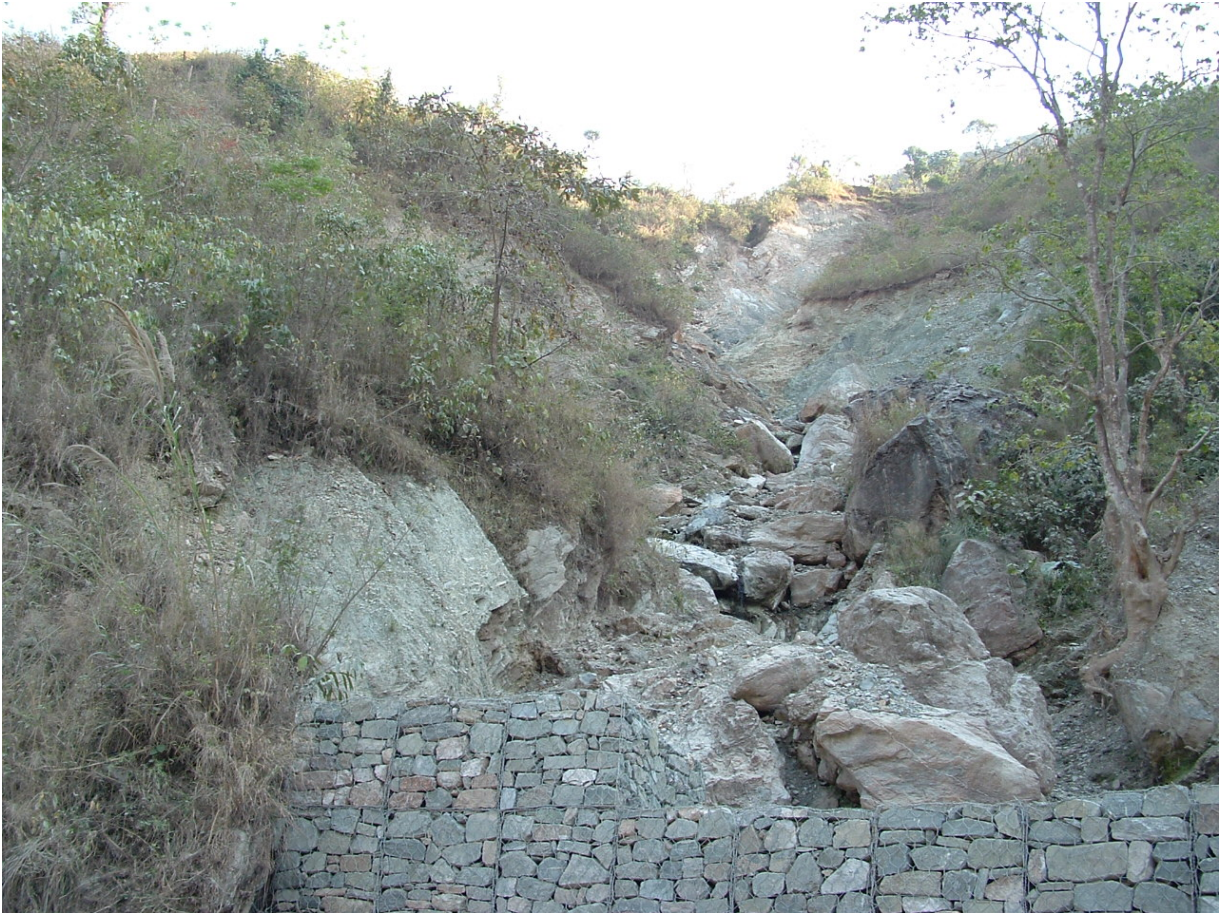
Fig. 3 Photograph showing the Dumre Besi landslide and its surrounding area, view towards south. Photograph is from the area incorporated in the box in Fig. 2

Dumre Besi landslide is one of the most active landslides along the Mugling–Narayanghat road section (Fig. 3); it was first recognized after the 2003 rainfall, when a small part of it activated below the Dumre Besi near Simaltal and damaged the road. In the same year, many other landslides were initiated along this road section, and the road was closed for several days. Since then, the road has been closed for some hours to some days in every monsoon due to this and other instabilities along the road.

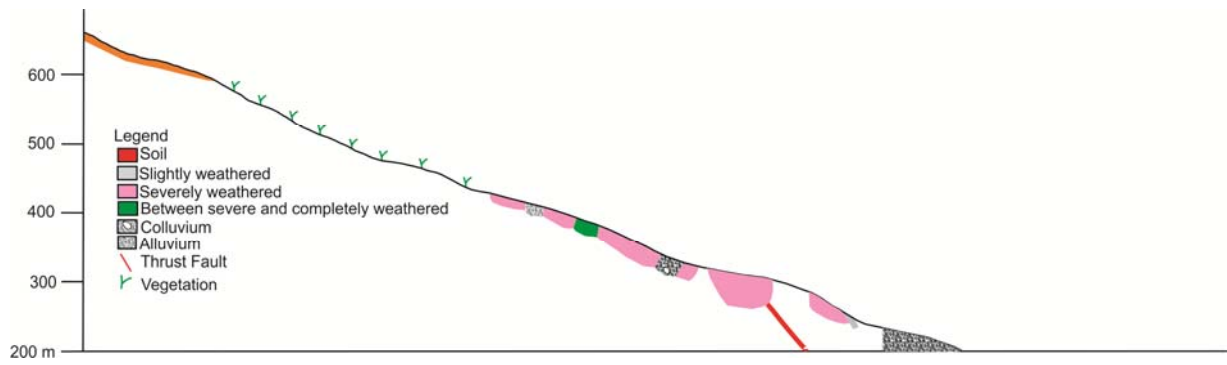
Fig. 5 Cross-section of the landslide

The landslide consists of two rock formations separated by a thrust fault; the rocks of the Benighat Slate Formation that crop out in the upper part of landslide consist of slightly weathered, light grey laminated dolomite, interbedded with light grey slate and, highly jointed and fractured, light grey phyllite and sandstone. The attitude of bedding planes is about $230^{\circ}/74^{\circ}$ NW. The rocks belonging to Nourpul Formation, forming the upper part of the landslide, consist of light grey to white, laminated, shiny phyllite and metasandstone. The rock is slightly weathered (Fig. 5).

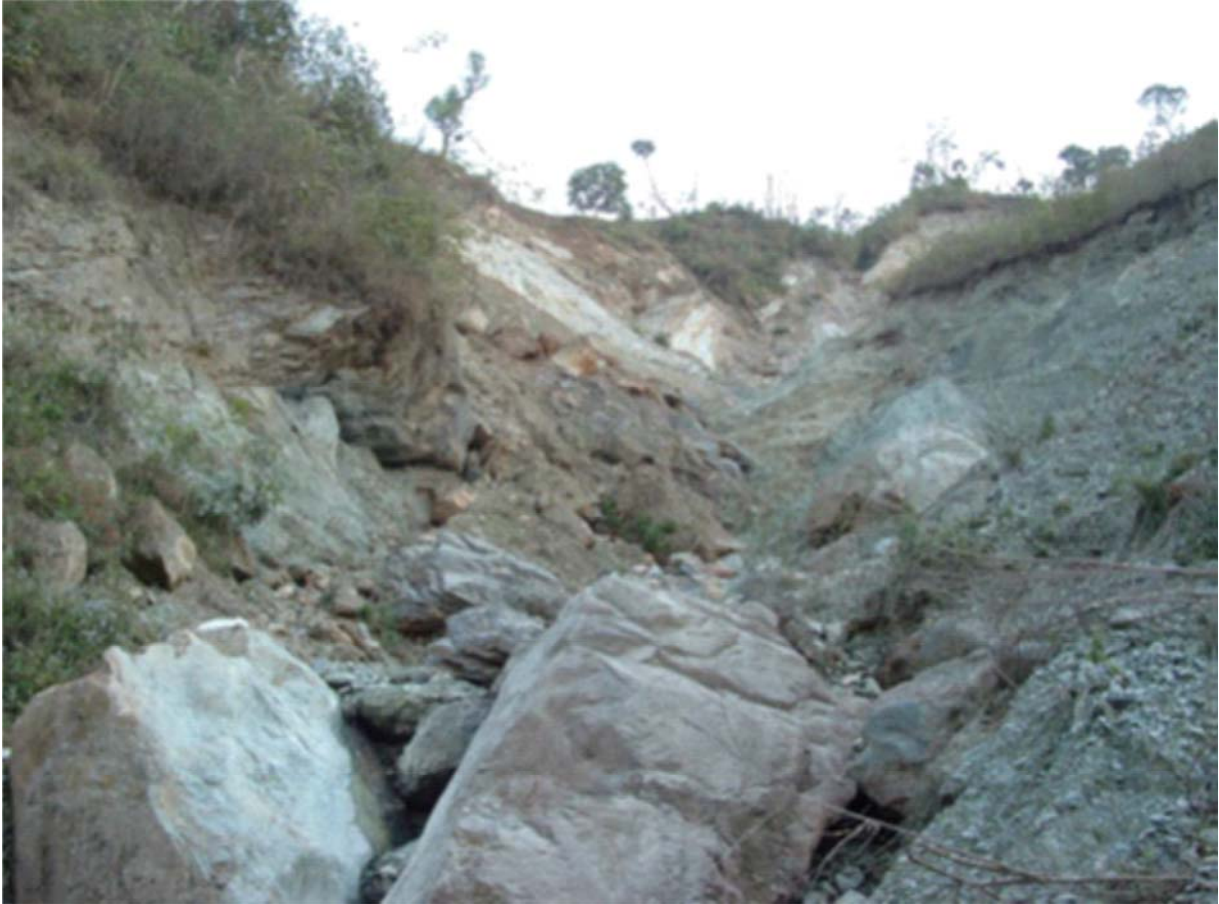
Fig. 7 Debris along the channel draining the landslide consists of boulders up to 7 m in diameter. View towards south (Location 1 in Fig. 4)

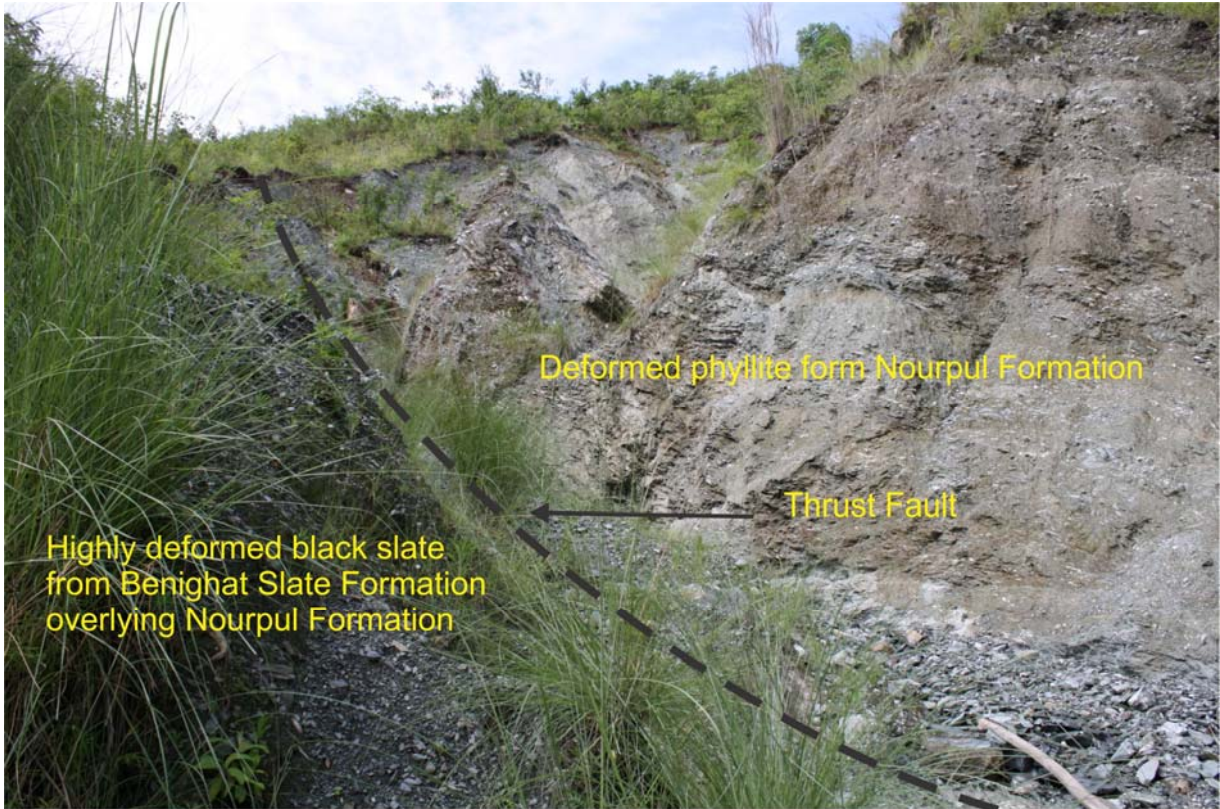
Fig. 8 Thick crushed zone developed along the thrust, view towards south (Location 2 in Fig. 4)

The thrust fault that passes through the central part of the landslide has created a thick crushed and sheared zone more than 15 m thick (Fig. 8). Highly folded and sheared black carbonaceous slate can be seen just near the thrust (Fig. 8), and rocks are highly deformed along the side of the thrust. This is the major source of debris in the stream. The rock around the thrust is mainly white deformed phyllite and black carbonaceous slate. These rocks are almost crushed to powder. The water flowing from this area is turbid with clay.

The heavy monsoon rainfall of 2003 triggered the landslide, and the volume of debris deposited along the road during that period was about 29,000 m³. The thrust has created a very shattered zone about 15 m thick (Fig. 8). Runoff easily infiltrates this zone, facilitating the weathering of rocks. This creates much loose material on the slope, which can easily be carried by the flowing water. The upper part of the crown and the sides of the landslide are covered by a thick deposit of residual soil and crumbled rock fragments. During rainy periods, materials from the landslide, as well as from above the crown and sides of the landslide, flow into the stream. The stream transports this debris downhill, depositing it on the road. Figure 9 shows the major sources of

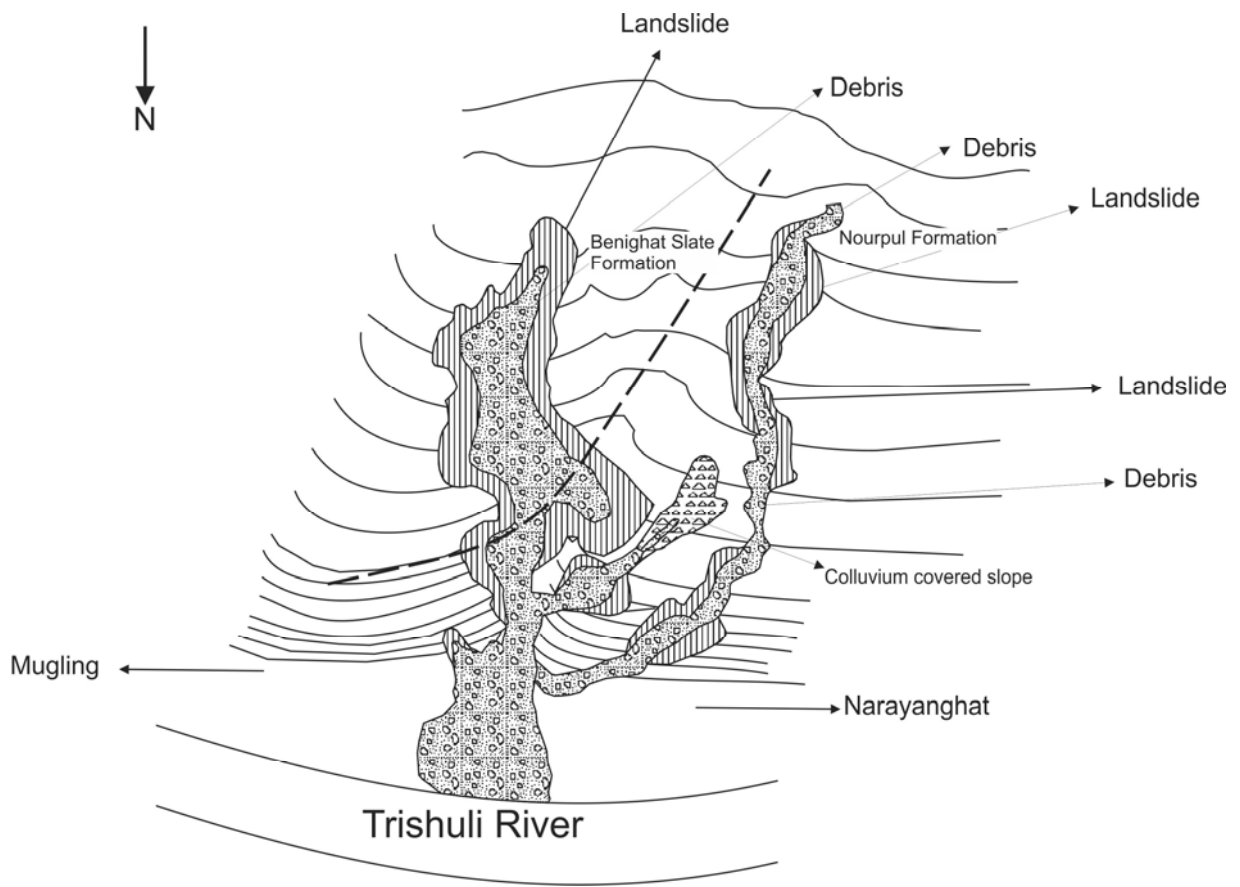
Fig. 9 Map showing the major sources of debris

debris and the mechanism of their flow. The main materials in the debris are rock fragments from weathered phyllite and black slate, and fine-grained muddy materials with greenish fresh phyllite, dolomites, and some argillaceous phyllite. The debris material ranges in size from boulder to clay. However, cobble- to pebble-size material dominates in the debris.

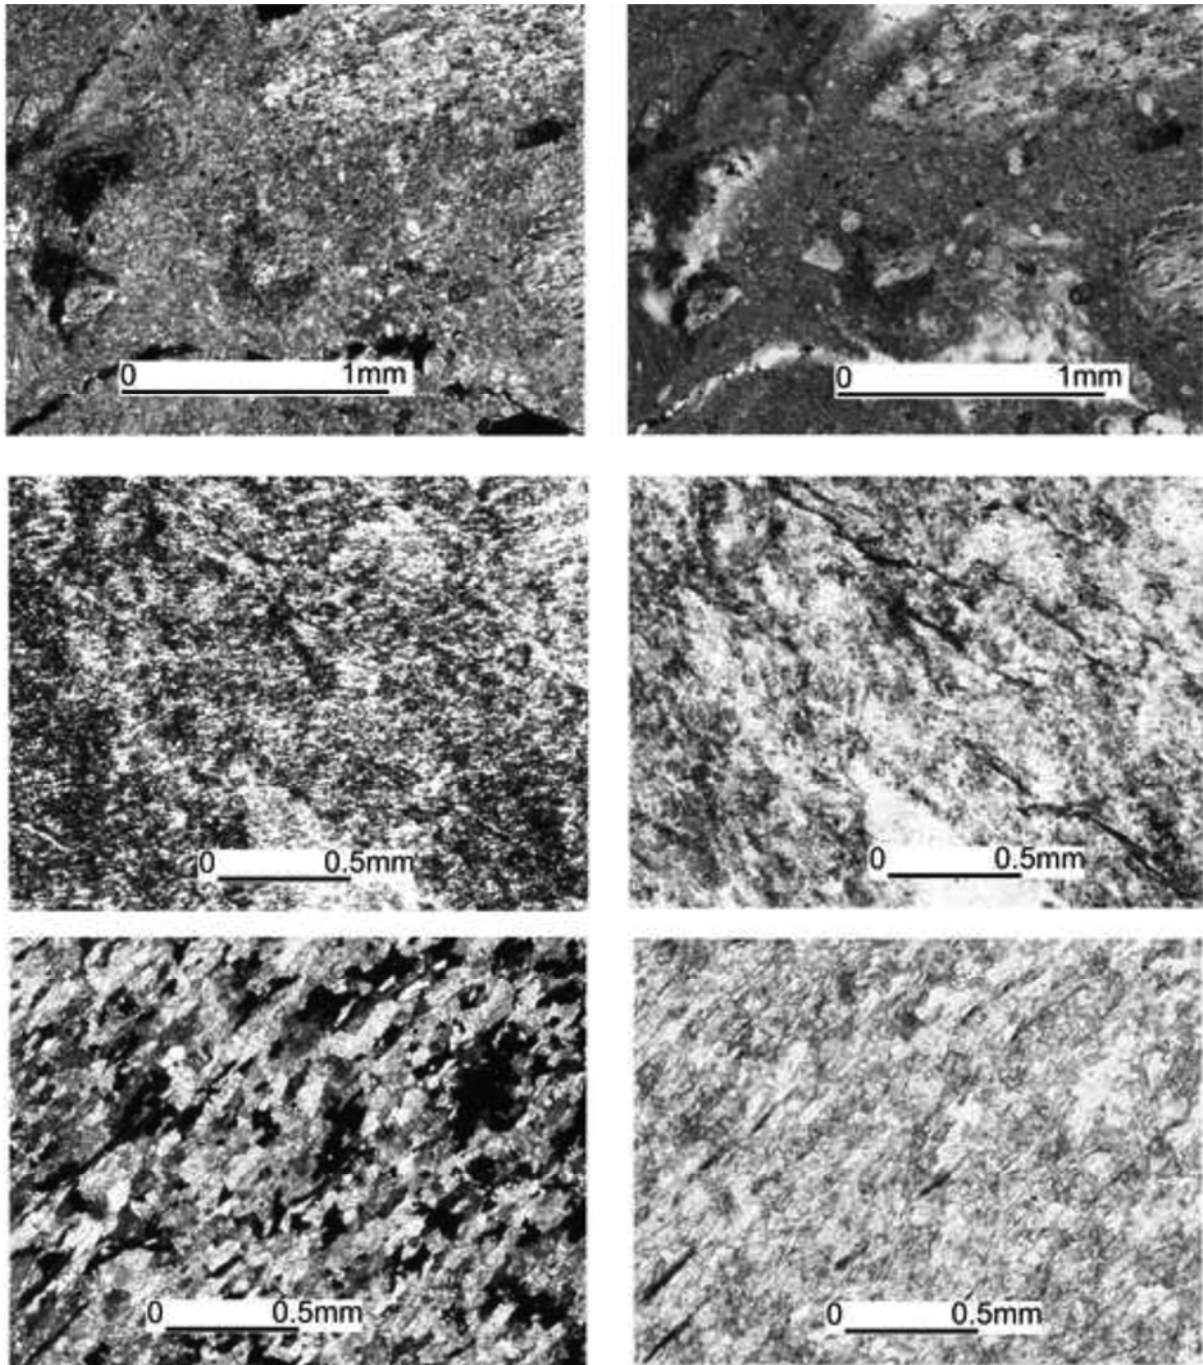
Fig. 10 Photomicrographs of different rock types from the landslide zone; both in cross nichols and plane polarized light. a Sp9: Severely weathered light grey phyllite from the thrust zone, many large and small crystals are found together; some crystals are angular. Many clay minerals are found here. b Sp12: Weathered black slate showing many cross-cutting quartz veins. These veins are discolored, indicating chemical weathering. The veins show at least two deformational phase. c Sp13: Well-developed cleavage plane in weathered dolomitic slate; many calcite and quartz crystals show preferred orientation

The main mineralogical constituents of the rocks along the landslide zone were determined from thin sections made from fresh and weathered rock samples (Fig. 10) and confirmed using XRD. XRD studies were made of randomly oriented specimens to examine mineral species in bulk samples, and on oriented specimens to facilitate clay-mineral identification. For the oriented specimens, the bulk samples were powdered and then centrifuged after suspension in water to obtain clay fractions <2 μm in size. The bulk and oriented specimens were analysed with graphite-monochromatized $\text{CuK}\alpha$ 40 kV and 40 mA. The diffractometer was calibrated using silicon as an external standard.

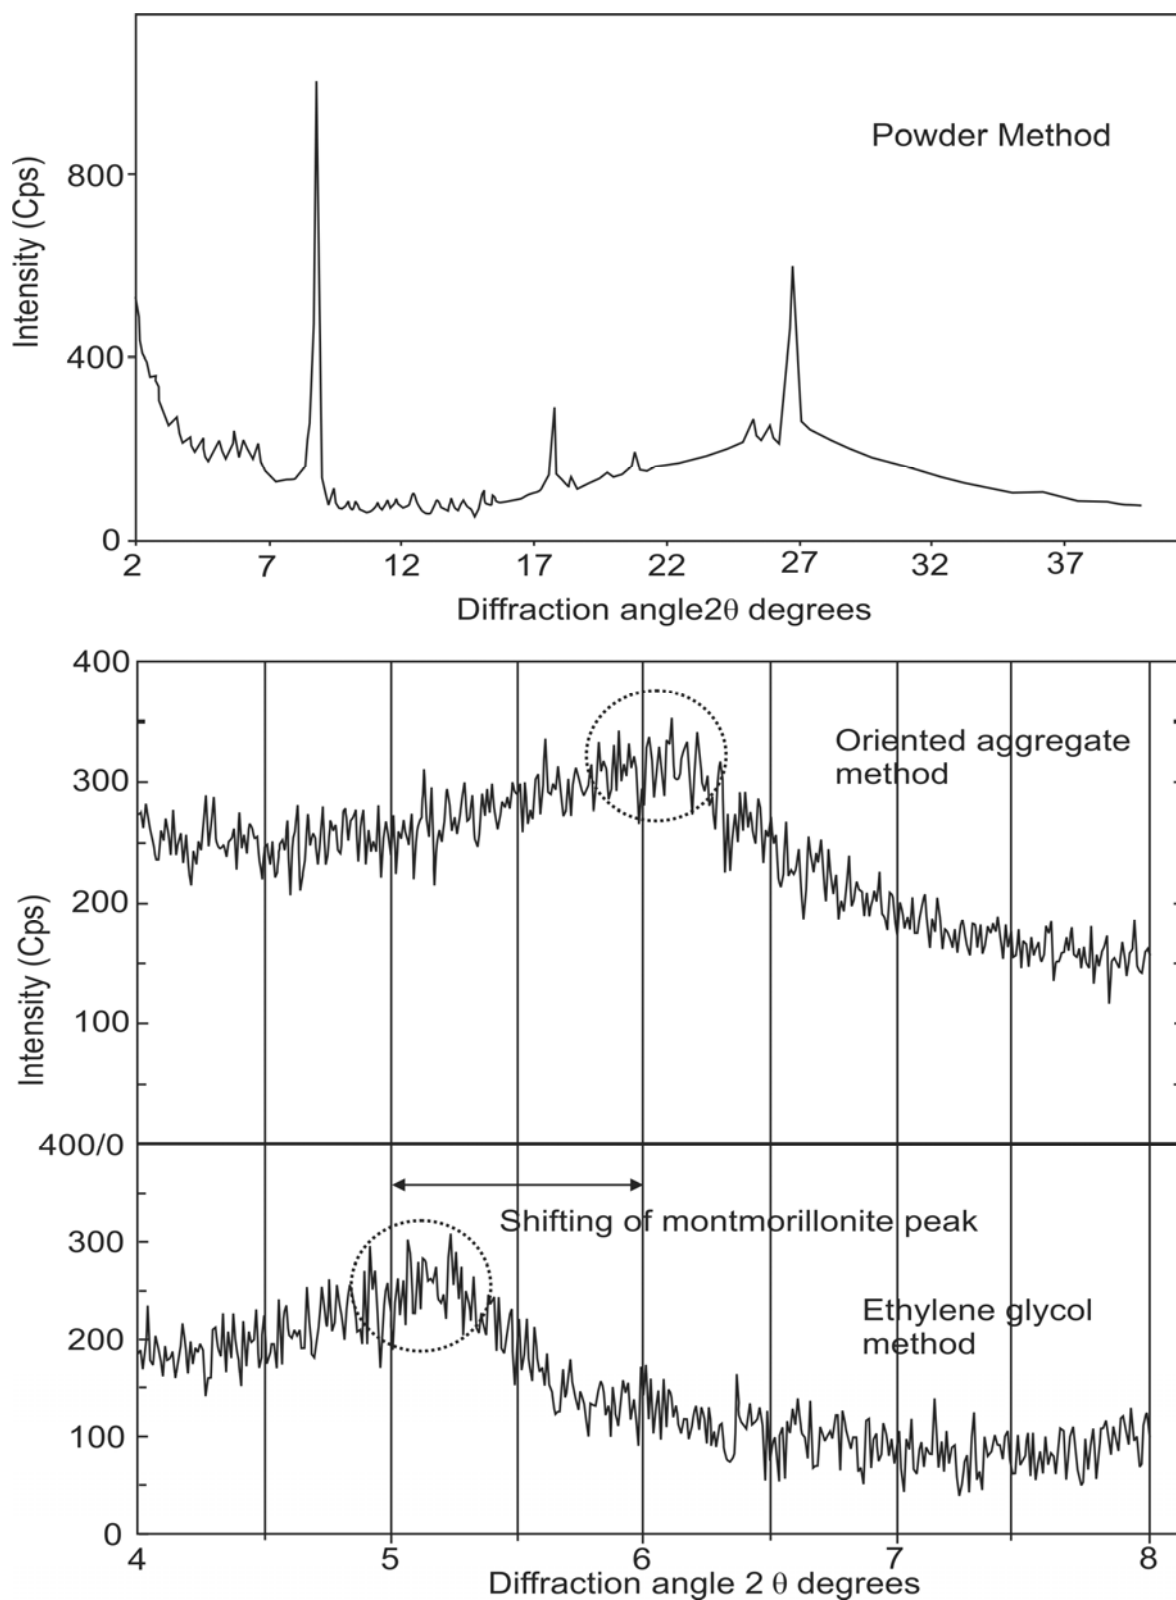
Fig. 11 XRD pattern of Sp8 (a) bulk sample, (b) oriented aggregate sample, and (c) ethylene glycol treated sample

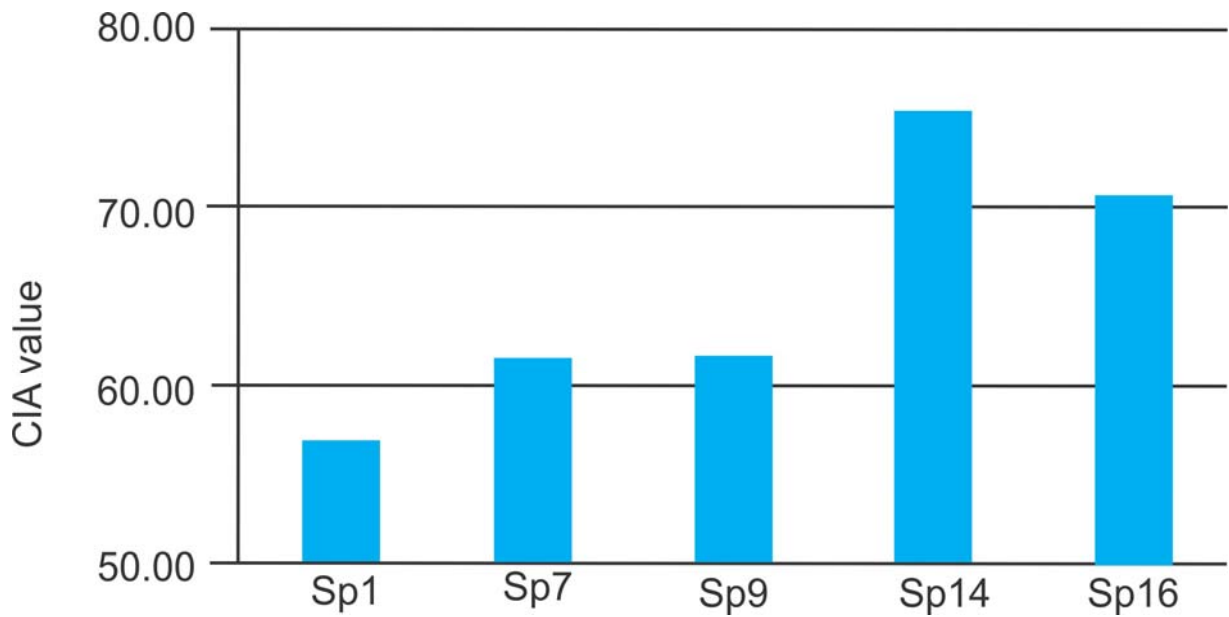
Fig. 13 Figure showing the Chemical Index of Alteration (CIA) plots of fresh and weathered rocks

The CIAs of both fresh and weathered rocks are shown in Fig.13. The CIA value of fresh phyllite is 57.08 while that of highly weathered phyllite is 61.73. In the case of slate, it is 70.81 for slightly weathered and 75.31 for weathered slate. This shows that the CIA value increases as the rock becomes more weathered, which is in accordance with the available literature (Price and Velbel 2003). From the geochemical analysis, it is seen that the elemental concentration of trace elements such as Ni, Zn, Ga, and Nb are below background levels, while the others are in the normal range. This suggests that these rocks are not significantly affected by hydrothermal alteration.
