Field study on the severity of photovoltaic potential induced degradation

Ghadeer Badran & Mahmoud Dhimish

Photovoltaic (PV) systems can be affected by different types of defects, faults, and mismatching conditions. A severe problem in PV systems has arisen in the last couple of years, known as potential-induced degradation (PID). During the early installation stage of the PV system, the PID may not be noticed because it appears over time (months or years). As time passes, it becomes more apparent since the output power may drop dramatically. We studied PV modules over the course of three years that were affected by PID. An electroluminescent and thermal imaging technique helped discover the PID. PID appeared in PV modules after being in different fields for 4–8 months, resulting in a 27–39% drop in power. An anti-PID box was fitted during the second year of the PV operation to recover the PID. Accordingly, it has stabilized the power degradation, but it could not restore the performance of the affected PID modules as compared with healthy/non-PID modules.

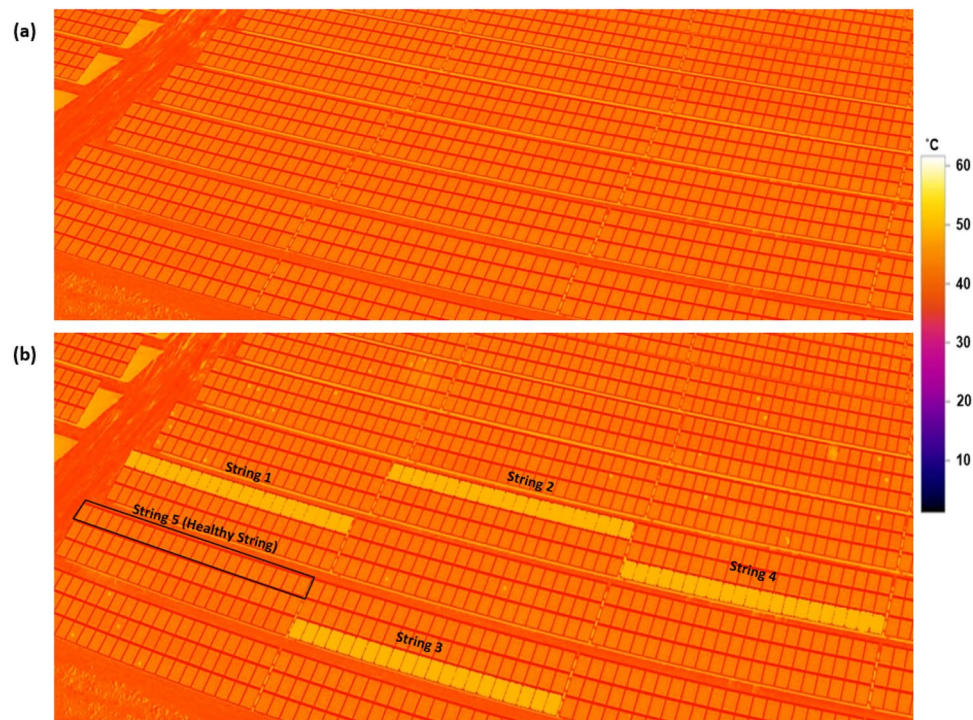
Figure 1. Thermography image of the tested PV strings during nigh-time. (a) Image taken on 01/08/2019, first day of PV operation (ambient temperature 34 °C). (b) Image taken on 03/08/2020, after 1-year of operation (ambient temperature 35 °C). The thermal image is taken using DJI Mavic 2 Enterprise Advanced drone with thermal sensitivity ± 2 °C.

The PV site was under construction in 2019 and was operational on 01/08/2019 when the thermal image was taken (Fig. 1a). We took these thermal images during the day when solar radiation was 712 W/m^2 , and the ambient temperature was 35 °C. No anomalies or faults were found. One year later, however, four PV strings were affected by PID, as shown in Fig. 1b. PID is characterized by an increase in PV module surface temperature to nearly 55–60 °C, compared with healthy PV strings which have a surface temperature of almost 37 °C.

The PID occurs in all PV strings due to a ground fault in the inverter, resulting in a -1000 V biasing, with each PV string containing 21 series-connected modules. In this way, the output power of the PV modules can further degrade and current can leak out. As a result, the PV modules will heat up, as shown in Fig. 1, and their output power performance will decrease over time. Note here that in the affected strings (1–4), they are all subjected

Each PV string's log of measurements was analyzed and compared with a healthy PV string (string 5, Fig. 1b). Unfortunately, the current–voltage and power–voltage curves of the individual PV strings were not measured during the thermal inspection. The healthy PV string, string 5, was carefully selected as other PV strings had already developed hotspots and other mismatching conditions. We calculated the output performance ratio (PR) for each month. The PR ratio would indicate when the PID developed in the PID-affected PV strings and how much deterioration in output power developed compared with the healthy PV strings.

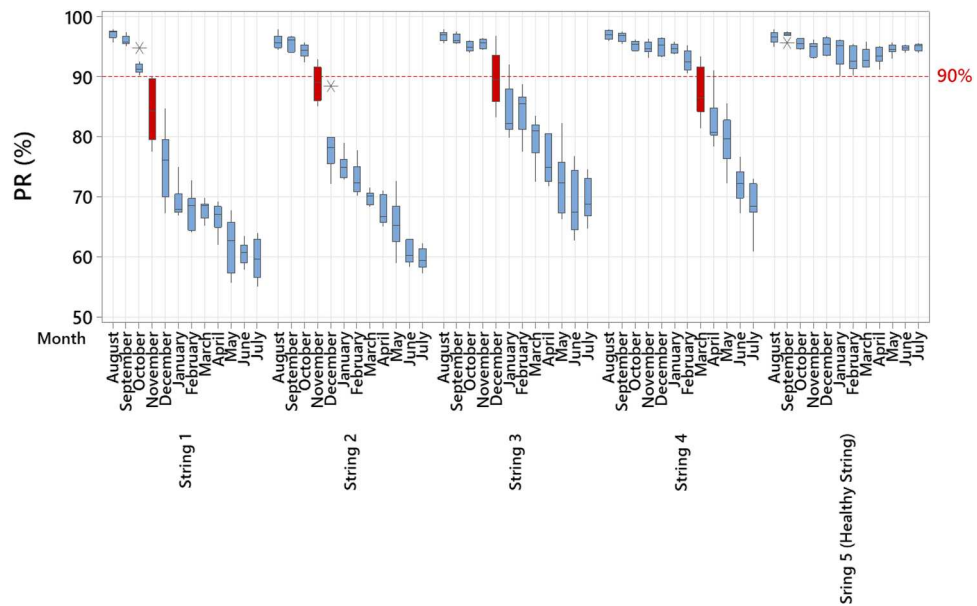
Figure 2. Performance ratio of the tested PV strings. The y-axis presents the PR ratio, and the baseline of 90% was selected to indicate low performance; the x-axis gives the month. This chart shows the PR ratio for the PV strings during their first year of operation and the red labelled boxplots for the individual PV strings believed to be the starting month of the PID.

The results of the monthly calculated PR ratio are presented in Fig. 2. The healthy PV string has no monthly PR ratio below 90% during the entire year of operation. However, the decline of the PR ratio of the other PV strings has been seen at different times. For example, in PV string 1, the monthly PR drop started in November (4-months after field operation); the same observation is valid for PV string 2. The third PV string has a slight decline in the PR starting from December; this suggests that PID has occurred after 5-months of field operation. In contrast, PV string 4 has no significant drop in the PR ratio during the first 7-months of field operation. However, a fast decline in its performance is evident in March, due to PID.

- (1) PID can have an instantaneous reduction in the output power of the PV strings. For example, in PV string 2, after 4-months of field operation, the PR has dropped from nearly 90% in November to 77% in December.
- (2) PID develops in the PV strings at different periods. This implies that the early thermal inspection (day one) is insufficient to detect PID abnormalities.

It is also clear from Fig. 2 that PIDs can accelerate during relatively hot months, May through July. Prior to our examination, there was inadequate information on whether the PID effect could still have an effect on PV modules during these months due to the lower differences between PV surface and ambient temperature. The opposite has been proven by our experiment. In addition, Table 1 shows the PR ratio difference in the first month compared with last month. The PR difference ranges from 27.9 to 39.9% for the PID-affected PV strings, while the PR difference for the healthy PV strings is only 0.3%. These results are consistent with those obtained by laboratory testing^{9,12}.

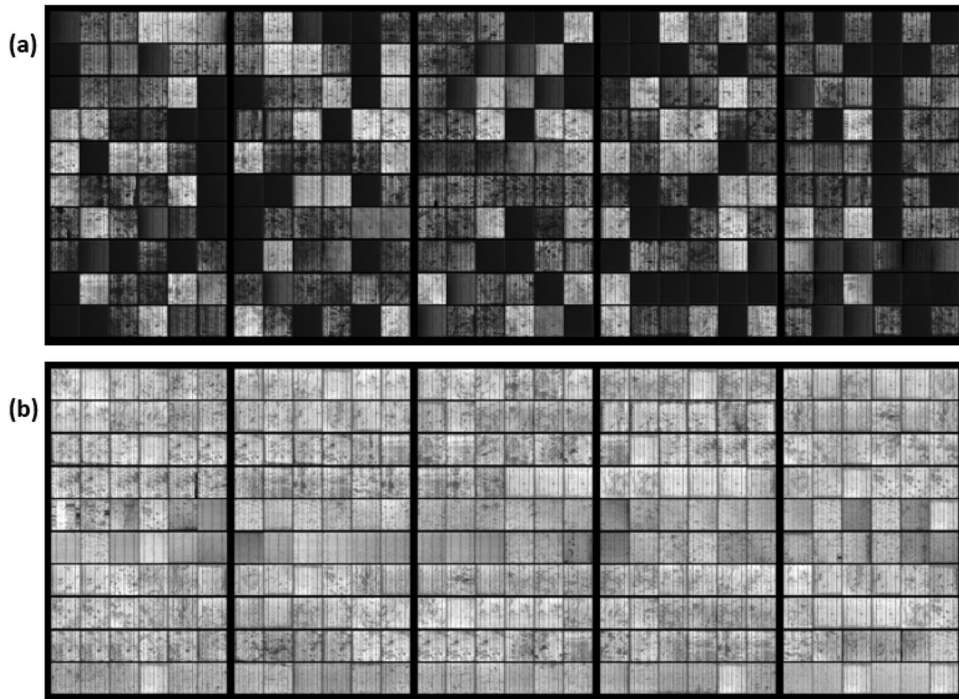
PID examination using electroluminescent imaging. The confirmed PID case in the PV strings was also supported by examining several PV modules under EL testing. For example, the output image of five PV modules from PV string 1 vs in the healthy PV string is shown in Fig. 3. Through EL detection, it is clear that the affected modules by PID, Fig. 3a, has low EL intensity compared with the healthy PV modules, Fig. 3b. In addition, the PID affected modules show shunting (blackout) cells that are likely to degrade the module's performance. However, unlike the healthy PV modules with homogenous EL intensity across the solar cells, these only have some micro cracks. Despite that some solar cells in the healthy PV modules have some cracks or minor

Figure 3. Electroluminescent image of two PV modules. (a) Modules located in a PID affected PV string (string 1). (b) Modules located in the healthy PV string (string 5). The electroluminescent images were taken during night-time, under an ambient temperature of 26 °C, and the modules were running at 90% of their short circuit condition.

shunting, these are typically normal to occur during the first year of operation and they have insignificant impact on the performance of the modules^{22,23}.

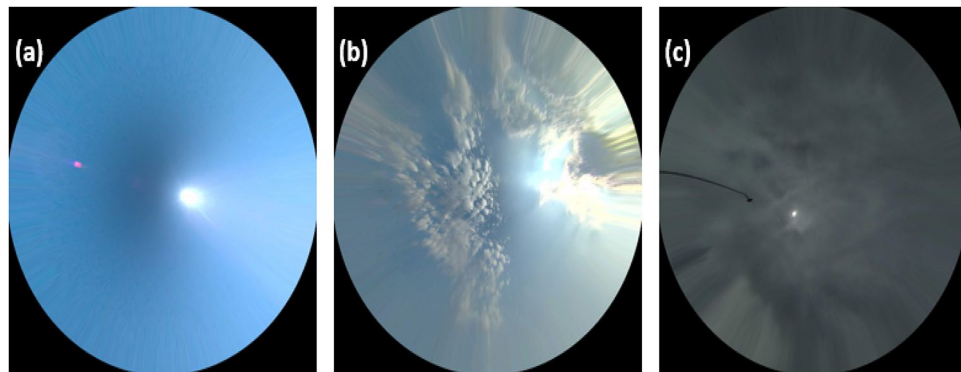
A series connection of PV modules in Fig. 3 was used to test the I-V curve under a variety of field conditions. Figure 4a shows the modules under no shading (cloud-free skies), while Fig. 4b shows them under partial shading (some clouds). Last but not least, the modules are evaluated when operating under overcast conditions (Fig. 4c).

Figure 4. Sky image for the PV operation condition. (a) Clear sky. (b) Partial shading. (c) Overcasting. These images were taken using TSI 440A total sky imager. The temperature of the PV modules at these conditions is 26, 23 and 19 °C, respectively; and the solar radiation is 730, 677, and 408 W/m².

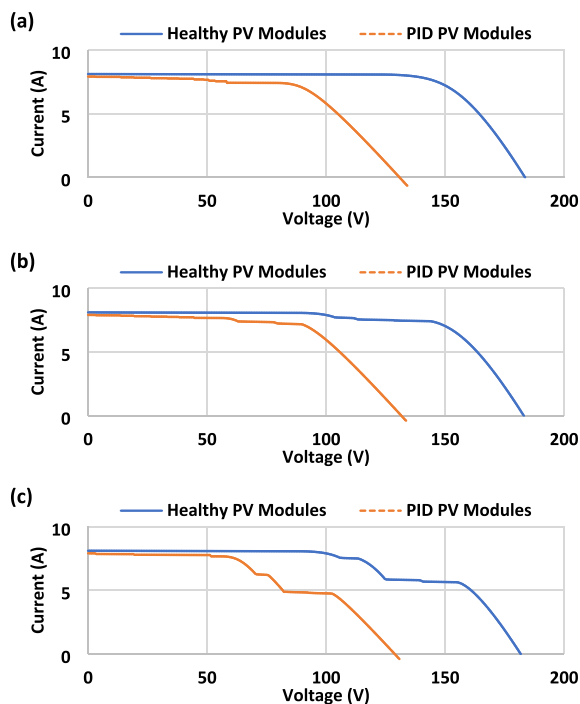
The I-V curves were taken for both the healthy and the PID PV modules during each different sky conditions (Fig. 5). In PID affected modules, I-V curves dropped steeply because PID has a significant impact on output voltage. According to Fig. 5a, the open-circuit voltage dropped from 183.6 V for the healthy modules to 134.1 V for the PID modules. PID-affected PV modules do not show a significant drop in short circuit current. In spite of this, the maximum current that can be extracted from the PID affected modules is less than that from healthy modules. As a result, the PID modules will generate less output power due to the voltage and current drop.

The PID causes leakage of the current in the PV modules, resulting in a decrease in the shunt resistance. The shunt resistance is necessary to keep at a high value because it determines the power output of the PV module, especially at low solar radiation conditions. Therefore, a typical reduction in the shunt resistance would accelerate the power reduction as in the case of PID affected modules.

Table 2 summarizes the electrical output parameters (compiled from Fig. 5) for the tested PV modules. Due to the reduced current and voltage, the PID modules had a significant drop in power at maximum power point (MPP). PID accelerates the power decrease (−39.69%) due to reduced shunting resistance at lower irradiance conditions (overcast, 408 W/m²). During clear sky and partial shading conditions, respectively, the output power of the PID-affected modules decreases by −37.15 and −36.29%. The I-V curve tracer endeavoured to track approximately the same current at I_{MPP} for the PID compared with the healthy modules at the clear sky and partial shading because the modules are relatively affected by high irradiance (> 650 W/m²). However, at low irradiance

Figure 5. Current–Voltage (I–V) curve measurements of the examined PV modules. (a) Clear sky. (b) Partial shading. (c) Overcasting. The I–V curve tracking accuracy is $\pm 0.5\%$. The blue curves show the healthy PV modules (free PID), and the orange curves show the PID PV modules.

conditions (overcasting), there is a -8.54% loss in tracking the I_{MPP} . On the contrary, it is incomprehensible to track the identical V_{MPP} due to the PID and the reduction in the shunt resistance.

These results explain the differences between healthy and PID modules under different environmental conditions. As a result, the power reduction of the PID affected modules is very high ($> 36\%$), even under high irradiance conditions. Furthermore, under low-irradiance conditions, the output power of the PID-affected PV modules may be further reduced due to reduced shunting resistance.

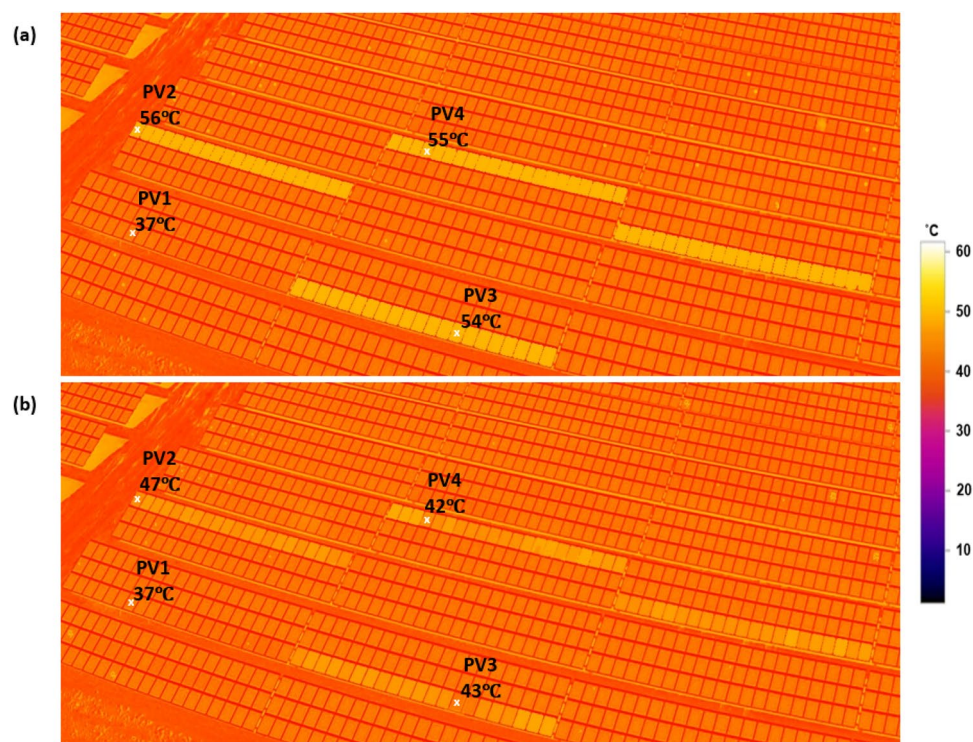
Figure 6 shows thermal images of PV strings after PID was confirmed (Fig. 6a) and after fitting the anti-PID box for a year (Fig. 6b). During the daytime, both images were taken under relatively the same ambient temperature.

Figure 6. Thermography image of the tested PV strings during night-time. (a) Image taken on 03/08/2020, after one year of PV operation (ambient temperature 35 °C). (b) Image taken on 10/08/2021, after 1-year of fitting the anti-PID box on the PV strings (ambient temperature 35 °C). The thermal image is taken using DJI Mavic 2 Enterprise Advanced drone with thermal sensitivity ± 2 °C, the selected points on the figure are rounded to the nearest integer.

As shown in Fig. 6b, the anti-PID box has partly improved the thermal performance of the PV modules. Three different instances were emphasised, where the PV surface temperature has dropped by nearly 9–13 °C; a summary of the results is presented in Table 3.

In spite of the fact that the surface temperature of the modules decreased, the performance ratio of the PV strings did not change significantly because PID reduces the shunt resistance of PV modules permanently. In

PID recovery. PV strings affected by PID were equipped with anti-PID boxes between the strings and the inverter. This anti-PID box reverses the voltage of the PV modules, and in effect, polarises all of the PV modules in order to recover the PID of -1000 V of the PV modules^{24–26}. It was decided to fit the anti-PID box only on the affected PV strings on 06/08/2020 after three days of confirming the PID through the use of thermal images of the PV strings.

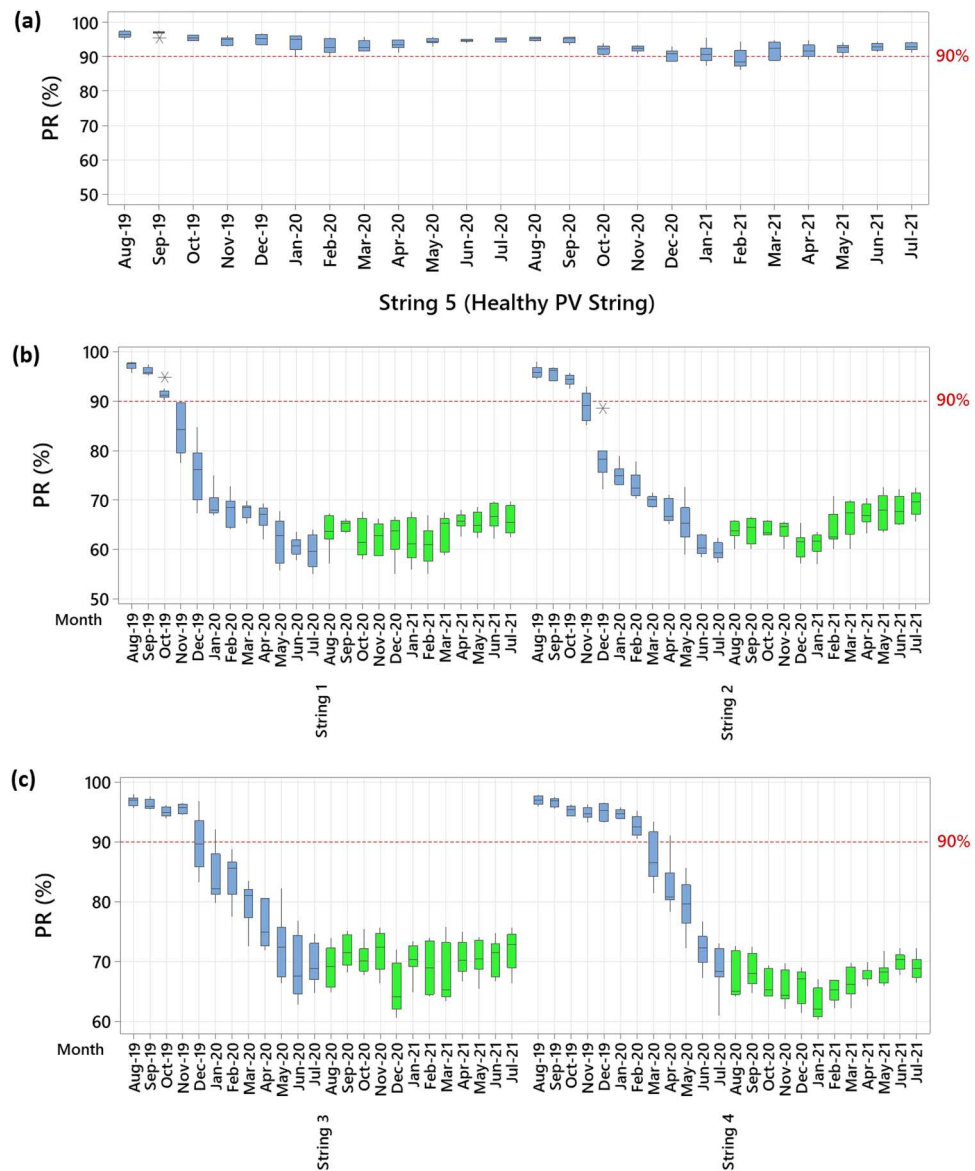
Figure 7. Performance ratio of the tested PV strings. (a) Healthy PV string (PV string 5). (b) PV strings 1 and 2. (c) PV string 3 and 4. The y-axis presents the PR ratio, and the baseline of 90% was selected to indicate low performance; the x-axis gives the month and the PV string number. This chart shows the PR ratio for the PV strings during their two years in the field, as well as the PR ratio after the anti-PID box is fitted.

Fig. 7, you can see the monthly PR ratio of the PV strings for each month. As shown in Fig. 7a, the healthy PV module maintains a superior performance over a period of two years, with a PR ranging from 88 to 96%. PV strings (1, 2, 3 and 4) that were confirmed to have PID had exactly the same PR ratio, even when the anti-PID box was installed, their PR remained consistently below 75% even after the anti-PID box was installed, as shown in Fig. 7b,c.

The anti-PID recovery, however, stops the acceleration of power losses for the affected PID modules. Figure 7b,c demonstrate a virtually constant PR ratio after fitting the anti-PID box (see green highlighted boxplots), and no further reductions (i.e., below 50% PR ratio) have been observed. The results suggest that the anti-PID box has a positive impact on already PID-affected modules, which delays the recycling of the modules when a suitable detection mechanism is in place.

Figure 7 illustrates another conclusion about the long-term impact of PID on PV modules. The study shows that PID can severely affect modules, resulting in a 25% to 40% reduction in output power. Sadly, unidentified PIDs can cause rapid power losses, and we see this frequently in large industrial PV assets. Thus, our results highlight the importance of regularly inspecting PV systems to avoid system complications, particularly those related to PID.

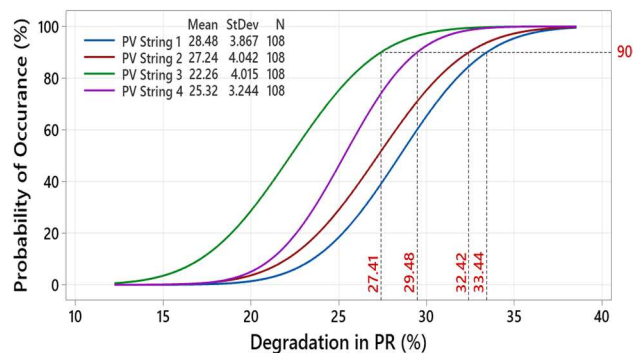
Figure 8. Plot of probability distribution functions for PV strings affected by PID. Probability of occurrence (in percentage) is represented by the y-axis, and degradation (in percentage) is represented by the x-axis. Plotting this figure requires data from Figs. 7b,c. N stands for the number of samples, and StDev for the standard deviation.

CDF is a widely used statistical analysis function that describes the probability of discovery of an investigated variable^{27,28}. To explore the degradation in PR, we plotted the CDF for the affected PID PV strings as shown in Fig. 8. There is a 90% probability that a PV string affected by PID will have a PR degradation between 27.41 and 33.44%. Nevertheless, this assumption is only valid if the PID affected the modules for at least six months, as our previous data shows.

Also shown in Fig. 8 is the standard deviation (StDev) and the mean of the samples. According to the PR, the mean degradation ranges from 22.26 to 28.48%. A low StDev (3 to 4) indicates that the data are clustered around the mean. In summary, the CDF plot shows a degradation in PR for PV strings with affected PIDs. The probability of accelerated power losses in a PV string affected by at least 6-months of PID is approximately 27% to 33% with 90% confidence. Due to the location of our investigated PV system in Spain, Barcelona, these results may also be more accurate during hot summers and cold winters.
