## New actions and land uses in the historical heritage: the case study of one of the oldest underground water tanks in Madrid (Spain)

Heritage  
Hydraulic industrial architecture  
Historical masonry structures  
Rehabilitation  
Water tank

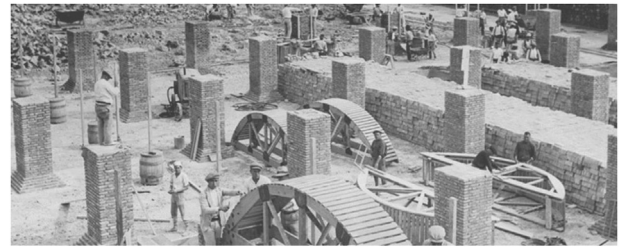
Figure 2. Construction of the Valencia water tank (1849–50) Source: Valencia History Museum, <https://mhv.valencia.es> (MHV, 2022).

Regarding interventions in buried reservoirs in Spain, it is worth highlighting the Rei Martí reservoir in Barcelona designed by Gaudí (Chalamanc et al., 2017) or the first Valencia water reservoir in Spain (Figure 2), one of the best examples of Valencian industrial architecture from the mid-nineteenth century, now converted into the city's History Museum (Aguilar-Civera, 2004).

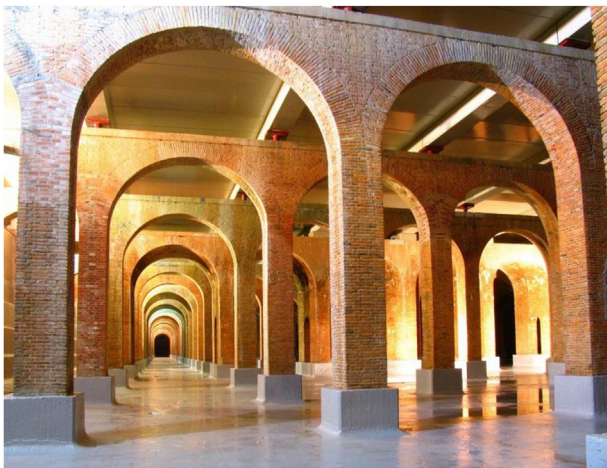
**Figure 4.** View of the new roof over the original brick arcade structure of the third underground tank. Source: [https://www.aguasresiduales.info/\(Aguasresiduales,2022\)](https://www.aguasresiduales.info/(Aguasresiduales,2022)).

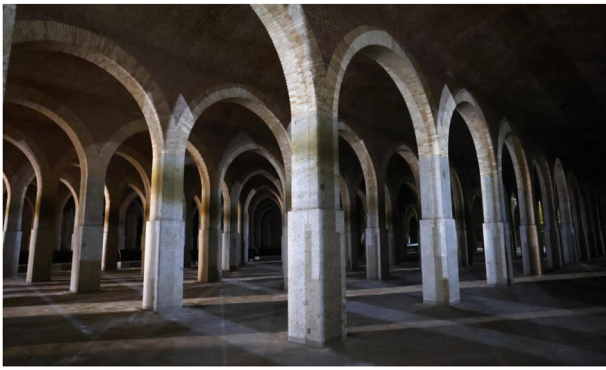
**Figure 6.** Interior view of the empty second (or Mayor) underground tank during the waterproofing works. Source: <https://www.comunidad.madrid/> (Madrid, 2021).

The structure of the second tank has a total size of  $208 \times 138 \text{ m}^2$  in plan view and consists of 1,040 brick pillars with stone bases and round arches covered by barrel vaults (Figure 6). The objective of this research was to assess the stress state of the vaults and masonry arches that allows analysing of the layout of overloads on the fill, because the construction of a new urban park on its surface, with the consequent increase in loads, was planned. The foregoing entails a stress study of the components of the structure, including the foundation, before and after the last performance of waterproofing the roof in March 2012 (CYII, 2012) as well as after the hypothetical application of loads, both distributed and punctual in the worst possible positions per element that allows obtaining admissible load recommendations for the roof in its current state.

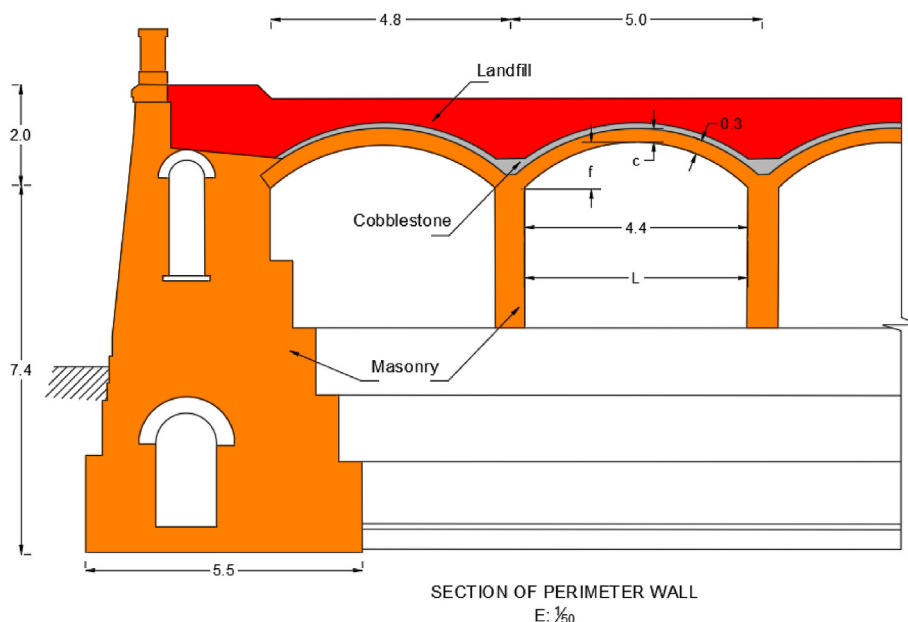
**Figure 7.** Detail on the perimeter wall and type arch-pier (dimensions are given in m).

In the structure under analysis, several elements can be distinguished. As a preliminary step, it is convenient to identify which of all of them develop a given structural mission. The most relevant structural elements are vaults, fills, arches, piers, foundations and the perimeter walls (Figure 7).

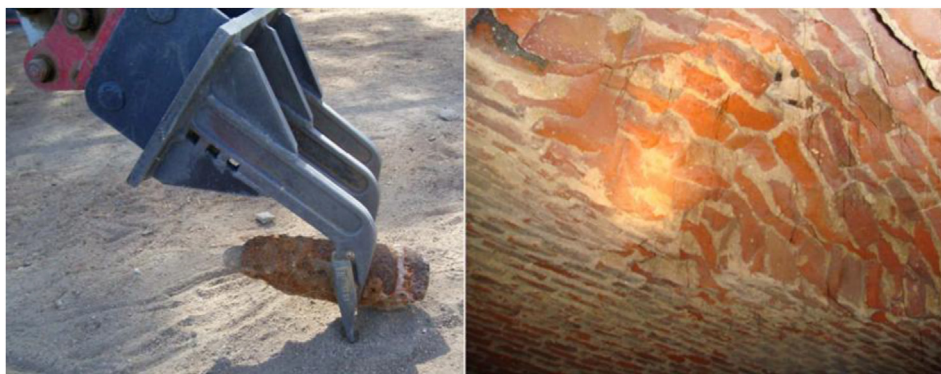
Figure 8. Shell found in the excavation during the operation and the detachment caused in the vault.

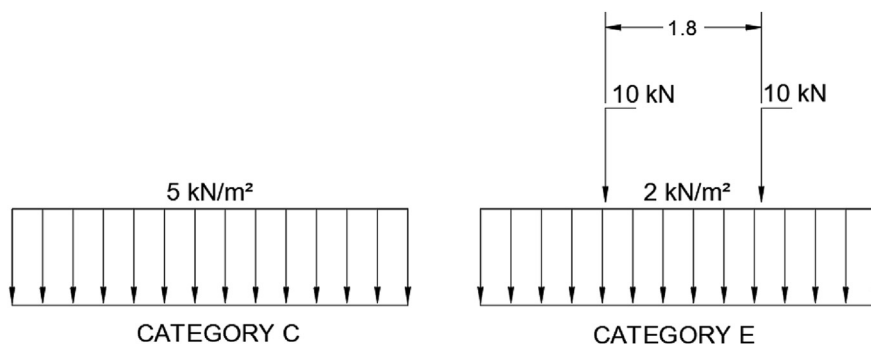
Figure 9. Loadings. Categories of use after (CTE, 2006) (dimensions in m).

According to the regulations about loads in building in Spain (CTE, 2006) for the use required for the roof, which is the opening as a public park, the category of use is C, public access areas, and within all sub-groups, since the structure is subject to the most unfavourable load, which is  $5 \text{ kN/m}^2$  for distributed loads. The category E is also taken into account for light vehicle traffic and parking areas (total weight  $<30 \text{ kN}$ ), consisting of a distributed load of  $2 \text{ kN/m}^2$ , in addition to a one-off load of  $20 \text{ kN}$ , broken down into 2 loads of  $10 \text{ kN}$  separated  $1.80 \text{ m}$  from each other. Therefore, both load cases (Figure 9) are studied non-simultaneously to obtain the response of the structure.

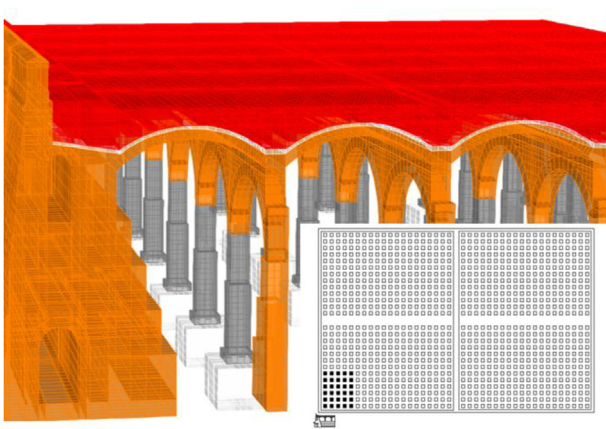
**Figure 10.** 3D view of the model as original before actuation in 2012, including all simulated elements and materials: masonry in orange, cobblestone in white, fill in red and granite in grey. Sketch of the simulated fraction out of the total structure, in plan view.

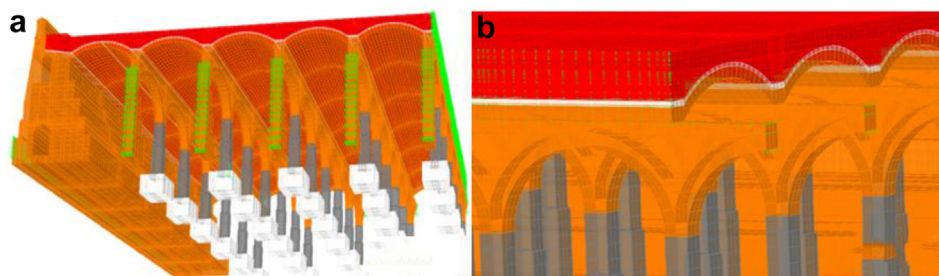
**Figure 11.** Boundary conditions in green. Longitudinal vault (a); Fills and lateral vault (b). Rest of colors meaning in Figure 10.

A linear (elastic) finite element model is proposed and, as long as it is verified that the tractions that appear are not significant, will help us to identify the working mode of the structure, as well as to quantify it so we can assess whether the failure of the materials is expected to happen or not. The modelling technique (Figure 10) consists of the use of solid finite elements, the main advantage of which is the direct determination of the shear stresses. In each node there are six degrees of freedom, corresponding to the three translations and three rotations of a three-dimensional problem that allows for simulating a continuous structure. Due to the excessive computational effort required for the complete study of the whole deposit, a representative part of it was simulated (Figure 10), which entails coercing the model at its ends in the direction of work of the vaults and arch. The fill has restricted displacements since it is confined by the structure (Figure 11(a, b)).

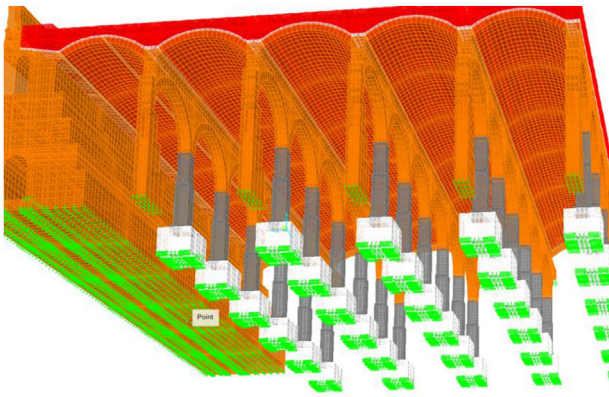
Figure 12. Boundary conditions under the footings in green. Rest of colors meaning in Figure 10.

The geotechnical characterization is deduced from the only geotechnical study available (CYII, 2011) and the vertical ballast module is adapted to the specific geometry of each foundation element (Figure 12).

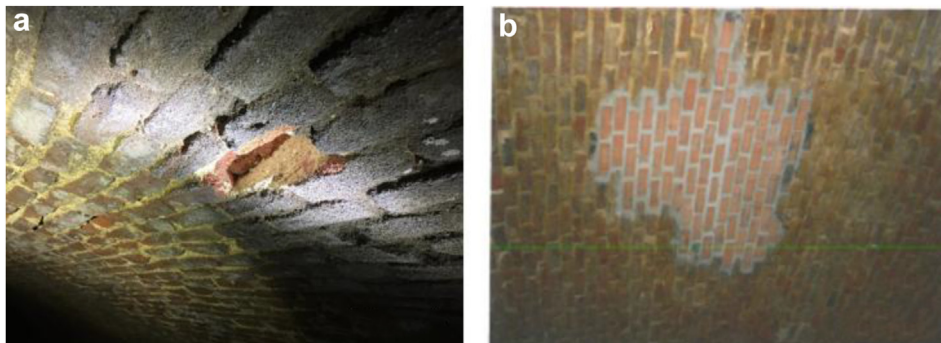
Figure 14. Detachment of materials from the vault (a) and repairs to vaults after the 2012 action (b).

In a previous inspection of the structure, it was concluded that its level of conservation is good (Intemac, 2011), and this is corroborated by the visit made as part of the present research. However, after a visual inspection of the deposit, some deteriorations such as those due to physical processes (humidity, salt attacks, loss of materials...) were identified (Figure 14(a, b)).

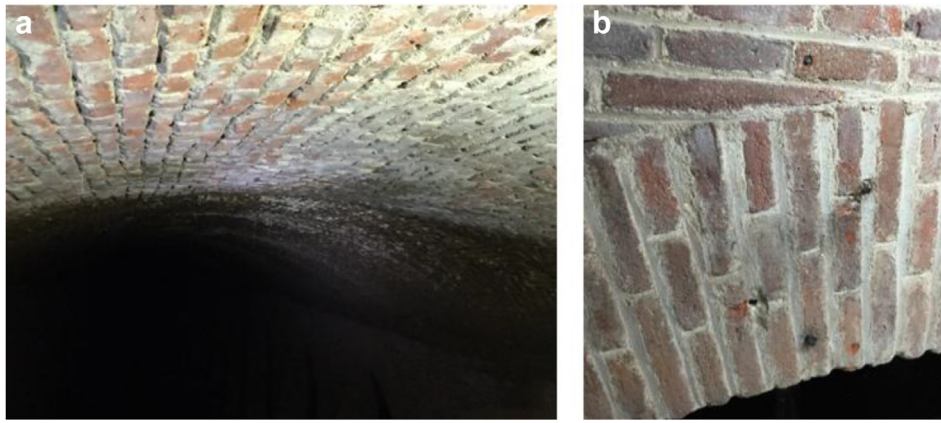
Figure 15. Lack of materials in the vault (a) and insignificant oxidation processes (b).

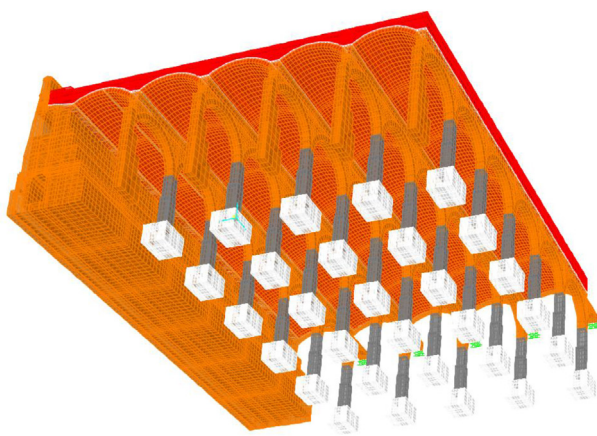
Figure 16. General view of the model developed (size  $30 \times 35 \text{ m}^2$  of total size  $208 \times 138 \text{ m}^2$ ) for the original situation where the red colour represents the landfill, the white the cobblestone used to cover the vault (10 cm) and also the foundation material, the orange colour is the masonry and the grey for the granite of the pillars.

A series of illustrations are attached as an overview of the model of the original structure, prior to the actuation which took place in 2012 (Figure 16) where the connection between elements simulates a continuous structure (Figure 17). Then, the results obtained are attached in a global form, such as the stress map of the whole tank (Figure 18). The

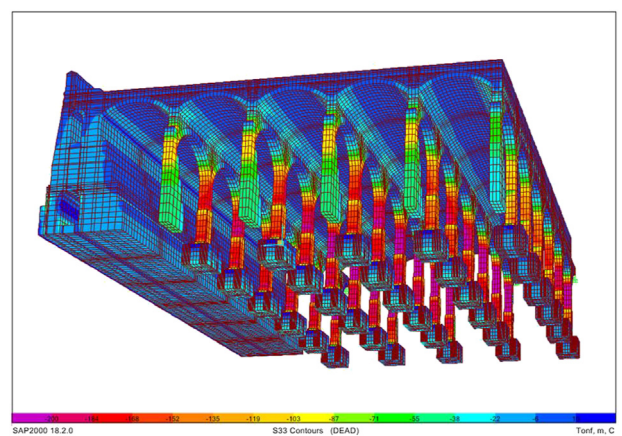
Figure 18. Normal Stresses in the original structure under gravity loads only. Units in Tons and negative values for compression.

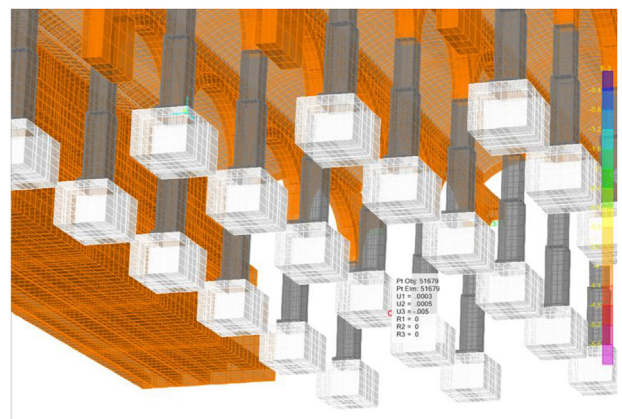
Figure 19. Foundation settlement.

foundation lowering is shown (Figure 19), considered equally in all the piles. The different structural functions of each element, infill, vault, arches, piers, and foundations, deserve a detailed and independent study. It is well known that they all contribute structurally and therefore each must comply with certain limit states. Such illustrations give a clear idea of the unambiguous analysis to be carried out, according to the data described above and bearing in mind that the uncertainty is large.

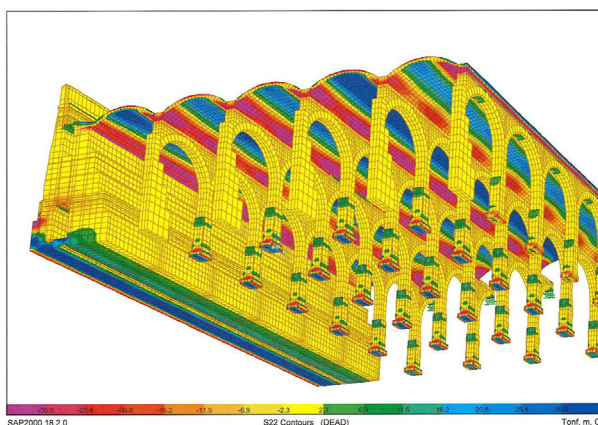
Figure 20. Tension map of the vaults of the deposit (Bottom view, Units in Tons and negative values for compression).

The results of the vault and masonry analysis indicate that the vertical stresses in the top and bottom fibre of the keystone masonry approach zero (Figure 20), reflecting the design optimization of the original

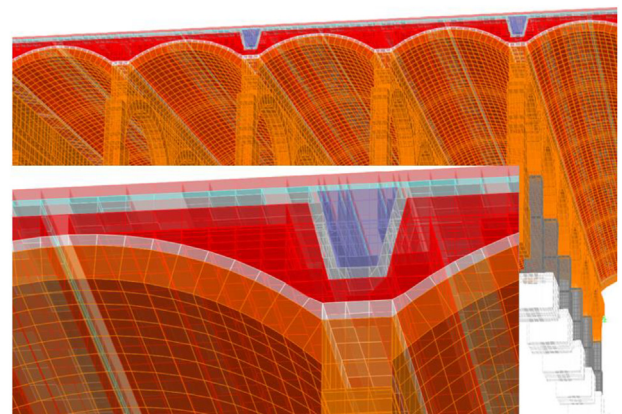
Figure 21. General view of the model and the connection between elements in current situation after 2012. Detail of modelling of masonry in orange, cobblestone in white, concrete in grey, gravel in blue, expanded clay in clear blue and graded in clear red.

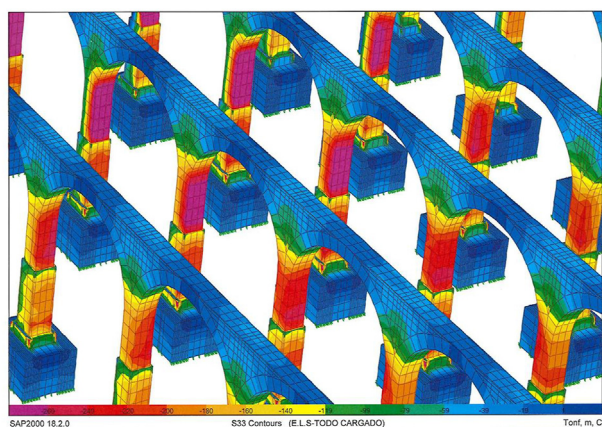
**Figure 22.** Normal Stresses in the arches, their starts, and pillars in the current situation with the new loads that are intended to be placed.

From the study of the loads to be placed over the structure for its new uses, once it is loaded and for the overload hypothesis of 5 kN/m<sup>2</sup> Kg/m<sup>2</sup>, compression values for the same section of 2400 kPa are reached, with which the limit of the recommended capacity is reached, surpassing the normal stress values of the primitive structure and also taking into account that the hypothetical safety coefficients that were established in the past, understood as we understand them nowadays, have been decreasing due to the age of the structure.
