Analytical and experimental procedures for the realigning of the 26th floor of the “Pirelli” tall building after the airplane crash on April 2002

This paper is meant to deliver an overview on the damages and the following repairs of the structures of the 26th and 27th floor due to the plane accident occurred on April, the 18th 2002.

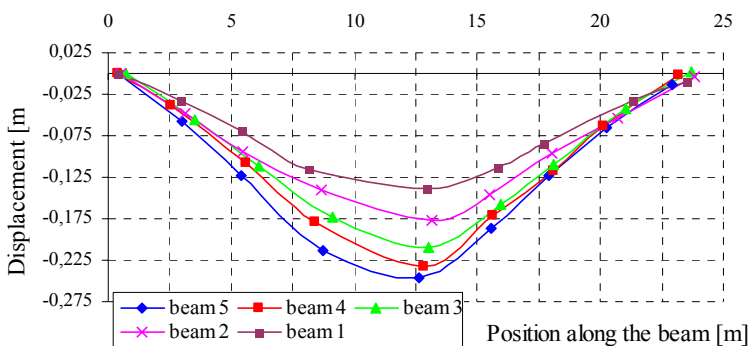
Fig. 3: Residual displacements of the 26th floor beams

The damage caused to the structures ([1], [2] and [3]) on the 26th floor indicated cracks at mid span of the longitudinal beams as well as at the fixed ends and along the perimeter of the thin r.c. slab above the beams (Fig. 4). That damages result in conspicuous displacements at mid span of the beams, ranging from a maximum of 25 cm of beam No. 5 to 14 cm of beam No. 1 (Fig. 3).

As regard to the deck of the 27th floor, the deformation evidenced an upward residual displacement of 5-6 cm at mid span of beam No. 5, the most severely damaged one, confirming the hypothesis that the impulse due to the explosion of the gasoline tanks was the major cause of the permanent displacements.

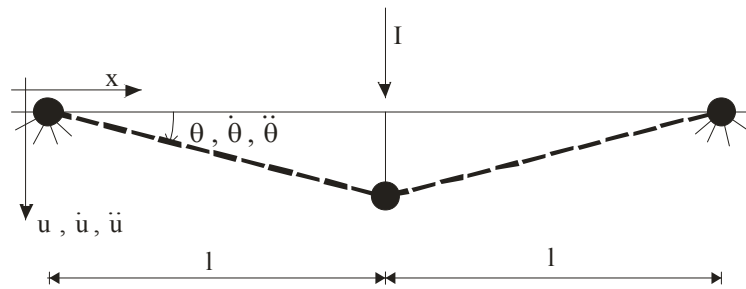
Fig. 5: Plastic hinges model of a generic beam of the deck

The following figure (Fig. 5) shows a simple model of a generic beam made of N. 3 plastic hinges connected by two rigid elements. The description of the kinematics of the system is expressed in terms of rotation, rotation velocity and rotation acceleration of the plastic hinge and displacement, velocity and acceleration of a point on the rigid links between two plastic hinges.

The analytical model predicts a distribution of impulsive loading as follows: on beam N. 5 an downward impulse of 56 kN×s and an upward impulse of 31 kN×s, on beam N. 4 an downward impulse of 41 kN×s and an upward impulse of 28 kN×s; beam N. 1 a downward impulse of 29 kN×s.

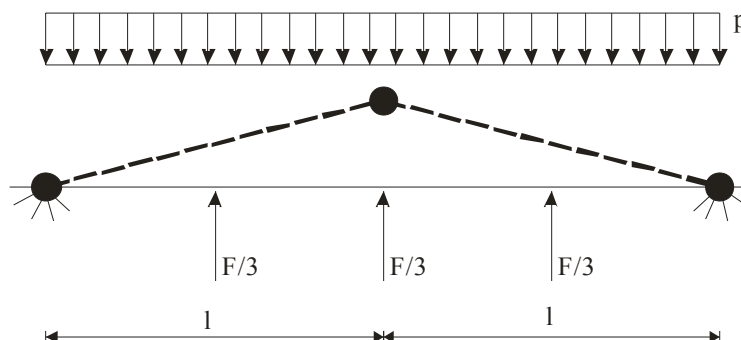
Fig. 7: Model for the realigning process

The following Fig. 7 shows the simple model where the notation is the same adopted in the previous paragraph. The applied forces are: N. 3 point loads equal to $F/3$, representing the action of the hydraulic jacks, and the self weight per unit length denoted with p .

$$F_u = \frac{3(M_L^{F+} + M_L^{S-})}{1} + \frac{3}{2}pl \quad (10)$$

Results: by applying the above formula to beams 1, 2, 3, 4, 5 and summing the obtained forces, a total force of approximate 2600 kN is obtained. The experimental results proved the goodness of the assumptions.

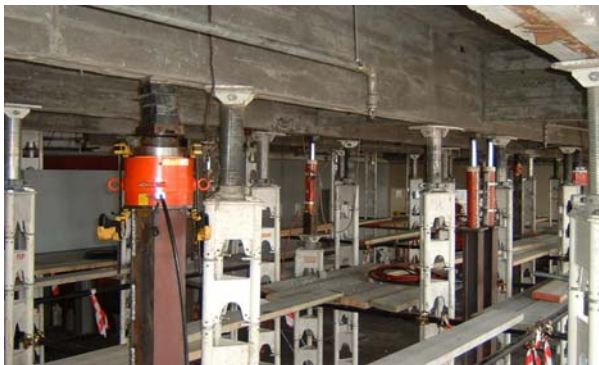
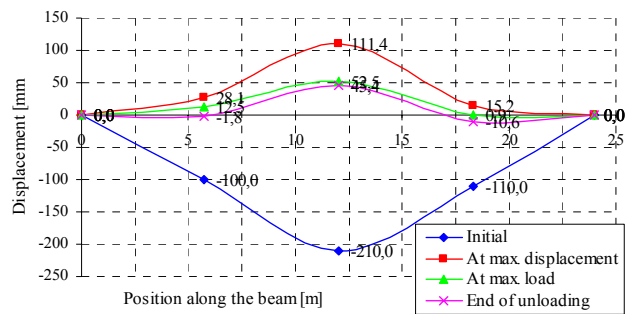
Fig. 9: left, prop and hydraulic jacks at beam No. 3 and, right, displacement monitoring during the forcing process

Total time required for the realigning process was about 30 hours, or 3 working days. The following Figure 9 shows a picture of the hydraulic jacks and props system (left) and the real time displacement diagram (right) during forcing phase.

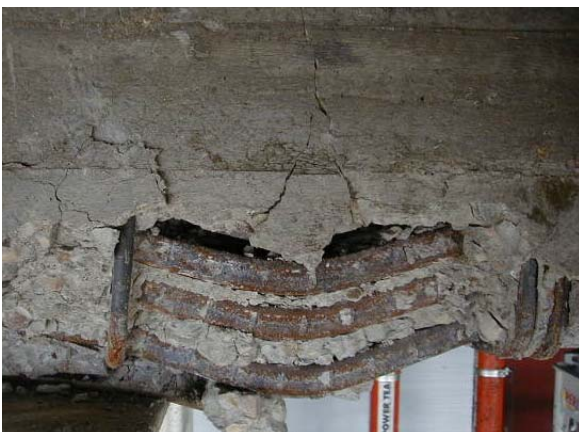
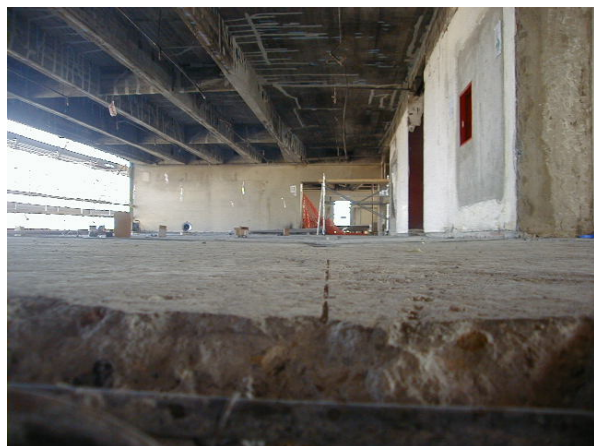
Fig. 10: left, plastic hinge at mid span of beam No. 5 and, right the floor at the end of the realigning process

The following Figure 10 (left) shows a picture of the mid span plastic hinge of beam No. 5 during the final stages of the realigning. It is remarkable the instable configuration of the compressed bars. Finally the same Figure 10 (right) shows a picture of the 26th floor at the end of the realigning process.
