Detection of exposed steel rebars based on deep-learning techniques and unmanned aerial vehicles

R. Santos^a, D. Ribeiro^{a,*}, P. Lopes^b, R. Cabral^c, R. Calçada^c

^a CONSTRUCT - LESE, School of Engineering, Polytechnic of Porto, Porto, Portugal

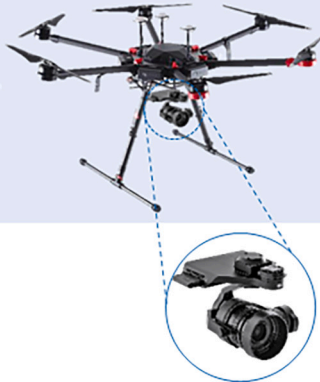
Max Takeoff Weight: 9.5 kg + 6 kg (payload) Max Flight Time: Approx. 32 minutes Hovering Accuracy Range: Vert.: ±0.5 m Horiz.: ±1.5 m Camera: DJI Zenmuse X5 Sensor: 4/3" CMOS Effective Pixels: 16 MP Image Size: 4608x3456p Photo Format: JPG

The DJI Matrice 600 Pro is a hexacopter with a maximum recommended take-off weight of 15.5 kg, a maximum horizontal speed of 65 km/h, a maximum service ceiling of 2500 m above sea level and an estimated flight autonomy of approximately 32 min (per battery set). The camera installed in the drone has a gimbal mounted DJI Zenmuse X5, with a 4/3" CMOS sensor and a resolution of 16 Megapixels. The gimbal ensures image stabilization along the three axes. The visualization of the images and the remote control of the drone were carried out by means of a DJI Matrice 600 Series remote controller and a high-resolution tactile DJI Crystal Sky monitor, with internal image storage capacity.

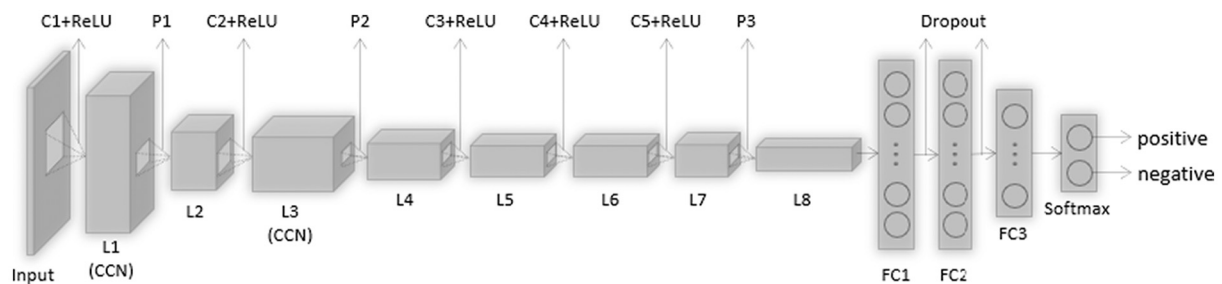
Fig. 4. Network architecture. L#: Operation layers; C#: Convolution operations; P#: Max pooling operations; CCN: Cross-channel normalization; FC#: Fully connected layers.

from the ImageNet database [34]. The network has a depth of eight layers, the first five being convolutional layers, and the last three fully connected layers. AlexNet can classify images into 1000 object categories, including keyboards, mouses, pencils, and many animals. The network has an image input size of 227×227 pixels.

Additionally, CNNs eliminate the need to perform a manual feature extraction, doing it automatically through the provided images. This automatic extraction makes the Deep Learning model highly reliable for object classification and require less pre-processing when compared to other image classification algorithms. The example of a CNN architecture applied to the recognition of characteristics in images can be found on Fig. 4.

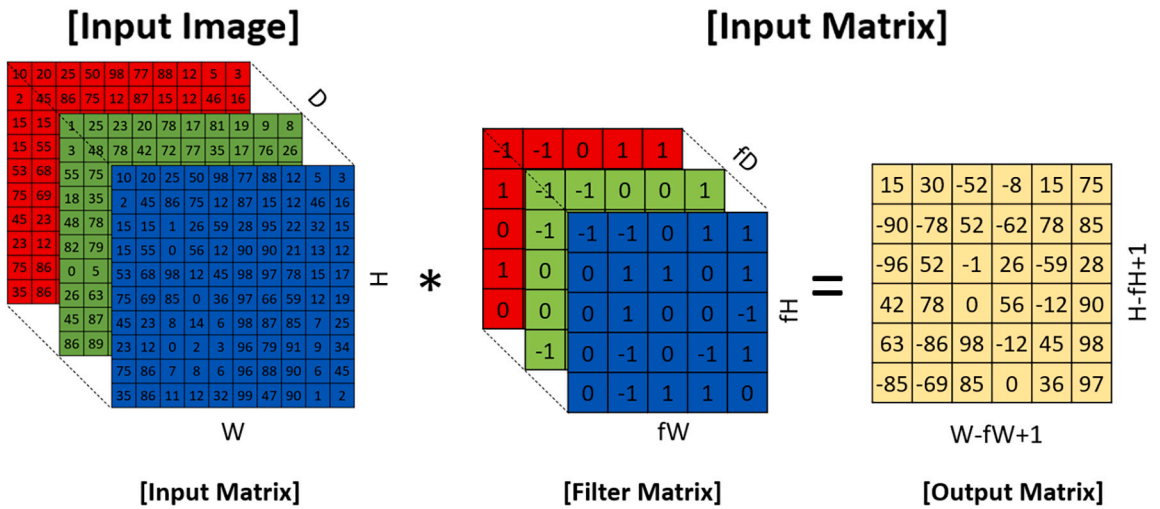
CONVOLUTION: The purpose of convolution is to extract features from the input image. It is a mathematical operation that has as input data, an image matrix and a filter matrix. The filter matrix runs through the entire image matrix, resulting in a smaller dimension matrix that will be easier to process. Convolution of an image with different filters can identify characteristics such as colours, gradient, orientation and borders.

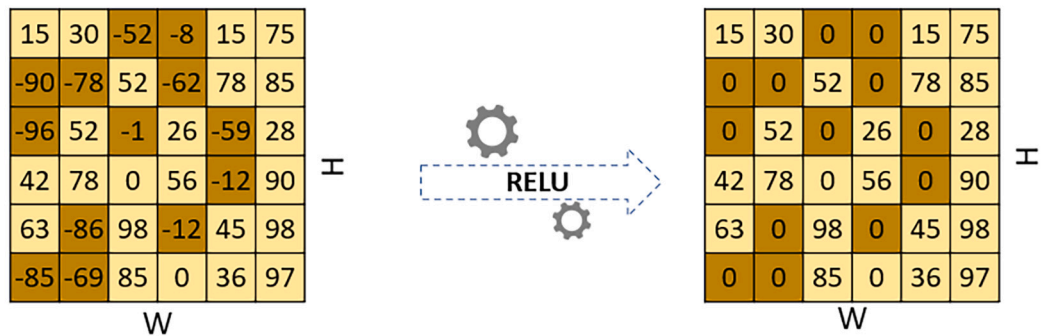
RELU: ReLU stands for "rectified linear units". In this layer the function $f(x) = \max(0, x)$ is applied. The purpose of this layer is to introduce non-linearity to the network. Since most complex problems are nonlinear, it is important to use this activation function.
