Amplification effect of cascading breach discharge of landslide dams

Zheng, H, Shi, Z, Peng, M, Guan, S, Hanley, KJ & Feng, S 2022, 'Amplification effect of cascading breach discharge of landslide dams', *Landslides*, vol. 19, no. 3, pp. 573-587. <https://doi.org/10.1007/s10346-021-01816-0>

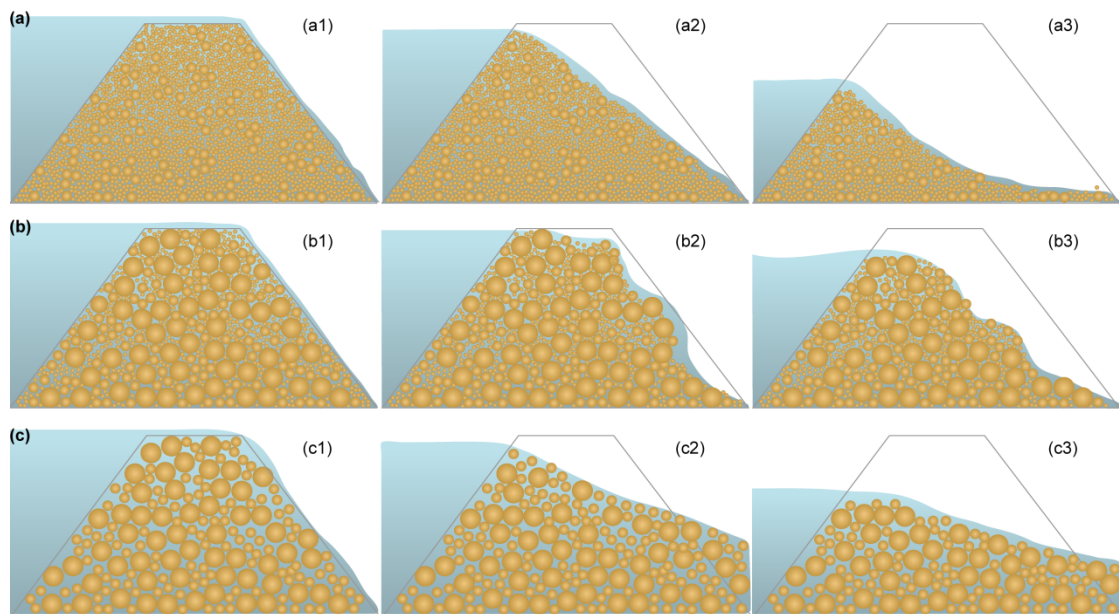
Fig. 7. Breach processes of landslide dams downstream in tests C1–C3. (a), (b) and (c) denote fine-grained, well graded and coarse-grained dams, respectively.

The downstream slope angle quickly decreased by the overflow for a downstream coarse-grained dam and this angle persisted during the breach (Figs. 7c and S5). This was similar to the failure process of the fine-grained dam in the downstream. The downstream slope angle ranged from $7.4\text{--}10.4^\circ$ which was smaller than the value for the fine-grained dam in the downstream. The reason was that some of the coarse debris grains transported by the outburst flood were deposited close to the dam site.

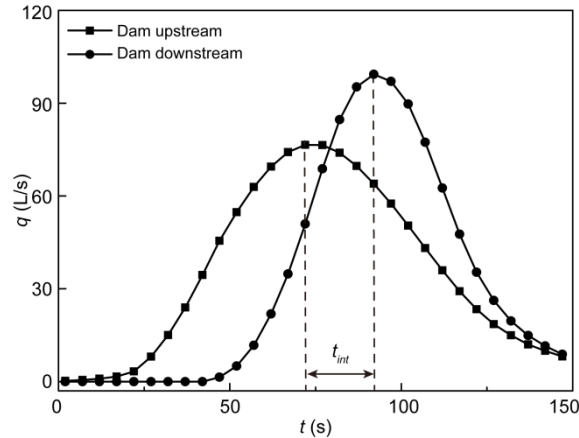
Fig. 10. Discharge hydrographs of the two dams in test C4.

Test C4 was the same as test C1 except the height of the downstream dam in test C4 was 0.3 m while it was 0.4 m in test C1. The peak discharge of the downstream dam in test C4 was amplified to 99 L/s: an increase of 46% on the upstream peak discharge. The peak discharge and amplification effect of the two dams in test C4 were smaller than those of test C1. The reason is that the highest upstream water level of the downstream dam in test C4 was 39.5 cm and the maximum lake volume during the breach process was smaller than that of test C1. The cascading breach discharge produced by the downstream dam was relatively limited. In addition, due to a smaller dam height, the t_{bo} was 24 s and the downstream dam had breached before the peak discharge of the upstream dam occurred. This is similar to the observations of the Tangjiashan and Xinjiecun landslide dams (Peng et al., 2014). The time interval t_{int} between peak discharges of the two dams in test C4 was 22 s: considerably longer than for test C1 (5 s). Therefore, the two dams in test C4 had a smaller amplification effect than for test C1.

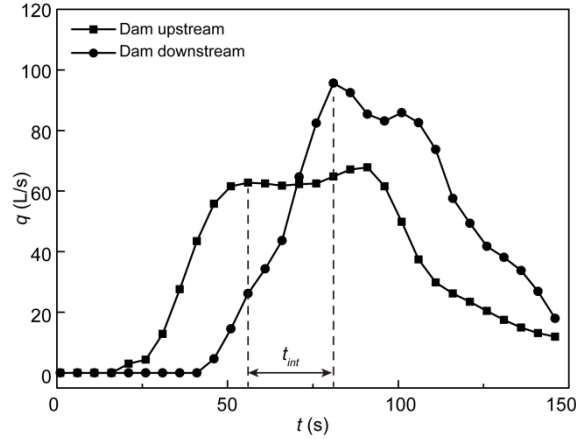
Fig. 11. Discharge hydrographs of the two dams in test C5. Considering that the upstream dam had completely breached before the first peak ($t = 56$ s), the time interval between the peak discharges of the upstream and downstream dams was determined to be 26 s.

Test C5 was the same as test C1 except the crest width of the downstream dam in test C5 was 0.6 m while it was 0.3 m in test C1. The peak breach discharge was amplified to 96 L/s: an increase of more than 41% on the upstream peak breach discharge (Fig. 11). Two peaks successively occurred in the discharge hydrograph of the downstream dam. The first peak (96 L/s) at 82 s was generated because the downstream dam had been breached by the outburst flood. The second peak (86 L/s) at 102 s was preceded by the second peak of the upstream dam (at 92 s). The peak breach discharge and its amplification effect in test C5 were smaller than those of test C1. The reason is that due to a larger dam crest, the time from the beginning of overflow to complete dam breach in test C5 was prolonged and persisted for about 15 s, while it was approximately 5 s for test C1. The t_{int} of the two dams was 26 s: longer than for test C1. The breach processes of the two dams in test C5 were highly separated and the amplification effect of the cascading breach discharge was thus reduced.

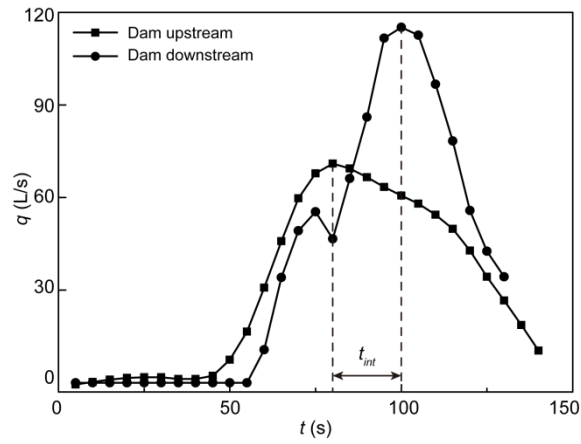
Fig. 12. Discharge hydrographs of the two dams in test C6.

Test C6 was the same as test C1 except the initial level of impounded water between the upstream and downstream dams in test C6 was 0.25 m while it was zero in test C1. The peak breach discharge was amplified to 112 L/s: an increase of approximately 60% on the upstream breach discharge (Fig. 12). The t_{bo} was only 11 s and the breach of downstream dam was advanced, compared with test C1. The combined initial water level and flood wave induced a surge wave (Fig. 13). After the surge wave passed through the dam crest, the downstream dam slope and dam crest were strongly eroded and partially collapsed as a result of the low shear strength of fine-grained material and high hydraulic gradient. The width of the dam crest was reduced by the surge wave and the breach process proceeded before the peak discharge of the upstream dam occurred. The t_{int} of the two dams in test C6 was 21 s which was longer than for test C1. Therefore, the two dams in test C6 had a smaller

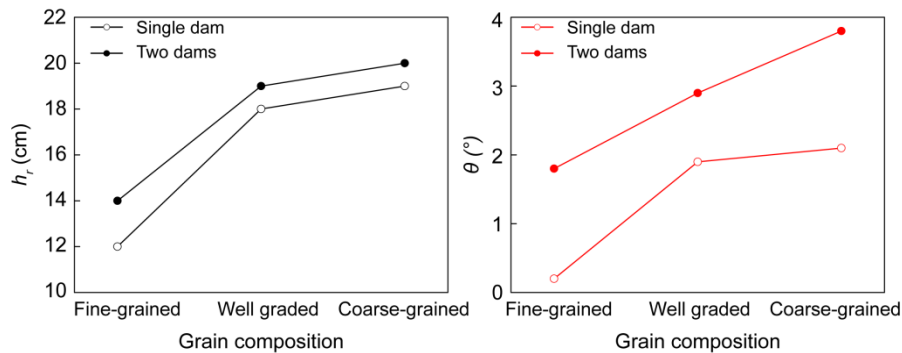
Fig. 15. Residual dam height h_r and slope θ (°) of single and paired dams.

Regardless of single or paired dams, the maximum residual dam height h_r and slope θ along the flume increase with increasing shear strength of the debris materials (Figs. 15 and S6). h_r of a single dam with fine-grained debris is 12 cm and the residual slope is nearly horizontal. These values are lower than the corresponding values for dams composed of well graded or coarse-grained debris. The reason is that as the proportion of fine grains increases, the dam material, especially in the upstream slope

of the dam, becomes more likely to be eroded by a breach flood contributing to a smaller residual slope. h_r and θ of a single dam are smaller than those of a downstream dam in a cascading test for the same grain composition, although a single dam has a smaller peak breach discharge than paired dams. Dam material with different grain sizes is eroded away by the outburst flood because the flow velocity during the breach is higher than the estimated critical velocity for grain initiation (Briaud, 2008). The breach processes last 62–66 s for the downstream dams (Fig. 9) and are shorter than those (~100 s) of the single dams. Due to a longer breaching process, much more material from single dams was transported downstream than from downstream dams in a paired configuration. In addition, part of the lake volume was retained by the upstream residual dam with a height of nearly 0.45 m, thus reducing the volume of the breaching flood from the upstream dam to erode the downstream dam.

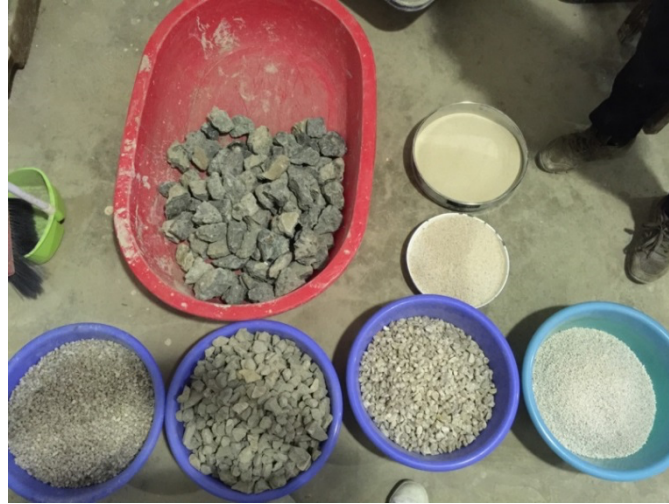
Fig. S1. Experimental dam materials in various components

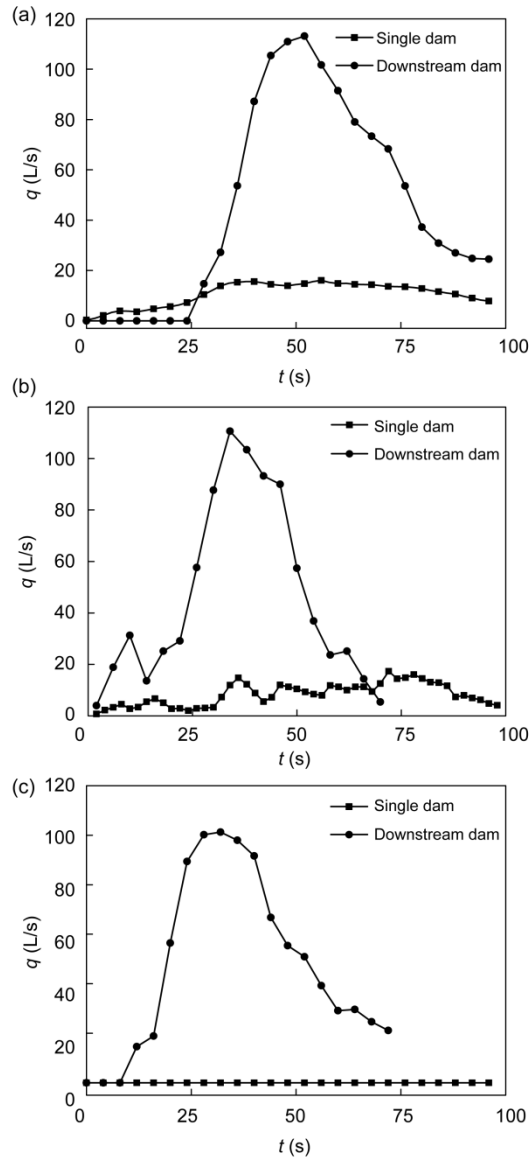
Fig. S7. Comparisons of the breach discharges between the single dams and downstream dams in the cascading tests. (a), (b) and (c), Comparisons of fine-grained, well graded and coarse-grained dams. The single landslide dam with coarse-grained debris did not fail at the inflow rate of 1.13 L/s and the peak breach discharge was equal to the inflow rate.
