Louisiana Transportation Research Center

Technical Assistance Report 19-03TA-P

Structural Assessment of Inundated Roads in Livingston Parish, Louisiana with the Falling Weight Deflectometer

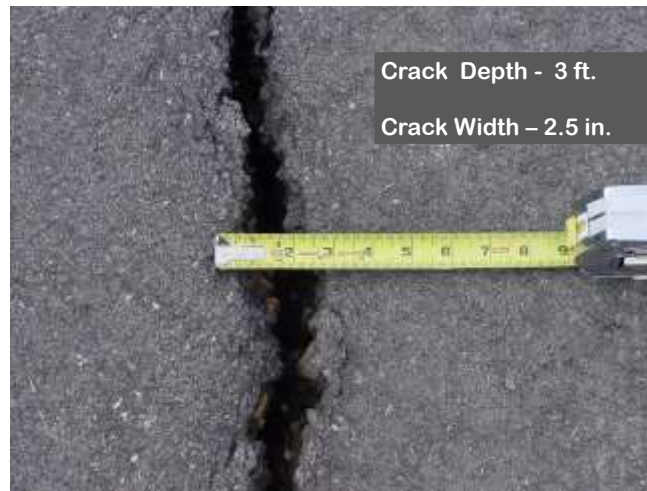
Figure 6
Parish road: St. Martin Parish

Longitudinal cracks in the pavement may also be caused by desiccation in the expansive clay subgrade. When the soil suction stresses induced by desiccation coupled with net normal stress exceed the tensile strength of the soil, a crack will form as shown in Figure 6 [39-41]. When this occurs beneath the pavement, it is possible for the crack to propagate through the pavement structure.

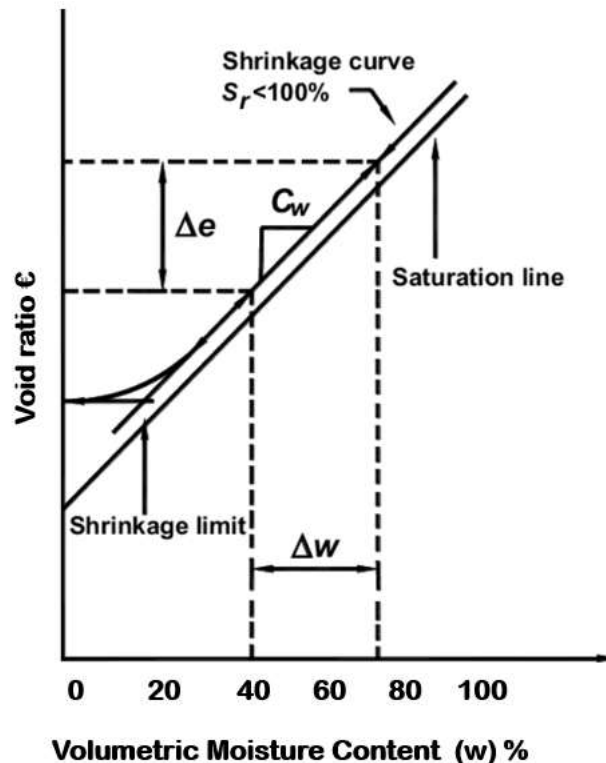
Figure 7
Volumetric moisture content versus void ratio

embankment, and natural ground become exposed to the atmosphere and sunlight, evaporation will occur. If it is in the spring and summer, evaporation will be even greater where trees are present due the transpiration of the trees and other flora. So instead of $\Delta MC1$, $\Delta MC2$, and $\Delta MC3$ ranging from their normal VMC maximums of 85 percent, 65 percent, and 55 percent, they now range respectively from 100 percent to 65 percent, 100 percent to 35 percent, and 100 percent to 15 percent. Such changes in the VMC in an expansive soil will increase the magnitude of its swell, thus, leading to a larger range of ground movement due to swell. Furthermore, as evaporation and transpiration remove water from the ground and beneath the pavement surface, shrinkage will occur leading to subsidence in the ground. However, under this circumstance, the range between swelling and shrinking is greater than the normal range experienced for this area under normal seasonal variation. Such a range in movement can damage the pavement leading to premature failures and cracking with subsequent service life reductions. Figure 7 presents the general relationship of void ratio (e) versus VMC for an expansive soil. Through formulas, the volume change and subsequent change in height or ground movement can be calculated. As the soil varies in its mineralogical composition, so will the relationship between void ratio and VMC [41-43].
