# Evaluation of Pavement Performance Using Remote Sensing Techniques

# EVALUATION OF PAVEMENT PERFORMANCE USING REMOTE SENSING TECHNIQUES

Anand J. Puppala, Ph.D., P.E., D.GE  
The University of Texas at Arlington

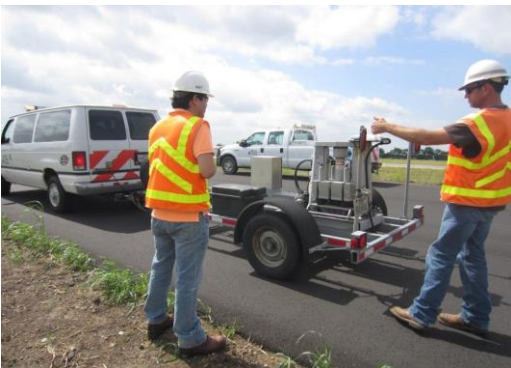
Figure 1. Testing Methods used for Pavement Evaluation (a) Falling Weight Deflectometer (FWD) (b) Light Falling Weight Deflectometer (LFWD) (Alshibli et al., 2005)

Some of the current practices for assessment of pavement performance and pavement condition include Falling Weight Deflectometer (FWD), Light Falling Weight Deflectometer (LFWD), and Plate Load Tests (PLT) and profilometer surveys. Falling weight deflectometers (FWDs) have been used to evaluate the condition of pavements since the 1980s, shown in Figure 1a. The pavement deflections are measured in response to a stationary dynamic load, simulating the passing wheel load. Using this data, structural capacity of pavements is evaluated for pavement maintenance purposes (Alavi et al., 2008). LFWD is a compact equipment that can be used for determining the dynamic modulus of the inspecting layer, shown in Figure 1b. Depending upon the manufacturers and countries of origin, several variants of LFWD with similar working principle are available in the market. LFWD generally comprises of equipment that generates a defined load pulse, a loading plate, and geophone sensors to measure the reaction of the center of the plate. The load pulse and deflection are used to back-calculate the layer properties (Alshibli et al., 2005).

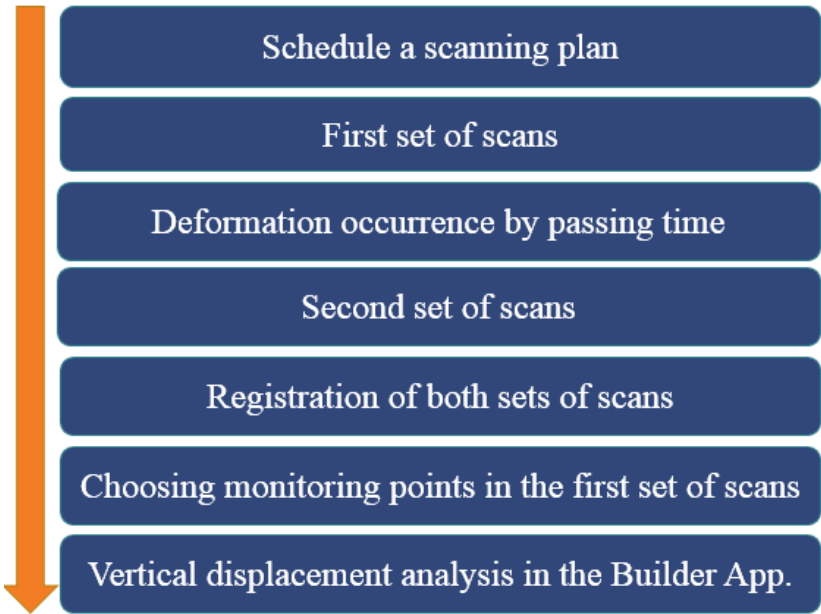
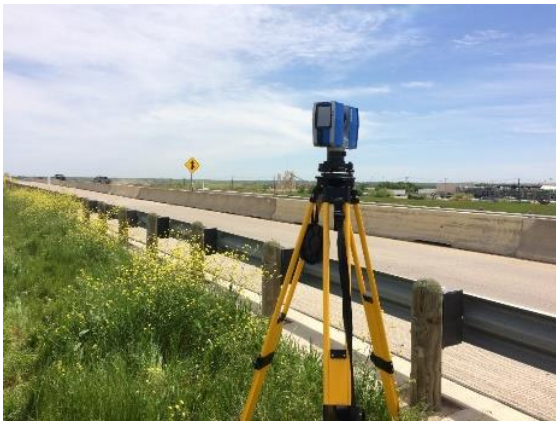
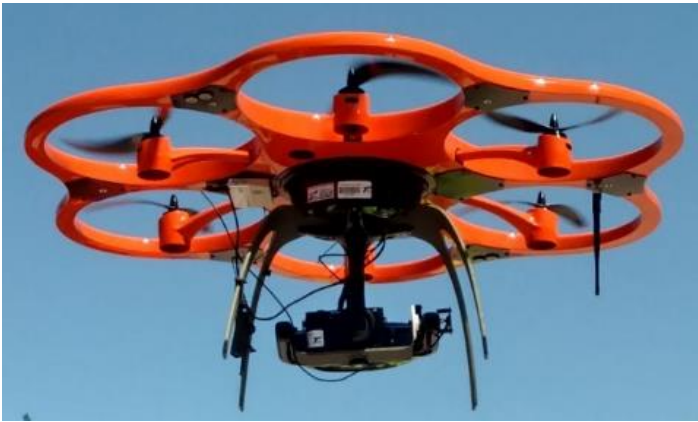
Figure 2. Cutting-edge Technologies (a) Steps for LiDAR Analysis (b) Data Collection using Terrestrial LiDAR (c) Aibotix X6 Hexacopter in Flight

Light Detection and Ranging (LIDAR) is used to map the area by emitting laser pulses on to the surroundings and receiving them. FARO FOCUS series X 330 Laser Scanner, as shown in Figure 2a, is utilized in this research to perform LIDAR investigations. X330 has a scanning range of 330 m and is equipped with GPS and remote scanning features. SCENE 5.4 software is used for registering and post processing the image files for construction of 3D cloud space of the scanned area. Constructed cloud space and associated data set are then transferred to builder application for further analysis. From Figure 2a, it can be observed that the first step for performing the LiDAR

The Aibot X6 hexacopter, shown in Figure 2b, is designed for a wide range of applications including surveying, infrastructure monitoring, precision agriculture and other areas. Underneath the hexacopter, green LED lights in the front and red LED lights in the back assist in determining its orientation during flight. It has six motor and propeller pairs enclosed in a lightweight composite airframe to handle high winds. It also consists of ultrasonic and barometric sensors that assist in maintaining altitude hold at a safe distance above the ground. The LVP antenna relays the video signals to the digital live video display unit (DLVP). Top and bottom servo gimbals on the copter accommodate and hold different types of sensors. The multi-cable geo-box triggers the camera in accordance with either the flight plan or intervalometer. The X6 has four legs that assist in takeoff and landing operations (Congress, 2018).

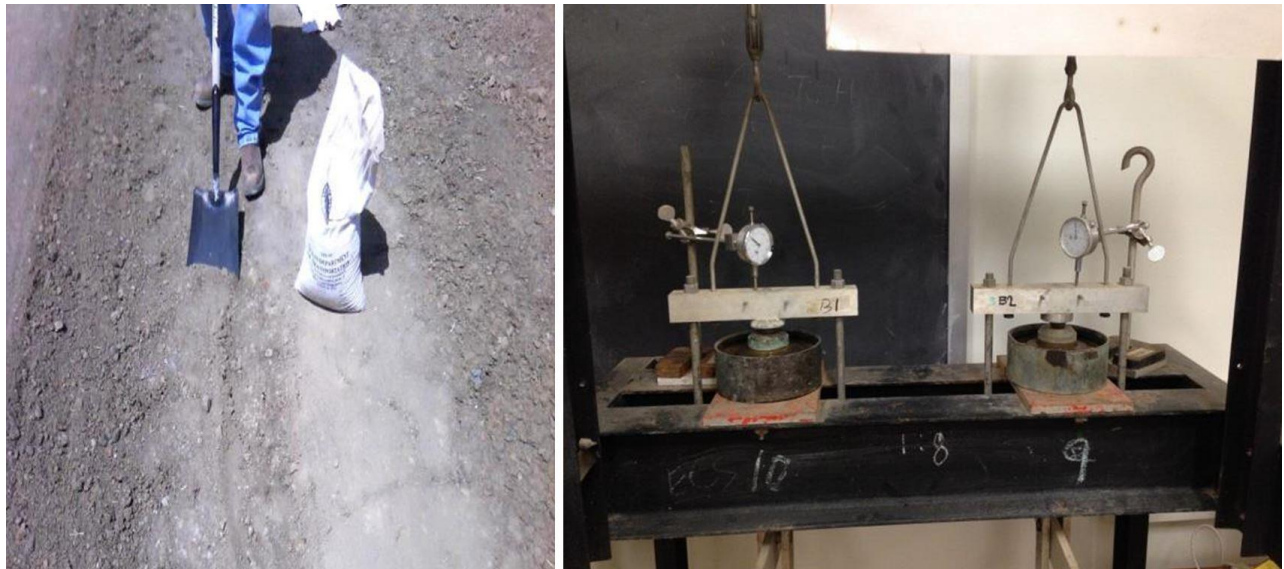
Figure 3. (a) Sample Collection (b) Laboratory Swell Tests

Swell strains of treated soil specimens collected from the field are determined using the standard procedure as shown in Figure 3b. Figure 4 provides the test results obtained from consolidation apparatus in the laboratory.

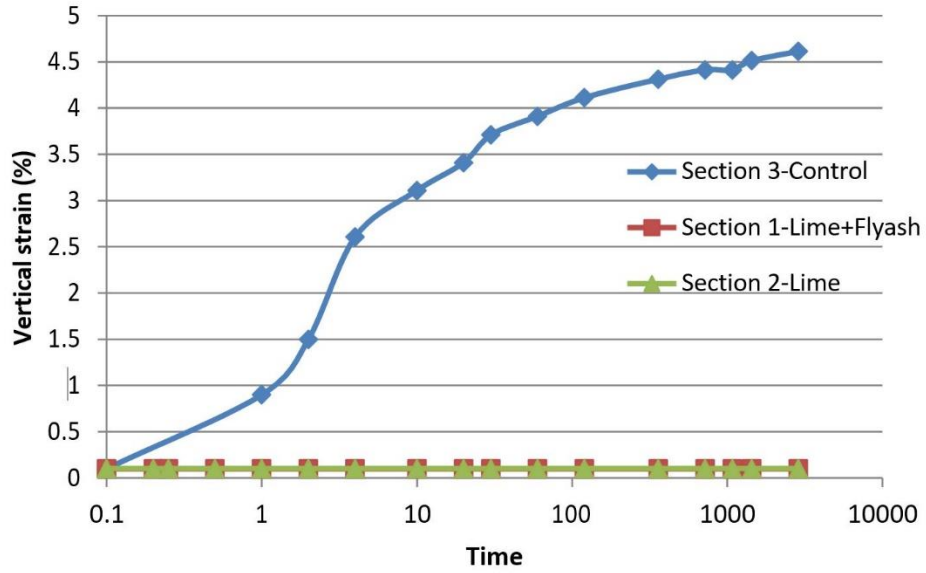
Figure 4. One Dimensional Swell Test Results of Soil Samples Collected during Pavement Reconstruction

It is observed in the above Figure 4, that control soil with lime treatment has shown considerable vertical swell strain of 4.5%, whereas lime (L) + fly ash (FA) treated subgrade with extended mellowing did not show any strains.

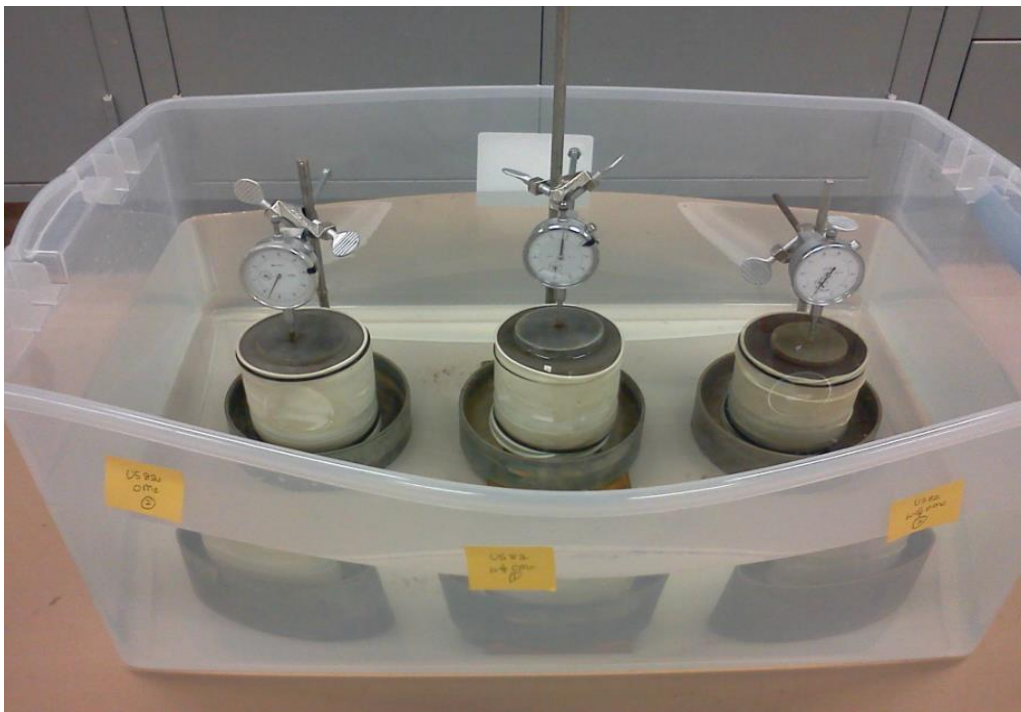
Figure 5. Three Dimensional Swell Test Setup

Three-Dimensional (3-D) free swell test measures the potential of the clay to swell in three (3) directions when soaked under water, as shown in Figure 5. Volumetric strain underwent by the soil specimen is determined by measuring the vertical and radial swell strains. Two identical specimens compacted at their maximum dry density (MDD) and optimum moisture content (OMC) are used for each test section and represented as OMC-1 and OMC-2. Figure 6 presents the vertical swell strain versus elapsed time for the soil samples collected from the test sections. From the test results, it is evident that soil from test section 1 (Lime with FA with extended mellowing) did not exhibit any swelling strain compared to soil samples from test section 3 (control section).

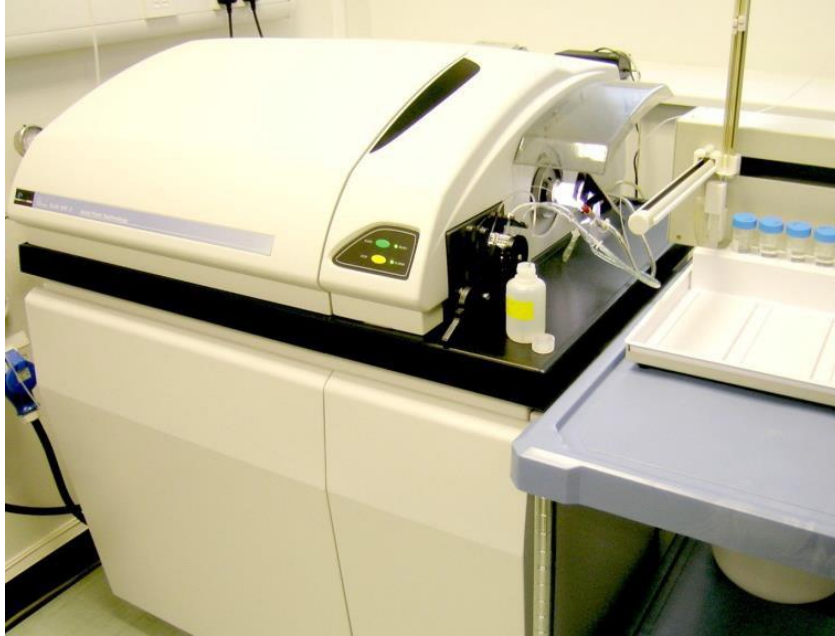
Figure 7. ICP-MS Equipment used for Determination of Silica and Alumina levels

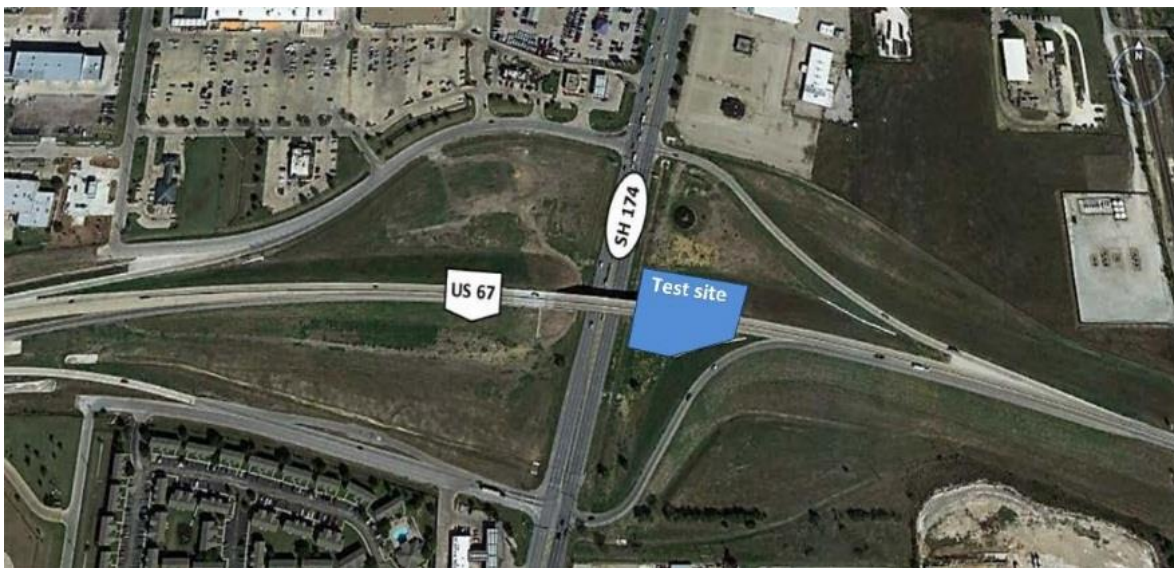
Figure 9. US 67 Bridge Approach Embankment Test Site

A 40-ft high bridge situated on US 67 over SH 174 in Johnson County, Cleburne, Texas has undergone more than 17 in. of settlement since its construction in 1995. Figure 9 presents the location of the bridge. Several rehabilitation measures such as soil nailing, hot mix overlays, foam slab jacking, and compaction grouting were attempted to mitigate this settlement thus alleviating the bump problem at the end of the approach slab. However, none of the rehabilitation techniques were effective. In 2012, Texas Department of Transportation, Fort Worth district (TxDOT-FTW) installed the light weight EPS geof foam as an embankment fill material to mitigate the bump phenomenon. The current research is performed to effectively collect the elevation profiled data of the bridge approach embankment using remote sensing data methods.

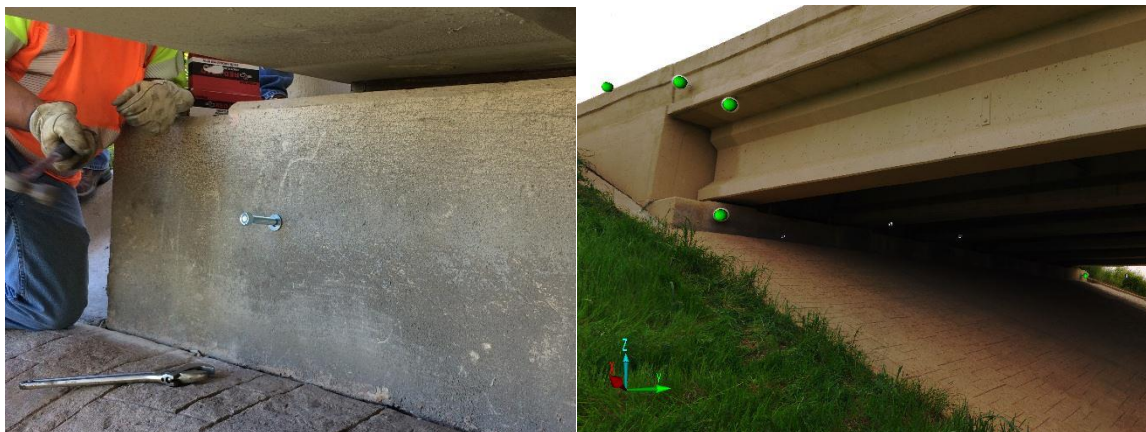
Figure 11. Installed anchors and reference spheres

of 10 different scan locations are determined, as shown in Figure 10. Small anchors to which spheres can be fixed, as shown in Figure 11, are installed at the US 67 bridge infrastructure to serve as ground control points required for the analysis.

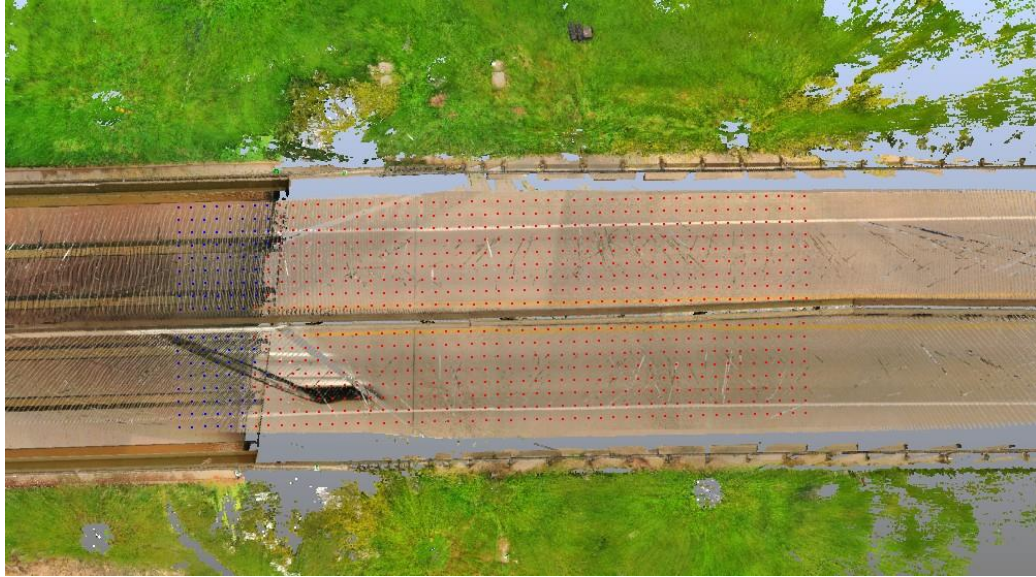
Figure 12. Set of Monitoring Points Placed over the Bridge Approach and the Deck

The first LiDAR survey was performed in April 2016 and the elevations determined from this analysis is used as the reference for measuring deformations for later surveys. To monitor vertical movements at the top of the pavement, two grids of points are chosen over grid dimensions of 98' x 32' as shown in Figure 12. The red dots indicate the monitoring points on the approach slab, whereas the blue dots represent the monitoring points on the bridge deck.

It is observed that the monitoring points at the top of the bridge approach embankment (red color dots) have different altitudes in comparison to the monitoring points located at the top of the bridge deck (blue color dots). Several other monitoring points are also selected at the pavement shoulder to assess the side slope embankment movements (see Figure 13).

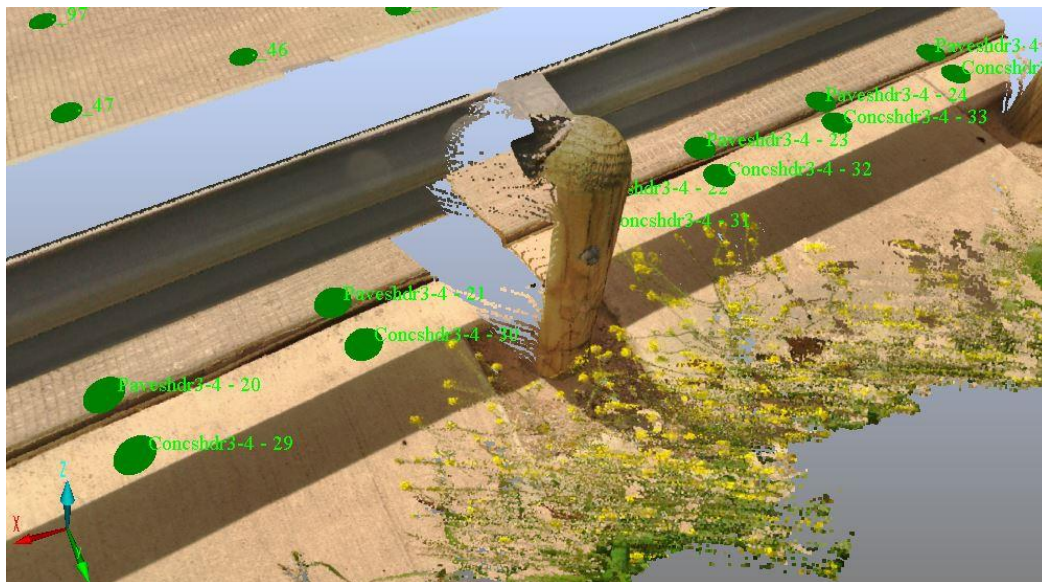
Figure 13. Monitoring Points on the Side Slope and Pavement Shoulder

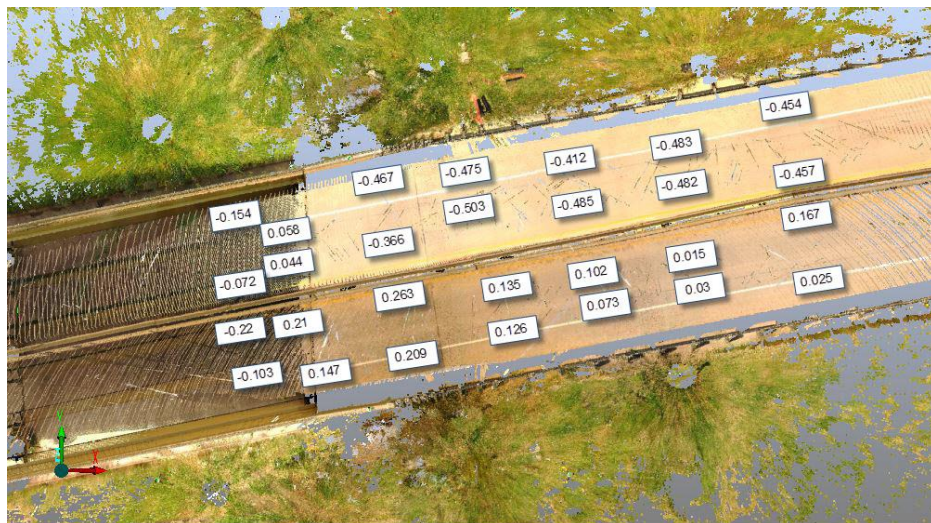
Figure 15. Cumulative total vertical deformations from April 2016 to July 2016

Similarly, analysis is performed on the scan data obtained in the month of July 2016. Figure 15 depicts cumulative total vertical deformations at the top of the pavement from April 2016 to July 2016. It is evident from the figure that one lane had undergone heaving and the other lane had experienced settling.

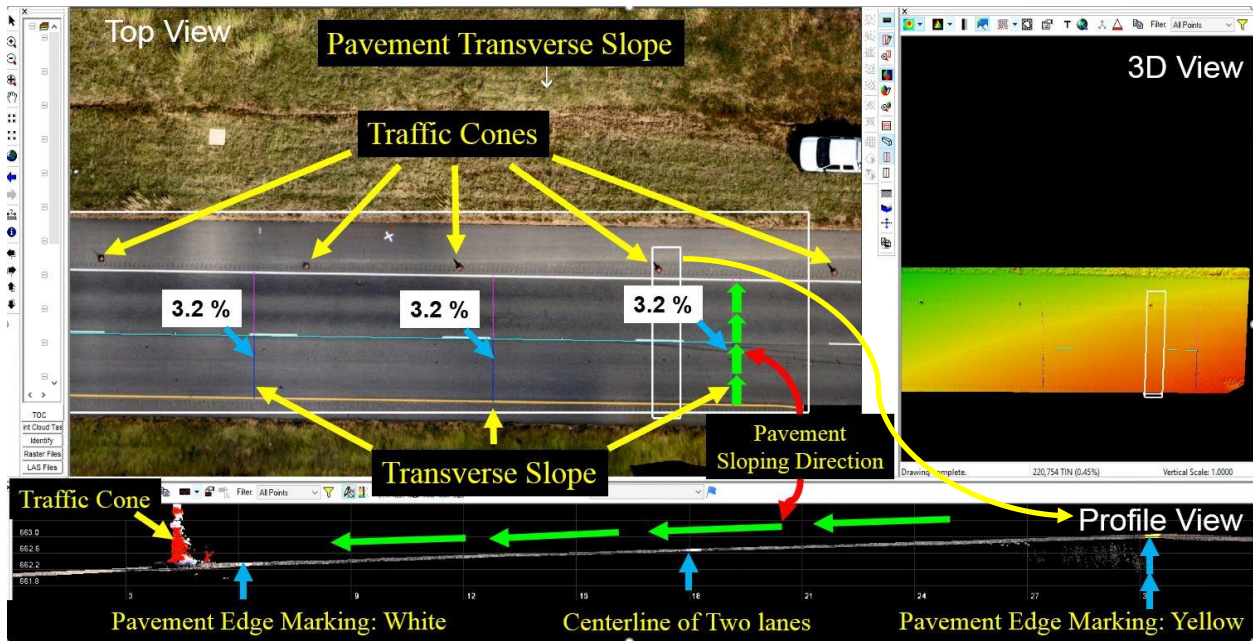
Figure 18. Transverse Slope Computed Along Three Paths

Due to the availability of dense point cloud models, the cross slope of the pavement is calculated at desired longitudinal spacing on the pavement section. For better representation, the cross slope is computed with points placed in the transverse direction of the pavement at 0.4 inch (1 cm) intervals. Transverse direction is selected according to AASHTO PP 70-10, which defines a transverse line as a line that deviates less than  $10^\circ$  to the perpendicular line of the pavement centerline. The transverse slope is calculated at 30 ft intervals along the longitudinal direction of the pavement. The cross slope sections provided in Figure 18 show a slope of 3.2% sloping towards the shoulder (indicated by the green colored arrows in the top and profile views). This can also be observed in the profile section view provided where the white and yellow pavement markings and the centerline of two lanes can be seen at the bottom of Figure 18.

It shows that the shoulder of the pavement, over which the traffic cones are placed, was at a lower altitude compared to the other side of the pavement in the transverse direction. The cross slope values obtained from LiDAR and UAV analysis has shown good match, indicating the accuracy of the aerial data.

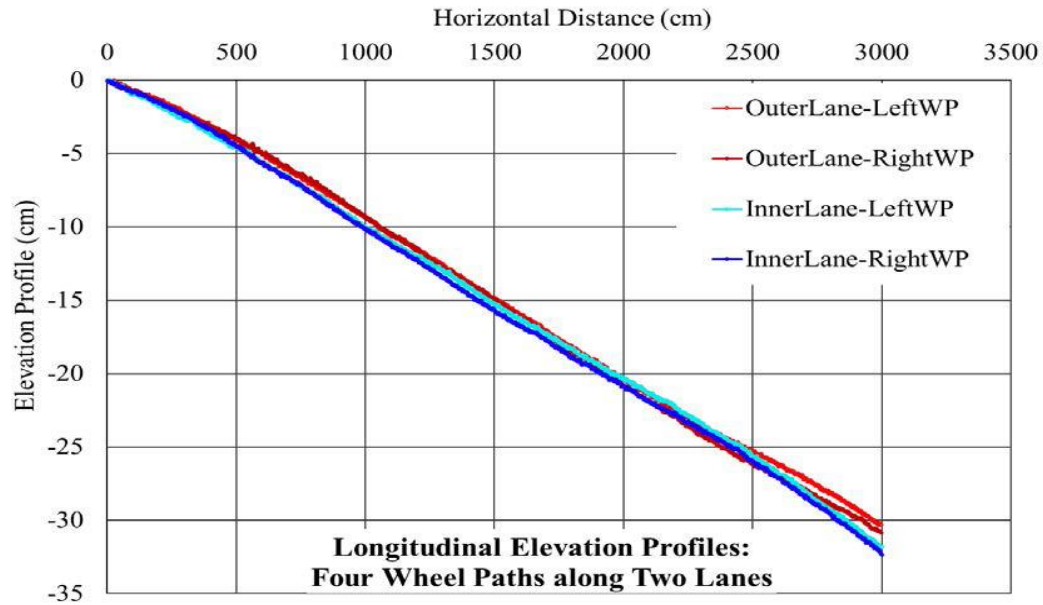
Figure 20. Longitudinal Elevation Profiles of Four Wheel Paths along Two lanes of the Pavement

Due to the enormity of the elevation data comprising of more than 10,000 points for each wheel path, elevation profiles of four wheel paths within a 100 ft (30 m) section along the vehicular direction of pavement are compiled, and these results are provided in Figure 20. Elevation profiles of outer lane right wheel path represented by orange; outer lane left wheel path represented by red; inner lane right wheel path represented by dark blue; inner lane left wheel path represented by cyan, are shown in Figure 20. The horizontal distance between the starting point of the 100 ft (30 m) stretch and all points within the stretch are plotted along X-axis and their corresponding elevation differences with the starting point are plotted on Y-axis.
