Seismic behavior of non-seismically designed eccentric reinforced concrete beam-column joints

Ying Liu^{1a}, Simon H.F. Wong^{*1}, Hexin Zhang^{2b}, J.S. Kuang^{3c}, Pokman Lee¹ and Winghei Kwong¹

¹Faculty of Science and Technology, Technological and Higher Education Institute of Hong Kong, Hong Kong, China

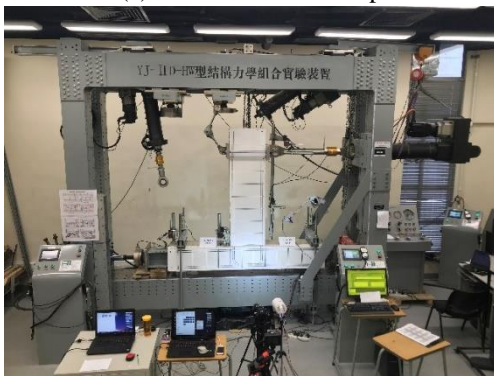
Fig. 2 Test rig

The experimental set-up and loading system are shown in Fig. 2. For convenience of testing and applying loading, the T-shaped exterior joint specimen was rotated 90 degrees, so that the column was in the horizontal position and the beam was in the vertical position. Proper boundary conditions were provided in the set-up to simulate the actual

(a) Schematic test set-up

(b) Actual test rig

working situation of the beam-column joint as if it was a part of frame structure, where the beam end is considered as the point of contraflexure and rollers are provided near the ends of columns to simulate inflection points in the structure.

In the test, columns of all the specimens were subjected to axial load, which was applied by a servo-controlled hydraulic jack. An electric servo-controlled actuator was employed to apply reversed cyclic load at the beam end. The moment arm for all specimens was 1350 mm from the centerline of the column.

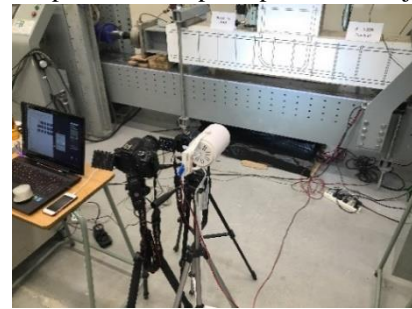
Fig. 4 Illustration of vision-based sensor for non-contact structural displacement

(a) Graphical data capture points on the joint

(b) Vision-Based Sensor Set-up

Specimens were instrumented with different types of measuring instruments in this experimental study. As shown in Fig. 3, strain gauges were attached in various locations to monitor the strain variation of longitudinal and transverse reinforcement bars. One linear variable displacement transducers (LVDT) with a range of 300 mm was installed to measure the lateral displacement of beam end during the experiment. All strain gauges and the LVDT were connected to the data acquisition system to record the strain and displacement data during the test. Vision-Based Sensors for Non-Contact Structure Displacement Measurement were adopted to monitor the shear deformation of the beam-column connection region as shown in Fig. 4. By using the digital single-lens reflex camera (DSLR) and a set of capture points installed at the four corners within the joint core, the photographic data was recorded and the shear deformation of joint was found by using a MATLAB algorithm.

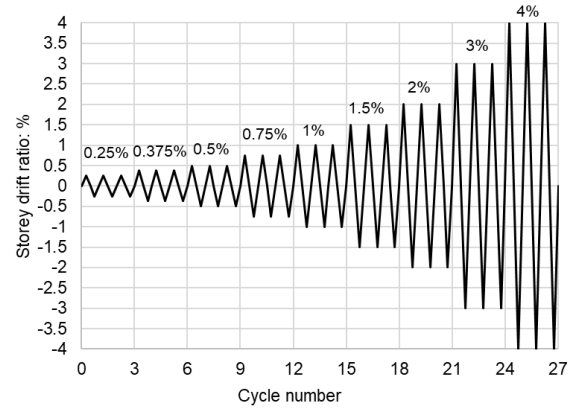
Fig. 6 Loading history

A typical lateral displacement history consisting of three cycles at monotonically increasing drift levels (0.25%, 0.375%, 0.5%, 0.75%, 1.0%, 1.5%, 2.0%, 3.0%, and 4.0%), as shown in Fig. 6, was used for all specimens until the restoring force is reduced to 80% of the peak load, when the specimen was assumed to have failed.

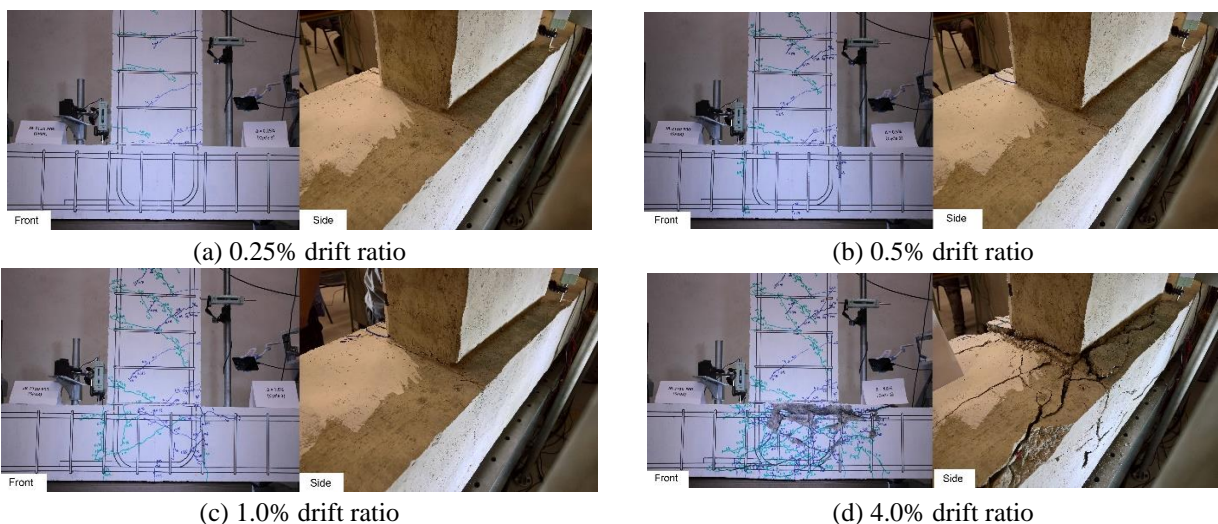
Fig. 7 Crack patterns of specimen E00

Fig. 7 shows the progressive crack pattern and the failure mode of specimen E00. In the initial stage of 0.25% drift ratio, small amount of flexural cracks developed at the critical region of the beam which were parallel to the

transverse reinforcement. Extensive flexural cracks formed in beam at 0.5% drift ratio. At the same time, fine vertical cracks around the joint region were found, which was caused by bond-slip behavior of steel bars. Diagonal shear cracks occurred in the joint region when the drift ratio was up to 1% and side cracks at the beam-column connection could be observed. As the drift ratio increased, the width and number of the cracks increased. When the drift ratio reached 4%, visible crushing and spalling of concrete in the joint region could be observed. Concrete expanded laterally and the damage pattern on both sides of the joint (sides A and B) was symmetrical. Joint shear failure was observed, and the critical region of beam cracked extensively due to the formation of a plastic hinge.

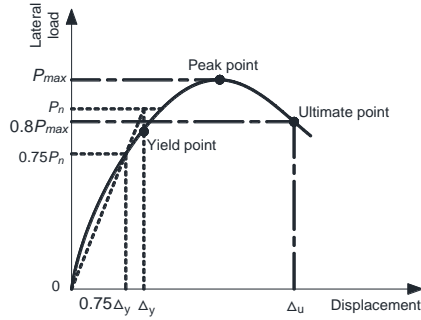
Fig. 13 Characteristic points on load-displacement curve

where Δ_y is the yield displacement shown in Fig. 13. It was determined by extrapolation from measured displacement at $0.75P_n$, and Δ_u is ultimate displacement corresponding to the loss of 20% of the maximum lateral load of the test specimen; V_j is the shear force in the beam-column joint; T_b and V_{col} are the tensile force in steel of the beam and the shear force of the column, respectively; P is the applied lateral load at the end of beam; d_b and L_c are the effective depth of beam and the length of column, respectively. The calculated results were shown in Table 2.

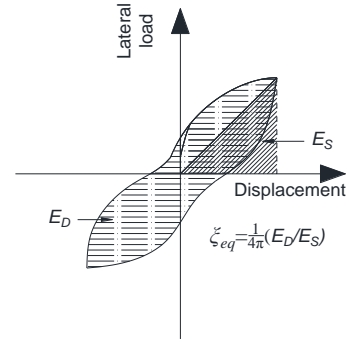
Fig. 14 Normalized index for energy dissipation capacity

where E_D is the energy dissipated per cycle, as shown in Fig. 14, and E_S is defined as the elastic strain energy.

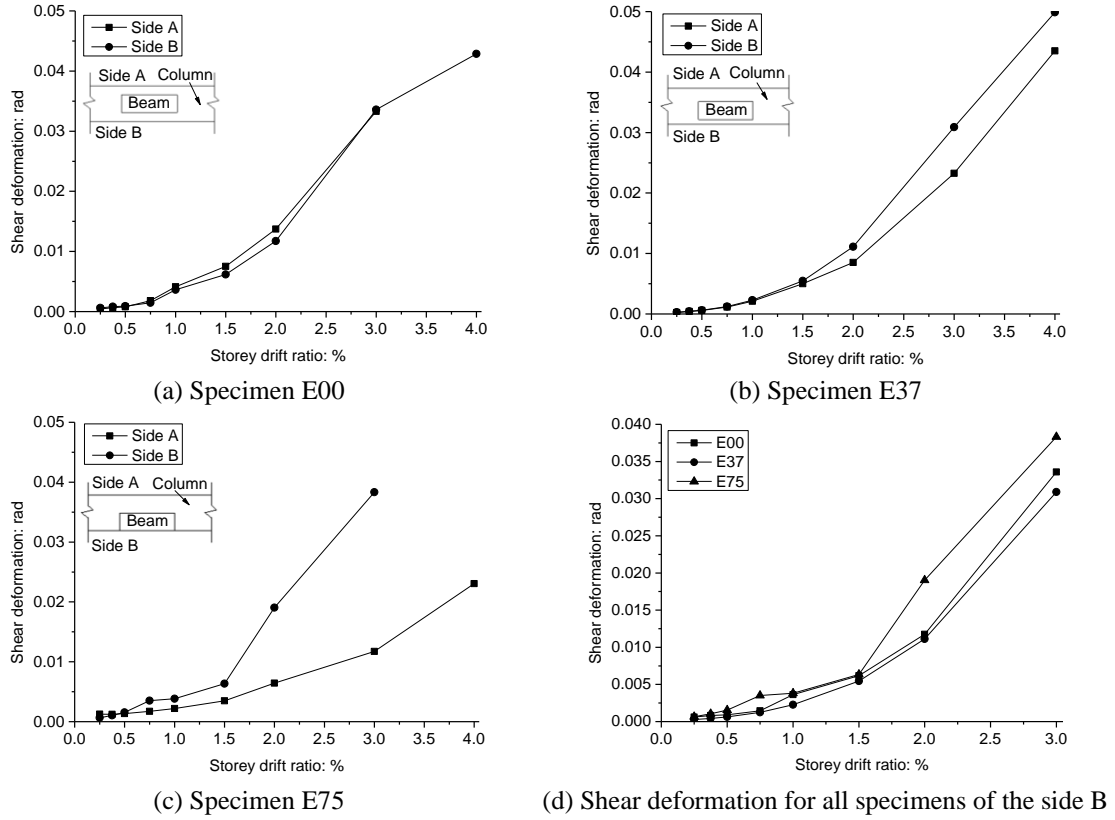
Fig. 17 Shear deformation in joint core

Fig. 17 illustrates the shear deformation of specimens and the missing data due to concrete spalling in the joint region. For specimen E00, as shown in Fig. 17(a), side B and side A show the similar joint shear deformation during the experiment, which implies that the concrete on both sides was evenly contributed to the shear resistance of the joint and the specimen had no torque in the joint core. As

can be seen from Fig. 17(b) for the specimen E37 and Fig. 17(c) for specimen E75, respectively, the shear deformation

of side B is greater than that of the side A. More specifically, the joint panel of side B was subjected to

significantly higher shear deformation for the eccentric specimen E75, which indicates that the eccentric side (side B) of joint would fail first with the increase of eccentricity.

Fig. 17(d) shows the comparison of shear deformation on the eccentric side of the three specimens. It can be observed that the shear deformation of specimen E00 and specimen E37 is almost similar, while the shear deformation of specimen E75 is significantly higher. This further shows that the small eccentricity has little effect on the shear strength of the non-seismically designed beam-column joints, but when it increases to $b_c/4$, the seismic performance of eccentric joint decreases significantly.

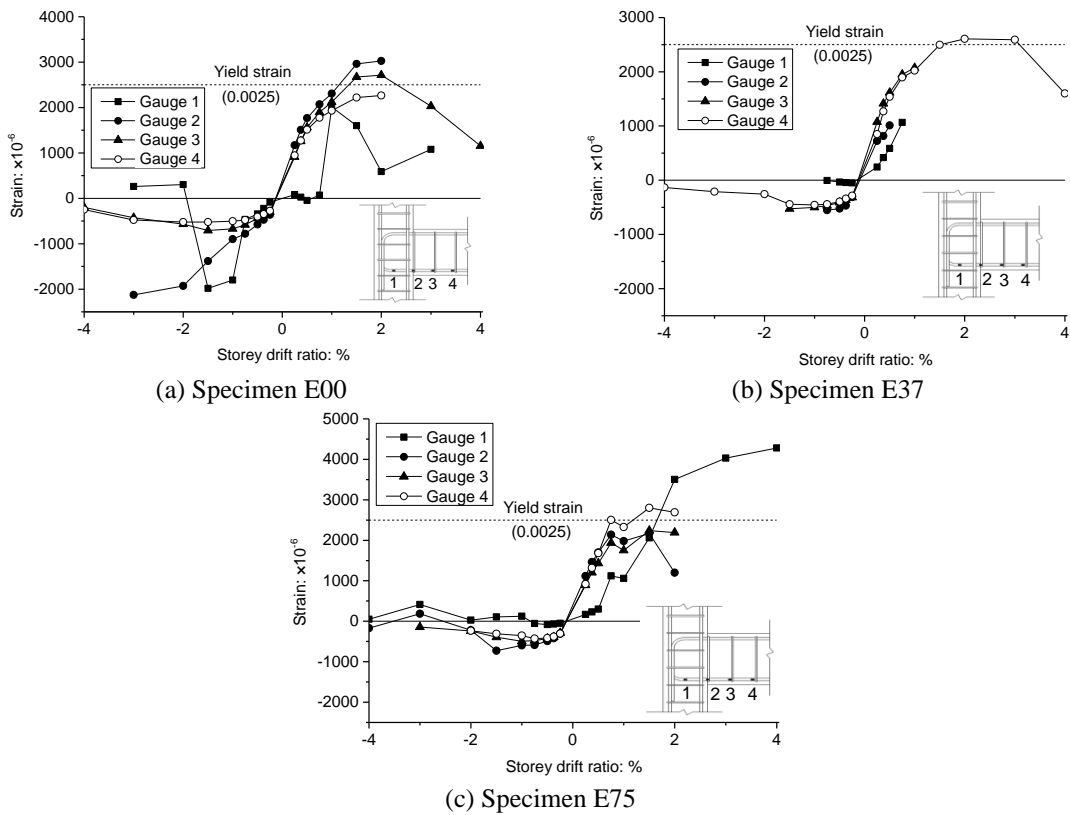
Fig. 18 Strain profiles of longitudinal reinforcement of beams

The strain of the flexural reinforcement and the stirrups in the joints are shown in Fig. 18 and Fig. 19, respectively. The yield strain is 0.0025 mm/mm for all steel bars in this

Figs. 18(a)-(b) show that flexural reinforcing bars yielded at the end of the beam near the joint when the storey drift ratio reached at around 1.5%, for specimens E00 and E37. In specimen E75 (Fig. 18(c)), however, the longitudinal bar inside the beam-column joint (Gauge 1) yielded until the drift ratio reached 2%, and the strain was significantly larger than others within the beam of this specimen, which is caused by the loose of bonding due to major cracks and spalling of concrete within the joint core. This comparison confirmed that the beam-column joints failed after the formation of plastic hinges at the end of the beam for specimens E00 and E37, while the failure of joint occurred when the beam just yielded before well development of plastic hinges for specimen E75.

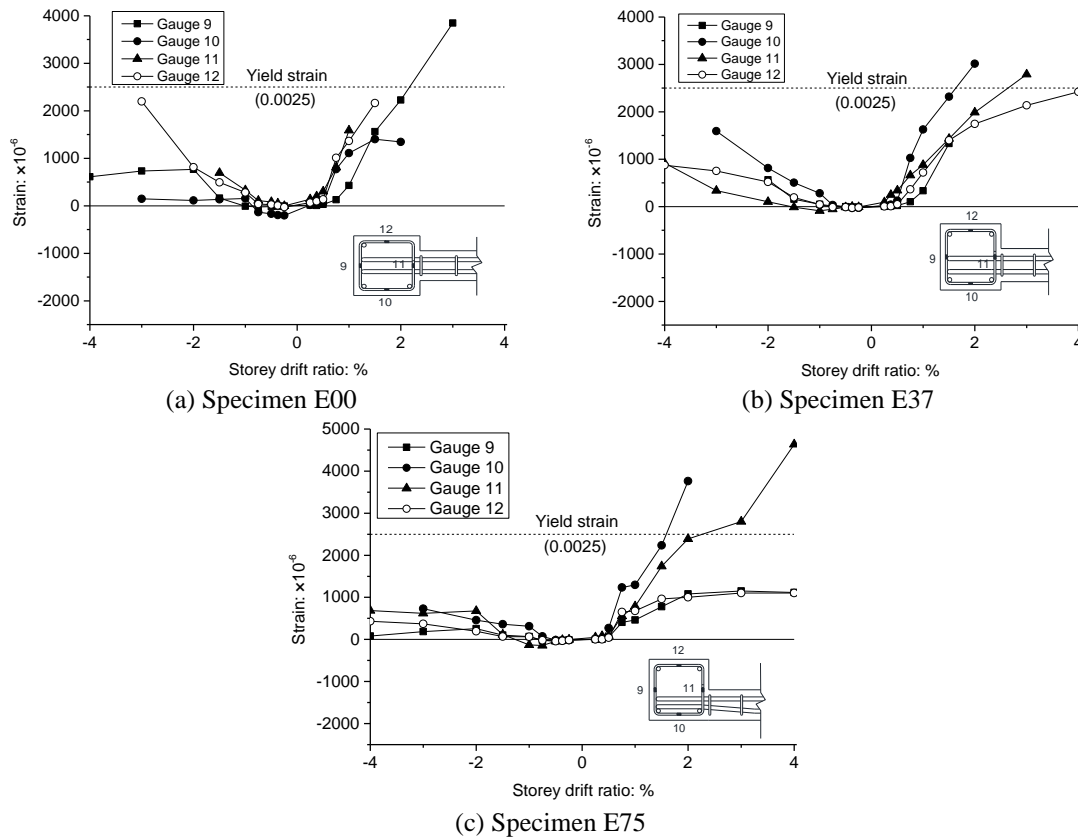
Fig. 19 Strain profiles of joint hoops

As shown in Fig. 19, it can be observed that the joint stirrups yielded when the storey drift ratio reached around 2%. In this stage, significant diagonal cracks developed in the joint and they were clearly shown in Figs. 7-9. Moreover, by comparing the strains of gauge 10 on side B and that of gauge 12 on side A, the uneven strain development for the specimens was observed. Specimen E00 with no eccentricity shows a similar strain distribution for both strain gauges 10 and 12. Fig. 19(b) shows the gauge 10 in specimen E37 yielded at the drift ratio of 2%, while the maximum strain of gauge 12 was 0.002422 mm/mm, which was close to the yield strain. In specimen E75, the maximum strain of gauge 12 was 0.001103 mm/mm, which was far less than the yield strain while that

of gauge 10 had reached the yield strain when the drift ratio was 2%. On side A, the strains of gauge 12 in eccentric specimens were less than those in specimen E00 due to the cancellation effect of shear stresses and torque which counteract each other. These results confirm the observations of more extensive shear or torsion cracks on side B of the eccentric connections.

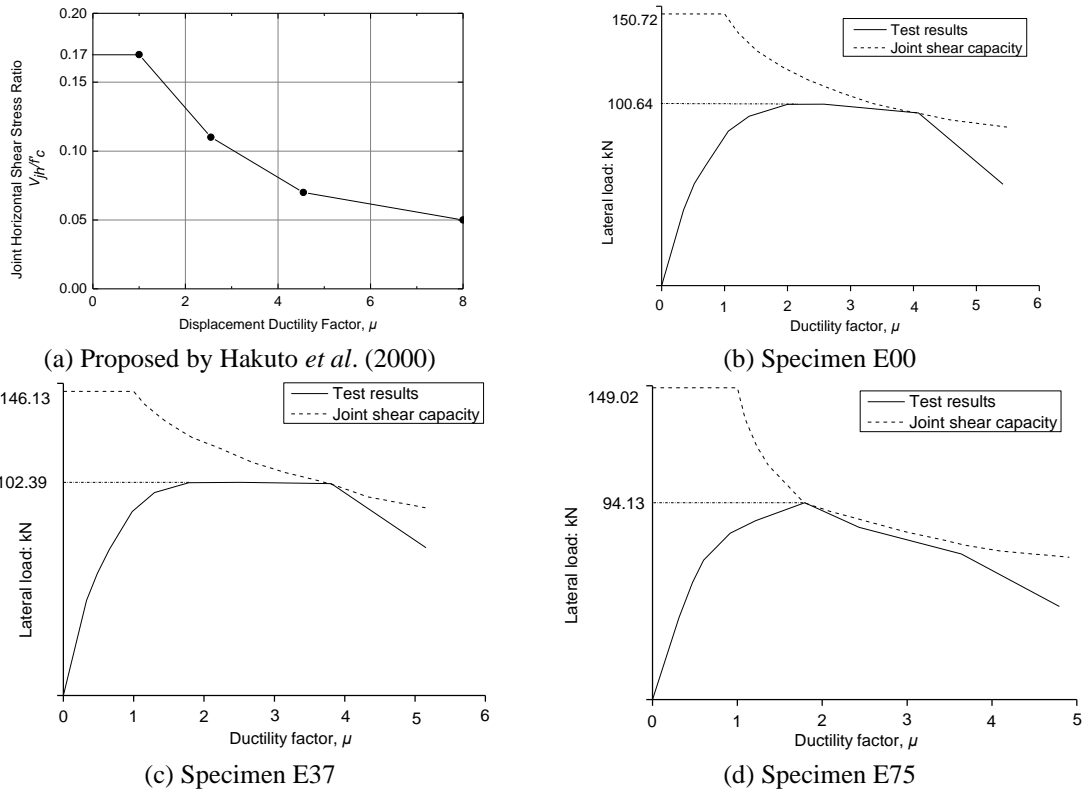
Fig. 20 Degradation of joint shear strength

Previous studies (Park and Paulay 1975, Zhang and Jirsa 1982, Park 1997, Hakuto *et al.* 2000) have shown that the shear strength of RC beam-column joints decreases with the formation of plastic hinge in the adjacent beam. It is caused by the effect of the loss of bond strength and yield penetration of reinforcement from the plastic hinges of the adjacent beam. The empirical model has been proposed based on the experimental results, as shown in Fig. 20(a) (Hakuto *et al.* 2000). According to the test results in this study, the conceptual model for the degradation of joint

shear capacity is shown in Figs. 20(b)-(d). The solid lines are reproduced from the positive envelope of the hysteretic curves of the tested specimens and the dotted lines represent the joint shear capacity.

For specimen E00, E37, and E75, according to HKSUC 2013, the values of lateral load derived from joint shear capacity are 150.72 kN, 146.13 kN, and 149.02 kN, respectively. The conceptual model for joint shear deterioration of three specimens were presented in Fig. 20. Without considering the effect of eccentricity, the failure mode of specimen E75 is the same as that of specimens E00 and E37 i.e., joint shear failure after beam yielding. However, it has been shown that joint shear failure occurred when the beam just yielded for specimen E75, which indicates that when the eccentricity reaches $b_c/8$, it has a negative effect on the joint shear capacity and the value is largely reduced from 149.02 kN to 94.14 kN, which is equivalent to 36% of the original strength.
