## ENERGETIC ANALYSIS OF HARD FACING AND WELD CLADDING OF AN AIR POWERED DROP HAMMER DAMAGED RAM

Original scientific paper

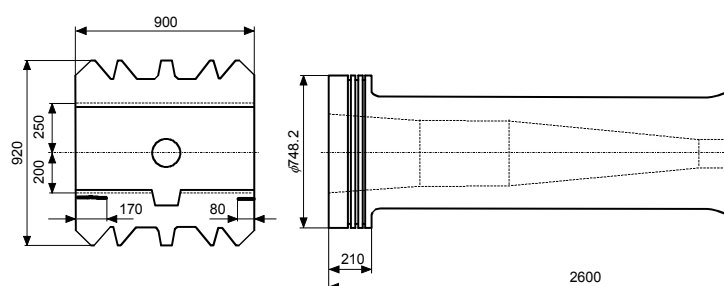
The ram (figure 1) is exposed to impact compressive loads, and partially also to the temperature gradient, *i. e.* to the thermal stresses, caused by an unbalanced temperature field [1-6]. This intensively loaded mechanical part operates under very complex conditions since, during exploitation, it is exposed to mechanical and thermal loads of high intensity. After a long period of operation, *i. e.* after a high number of repeated cycles, cracks are observed on the ram, as shown in figure 1.

Figure 1. Appearance of the ram and places of the noticed cracks

Before applying the optimum technology of hard facing, verified on models, a detailed control of observed damages was performed by visual inspection of the corresponding zones, magnetic defectoscopy, ultrasonic control and penetrating liquids. This enabled performing the adequate preparation of welding grooves (figures 5 and 6), bearing in mind that the groove root should reach the in-depth crack (see also figure 1).

Ultrasonic defectoscopy registered two cracks (figure 1), and they were processed to make grooves that needed minimum deposit material (figures 5 and 6). Damaged bat sliding guides were also machined. Machining time of the two used axle milling machine with the power  $P_1 = 20$  kW was  $t_1 = 30$  h. Thus, energy consumption was  $Q_1 = P_1 t_1 = 600$  kWh.

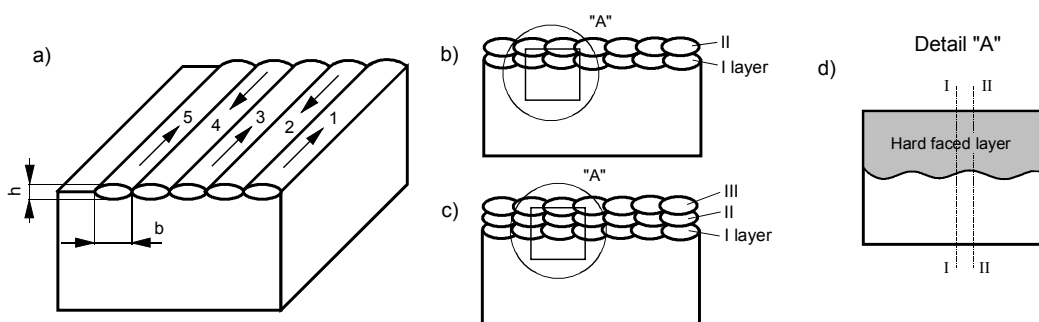
Figure 2. The order of the hard-faced layers deposition [1, 2]

The ram model was repaired with electrodes  $\phi$  3.25, 4.0 and 5.0 mm. The order of the hard faced layers deposition is presented in figures 2a and 2b. In this way, the optimum repairation technology suitable for the real part was determined (tab. 3). The microstructure analysis, hardness measurements, and visual examination confirmed that the weld layers did not have pores, cracks, ruptures and other failures and that the bond between the base material (BM) and the filler material was of good quality.

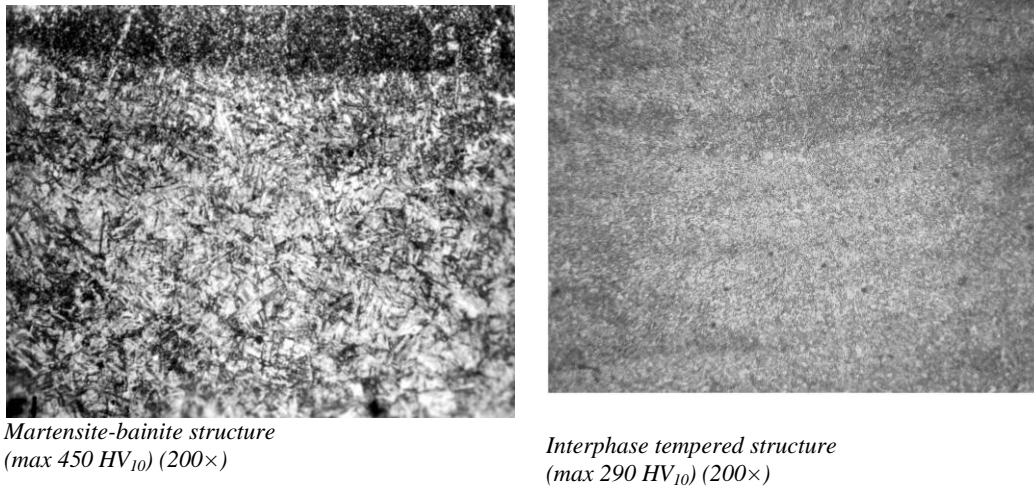
**Figure 3. Hard faced HAZ with and without tempered microstructure ( $T_p = 300^\circ\text{C}$ )**

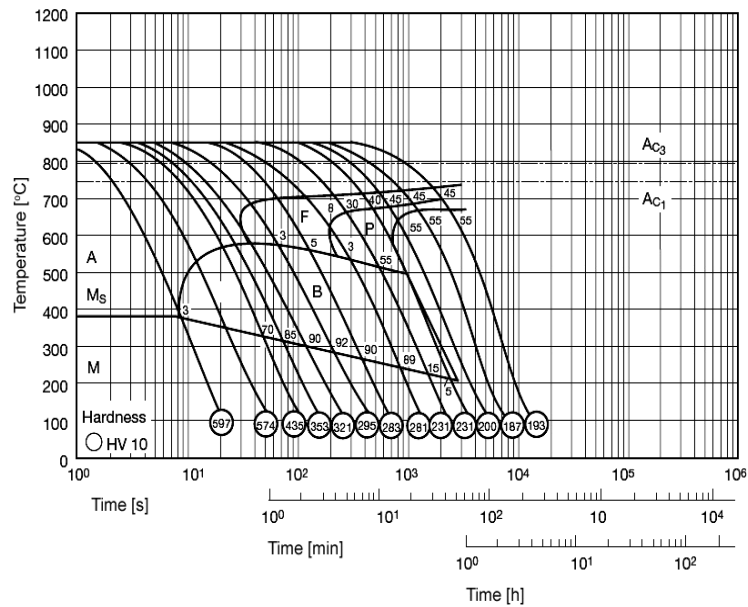
The KH diagram shows characteristic temperatures as well as periods of particular phase changes (figure 4). These readings depend on austenitization temperature, period of

Figure 4. Continuous-cooling diagram for steel Č4731 (34CrMo4)

Putting the calculated cooling time  $t_{8/5}$  into the KH-diagram for the given steel enables estimation of the novel structure and hardness of the HAZ. Based on the known cooling diagrams of some characteristic temperature cycle structures, the structures from the KH diagram and the results of metallographic measurements were compared (figure 3). The presented KH diagram (figure 4) shows that the limit cooling time has the value of  $t_{8/5} = t_{100} = 8.5$  s, which means that hard facing or welding performed with the input heat as shown in tab. 4 without preheating ( $T_o = T_p = 20^\circ\text{C}$ ) leads to a pure or predominantly martensite HAZ structure. Hard facing or welding performed with the same input heat but with preheating leads to a mixed structure (M+B) which is slightly less hard. Therefore, it is necessary to perform post tempering in order to lower the level of the residual stress and hardness of the HAZ as well as to increase the plasticity of certain hard faced zones.

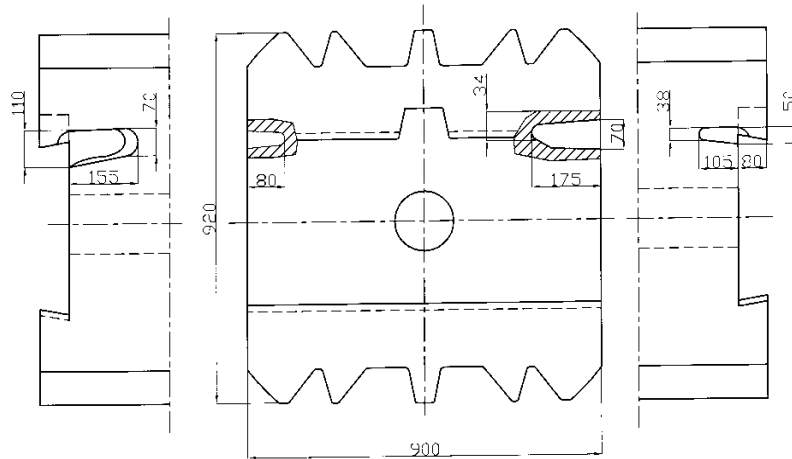
Figure 5. Shape and geometry of the prepared grooves

For reparation of larger cracks, the construction of minimum volume grooves was planned (figures 3 and 4). Machining of grooves was first performed on two spindle milling copy machine and then it was finished manually [1-3].

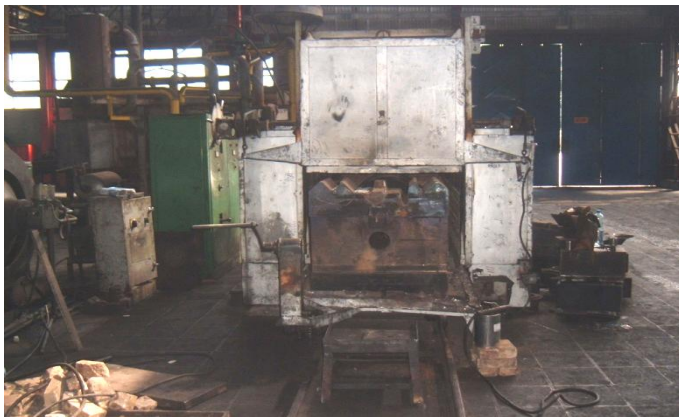
**Figure 7. Preheating of the ram in the horizontal electroresistance furnace**

When the grooves were prepared, the damaged part was placed into the horizontal furnace with an electro-resistance heater (figure 5), where it was first preheated and then heated through for several hours. After that, the ram was partially pulled out from the furnace chamber and the reparation process began.

After machining, the ram underwent a slow heating in the horizontal chamber electrical heater for approximately 9 hours before the preheating temperature of  $T_p \approx 300$  °C was reached. That temperature level was kept for approximately 11 hours, with additional heating when the temperature dropped down below 250 °C, which was for about 20 hours. The power capacity of the heater was  $P_2 = 120$  kW, which lead to the consumed energy of  $Q_2 = P_2 \sum t_i = 4800$  kWh.

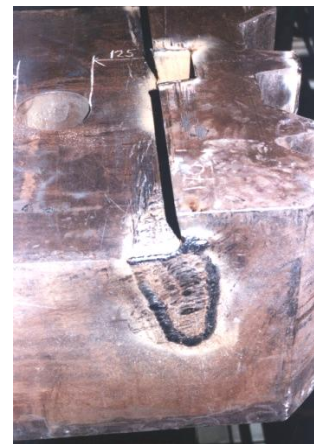
**Figure 8. Appearance of the ram after the hard facing**

Depending on the requirements, the part was either additionally heated with the gas heater and gas burner, or put back into the furnace, if the temperature of hard faced zones dropped down below 250 °C. The time needed for heating through of the ram, in the horizontal electro-resistance furnace (figure 7), was about 11 hours ( $T_p \approx 300$  °C). The reparation procedure was conducted according to scheme given in figure 6c. Root weld layers and fillers were welded first according to the prescribed sequence. The non-cooled welds, except for the root and cover layers, were forged by the tool with obtuse head. During the surface forging of the weld, one has to be careful that grooving does not cut over the depth. One must also take into account the strain hardening in order to preserve the impact toughness, therefore, the hot weld was forged only above the recrystallization temperature ( $T > 480$ °C). The total time for frame reparation was about four days (with two workers). The appearance of the repaired parts is given in figure 8.

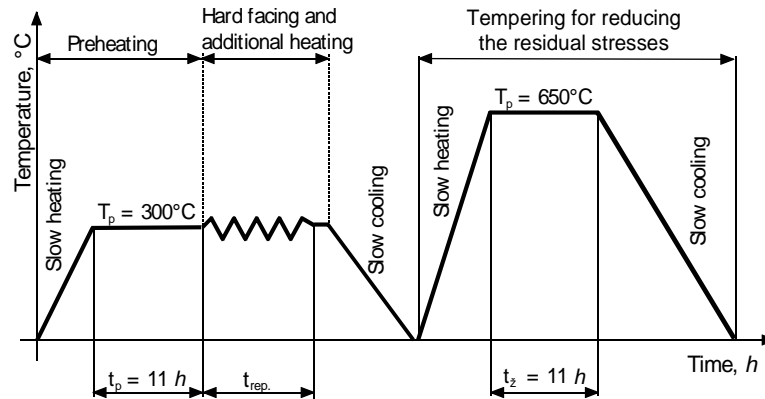
Figure 9. A complete cycle of the hard facing of the hammer's ram [1-3]

Immediately after the welding operations, the ram was returned into the furnace and cooled down to the room temperature. Then, the thermal treatment was performed according to the regime  $T_t = 650$  °C/11 h (figure 9). After the tempering, it was necessary to perform a slow cooling of the ram in the furnace that was switched off [1-3]. Such a complex procedure of thermal treatment (prior, current and additional), was performed mainly because of the function of the ram, which imposes the necessity to minimize the unfavorable changes in the vicinity of the weld. This refers primarily to reduction of the residual stresses, decrease of hardness, obtaining of the unfavorable structure, easier diffusion of hydrogen, *etc.*

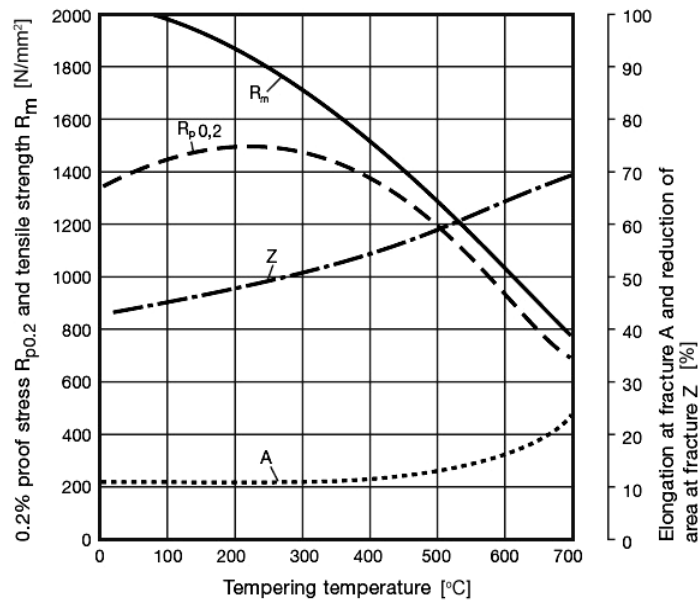
Figure 10 shows the dependence of the most important mechanical properties of the steel Č4731 (34CrMo4) in relation to the tempering temperature.

Figure 10. Steel properties at raised temperatures

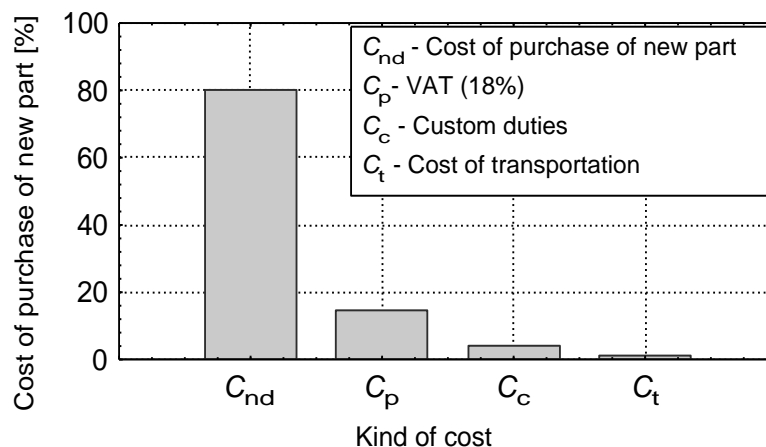
Figure 11. The structure of expenses for a new ram

- Price of a new part  $C_{nd} = 67470.00$  €/ram,
- VAT (18%)  $C_p = 12144.00$  €/ ram,
- Customs duty (5%)  $C_c = 3373.00$  €/ ram,
- Transportation costs  $C_t = 1000.00$  €/ ram.

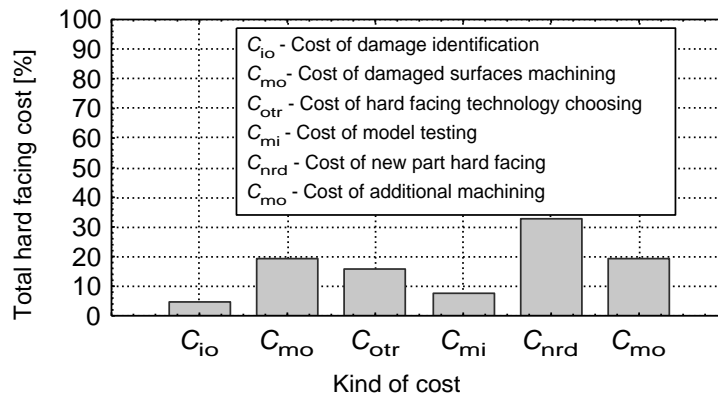
Figure 12. The structure of the greatest expenses for the ram repair

- Damage identification  $C_{io} = 240.00 \text{ €/ram}$ ,
- Machining of damaged surfaces  $C_{mo} = 960.00 \text{ €/ram}$ ,
- Hard facing technology determination  $C_{otr} = 768.00 \text{ €/ram}$ ,
- Model verifying  $C_{mi} = 384.00 \text{ €/ram}$ ,
- Hard facing of the operating part  $C_{nrd} = 1600.00 \text{ €/ram}$ ,
- Cost of the hard faced surfaces machining  $C_{mo} = 960.00 \text{ €/ram}$ .

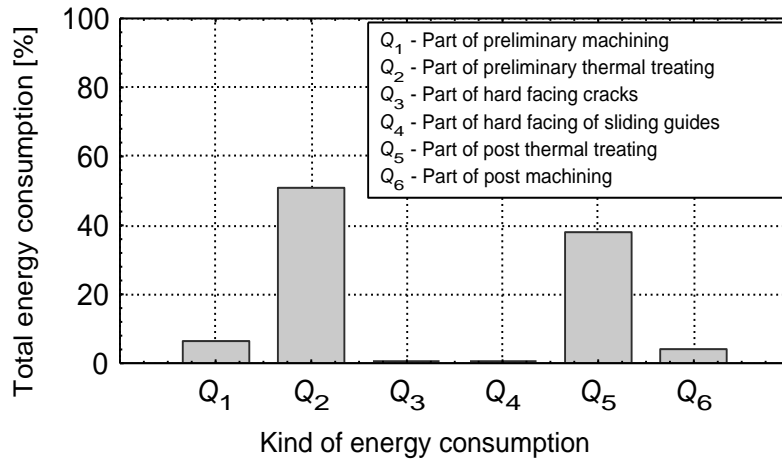
The total consumption of electrical energy  $Q_T$  during the reparation process of the hammer's ram was  $Q_T = \sum Q_i = 9468.5$  kWh. The energy consumption histogram is shown in figure 13.

Figure 13. The structure of energy consumption for repair of the hammer's ram

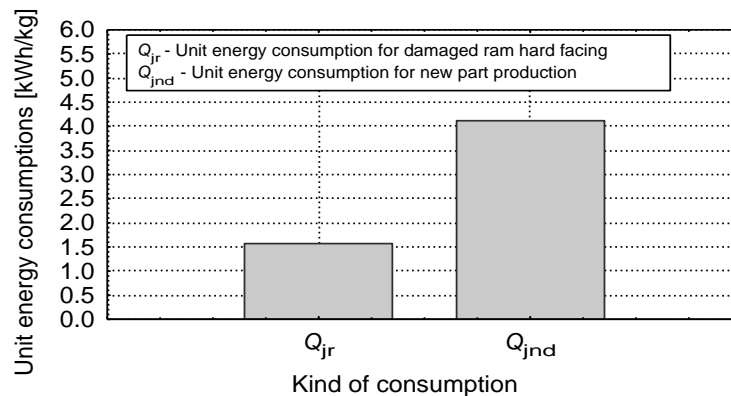
Therefore, based on the energy consumption analysis, it can be concluded that reparation of a damaged and worn hammer's ram is justified because the electric energy consumption for reparation of the ram is 2.6 times less than for production of a new one (figure 14).

Figure 14. The structure of energy consumption for reparation of the hammer's ram ( $Q_{jr}$ ) and for purchase of a new one ( $Q_{jnb}$ )
