ASSESSMENT OF INTEGRITY OF PRESSURE VESSELS FOR COMPRESSED AIR PROCENA INTEGRITETA POSUDA POD PRITISKOM ZA KOMPRIMOVANI VAZDUH

Abstract

PRESSURE VESSELS AT RHE BB

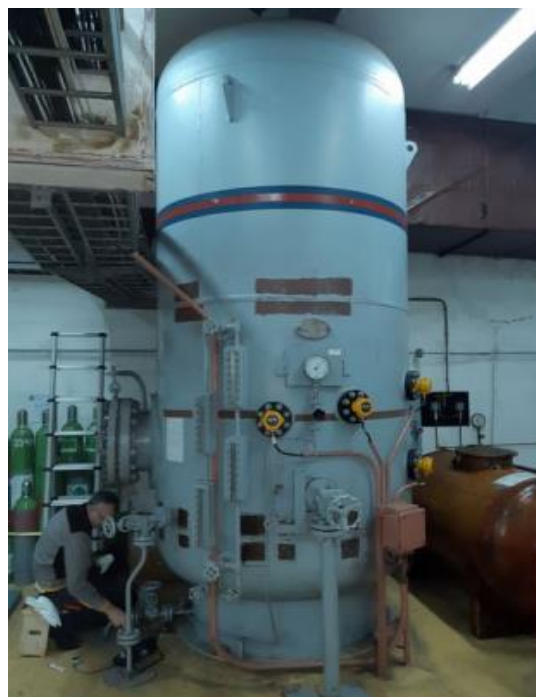
Figure 1. The pressure vessel 977 at RHEBB.

It should be noted that the base material of the inspected vessels is micro-alloyed steel NIOVAL 50, /12/ and the pressure in vessel 977 (Fig. 1) is $p = 78$ bar. The geometry of this vessel is: thickness $t = 42$ mm, with mean diameter $D = 1958$ mm. Vessel 977 is inspected by 100 % ultrasonic testing on two vertical welded joints, and three circular welded joints, by USM 36XL Krautkramer device.

After the final UT testing of the vessel 977, Fig. 1, defect marked 2.5 is found with the following geometry and location: length 170 mm and width/depth 14 mm in a circular seam in the middle of the vessel, depth ranges from 28 to 42 mm. The position on the vessel where defect 2.5 is indicated is shown in Fig. 3. Another unacceptable edge surface defect in vessel 977 is marked as 1.6, of size 20×15 mm, also in a circular seam, between upper cover and mantle, which requires additional analysis, i.e. structural integrity assessment.

Defects 1.6 and 2.5, vessel 977, with very high risk level, indicated a need to remove the defect by repair welding, especially knowing that residual stresses are not taken into account.

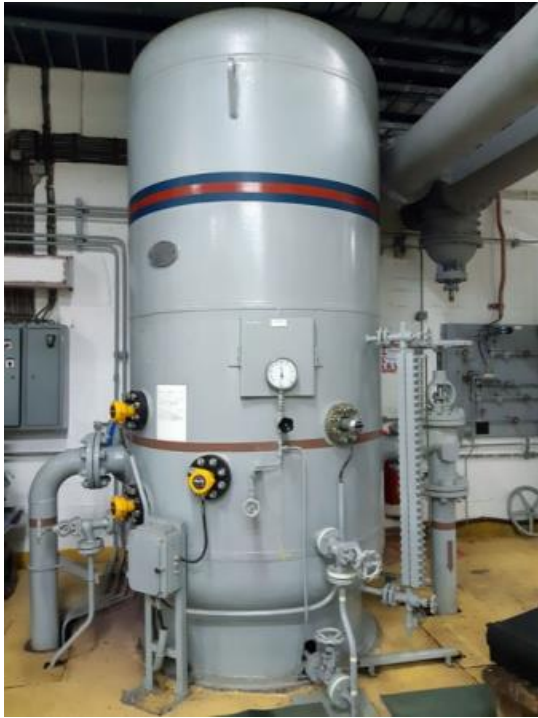
Figure 2. The pressure vessel 976 at RHEBB.

Internal pressure of vessel 976 (Fig. 2) is $p = 59$ bar. Geometry of vessel 2 is: thickness $t = 30$ mm, with mean diameter $D = 1958$ mm. The following defects are found in this vessel, using UT testing:

Defects 1.1, vessel 976, with low risk level, indicating only the need for further monitoring by NDT.

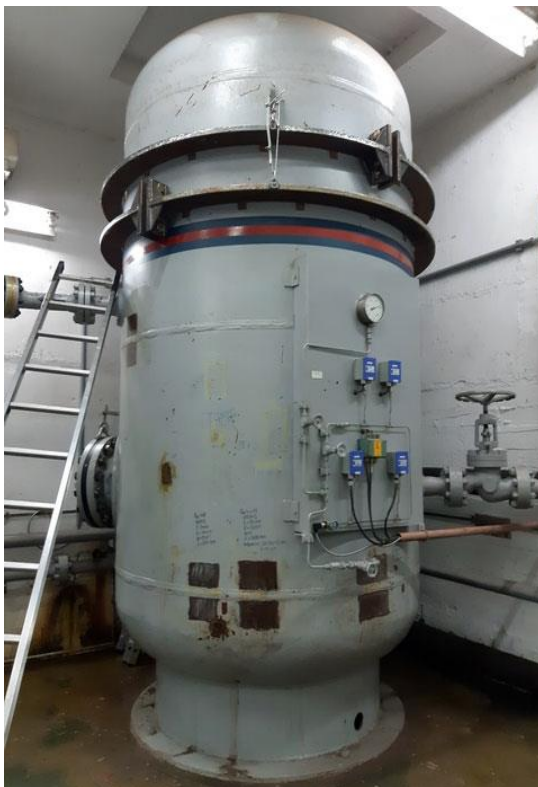
Figure 3. The pressure vessel 970 at RHEBB.

Finally, pressure vessel 970 is analysed: $p = 78$ bar, thickness $t = 50$ mm, diameter $D = 2150$ mm. Vessel 970 was inspected by 100% ultrasonic testing on two vertical welded joints, and three circular welded joints, in the same way as the previous ones. Several defects are found, with unacceptable defect 5.6 (75×20 mm) as the worst case, positioned in the centre of welded joint, 18-38 mm, Fig. 6.

Defect 5.6, vessel 970, with very high risk level, indicated a need to provide a special solution for PV 970, since the repair welding was not an option for the central, internal crack.

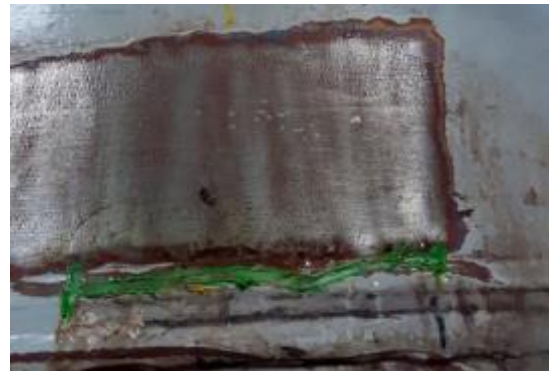
Figure 3. Position and size of defect 2.5 in vessel 977.

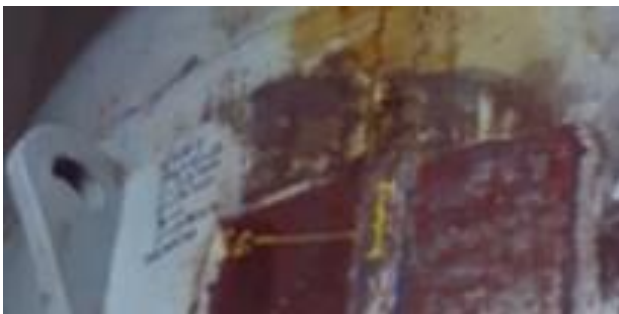
Figure 6. Defect 5.6, size 75×20 mm.

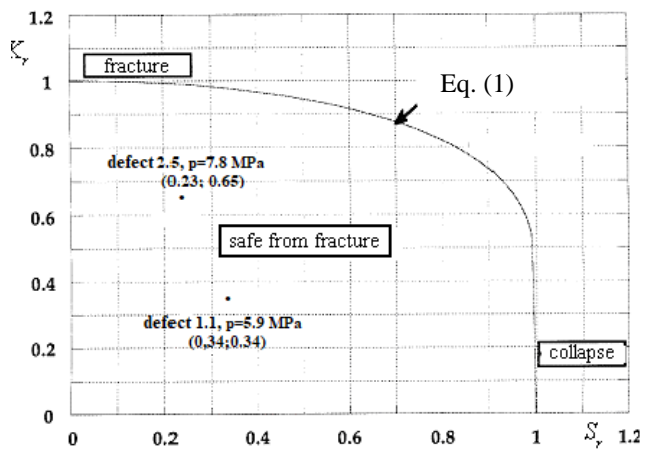
The coordinates of the point in the Failure Assessment Diagram (FAD) (0.23; 0.65) are in the safe area, at the level of fracture probability approx. 0.66, Fig. 6.

Similar analysis can be performed for defect 1.6, with the only difference being $a = 15$ mm instead of 14 mm, leading to the following values: $Y = 1.87$; $K_I = 1138 \text{ MPa}\sqrt{\text{mm}}$; $K_I/K_{Ic} = 0.72$; $n = 140$ MPa; $S_R = 0.25$, at the level of fracture probability approx. 0.73, Fig. 6.

Figure 6. Failure Analysis Diagram for defects 1.1 in vessel 976; 1.6 and 2.5 in vessel 977; and 5.6 in vessel 970.

The coordinates of the point in the FAD are (0.34; 0.34), so the level of fracture probability is approx. 0.35, Fig. 6.

Coordinates of the point in the FAD are (0.49; 0.74), so the level of fracture probability is approx. 0.77, Fig. 6. One should notice that results presented here for vessel 970 are obtained taking into account the length of defect 5.6 ($2c = 75$ mm).

The risk matrix can now be obtained in the usual way, as shown in /18, 19/, for the case of pressure vessels shown in Figs. 1 and 2. The risk matrix is given in Table 1, indicating medium level risk for PV 976 and high level risk for pressure vessel 977, which was the reason for repair of defect 2.5, and special solution for PV 970.
