REPAIR WELDING PROCEDURE AND TECHNO-ECONOMIC ANALYSIS OF BURNER PIPE REPARATURNO ZAVARIVANJE CEVI GORIONIKA SA TEHNO-EKONOMSKOM ANALIZOM

Originalni naučni rad / Original scientific paper
UDK /UDC:

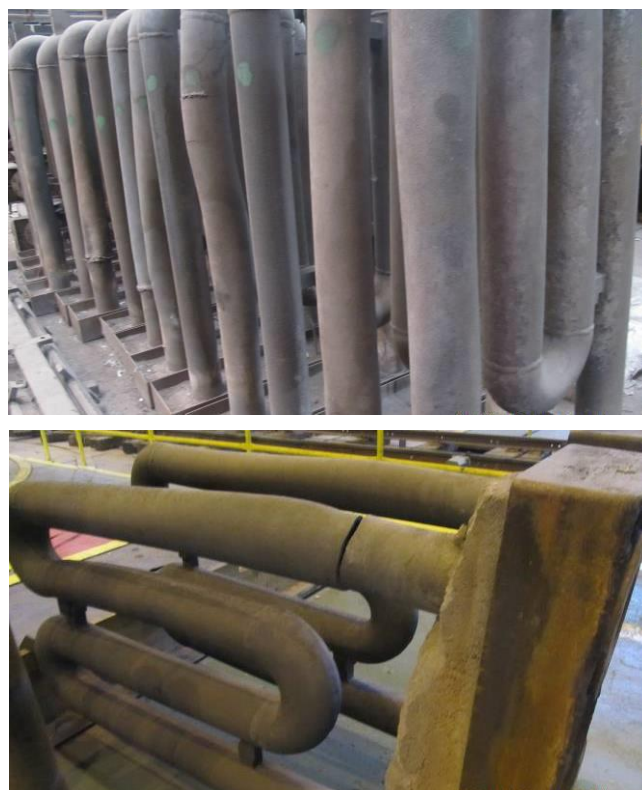
Due to high temperatures that can reach up to 850°C and 'explosions' that occur during gas ignition, cracks may occur in the input part of the 'W' burner. Some of the damage on the 'W' burners is shown in Fig. 2. Damages have occurred

in the base material, however, locations most vulnerable to cracking were in the welded joints.

Figure 2. 'W' burner pipe input damage.

Damages, as mentioned in the introduction, resulted in the need for repairing the damaged pipe parts. The repairs involved cutting off from the damaged part of the pipe and replacing it with a new pipe. The base material used for the burner is stainless steel nickel alloy X12NiCrSi35-16, of chemical composition as shown in Table 1, whereas its microstructure can be seen in Fig. 3. Base metal microstructure is austenitic with spheroidal pearlite. A significant presence of carbides is observed in the base material structure.

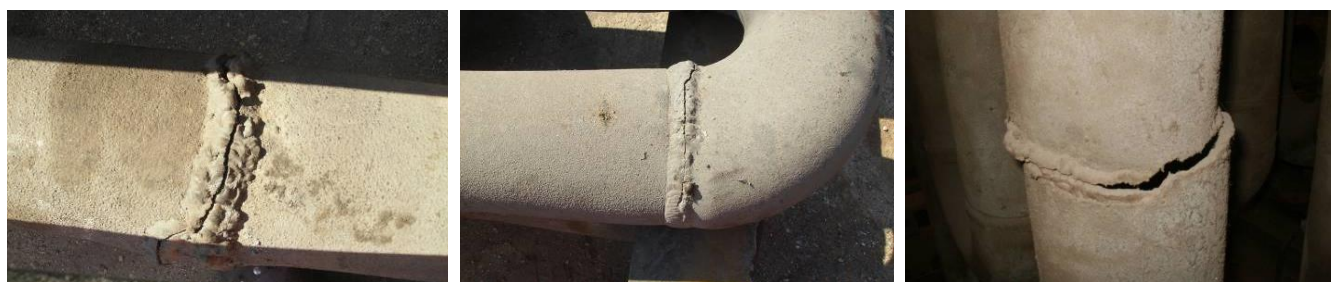
During the previous repair welding of burner pipes, electrodes containing 25% Cr and 20% Ni (in further text, electrodes type 25/20), i.e. electrodes PIVA 25/20 and INOX 25/20 B were used. Experience has shown that, for most welded joints, cracks will typically occur due to conditions under which the pipes are working (high temperatures and its cyclic change) which lead to crack initiation, most commonly encountered in the weld metal. Cases of burner pipes in which cracks occur along the welded joint length are shown in Fig. 4, as a very rare case in practice.

Figure 4. Cracks along the welded joint length in burner pipes.

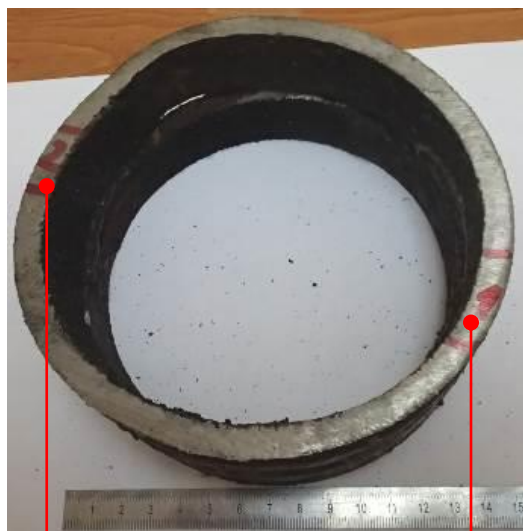
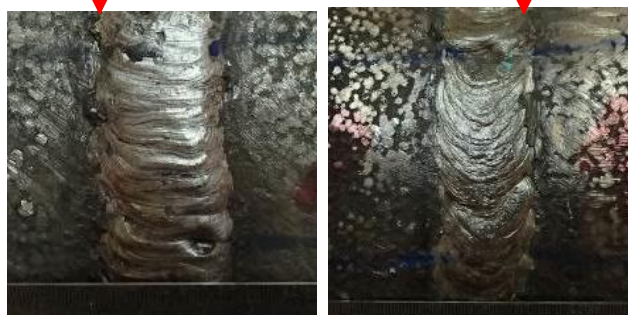
For the purpose of analysing the selection of filler metal for burner pipe repair welding, a parallel testing of welded joints is performed, wherein these joints are welded using 25% Cr and 20% Ni electrodes and Castolin 6825 electrodes. The pipes are welded using the two materials and specimens are taken from locations 1 and 2 (Fig. 5). These specimens are subjected to hardness tests, along with macro and microstructural analyses. Chemical compositions of electrodes used are shown in Table 2.

Figure 5. Location 1 (welded with Castolin 6825 electrode) and location 2 (welded with PIVA 25/20 B electrode) in pipes.
