Review of Innovative Rehabilitation Techniques for Reinforced Concrete Buildings

**Problem Report submitted to the
Benjamin M. Statler College of Engineering and Mineral Resources
at West Virginia University
in partial fulfillment of the requirements
for the degree of**

**Master of Science
in
Civil Engineering**

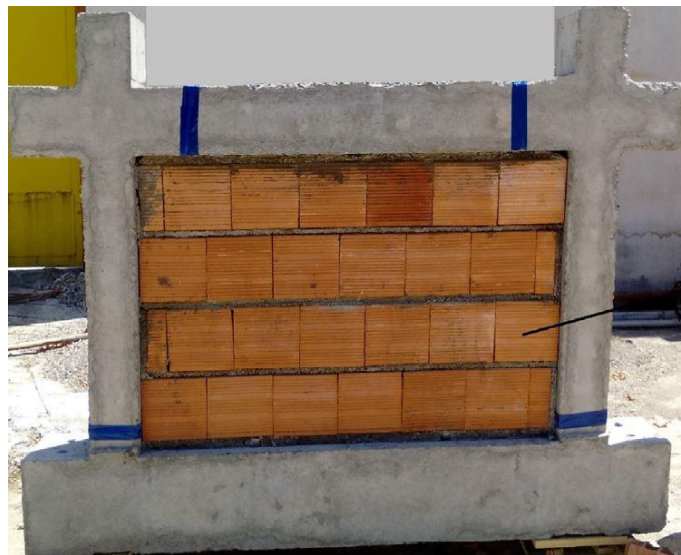
Figure 2.2 Masonry infill wall (Sharbatdar and Tajari 2021)

The presence of masonry infill walls in RC buildings can have both positive and negative effects on their seismic behavior. Infill walls are non-load bearing walls that are typically used between rooms as separation, and as outer walls to protect the building from the environment (Figure 2.2). The addition of infills to a frame contributes positively to the seismic behavior of the frame by increasing its lateral stiffness, lateral strength, and energy dissipation.

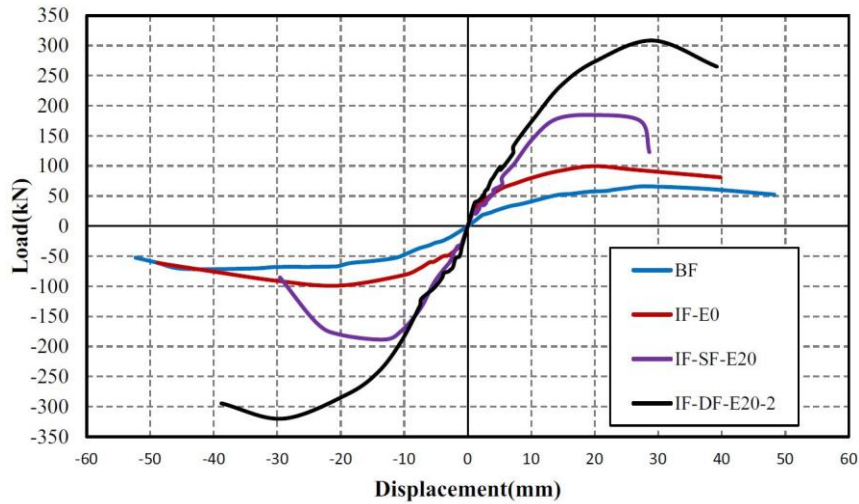
Figure 2.7 Load-displacement curves of test specimens. (Sharbatdar and Tajari 2021)

The results showed that, compared to the unreinforced infilled frame IF-E0, the reinforced frames IF-SF-E20 and IF-SF-E20-2, had 1.89 and 3.21 times the lateral load capacity, 1.00 and 1.32 times the initial lateral stiffness, and 0.86 and 2.02 times the cumulative energy dissipation respectively (Figure 2.7). The reduced energy dissipation of the IF-SF-E20 frame was due to an early shear failure of the infill wall (Figure 2.8), which also led to a reduced maximum displacement of 13.16 mm (4/8") compared to 19.86 (6/8") of the IF-E0, while the IF-SF-E20-2 had 28.90 mm (1 1/8").

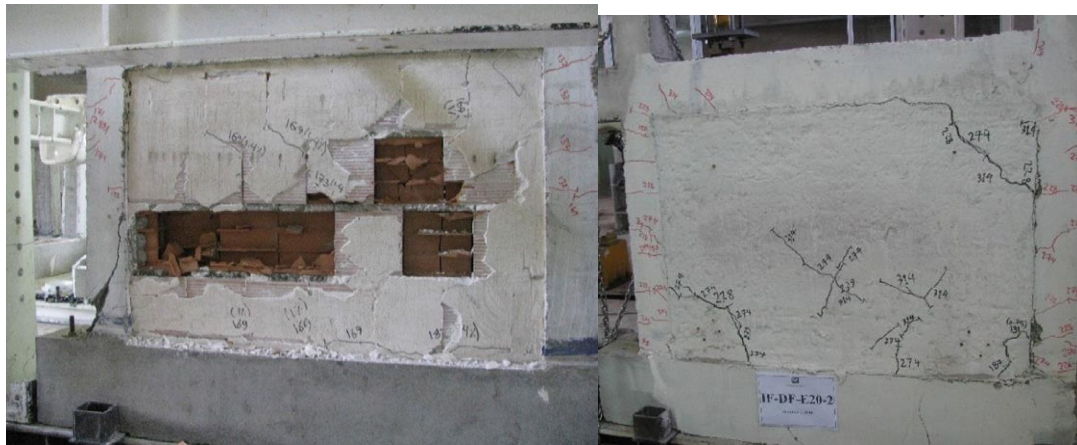
Figure 2.8 Left: Early shear failure of specimen IF-SF-E20. Right: Specimen IF-DF-E20-2 at failure. (Sharbatdar and Tajari 2021)

The ECC reinforcement also caused a reduction in the deterioration of the lateral stiffness of the frames, prevented severe local damages, and partially maintained the infill wall's integrity. Finally, the authors compared their test results with different analytical models for estimating an RC frame's initial stiffness and lateral load capacity and concluded that the Masonry Standard Joint Committee, the FEMA (2000), and the New Zealand seismic assessment standard methods had sufficient accuracy in predicting the initial stiffness, while the ASCE/SEI 41 (2017) method accurately predicted the lateral load capacity, but heavily overestimated the initial lateral load capacity.

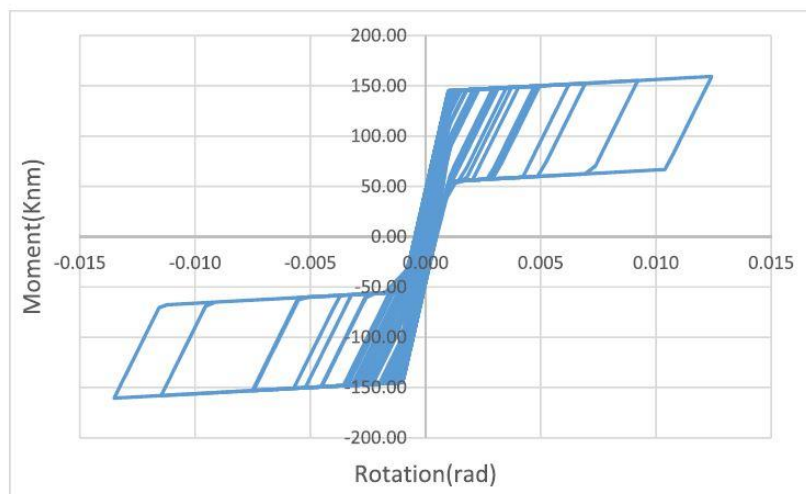
Figure 2.10 Flag-shaped hysteresis curve of the first floor of the 5-story building under the Loma Prieta earthquake. (Eldin et al. 2020)

of the modeled buildings, with the optimal yield strength of the friction dampers at each story of the buildings determined by a genetic algorithm. The results of the non-linear dynamic analyses showed the desirable flag-shaped hysteresis curve (Figure 2.10) and a significant reduction in the inter-story drift of the first floor in all cases, achieving the goal of the rehabilitation in all but the three-story building affected by the Northridge earthquake, where the inter-story drift of the first floor was reduced from 4% to 2.5%. The results of the incremental dynamic analyses showed improved fragility curves for the retrofitted buildings, with lower probabilities of reaching 1, 2, and 3% inter-story drift in all cases.

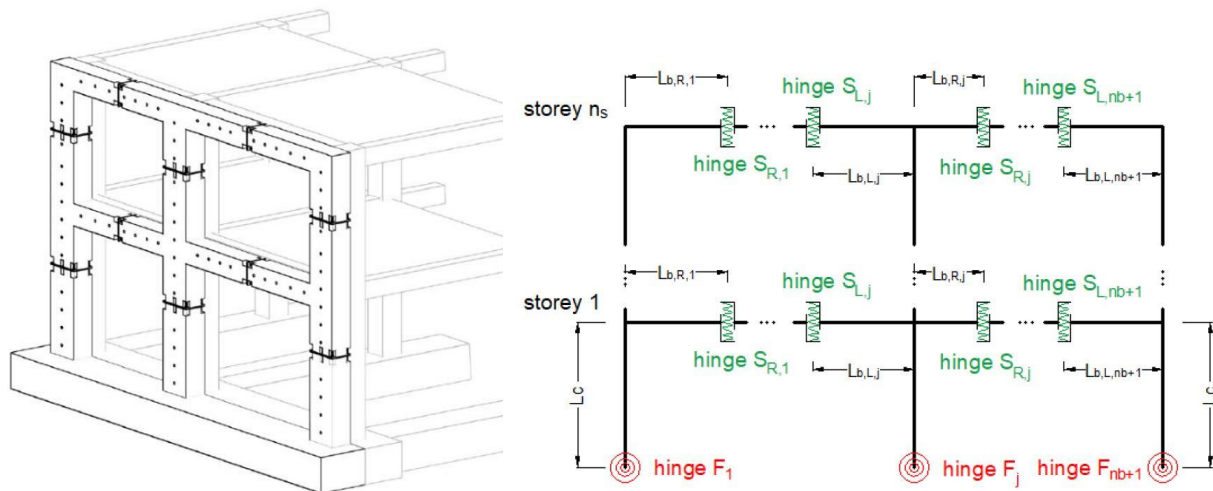
Figure 2.13 Left: 3D view of the exoskeleton of the original solution (Manfredi et al. 2021)

The pre-cast RC exoskeleton proposed in this article, referred to as the High-Performance Dissipating Frame (HPDF), is based on an original solution patented by the authors and presented in a previous article (Manfredi et al. 2018). The original solution consisted of pre-cast RC beam-column joint elements, with each element carrying half the span of its respective beams and columns and connecting with other elements through rigid steel connections. The exoskeleton would be based on a new foundation, independent from the existing structure's and it would be connected to the existing structure via shear connectors with epoxy resin at the beam-column joints (Figure 2.13 Left). The newer, improved solution replaces certain rigid connections with dissipating ones, namely the ones at the midspan of the beams with shear hinges and the ones at the base of the columns with flexural hinges while keeping the rest of the original solution intact (Figure 2.13 Right).

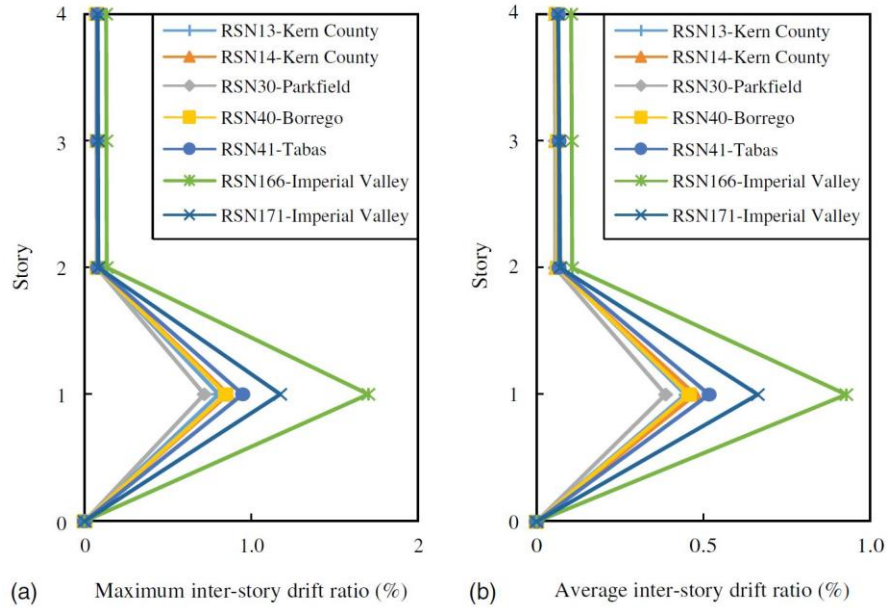
Figure 2.21 Interstory drifts after retrofit. (Javidan and Kim 2019)

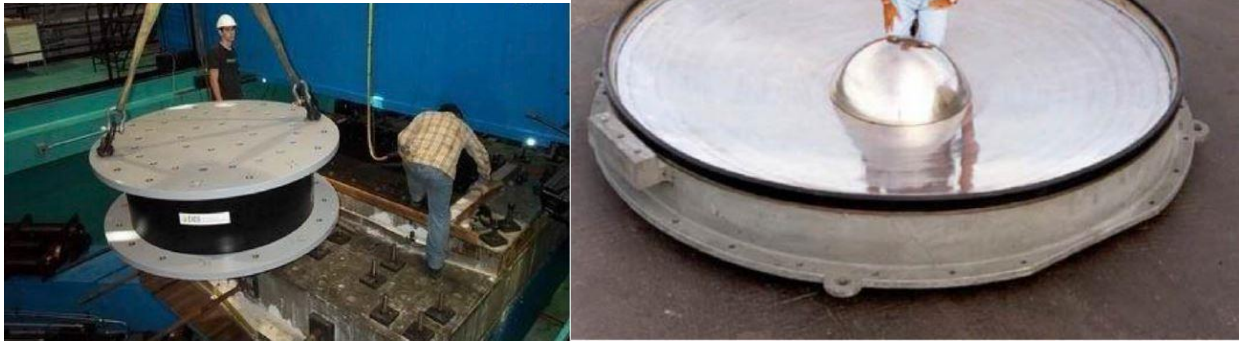
Figure 2.24 Left: Rubber bearing isolator with a diameter of 1300 mm, tested at the University of California, Berkeley (De Luca et al. 2019)

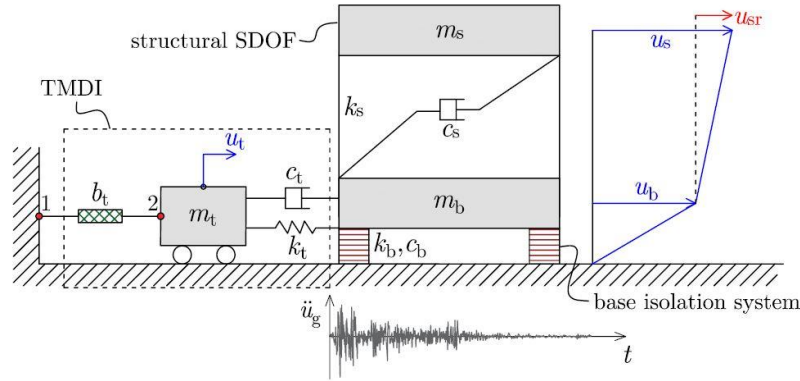
Figure 2.25 Sketch of the 3DOF system representing the proposed solution applied to a one-story SDOF building. (De Domenico and Ricciardi 2017)

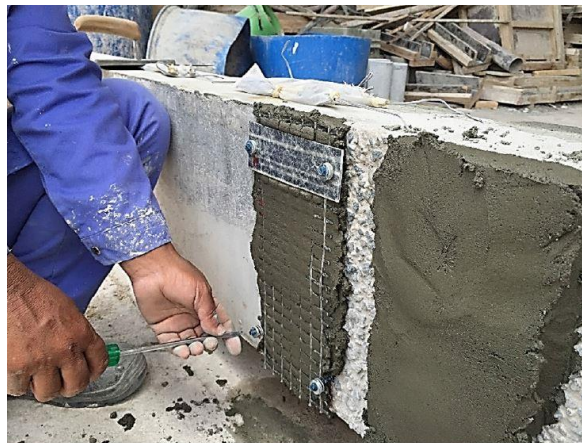
Figure 3.10 Application of the anchorage for the FRCM reinforcement. (Younis et al. 2017)

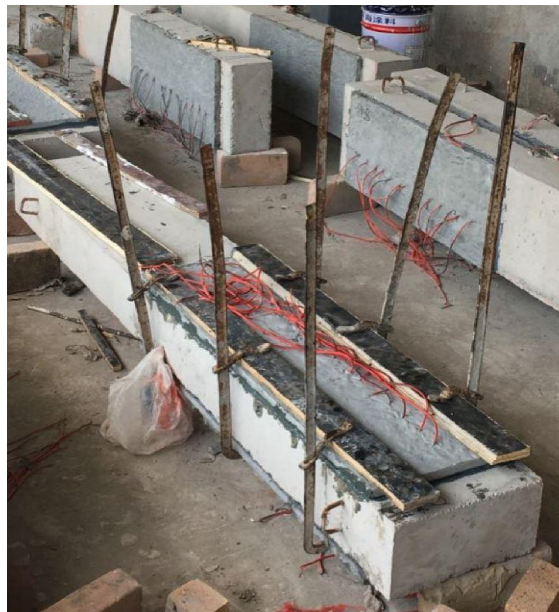
Figure 3.12 Installation of prefabricated strengthening layers. (Yang et al. 2020)

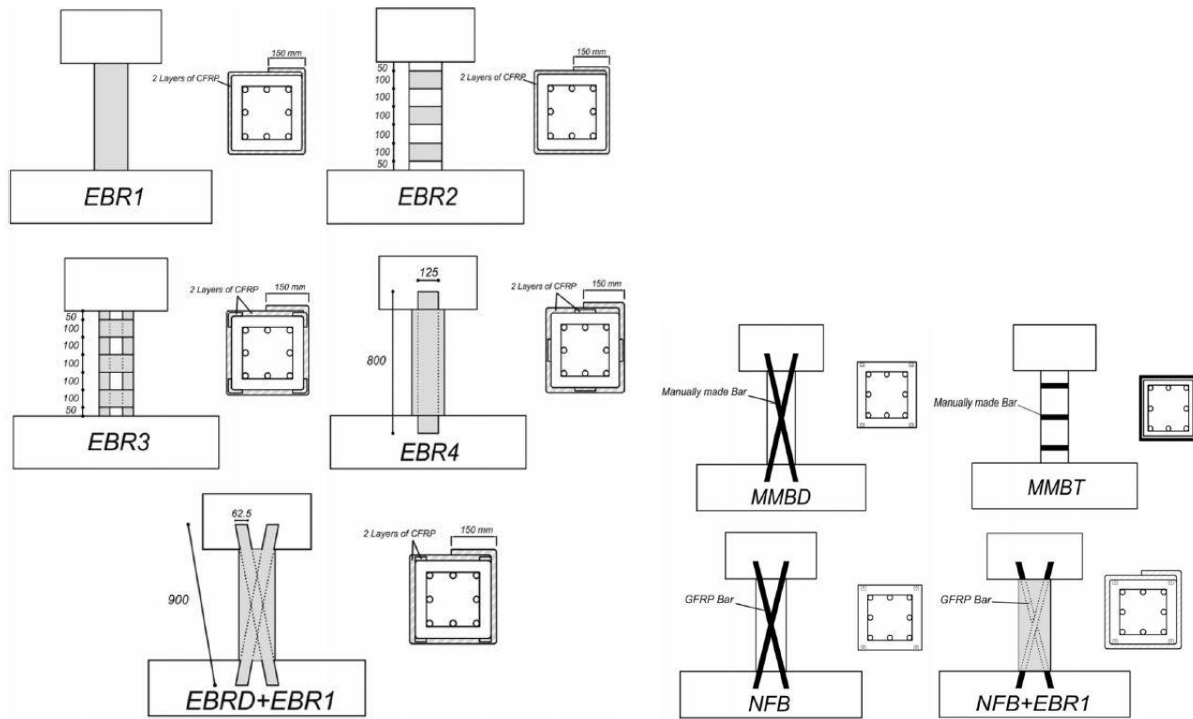
Figure 4.2 EBR configurations with the use of CFRP sheets and NSM configurations with the use of GFRP bars and manually made CFRP bars (Kargaran and Kheyroddin 2019)

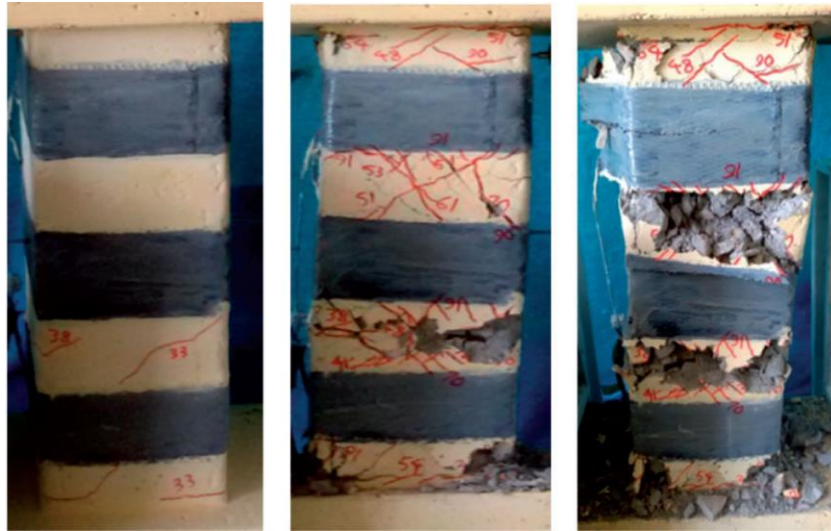
Figure 4.3 Damage and cracking patterns of specimen EBR2. (Kargaran and Kheyroddin 2019)

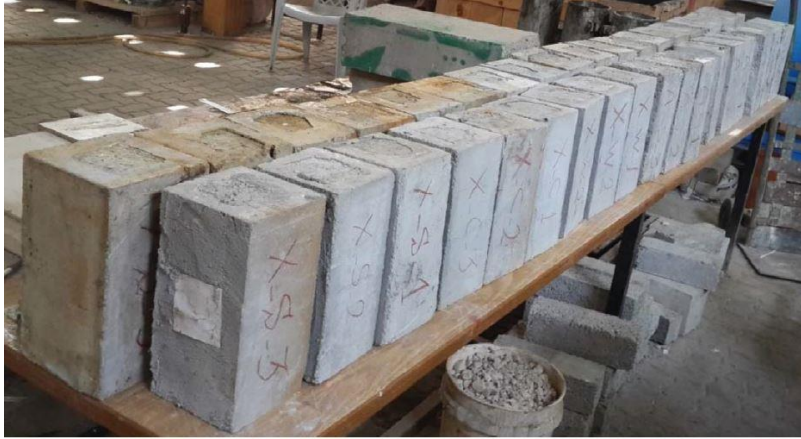
Figure 4.6 Test specimens. (Tayeh et al. 2019)

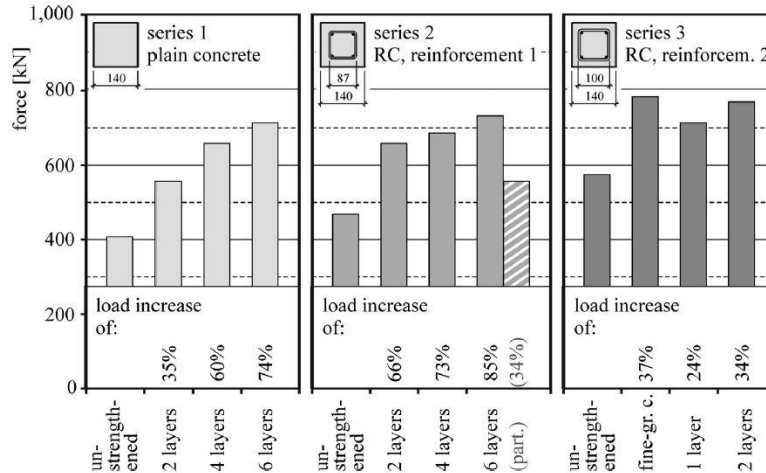
Figure 4.7 Results of the axial compression test (Ortlepp and Ortlepp 2017)

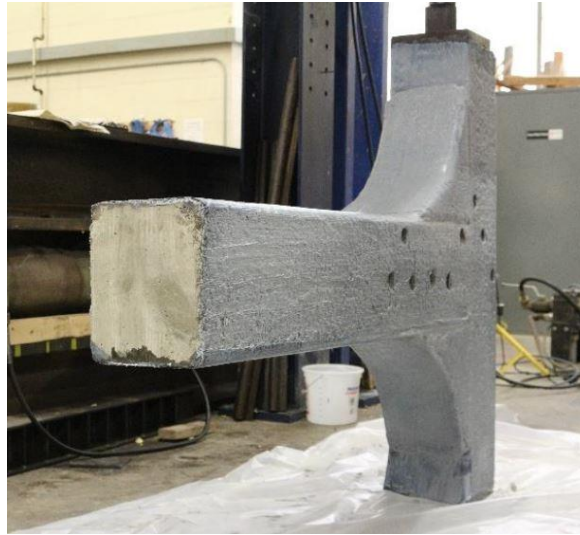
Figure 5.2 Specimen with a curve-shaped filler-module, coated with primer prior to the installation of FRP wraps. (Majjigapu 2020)
