Article

Heat and Moisture Relevant In Situ Measurements in a Railway Passenger Vehicle Driving through the Swiss Alpine Region

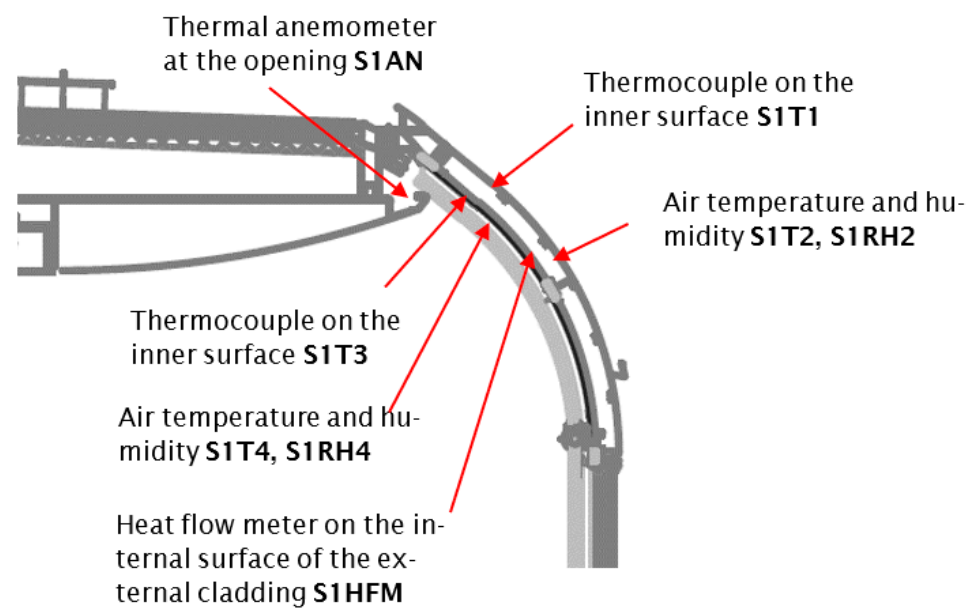
The structure of this area consists of the external cladding made of extruded aluminum profiles, 40 mm thermal insulation, and an air cavity of 16 mm between the thermal insulation and the interior cladding made of glass reinforced plastic (GRP). The sensors of this group are shown in Figure 3.

Figure 3. Type of sensors of Group S1 and their position in the vehicle.

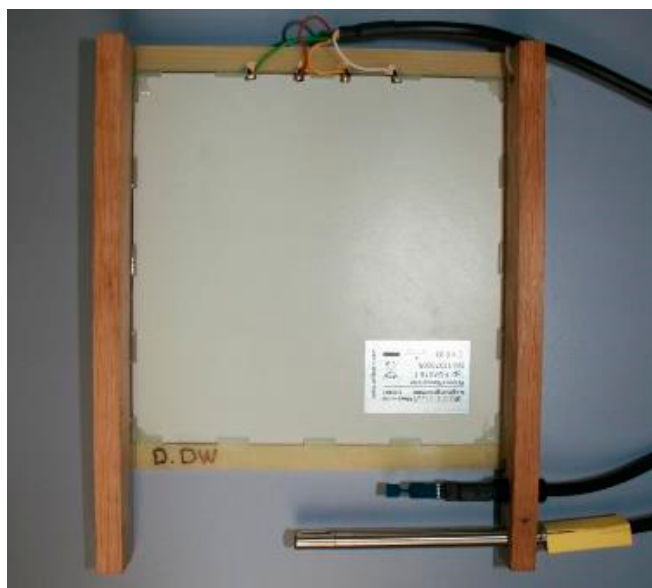
All other sensors were mounted using a frame with a bar (Figure 6). The whole unit was screwed or glued to the interior cladding. The bars in the frame are dimensioned in such a way that the heat flow plate is pressed lightly against the thermal insulation. This ensures a correct measurement of the heat flow without additional air gaps falsifying the results. The exact distance was determined by measuring the free space after the interior cladding had been dismantled.

Figure 6. Auxiliary construction for fastening the thermal anemometer (shiny metallic probe at the bottom), the heat flow plate (gray square), and the combined air temperature and relative humidity sensors (black) into their relative positions indicated in the previous figures.

This auxiliary construction has the following advantages:

- The frame material is made of pine/epoxy resin (for better strength);
- Recesses on the epoxy resin profile reduce the contact between the frame and the heat flow meter plate (Figure 6);
- The measurement is not influenced by highly thermally conductive materials;
- The heat flow through the aluminum cladding of the thermal insulation is reduced by the frame zone;
- The complete unit can be attached or glued to the interior cladding with two screws;
- The heat flow meter plate is pressed against the thermal insulation without gluing. The exact distance was adjusted to the specific proportions/dimensions by adjusting the bars before assembly;
- Rounded frame edges reduce damage to the thermal insulation and the aluminum cladding.

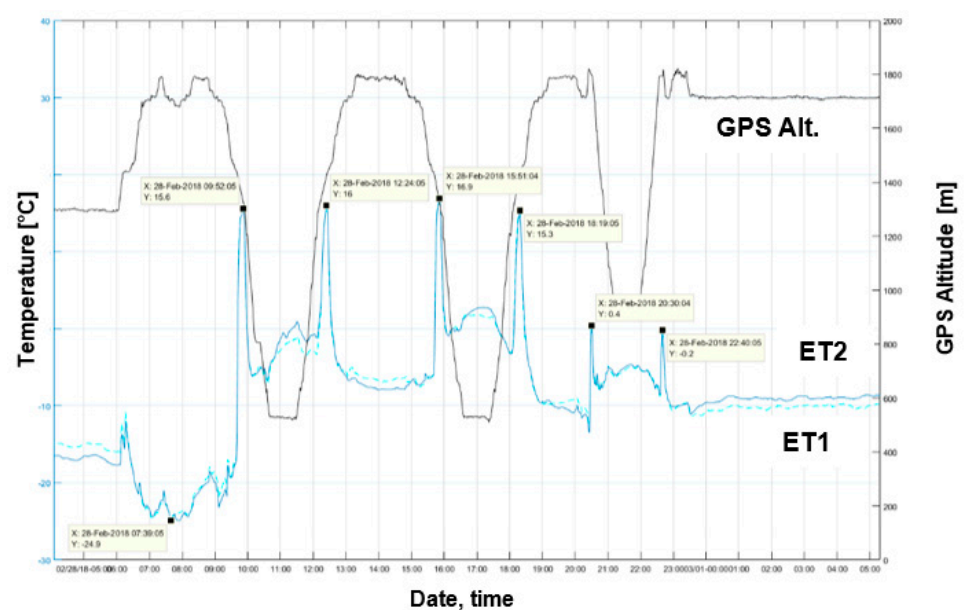
In periods of generally low outside temperatures, we repeatedly measure short periods of outside temperatures above 10 °C. Figure 10 shows this effect as an example for 28 February 2018. A spot check showed that this effect can be assigned to the tunnel passages through the Vereina Tunnel and the Albula Tunnel.

Figure 10. Measured external air temperature (ET1 and ET2, left y-axis) and GPS altitude (black, right y-axis) for the whole day of 28 February 2018.

09:52 a.m.: passage through the Vereina Tunnel in the direction of the Rhine Valley
 12:25 p.m.: passage through the Vereina Tunnel in the direction of the Engadin
 03:52 p.m.: passage through the Vereina Tunnel in the direction of the Rhine Valley
 06:18 p.m.: passage through the Vereina Tunnel in the direction of the Engadin
 08:30 p.m.: passage through the Vereina Tunnel in the direction of Tiefencastel
 10:40 p.m.: passage through the Vereina Tunnel in the direction of the Engadin

There is a slight difference between the two sensors **ET1** and **ET2** (dotted and full blue lines in Figure 10). This might be due to several factors, such as different local exposure to wind flow, solar irradiation, ice formation, or sensor accuracy. As they are considered as negligible, their discrepancy will not be followed further.

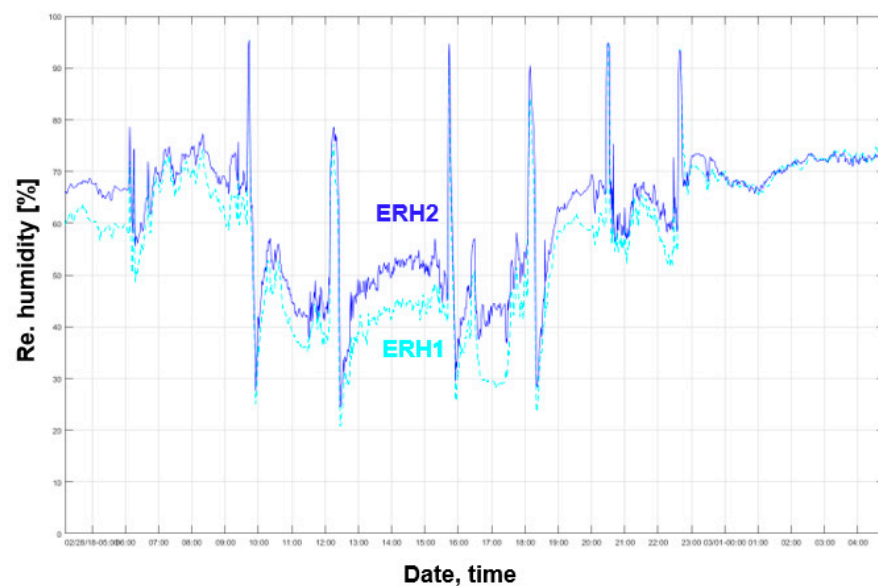
Similar to the external air temperature sensors, the corresponding humidity sensors (ERH1, ERH2 in Figure 13) show slightly different values, which can be neglected in the further discussion of the results.

Figure 13. Measured relative humidity of the external air ERH1 and ERH2 (see Figure 7).

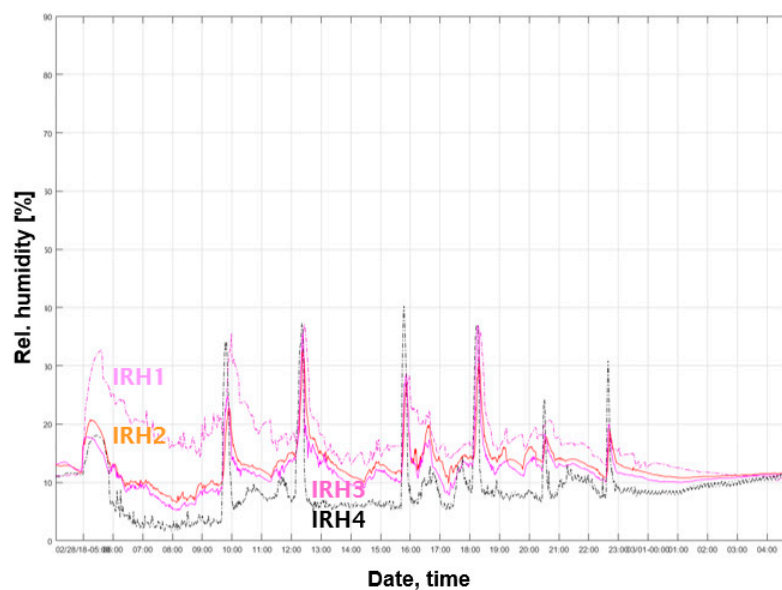
The relative humidity at the measuring points in the passenger compartment (sensor humidity **IRH2** and sensor humidity **IRH3**) differs only slightly (Figure 14). The evolution of the two values also has similar characteristics. Slight deviations are to be expected due to air currents in the compartment, temperature stratification of the air horizontally and vertically, and different distances between the sensors, the compartment door, and the passengers.

**Figure 14.** Measured relative humidity of the internal air IRH1, IRH2, IRH3, and IRH4.

The relative humidity in the luggage compartment (humidity sensor **IRH1**) differs significantly from the relative humidity in the passenger compartment (Figure 14). This can be explained due to the fact that the luggage compartment is directly exposed to the opening and closing of the outer door. The evolution of the relative humidity in the luggage compartment and in the passenger compartment differs in detail, but not fundamentally. This indicates that the relative humidity in the vehicle is massively influenced by the humidity of the outside air.

The relative humidity measured in the air duct (humidity sensor **IRH4**) also differs significantly from the relative humidity in the passenger compartment and in the luggage compartment (Figure 14). This can be explained by the fact that the air in the supply air duct comes directly from outside and has not yet been exposed to any influences in the passenger compartment. In the case of significant changes in humidity, however, the course of the measured values over time is very similar at all 4 measuring points. This indicates that the relative humidity in the vehicle is massively influenced by the humidity of the

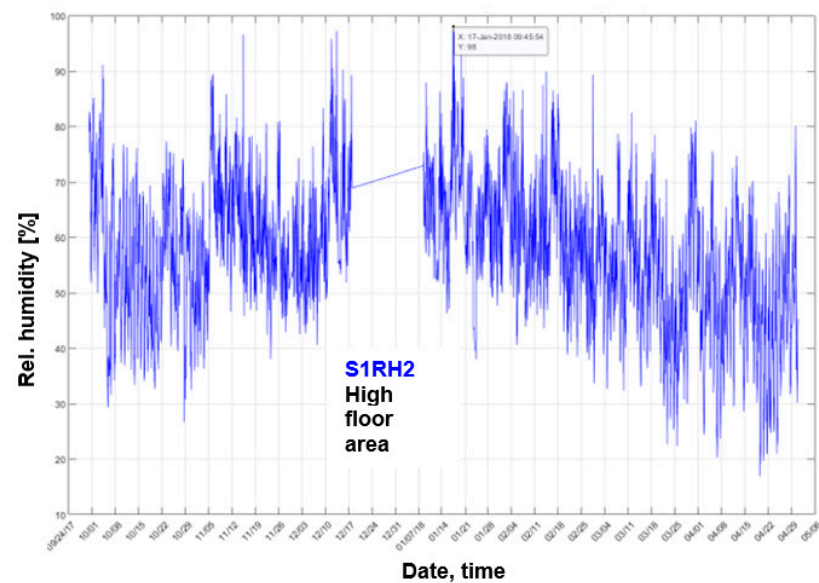
In the passenger compartment (high-floor area and low-floor area, see Figure 2), critical relative humidity (above 90%) is only reached at a few points for a short period of time, as can be seen in Figures 15 and 16. The roof area of the luggage compartment has the greatest potential for condensation to form. Here, the number and periods of conditions critical for condensation formation are more frequent and longer than in the passenger compartment (Figure 16). However, the number and duration of periods with critical conditions for condensate formation are also extremely low at this position.

Figure 15. Measured relative humidity S1RH2 (see Figure 3) on the roof of the high floor area (see Figure 2) during the monitoring period, including the measurement gap mentioned previously (3.1).

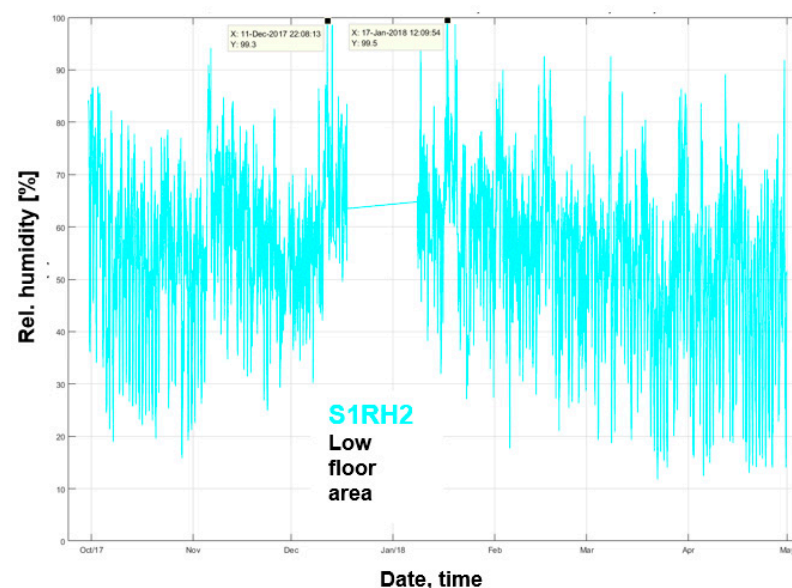
Figure 16. Measured relative humidity S1RH2 (see Figure 3) on the roof of the low floor area (see Figure 2) during the monitoring period, including the measurement gap mentioned previously (3.1).

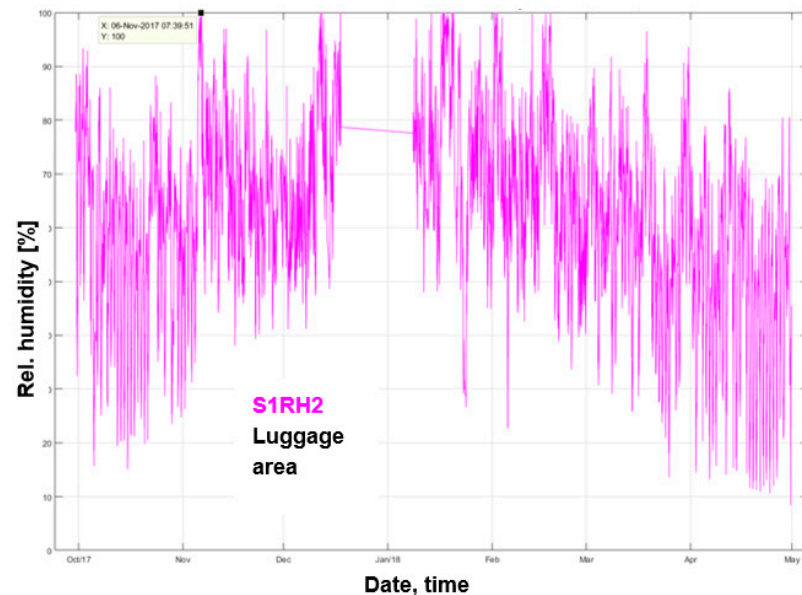
Figure 17 shows that periods of critical moisture conditions are always followed by periods of significant drying. If condensation occurs at all at this measuring position, this is only short-term and does not lead to permanent moisture build-up at this position.

Figure 17. Measured relative humidity S1RH2 (see Figure 3) on the roof of the luggage area (see Figure 2) during the monitoring period, including the measurement gap mentioned previously (3.1).

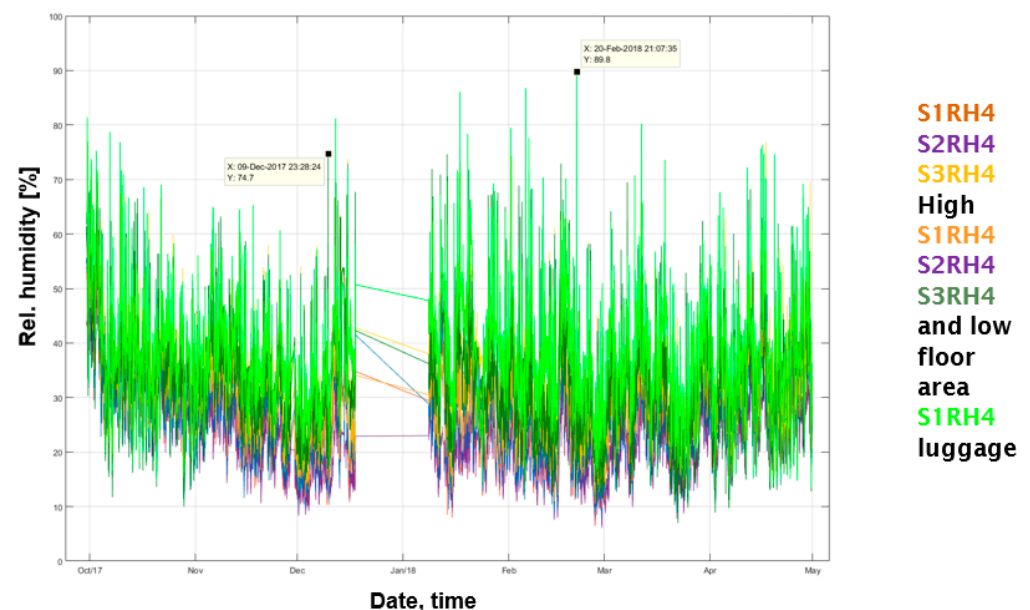
At the measuring points where the relative humidity of the air layers close to the surface of the interior lining is measured S1RH4, S2RH4, and S3RH4 (in Figures 3–5, respectively) we did not measure any values during the evaluation period that would indicate the formation of condensation on the interior lining (Figure 18). Here too, we measured values for relative humidity in the wall area above the windows, the luggage compartment, the low-floor area, and the high-floor area, in diminishing order.

Figure 18. Measured relative humidity S1RH4 (Figure 3), S2RH4 (Figure 4), and S3RH4 (Figure 5) of the high and low floor areas (Figure 2) and in the luggage compartment during the monitoring period, including the measurement gap mentioned previously (3.1).

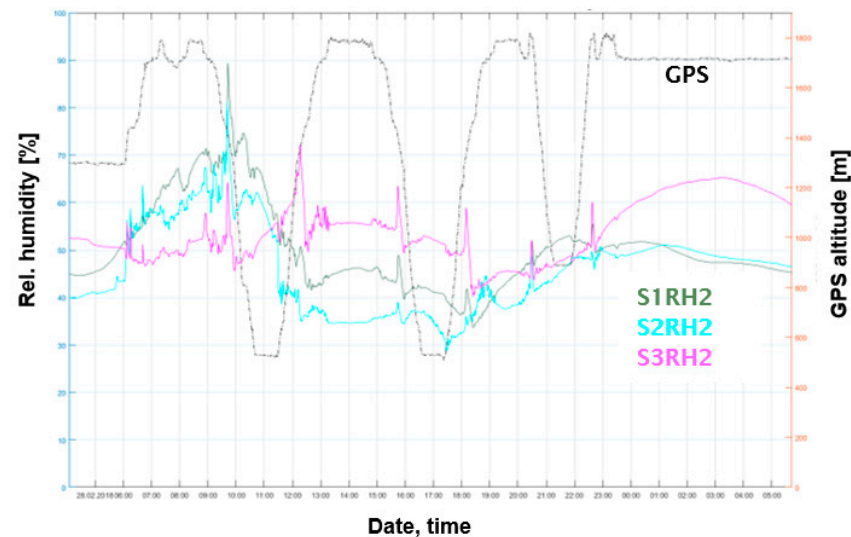
The passage through the tunnels (Vereina Tunnel and Albula Tunnel) led to an increase in the relative humidity in the vehicle wall, which varied in intensity at the different measuring points. The increase in relative humidity remained in a non-critical range (Figure 19).

Figure 19. Measured relative humidity S1RH2 (Figure 3), S2RH2 (Figure 4), and S3RH2 (Figure 5) for 28 February 2018.

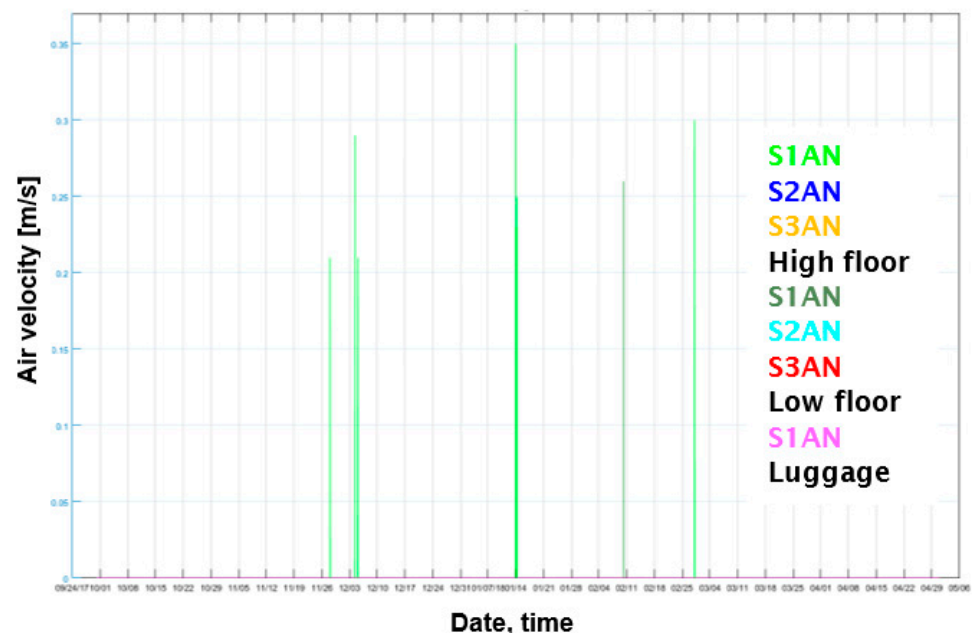
As Figure 21 shows, out of seven anemometers measuring air movements, only two showed some relevant values, and these lasted for only short periods of time between 4 and 10 min. This is a clear indication that no convection effects occur in the air cavities of the vehicle envelope; hence, no moisture transport is foreseeable from the warm interior to the cold surfaces.

Figure 21. Measured air velocity by anemometers S1AN (Figure 3), S2AN (Figure 4), and S3AN (Figure 5) in the three areas: high floor, low floor, and luggage compartment (Figure 2).

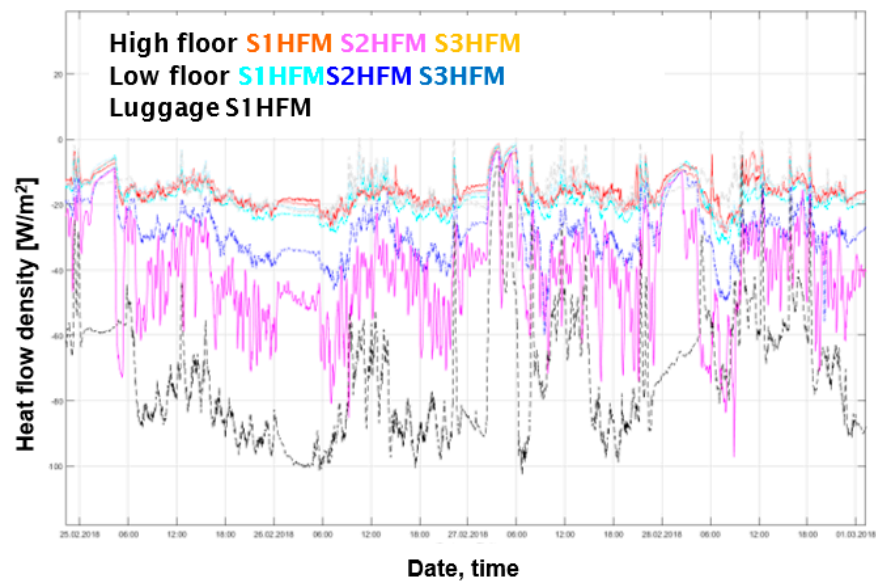
The heat flux densities are close to each other in 5 of the 8 heat flow plates. We measure significantly increased heat flow densities with 3 heat flow plates (Figure 22).

Figure 22. Measured heat flow densities S1HFM, S2HFM, and S3HFM through the vehicle walls (high floor, low floor, luggage compartment) for the period between 25 February 2018 and 1 March 2018.

Two heat flow plates with increased heat flow densities are located in the parapet area of the low-floor and high-floor areas (Figure 22). This corresponds to the temperatures measured in the high floor area (Figure 12) and our statement regarding increased heat losses at these points. A heat flux plate with a greatly increased heat flux density is located in the area next to the luggage compartment window (Figure 22). There was no immediate explanation for this high heat flow density from the measured temperatures. When installing the BFH measuring device, we found that the thermal insulation in this area was less thick than in the passenger compartment. This explains the deviating behavior with regard to the heat flow density at this measuring point.
