Construction and Building Materials

Focus on soluble salts transport phenomena: The study cases of Leonardo mural paintings at Sala delle Asse (Milan)

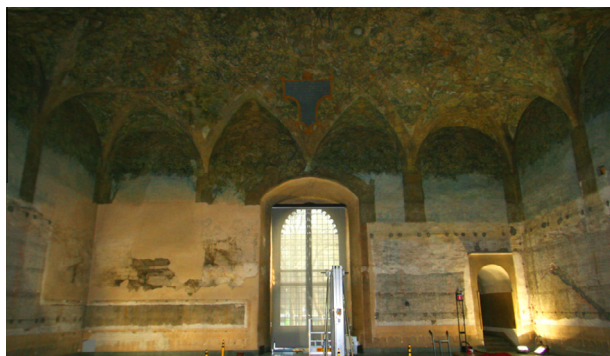
Fig. 2. Sforza Castle. Milan. Sala delle Asse, view of the north eastern side, with the monochrome on the left and with part of the vault, before restoration (December 2012).

the two walls (Fig. 2). In 1954–56, Ottemi Della Rotta removed most of the Rusca's over-paintings with the aim of showing better the layers underneath; he used very invasive mechanical cleaning and, furthermore, he did not document the used methods.

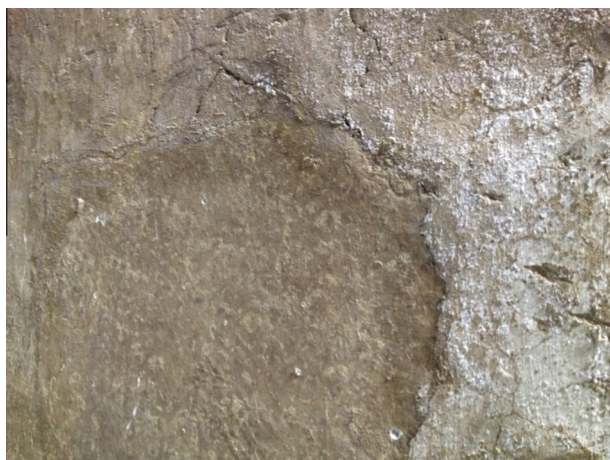
Fig. 3. Sample 1 C. Monochrome wall: white efflorescences are mainly located alongside the border of a patch composed of a different cement mix compared to the surrounding matrix.

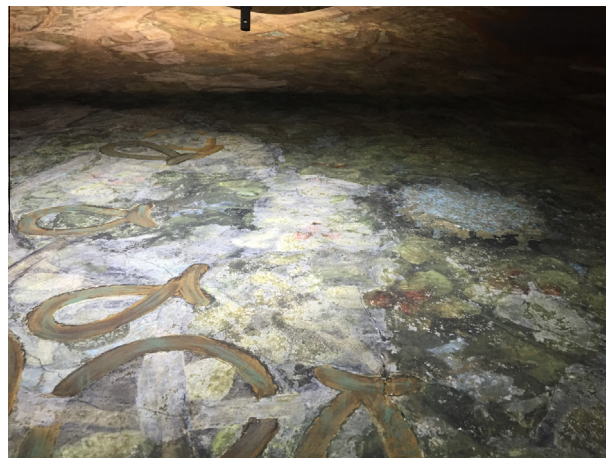
Fig. 4. Polychrome vault: white efflorescences are unevenly distributed forming a whitish covering layer.

At present, the poor condition of the paintings require a thorough intervention, especially, the monochrome decoration on the northwestern and northeastern walls, certainly painted by Leonardo himself: the assessment results are that soluble salts efflorescences whitened the surface, altering the pictures and endangering the plaster cohesion. Whitish formations are mainly located on the right part of the wall with the monochrome by Leonardo, even if their distribution is also on several other parts such as the vault, their micro-distribution is quite peculiar; in fact, they are concentrated in the ancient plaster close to the modern plaster patches (Fig. 3). Soluble salts whiten the painting with a thin powdery layer not present on the ribbons' decorative elements (Fig. 4); at closer observation, it is possible to see crystals aggregates in slight relief compared to the painting surface (Fig. 5).

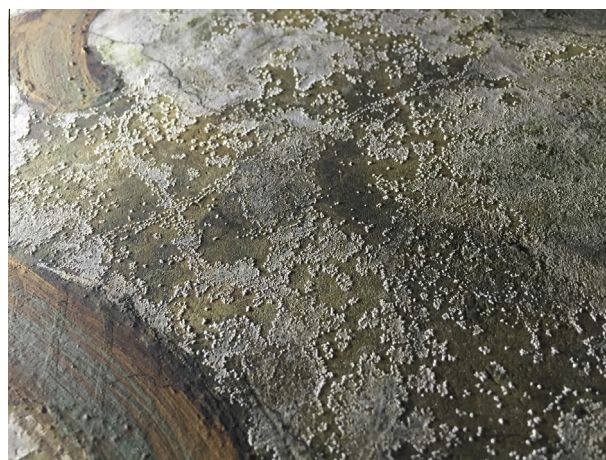
Fig. 5. Polychrome vault: soluble salt crystal aggregates morphology.

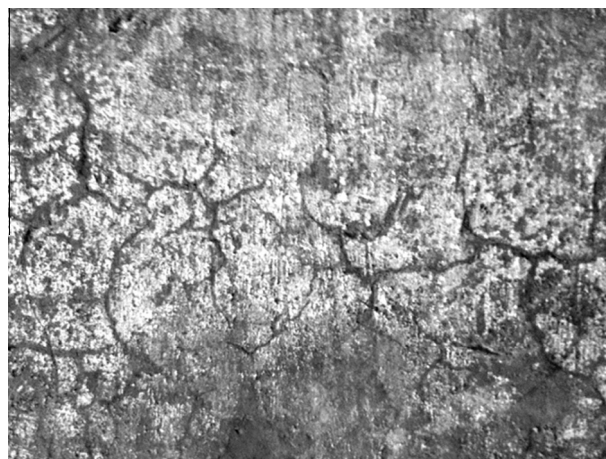
Fig. 6. Sample 1. White efflorescence analysed by X Ray diffraction (see Fig. 7).

Documentation regarding the assessment of materials and their state of conservation [5] permit to hypothesize that the paintings require a complex, urgent, articulated intervention above all for the safeguard of the remaining Leonardo monochrome fragments (see Fig. 6).

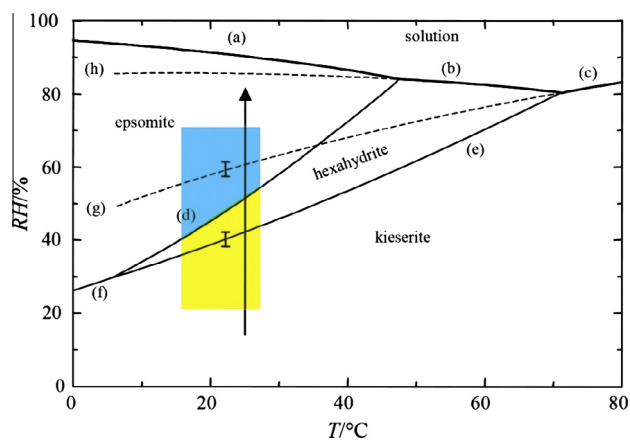
Fig. 17. Deliquescence behaviour in the system $MgSO_4-H_2O$. The relative humidity RH is plotted versus the temperature. The yellow strip indicates the span results of T °C and RH in Sala delle Asse between 2012 and 2015: the discussion of results will deal with the events occurring only at $T > 21.5$ °C (only at this condition, the phase is steady).

The diagram of the magnesium sulphate phases (Fig. 17) shows the crystallization curves of all the magnesium compounds.

Because of the thermal dynamic instability of kieserite ($\text{MgSO}_4 \cdot 4\text{H}_2\text{O}$), the calculation of the changes of phase is limited to the upper line which divides light-blue and yellow areas, in the span of RH and T values resulting from the monitoring of
