HYDRO-GEOTECHNICAL ROCK SCOUR ASSESSMENT AT PETIT-SAUT DAM

Key words: Scour, Rock, Hydro-geotechnical scour assessment.

Summary. This paper presents a recommended design procedure for assessment of rock scour which is illustrated for the case study of Petit-Saut Dam in French Guiana. The methodology, referred to as a “hydro-geotechnical scour assessment”, promotes a multi-discipline approach, applying expertise in both rock mechanics and hydraulics, and guides the diagnosis of scour and response to risk by application of currently available scour assessment techniques.

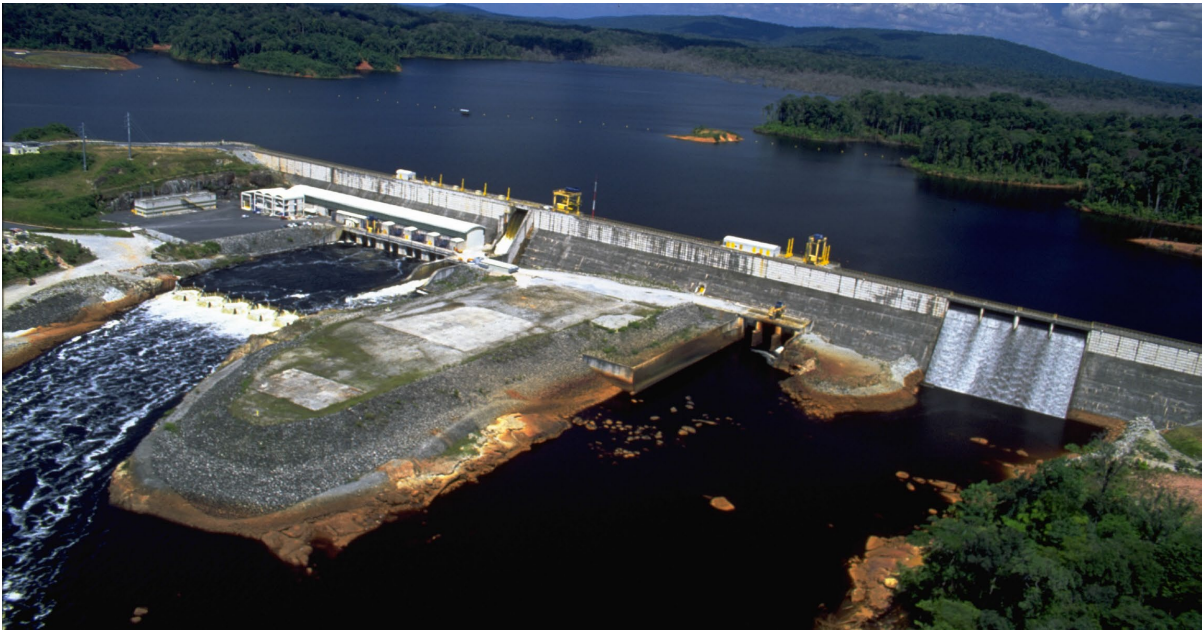
Figure 2: Overview of Petit-Saut Dam (1 July 1995).

The primary dam at Petit-Saut is a roller compacted concrete gravity structure, 740 m long and with crest elevation of 37m NGG and a maximum height 44 m. A photographic overview of the dam is shown in Figure 2. The dam features four (4) outflow locations (Figure 3):

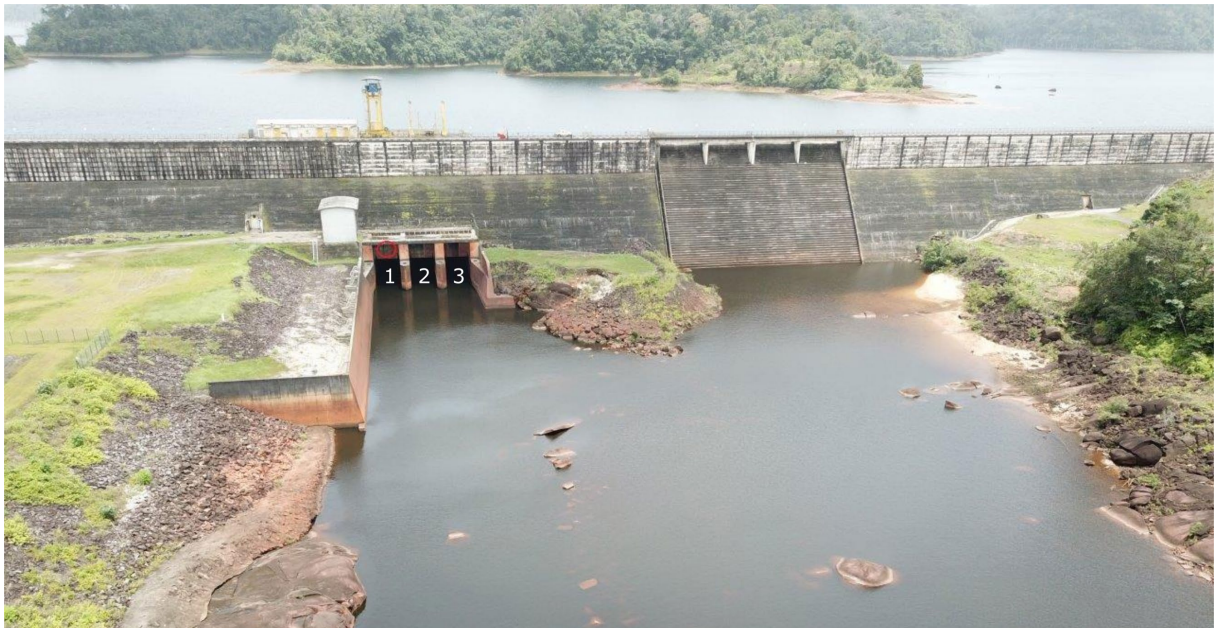
Figure 4: View of bottom outlet (showing numbering convention) and overflow spillway (1 July 1995).

The bottom outlet is the focus of this paper. It comprises three gated outlets, with numbering convention as shown in Figure 4. Each gated outlet is 7 m width and 6.7 m high. Flow is controlled by sluice gates – there is an upstream guard gate (usually open) and a downstream service gate, which is manipulated to control flows. Whereas the power station discharges are released into a constructed tailrace, flows from the bottom outlet are released to the right bank of the original river channel. A concrete wall retains earth and rock materials on the right bank for a distance of approximately 80 m downstream of the bottom outlet, as seen in Figure 4.

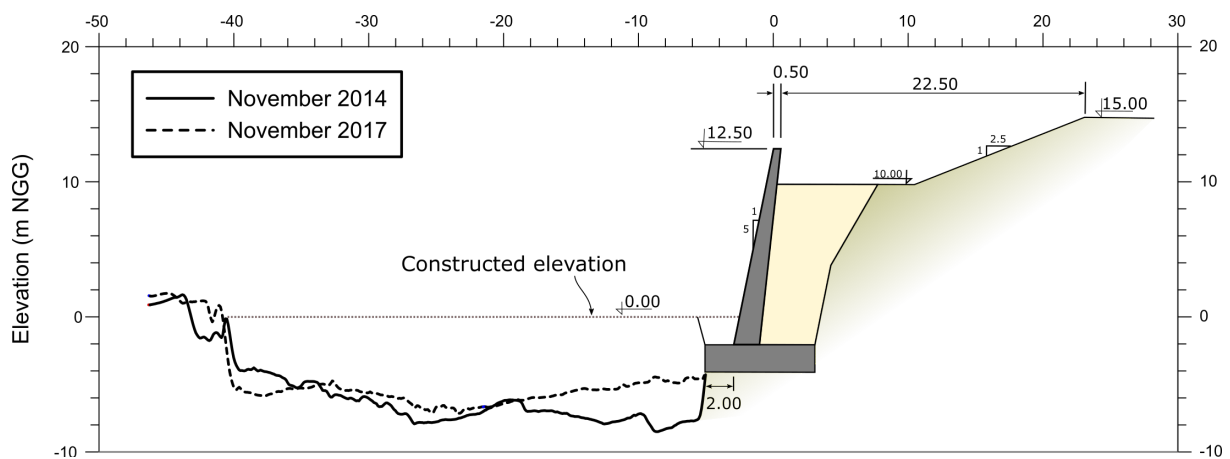
Figure 7: Cross-section through bottom outlet looking downstream, 2014 elevation.

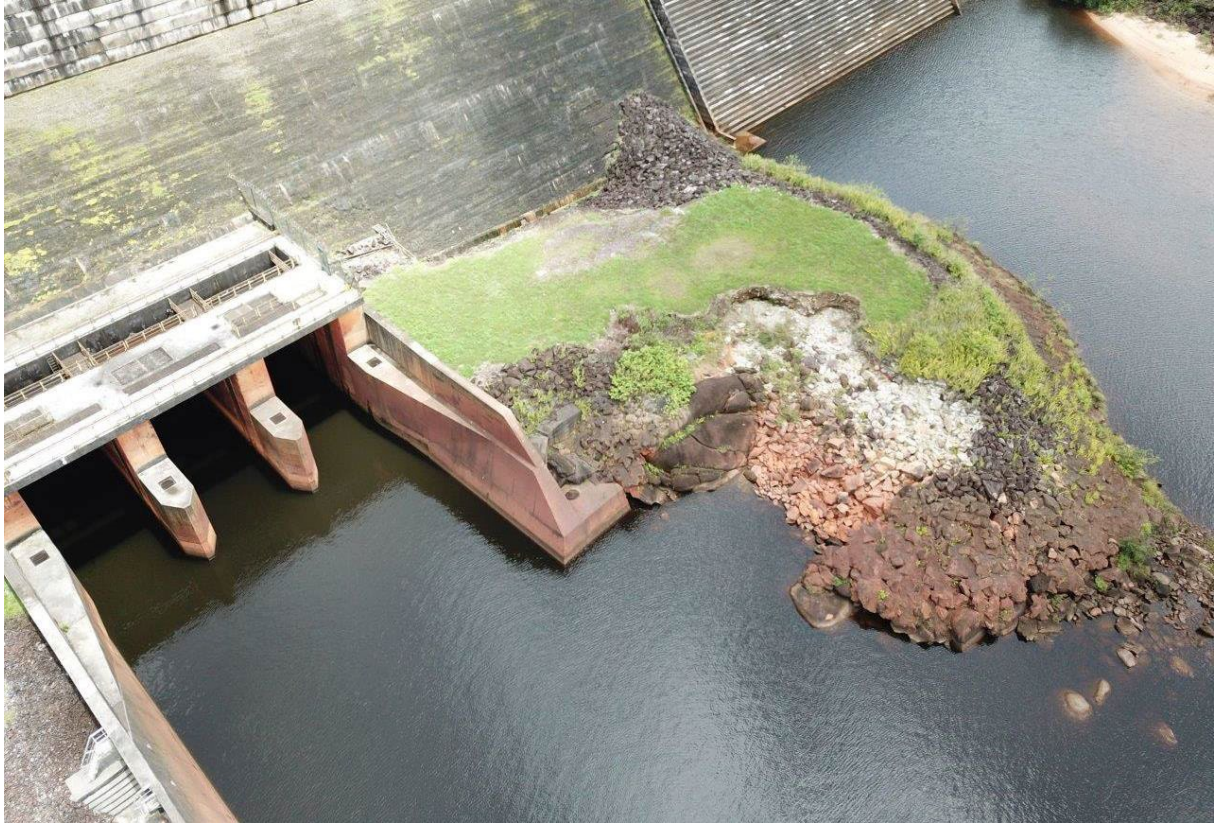
Figure 8: Erosion of the left bank to the bottom outlet (2018).

- A pile of loose rubble located at the left bank is visible in the 2014 survey, interpreted to be derived from erosion extending laterally into the left-hand bank (**Figure 8**). In the 2017 survey, the rubble adjacent to the left-hand bank was removed with a corresponding accretion of rubble at the right bank in the 2017 survey. This is

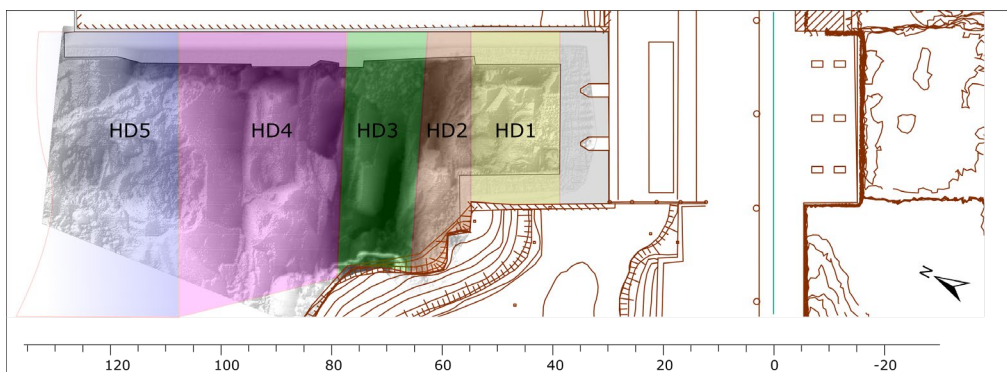
Figure 12: Interpreted hydraulic domains.

Five different hydraulic domains (HD) were defined as shown in Figure 12. Assessed hydraulic indices for each HD is presented in Table 2. The following observations are made on the results from FLOW3D:
