Biomechanical Behavior of a Variable Angle Locked Tibiototalcaneal Construct

Abstract: This paper examines the mechanics of the tibiototalcaneal construct made with a PHILOS plating system. A failed device consisting of the LCP plate and cortical, locking, and cannulated screws was used to perform the analysis. Visual, microstructure, and fractographic examinations were carried out to characterize the fracture surface topology. These examinations revealed the presence of surface scratching, inclusions, discoloration, corrosion pits, beach marks, and cleavage and striations on the fracture surface. Further examination of the material crystallography and texture revealed an interaction of S, Ni, and Mo-based inclusions that may have raised pitting susceptibility of the device made with Stainless Steel 316L. These features suggest that the device underwent damage by pitting the corrosion-fatigue mechanism and overloading towards the end to fail the plate and screws in two or more components. The screws failed via conjoint bending and torsion fatigue mechanisms. Computer simulations of variable angle locking screws were performed in this paper. The material of construction of the devi

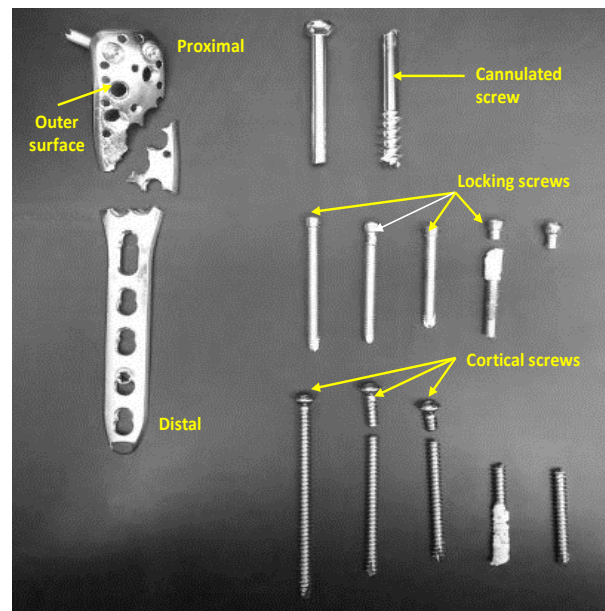
Figure 1. PHILOS Plating System failed parts.

The analysis of the tibiototalcaneal construct made with the PHILOS plating system (Figure 1) has been discussed in previous efforts; the plate and the screws were investigated separately [17,18]. This paper further elucidates the quantitative topography of microstructure and texture, damage mechanisms such as pitting and computational evaluations of loading and resulting stresses. In addition, we hypothesize that the angle of inserting the screws in the plate and the distance of the screw from the loading surface might affect the stress distribution and total displacement of the PHILOS plate, therefore the biomechanics of variable angle locking screws construct was performed with representative models investigating thirteen different insertion angles (0° , 5° , 10° , 15° , 20° , 30° , 40° , -5° , -10° , -15° , -20° , -30° , and -40°) and three different positions. The results from finite element analysis were used to develop the fatigue analysis using the traditional Paris equation and attempts made to interpret the crack nucleation phase controlled by the pit aspect ratio and crack propagation life estimated.

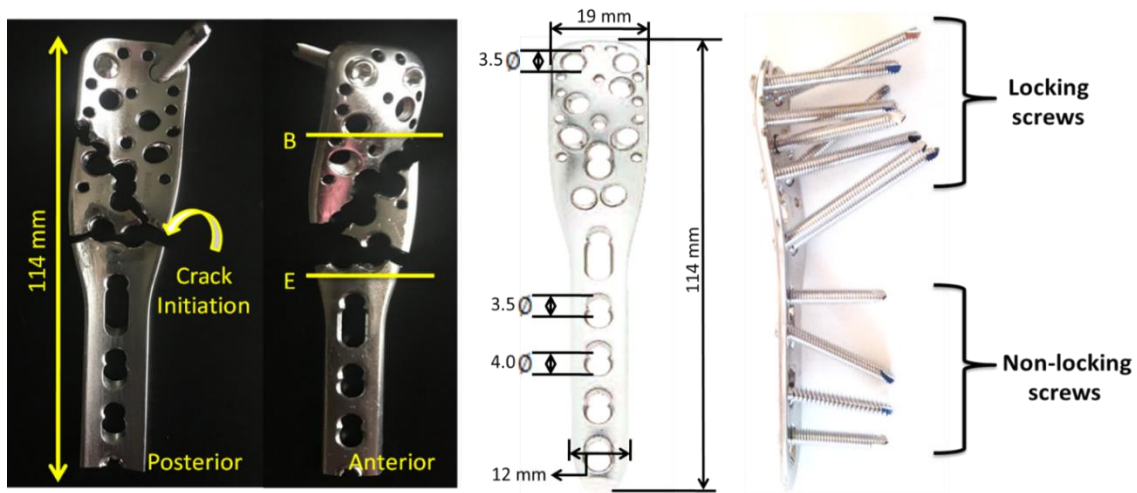
Figure 2. Anterior and posterior views of the PHILOS plate divided into six levels (A–F) showing the geometry, dimensions, and locking and nonlocking screw locations on the plate.

We divided the investigation of the PHILOS plate into six levels (A–F), as shown in Figure 2. Additionally, investigation on the screws was performed as well to understand the effect of screws on the failure of the PHILOS construct. The screws that have been investigated with SEM were CS1 (the proximal cortical screw), CS2 (the distal cortical screw), LC (the locking screw inserted at level C), and LE (the locking screw inserted at level E). Fractography was performed using FEI Quanta 650, at 15 kV, spot size 3, and aperture 30 μm .

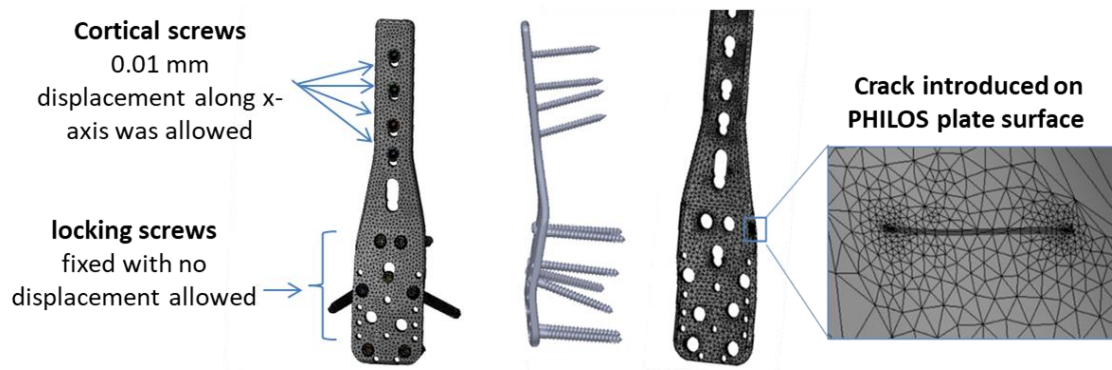
Figure 3. The PHILOS plate and crack meshing showing the locking and cortical nonlocking screw position and angle.

The stresses on the PHILOS construct vary continuously during the gait cycle resulting from activities of daily living such as walking or stairs climbing. This variation combined with bone friction against the plate and screws can initiate fatigue crack in the PHILOS construct. Inside the human body the pH value changes, so do temperature and load with activities, and these environments have been proven to cause corrosion of implants and fatigue cracking under cyclic loading. It is well known that fatigue precedes an incubation period which is both cycle and time-dependent. However, pit aspect ratios of sufficient size can form a crack which may propagate under steady-state condition or lead to tertiary crack propagation phase where abrupt failure may occur. To understand how the crack nucleates and propagates, a surface crack with different lengths was introduced in the modeling. In relation to the stress intensity factor present at the crack tip of the PHILOS plate under the same loading and boundary conditions used in Hamandi et al. [18], namely K_I , those were determined from the FEA. One semi-elliptical crack was introduced on the surface of the plate at level E of the plate (Figure 3) simulating almost straight through-the-thickness cracks. Hence, cracks with an arc-length of 1 mm were introduced with four different aspect ratios ($a/2c = 1, 0.8, 0.6, 0.4$). The material properties were defined as elastic, homogeneous, and isotropic, with Young's Modulus equal to 200 GPa and a Poisson's ratio equal to 0.265. X-ray image of the PHILOS construct after two years, 3D model, boundary conditions, and loads are shown in Figure 4. The tetrahedral element type was applied to the model with approximately 94,000 nodes and 55,000 elements with the use of convergence tools in ANSYS Workbench 19.2 (ANSYS Inc., Canonsburg, PA, USA) with five percent convergence, and the meshing around the crack geometry was modified to a fine mesh.

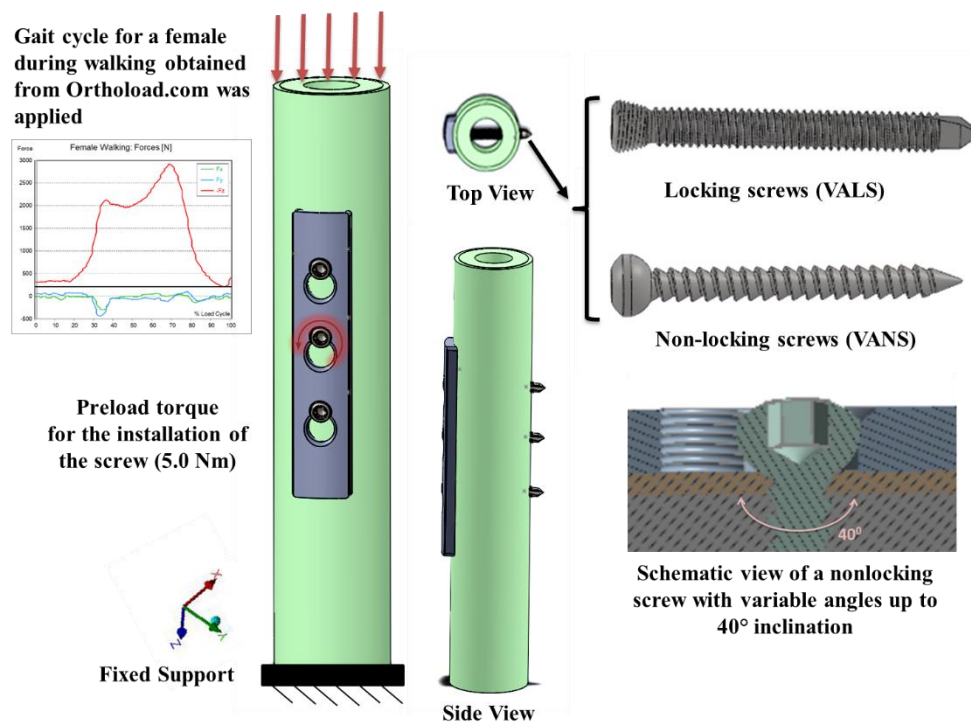
Figure 5. The 3D model of the bone, plate, and screws. Schematic view of a nonlocking screw with variable angles up to 40° inclination. Gait cycle for a female during walking obtained from Orthoload.com.

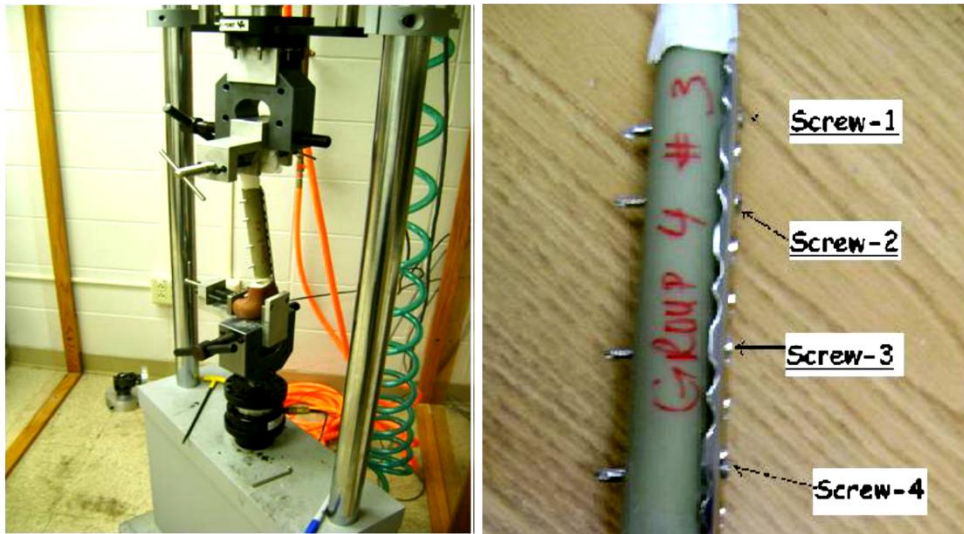
Figure 6. The synthetic bone with plate fixation in the EnduraTEC BOSE machine (left). The bone shaft showing the plate and screws [22] (right).

Experimental work performed at Miami Valley Hospital/Biomechanics Laboratory, Dayton, OH, included twenty synthetic bones [22] was compared with the proposed model, Figure 6. This comparison focuses on comparing the effect on the bone other than the plate and screws, as it was very important to investigate the computational simulation changes in bone stiffness with the experimental results to validate the simulation despite the design of the device.

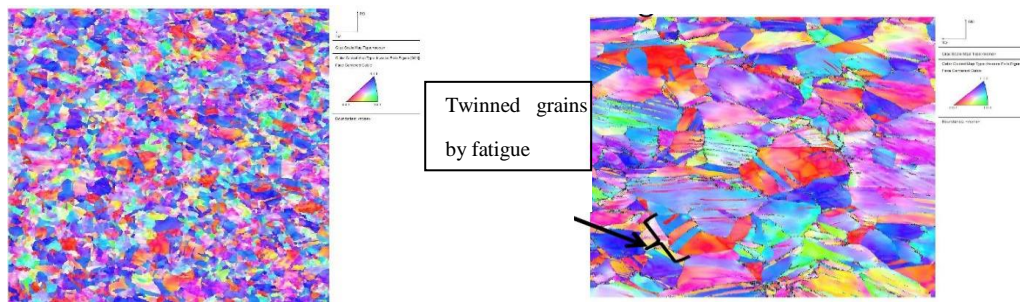
Figure 7. Electron backscatter diffraction (EBSD) grain map of the PHILOS Plate (**left**). Crystallographic characterization of plate microstructure inverse pole figure (**right**).

The map, Figure 7, shows a different orientation of the distribution of the grains on the surface of the material. ImageJ program was used to calculate the density percentages of different crystallographic orientations from the map of the PHILOS plate. The results showed that the density percentages were the highest at $\{1\ 1\ 0\}$ plane and the least at the $\{1\ 1\ 1\}$ plane. Literature showed that crystallographic orientation $\{1\ 1\ 1\}$ is the least susceptible to pitting [23,24]. This means that having lower densities of these crystallographic orientations increases the susceptibility to pitting corrosion. Additionally, the grain map showed a random distribution. This random distribution of the grains indicates a weak texture with grain size distribution that acts as an additional factor to reduce the pitting corrosion resistance.

Figure A2 shows the frequency of grain size distribution for that sample area of 316L stainless steel PHILOS plate. Additionally, twinning was observed on the map, as shown in Figure 7, which had a considerable contribution to the displacement mechanism of the material. Further examination of the material revealed an interaction of S, Ni, and Mo-based inclusions that may have raised the pitting susceptibility of the device and suggest that the device underwent damage by pitting corrosion-fatigue mechanism and overloading towards the end to fail the plate and screws in two or more components, as discussed in Ina et al. [17].

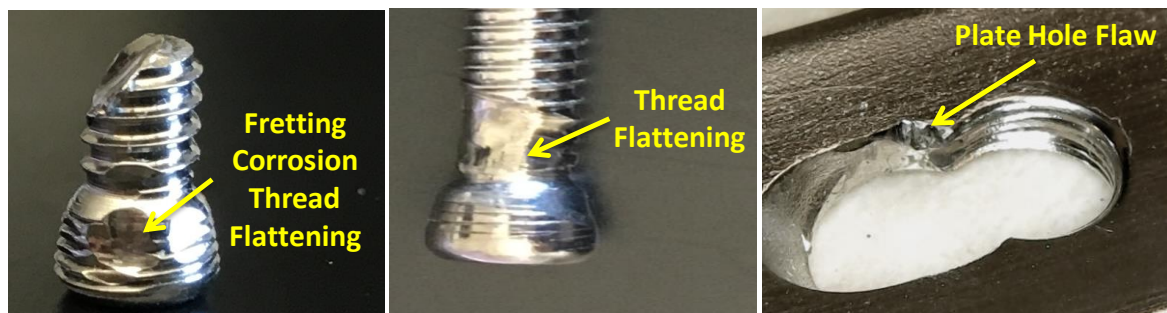
Figure 8. Thread flattening was observed on locking screws (**left, middle**) and plate hole flaw (**right**).

Visual examination of the plate showed that it fractured into three pieces. One cannulated, three cortical, and three locking screws were fractured into two pieces. The images from the optical microscope showed scratches on both the plate and screws. Some of these scratches may have occurred during the removal of the device from the body or handling of the devices. Thread flattening was observed on locking screws and visible damage to the plate threading was observed as a result of in vivo micromotion, fretting between the screw and the bone and/or the plate, as shown in Figure 8. Pitting was observed also on the surface of the plate. ImageJ software was used to find pit aspect ratios (depth (a) over width (2c) ratio), as shown in Figure A3. The aspect ratio was calculated for each pit and it ranged from 0.46–1.78, and Figure A4 shows the density of pits aspect ratio distribution. Figure A5 plots the probability of failure with respect to pits aspect ratio and Weibull distribution with a 95% confidence interval, and the results are shown in Table 2. A probabilistic evaluation was performed on different aspect ratios (0.5, 0.6, 0.7, 0.8, 0.9, 1.0). It can be noticed that the highest distribution of the pit aspect ratio was within the range of 0.46 and 0.98.

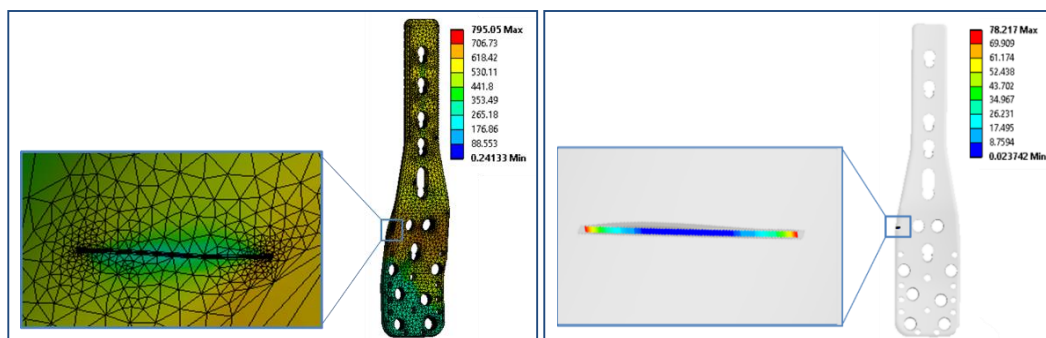
Figure 9. The von-Mises stresses in the 316L SS plate with screw design B, 2000 N axial load, 0.5 coefficient of friction between the screw and the plate, 0.1 mm cortical screw displacement, and 1 mm crack length (left). The stress intensity factor distribution across the crack for 0.6 aspect ratio (right).

The stress intensity factor was estimated at the tip of the crack nodes in the form of six contours. The contours were used to identify the regions of high and low von Mises stresses. It can be noticed that the maximum von Mises stresses are at levels B–E. Moreover, K_I values were determined for four different aspect ratios (0.4, 0.6, 0.8, and 1). The stress intensity factors, maximum von Mises stresses, and fracture toughness for each crack length are presented in Table 3. The average value of K_I was used for further analysis to calculate the stress needed to cause the final failure of the PHILOS construct (Section 3.4.4). Figure 9 illustrates the von Mises stress of the plate (795 MPa) with screw design B, 2000 N axial load, 0.5 coefficient of friction between the screw and the plate, 0.1 mm cortical screw displacement, and 1 aspect ratio. Fatigue limit at 10^7 cycles (stress level below which fatigue does not happen) corresponds to 440 MPa maximum stress level [25]. As the quantitative analysis of pits and resulting aspect ratios are much higher, we need to explore the pit transition to pitting corrosion fatigue crack growth mechanisms and life of the PHILOS constructs controlled by corrosion fatigue crack propagation than the durability aspects of fatigue design.

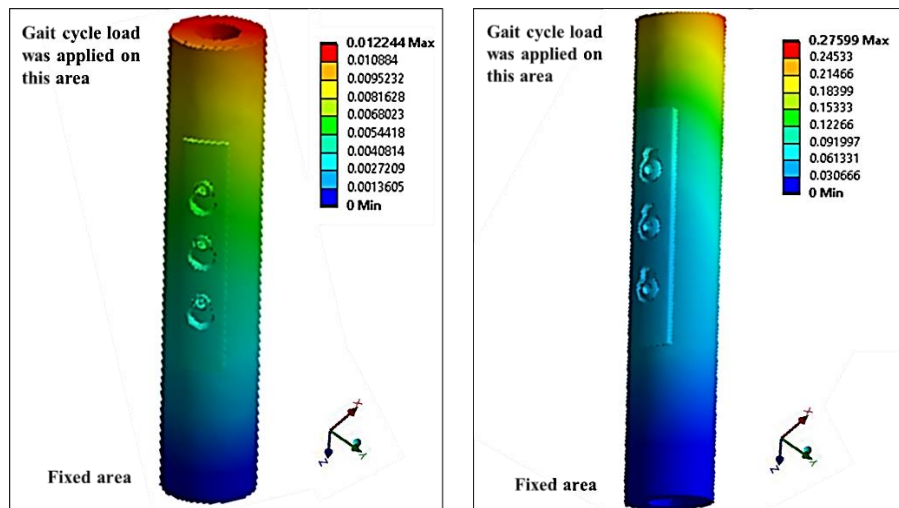
Figure 10. The total displacement (mm) in the 3D model of the plate with screws perpendicular to the plate. The variable angle locking screws (VALS) model (left) and the variable angle nonlocking screws (VANS) model (right).

Previous FEA results showed that the angle of the screw might have had an effect on increasing the stress distribution across the screws and the plate. The results of the 26 models (13 VALS & 13 VANS) illustrate that there is a significant difference between the screws at different levels, as shown in Figures 10 and A17, Figures A18–A20. The total displacement of the plate with a perpendicular angle to the neutral axis (0°) is twenty times higher in VANS compared with VALS, shown in Figure 10. The stress and displacement are highest at screw one (0.25 mm) and least at screw three (0.15 mm). It can be noticed for VALS, the displacement of screw one is 21% higher than the second screw and 55% higher than screw three. While for VANS the difference is more noticeable to be 34% higher than the second screw and 70% higher than the third screw. Additionally, the stress and displacement increased significantly with the increase in the angle of the screws to be the highest at 40 degrees above the neutral axis (from the center of the screw hole). Figures A17 and A18 show the total displacement of the PHILOS construct with VALS and VANS at different angles. VALS results show that the displacement is (0.01 mm) when the VALS is perpendicular to the plate and increased by 1%, 14%, 26%, 39%, 53%, 68% as the angle increased by 5°, 10°, 15°, 20°, 30°, and 40°, respectively. However, the displacement increased by 1%, 2%, 3%, 4%, 5%, and 6% with −5°, −10°, −15°, −20°, −30°, and −40°, respectively. VANS results show that the displacement is (0.25 mm) when the VALS is perpendicular to the plate and increased by 1%, 15%, 38%, 51%, 67%, and 83% with 5°, 10°, 15°, 20°, 30°, and 40° and an increase of 1%, 3%, 14%, 26%, 38%, and 52% with the negative angles of 5°, 10°, 15°, 20°, 30°, and 40°.

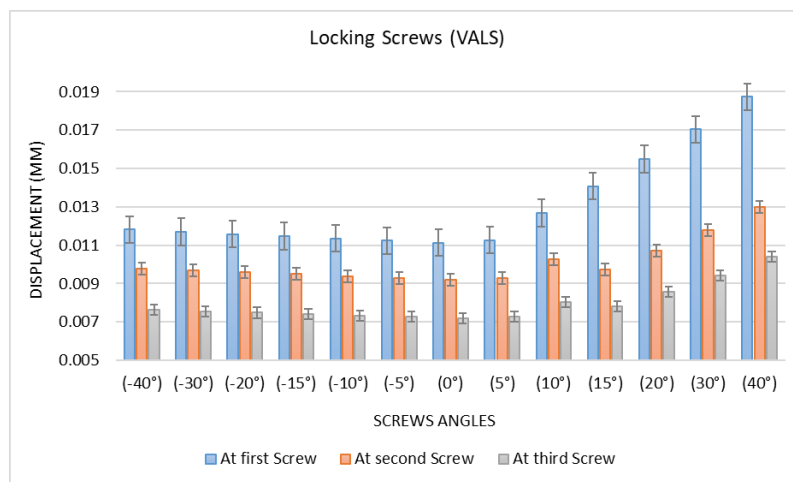
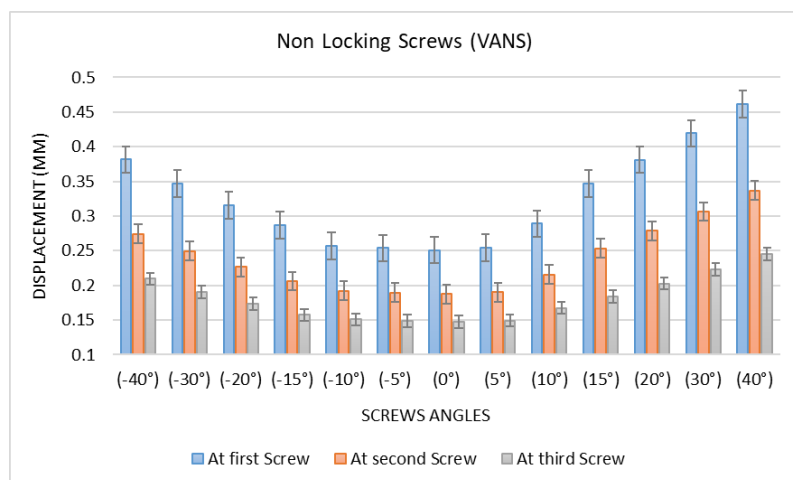
Figure 11. (a) VANS displacement. (b) VALS displacement.

Figure 11a shows that there is a distinct difference between the positive slope of the upward angles and downward angles of VALS, as the upward angles results have a higher positive slope and the displacement of VALS with 40° upward angle is (59%) higher than VALS with 40° downward angle. Similarly, Figure 11b shows that there is a distinct difference between the positive slope of the upward angles and downward angles of VANS, as the upward angles results have a higher positive slope and the displacement of VANS with 40° upward angle is (21%) higher than VANS with 40° downward angle. Furthermore, having the VANS in downward angles showed a significant increase when compared with the screws in perpendicular angles to the plate (52%), while there was no significant change in the VALS (6%).

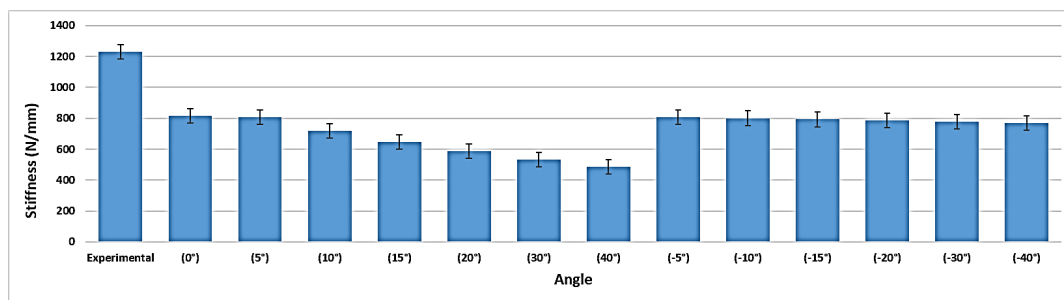
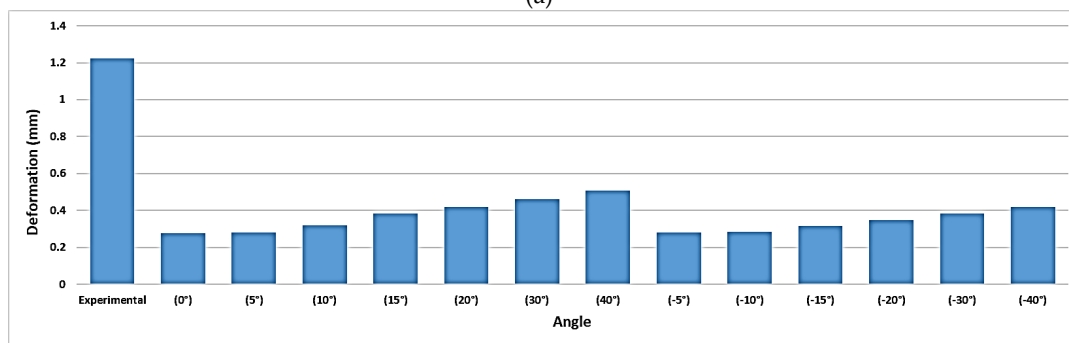
Figure 12. (a) The stiffness for the experimental work versus VALS FE results. (b) The displacement for the experimental work versus the VANS FE results.

Stiffness and displacement were measured for different screw combinations groups, as shown (see Appendix A Table A1). It can be noticed that displacement results are 52% higher in the experimental work than the finite element simulation. This may have been a result of the grip-to-grip change in length versus the change in length between two reference points in the simulations and the combined axial and torsion loads. Even though we notice such a change in length, the two results are acceptable with a degree of confidence. However, the stiffness results were in a good agreement with the experimental results. This establishes the applicability of finite element simulation in more complex designs, as shown in Figure 12. Figure 12a shows the highest stiffness when the screws are perpendicular to the plate (0°) and the stiffness decreases as the angle increases to be 40° upward. While there is no significant decline in the stiffness as the angle decreases in the negative side. Additionally, Figure 12b illustrates that there is a significant difference between the experimental displacement results (1.2 mm) and FE displacement results (0.5 mm). In addition, it can be noticed that the displacement increases as the angle upward or downward changed to be the highest at a 40° upward angle (0.5 mm).

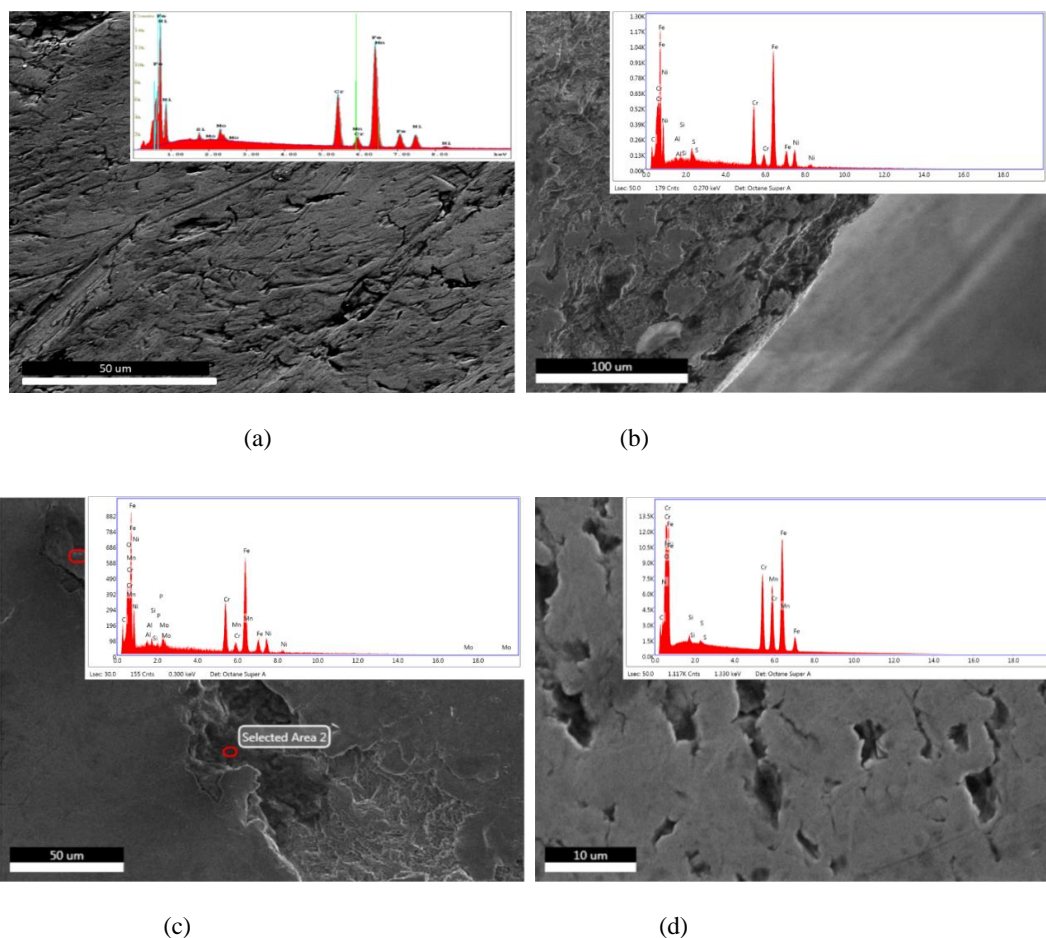
Figure A1. Energy-dispersive X-ray analysis shows the peaks of different element weight percent in (a) the plate, (b) cortical screw, (c) locking screw, and (d) cannulated screw.

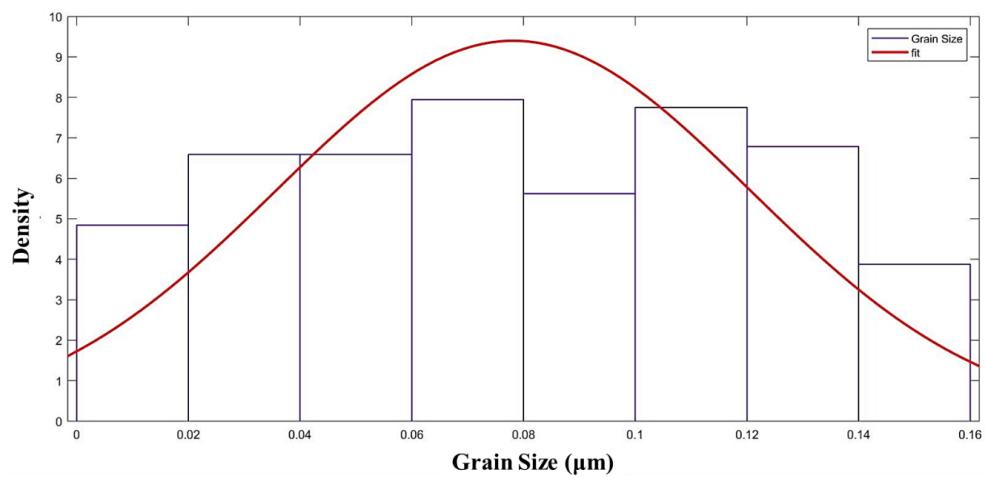
Figure A2. Density plot of grain size of 316L SS sample.

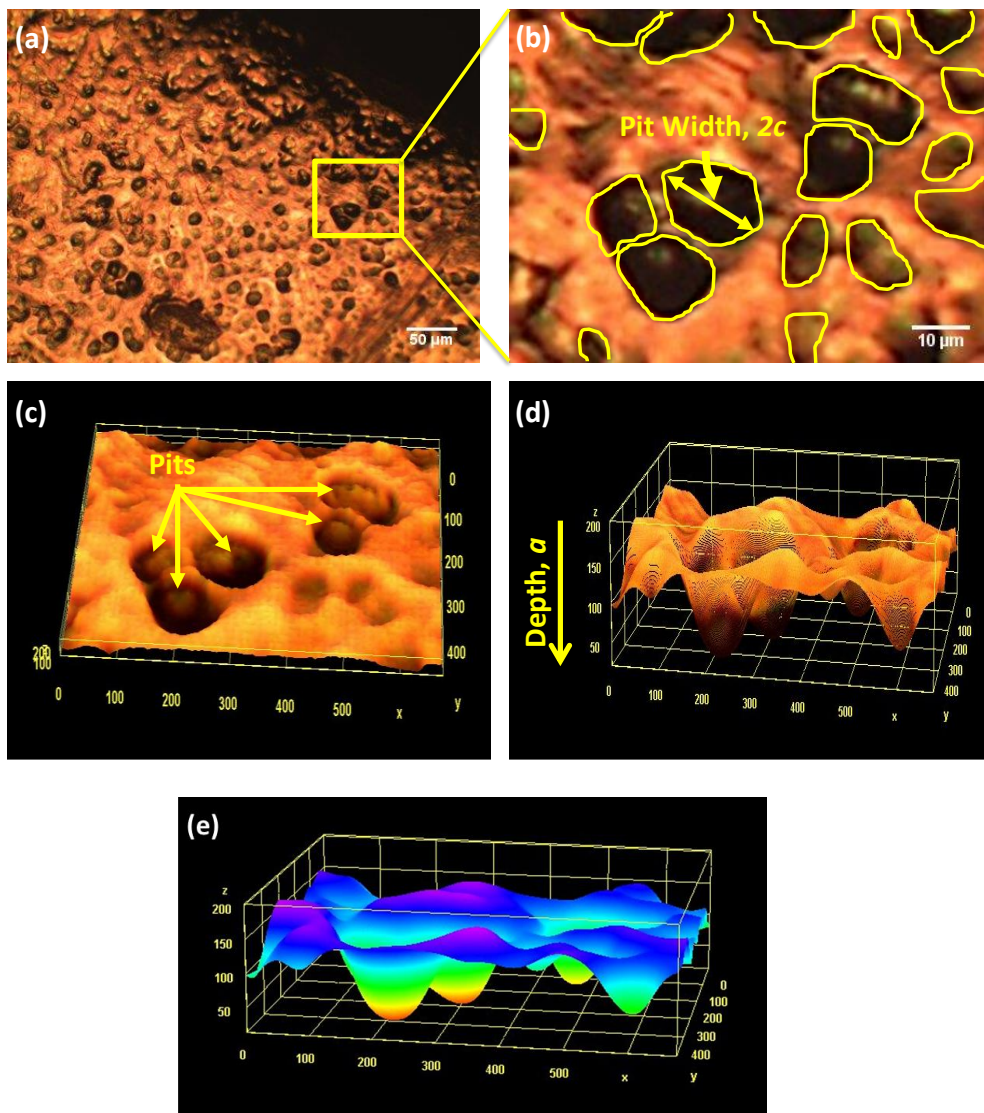
Figure A3. Pitting observed on the PHILOS plate. (a) High magnification image indicates pitting. (b) Higher magnification image showing pit boundaries. (c) 3D morphology; (d) 3D surface plot showing the depth of the pit. (e) The spectrum of the 3D surface plot (red represents the deeper part and blue represents the surface). The scale represents the number of pixels (10 pixels = 1 μm).

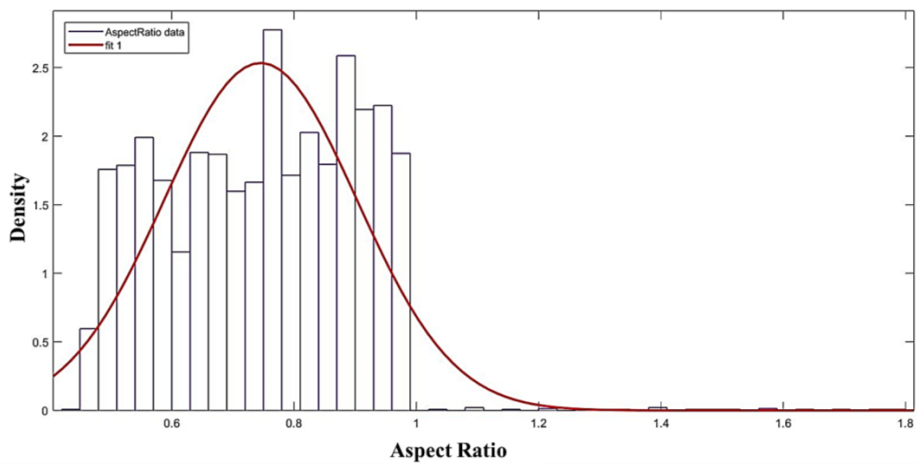
Figure A4. Density plot of pits aspect ratios ranges from (0.46–1.78).

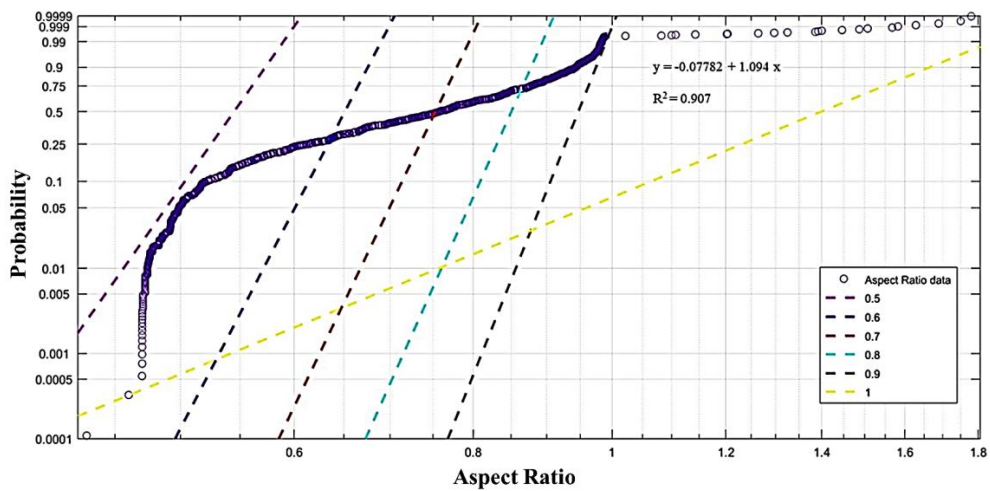
Figure A5. Probability plot of pits aspect ratio (Weibull, 95% CI).

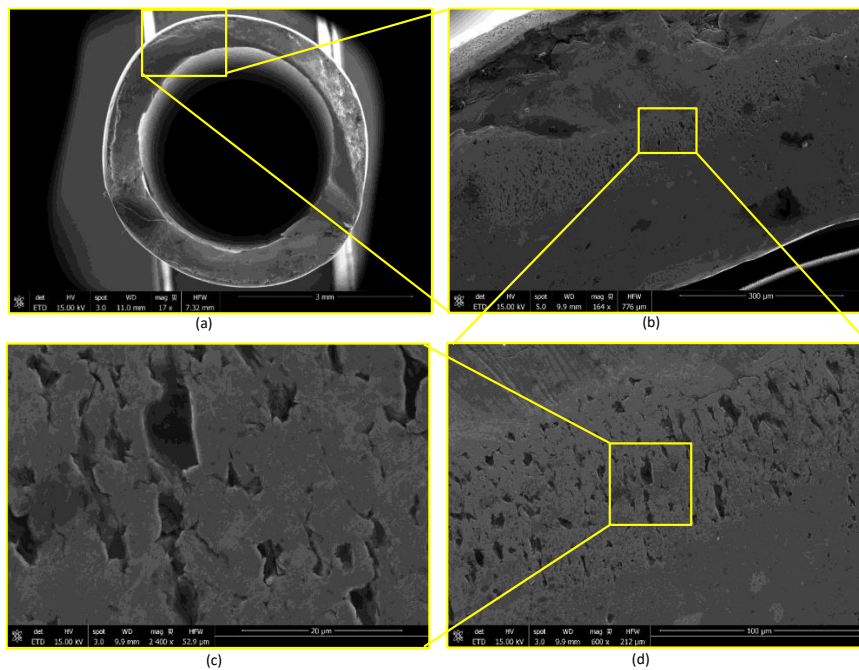
Figure A6. (a) Montage of SEM images showing the fracture surface of the cannulated screw, (b–d) dimples/overloading.

It was observed that most pieces showed extensive post-fracture rubbing/displacement which obscures any obvious fracture information. However, striations were found in CS1 and CS4. Cannulated screw showed indications of intergranular cracking, as shown in Figures A6 and A7. Additionally, the CS1 cortical screw showed striations and river lines perpendicular to striations, and river lines point towards the initiation point, as shown in Figure A8. In addition, some mechanical damage

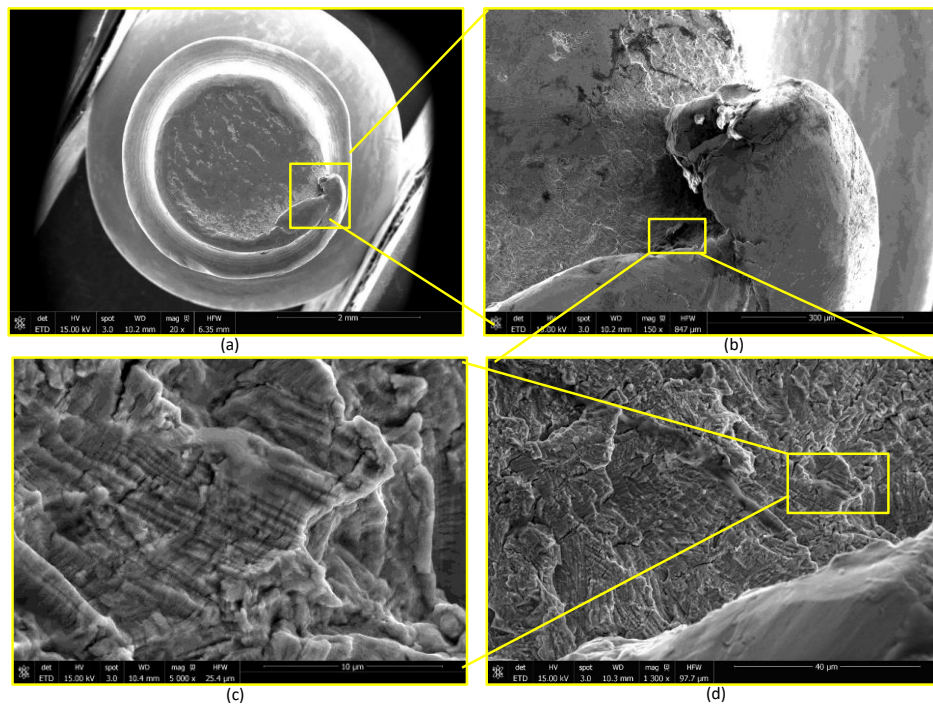
Figure A7. (a) Montage of SEM images showing fracture surface of the cortical screw (CS1), (b–d) striations, river lines perpendicular to striations. River lines point towards the initiation point (river lines run bottom left to top right).

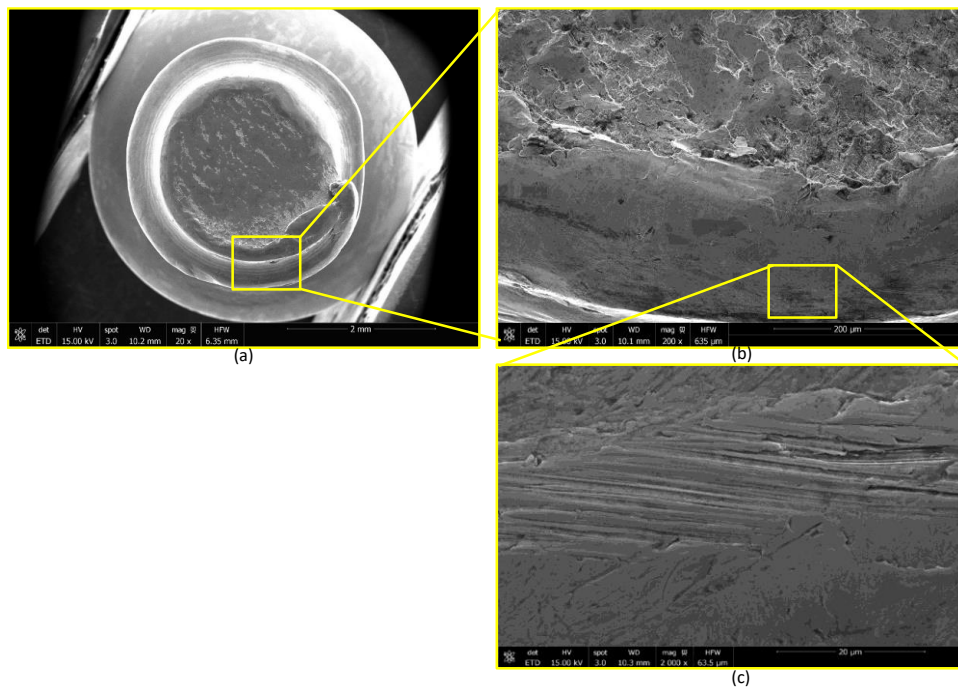
Figure A8. (a) Fracture surface of the cortical screw (CS1) and (b,c) mechanical damage caused by scratching the other side after failure.

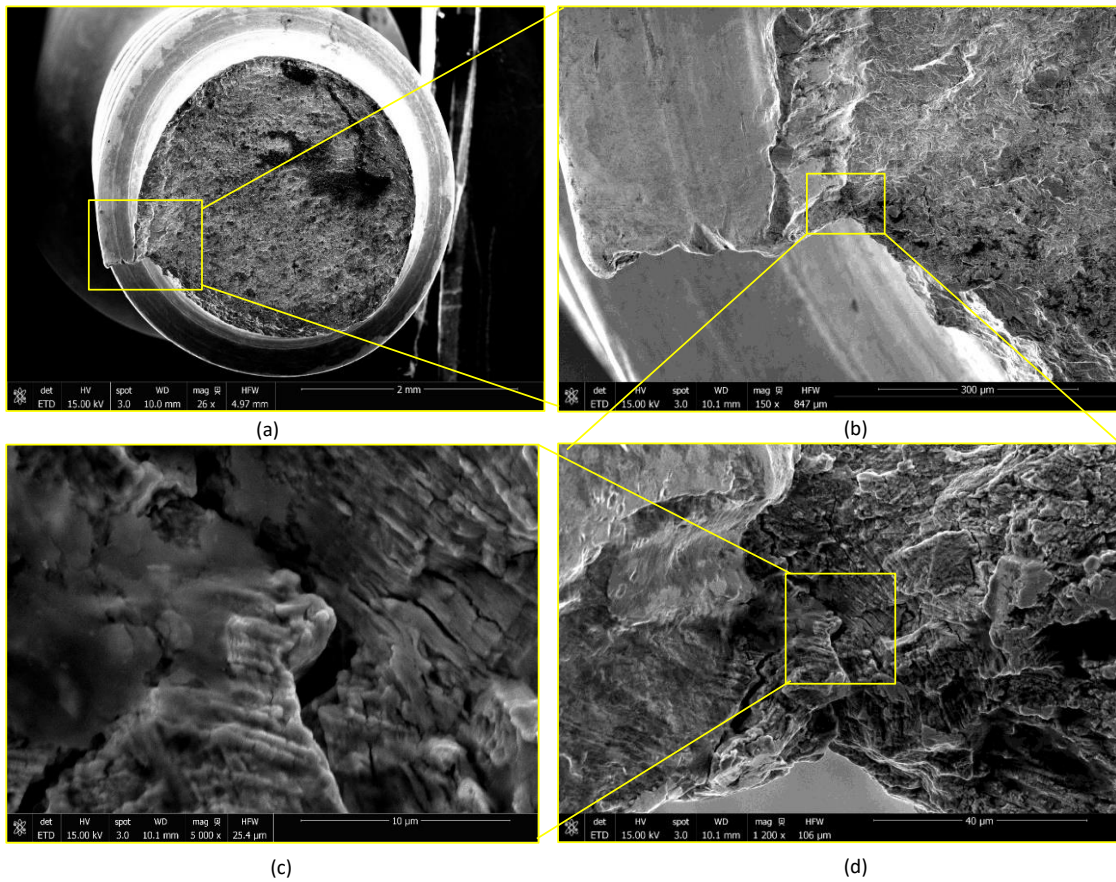
Figure A9. (a) Montage of SEM images showing the fracture surface of the cortical screw (CS4), (b–d) fatigue striations.

caused by scratching the other side after failure can be observed, as shown in Figure A9. CS4 cortical screw showed shiny marks indicative of fatigue damage and secondary cracks; though there was no strong indication of directionality, as shown in Figure A10. Flattening from rubbing is shown in Figure A11. LC locking screw showed a pore or site of inclusion pull out after fracture (Figure A12). Finally, Figures A13 and A14 show evidence of Si-based inclusions. These have sharp points and could be crack initiators. In general, screws investigation illustrated inclusions, pitting, secondary cracks, and striations that may be an indication of device failure as a result of the corrosion-fatigue mechanism. However, upon linking with the screw-holes, a crack, perpendicular to loading direction also propagated resulting in multiple fractures. Additionally, striations presence at the bending areas illustrates that the screws failed via conjoint bending and torsion fatigue mechanisms, discussed in another study [24]. Striation spacing was determined from the fractographic examination on the surface of the CS1 screw, as shown in Figure A15. Figure A16 shows a linear trend with $R^2 = 0.99$ between ΔK and striation spacing and $\frac{da}{dN}$, which means that the relationship is nearly linear.

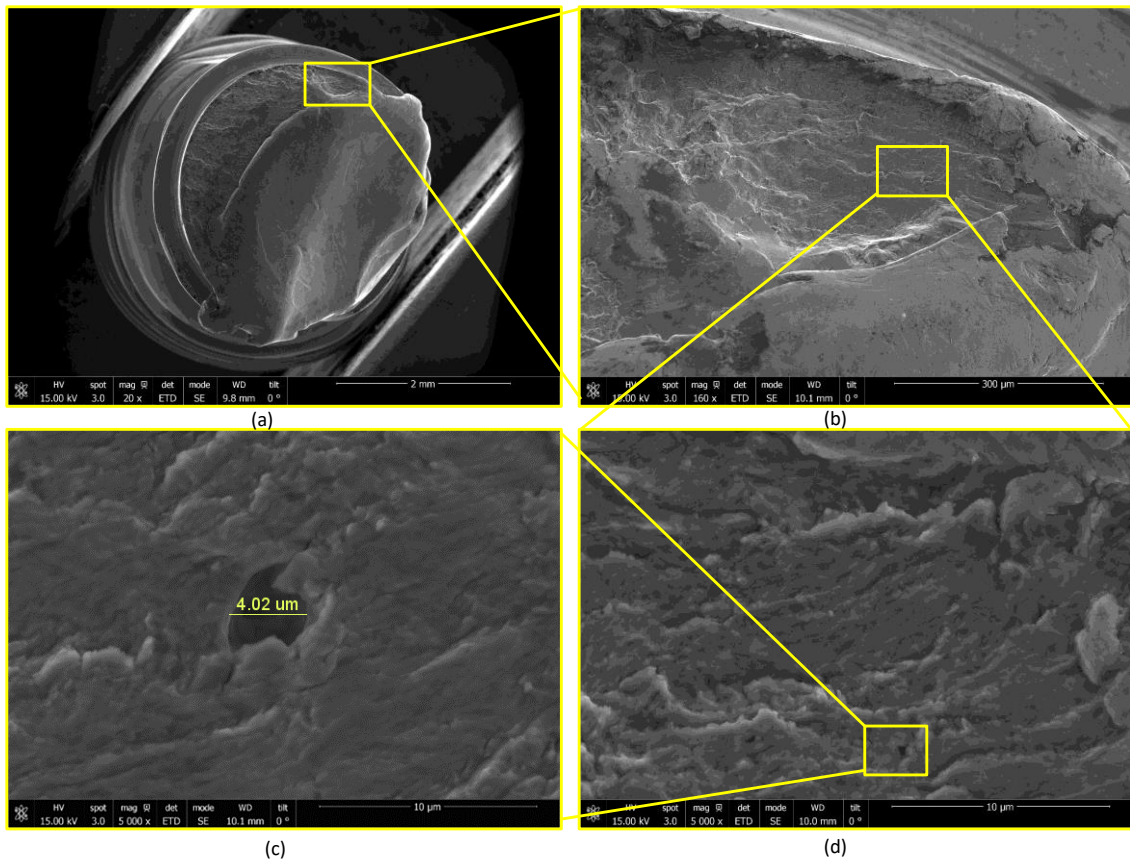
Figure A11. (a) Montage of SEM images showing fracture surface of locking screw (LC), (b–d) pore or site of inclusion pull out after fracture resulting in dimples and/or porosity.

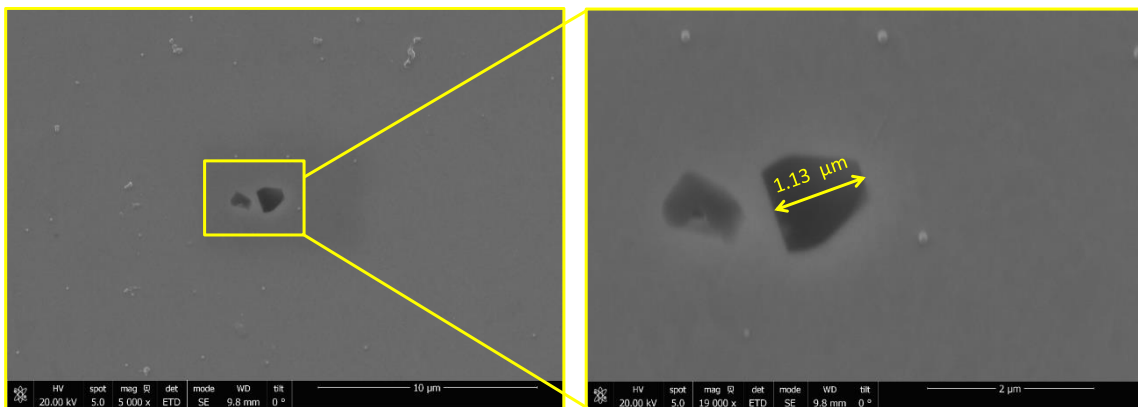
Figure A12. Evidence of Si-based inclusions, these inclusions have sharp points and could be crack initiators.

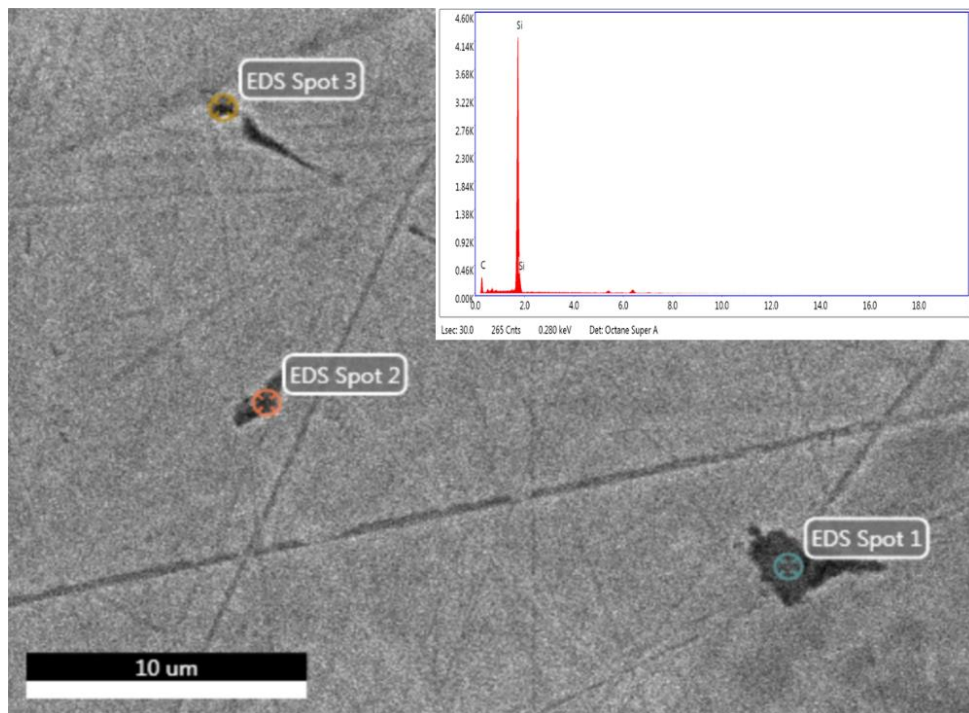
Figure A13. CS4 EDS showing Si-based inclusions.

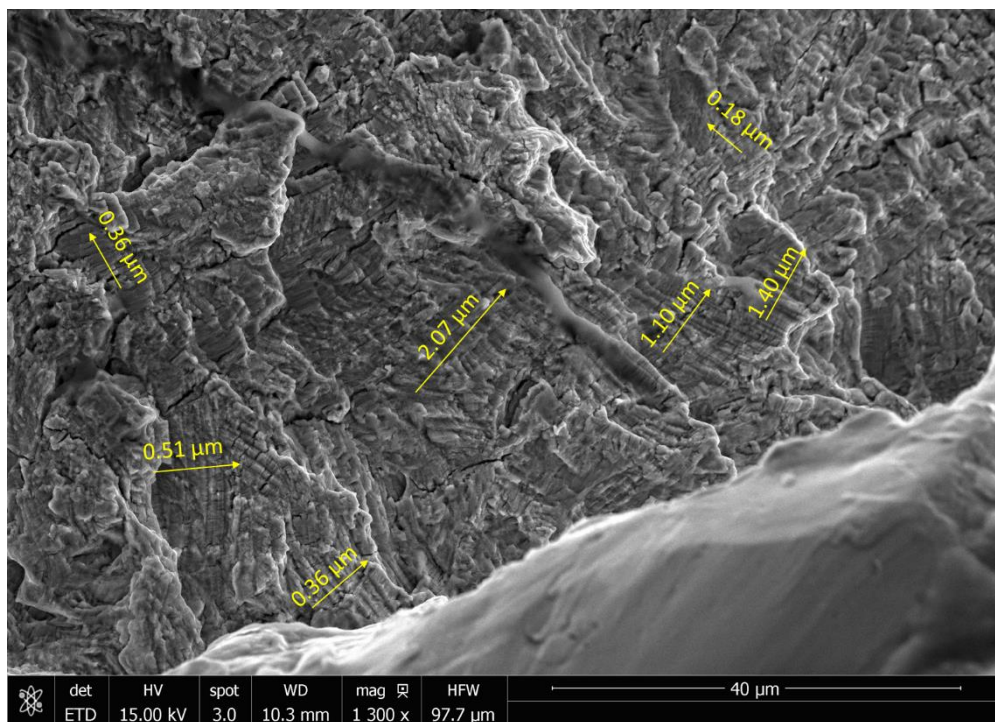
Figure A14. Counting the average striation spacing on the surface of the CS1 screw shows that the crack propagated from the bottom left to the top right.

Striation spacing was determined from the fractographic examination on the surface of the CS1 screw. Then, the striation spacing was used to calculate the stress intensity factor (ΔK) by using Bates and Clark equation [19] in its simplest form to estimate a range of stress intensity for the crack growth,

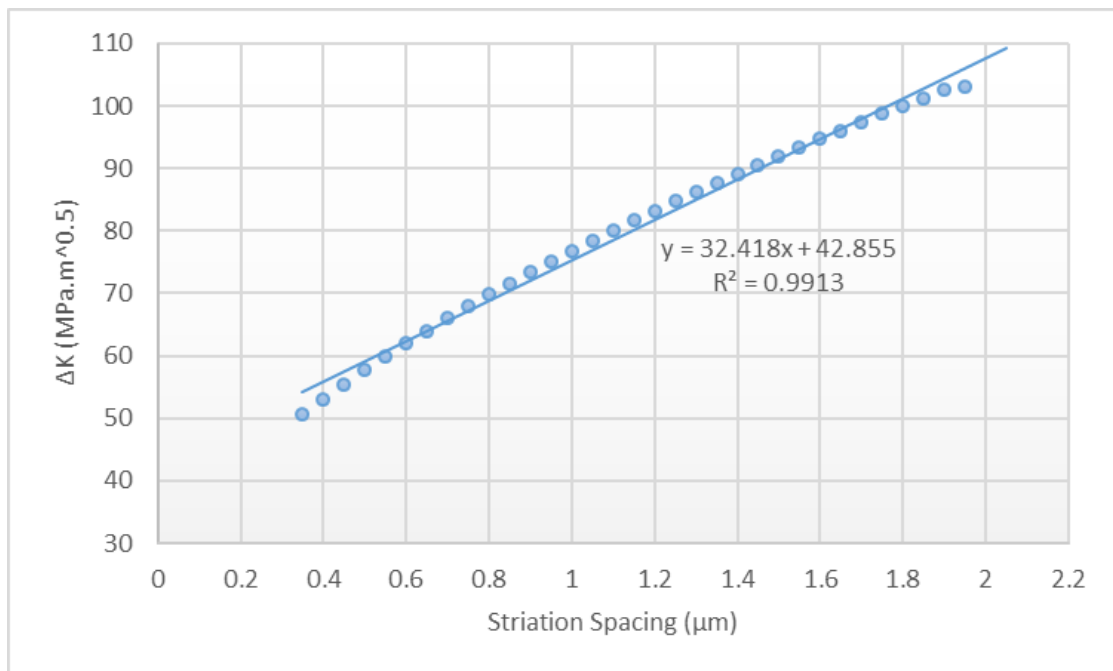
Figure A15. Stress intensity factor (ΔK) vs. striation spacing.

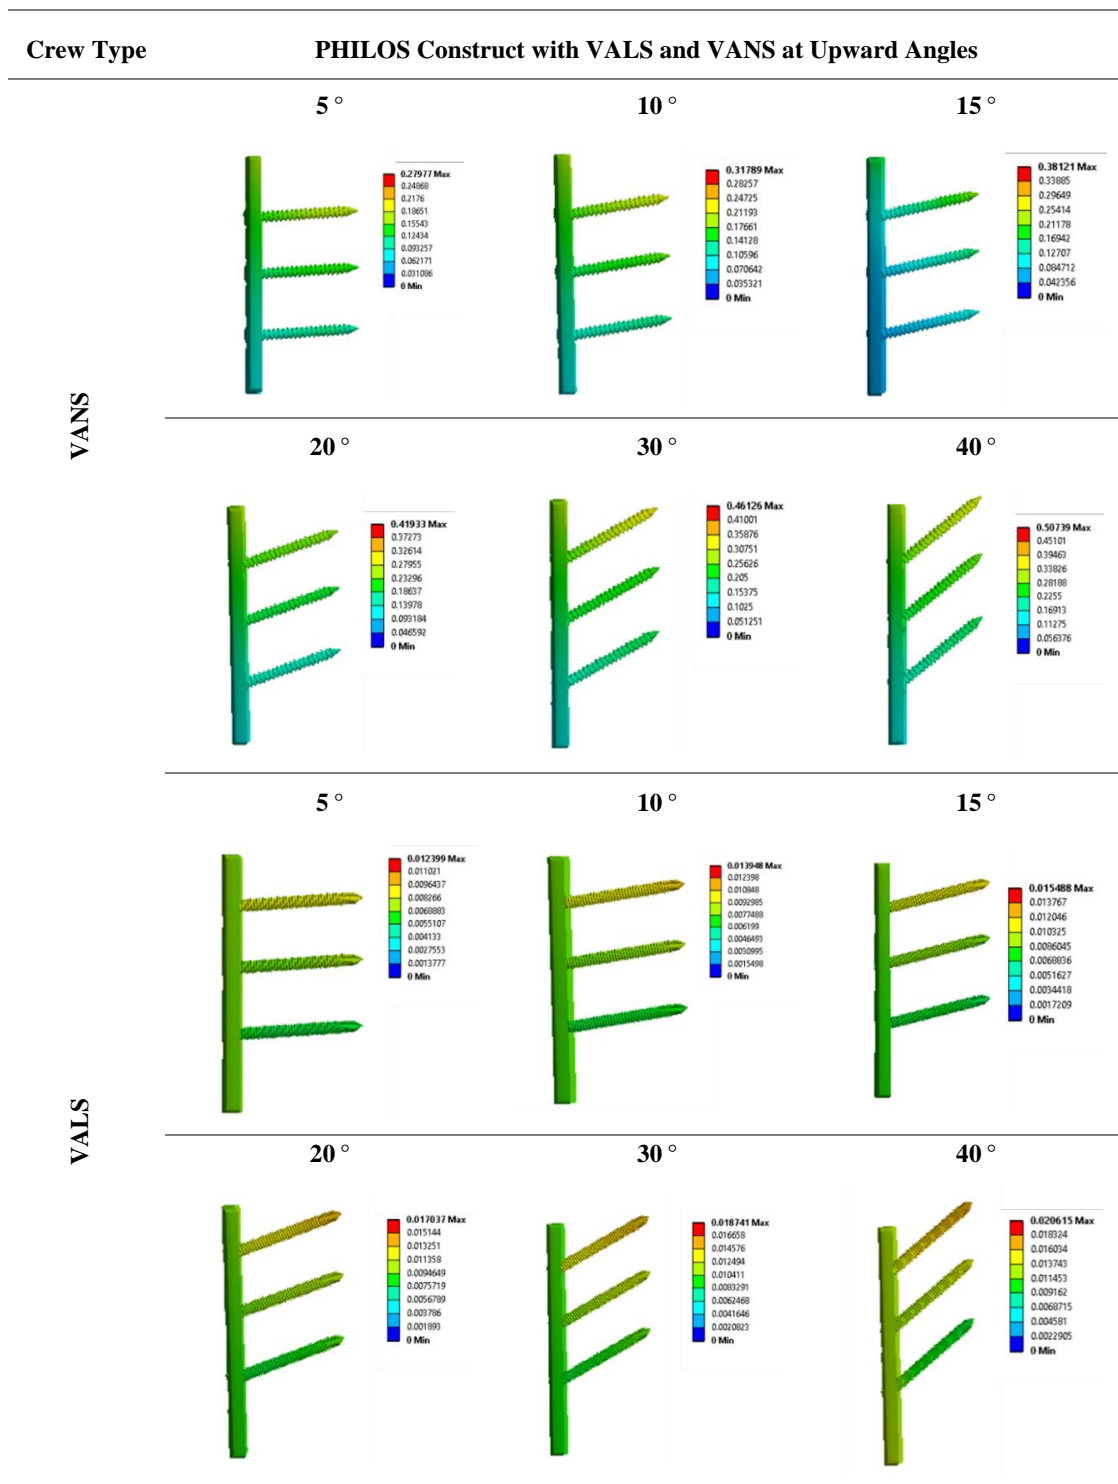
Figure A17. Total displacement (mm) of the PHILOS construct with VALS and VANS at upward angles (5°, 10°, 15°, 20°, 30°, 40°) to the neutral axis.
