Biomechanical Behavior of a Variable Angle Locked Tibiototalcaneal Construct

Abstract: This paper examines the mechanics of the tibiototalcaneal construct made with a PHILOS plating system. A failed device consisting of the LCP plate and cortical, locking, and cannulated screws was used to perform the analysis. Visual, microstructure, and fractographic examinations were carried out to characterize the fracture surface topology. These examinations revealed the presence of surface scratching, inclusions, discoloration, corrosion pits, beach marks, and cleavage and striations on the fracture surface. Further examination of the material crystallography and texture revealed an interaction of S, Ni, and Mo-based inclusions that may have raised pitting susceptibility of the device made with Stainless Steel 316L. These features suggest that the device underwent damage by pitting the corrosion-fatigue mechanism and overloading towards the end to fail the plate and screws in two or more components. The screws failed via conjoint bending and torsion fatigue mechanisms. Computer simulations of variable angle locking screws were performed in this paper. The material of construction of the devi

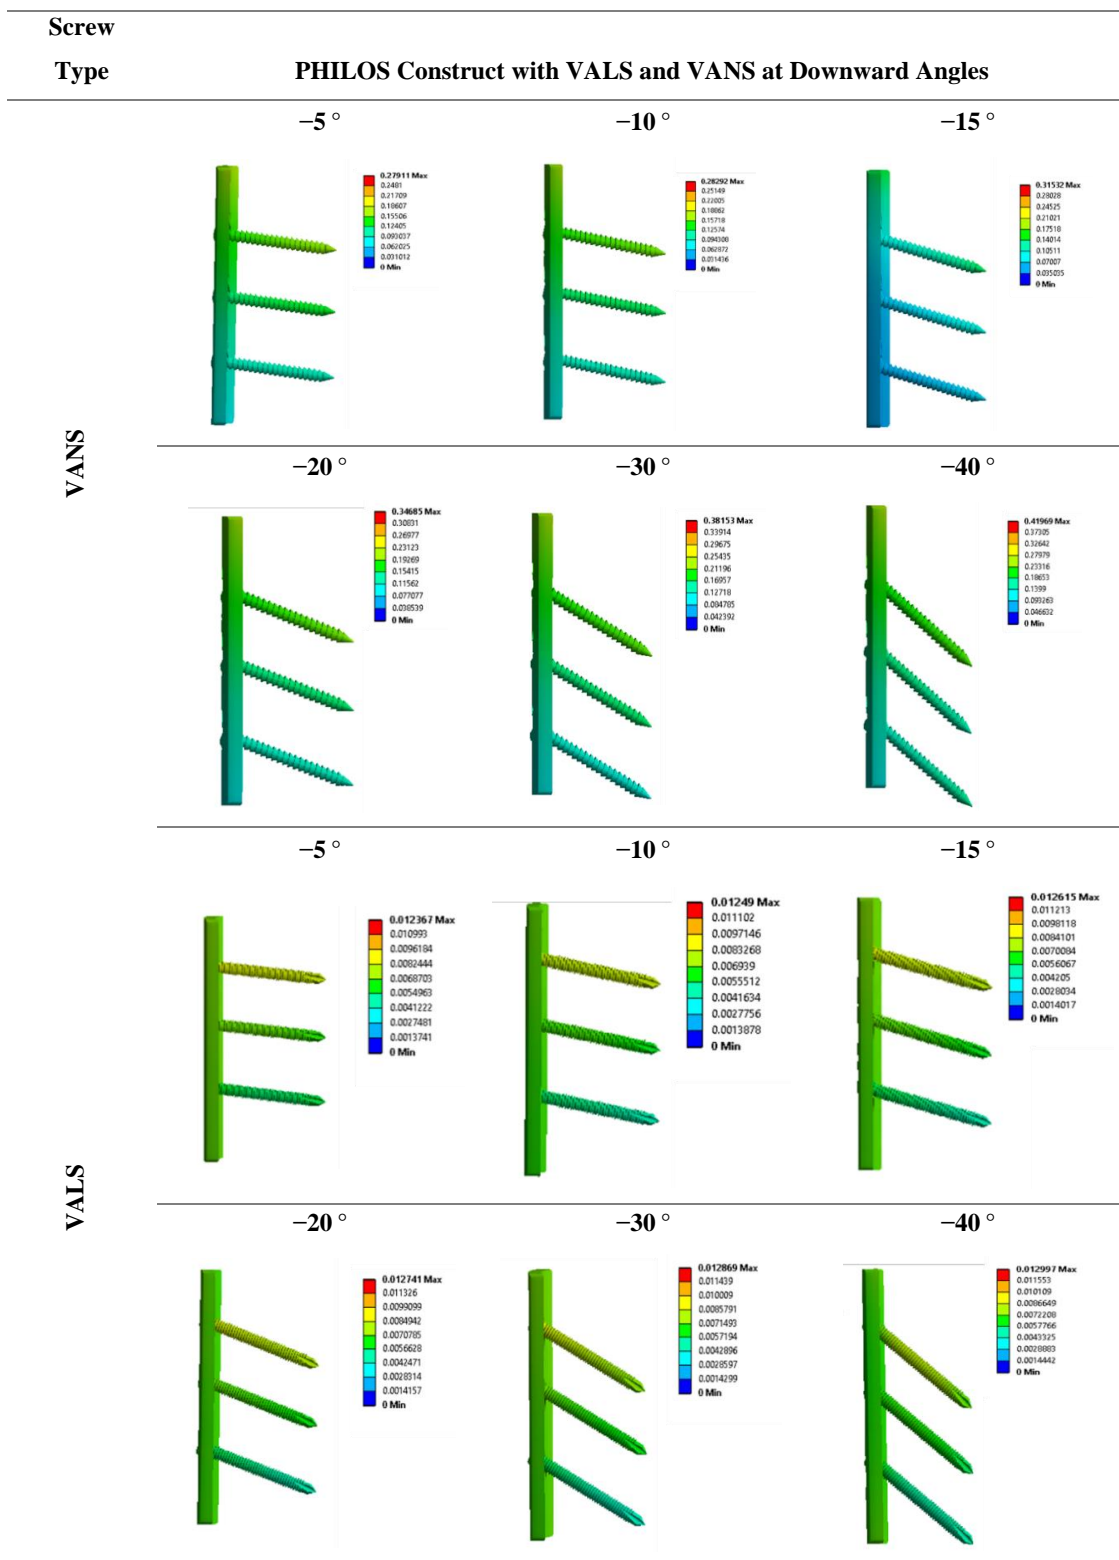
Figure A18. Total displacement (mm) of the PHILOS construct with VALS and VANS at downward angles (5°, 10°, 15°, 20°, 30°, 40°) to the neutral axis.

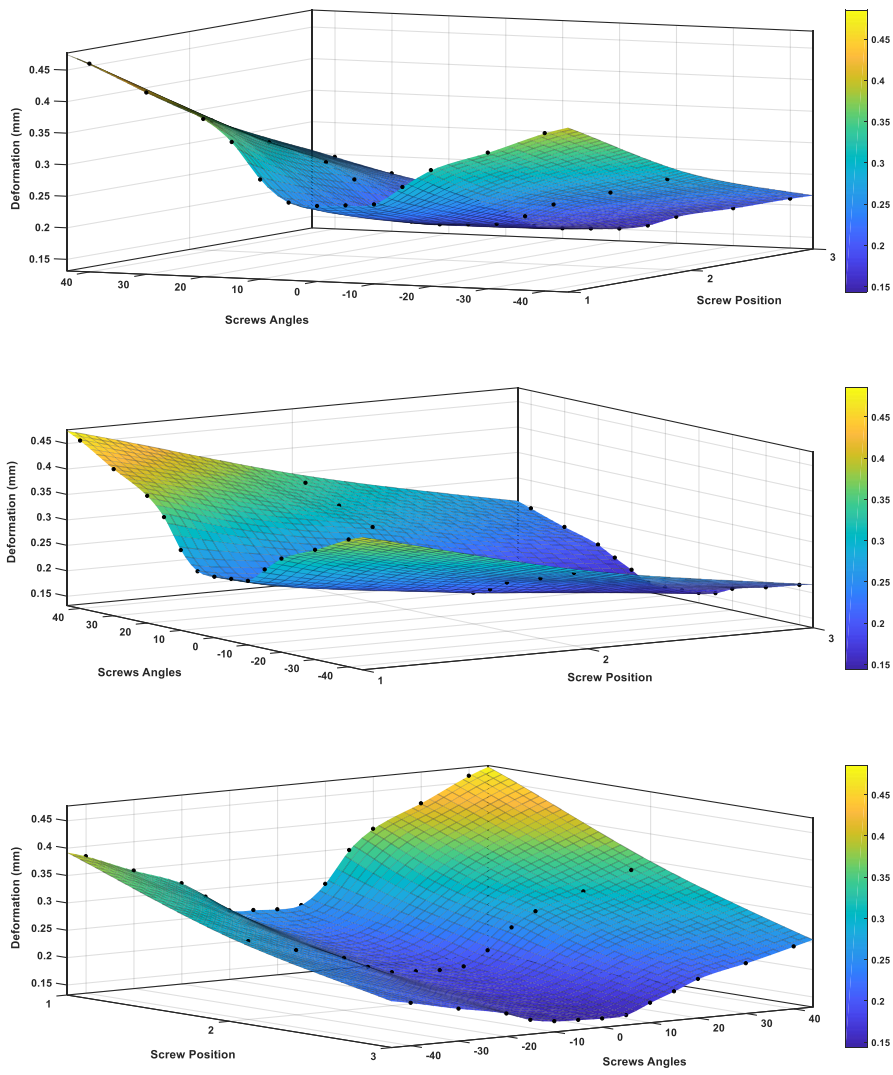
Figure A19. VANS displacement vs. screw angles and screw position.

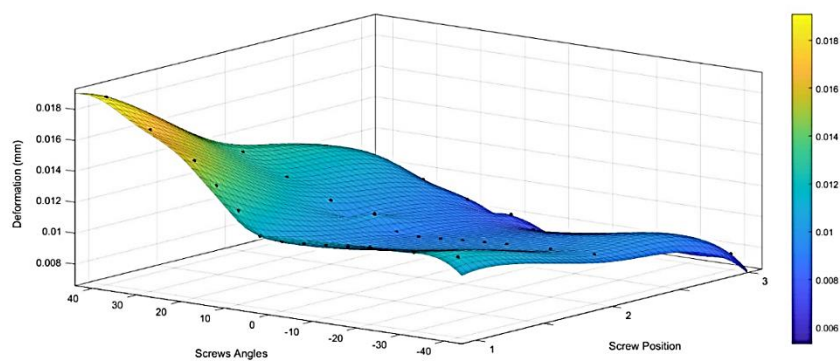
Figure A20. VALS displacement vs. screw angles and screw position.
