Investigation of Retrieved Cardiac Devices

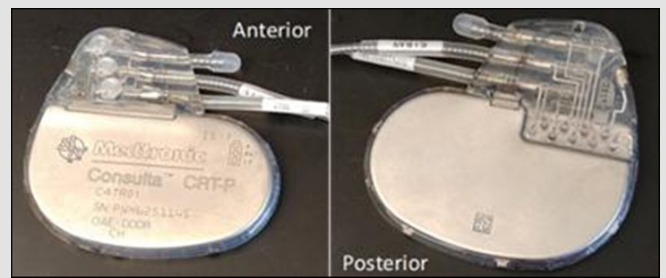
Figure 1: Anterior and Posterior side of the pulse generator.

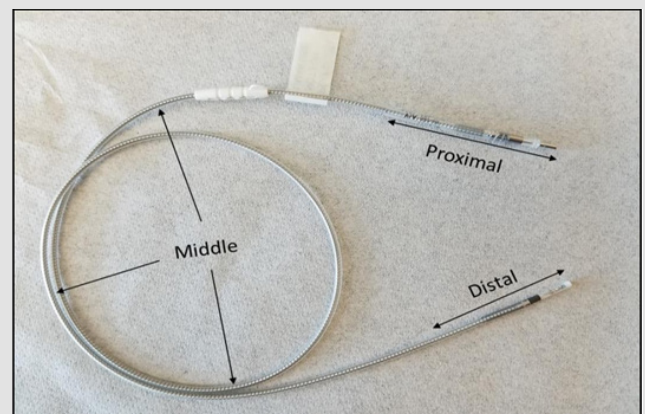
Figure 2: Lead as received from MDT, showing proximal, middle and distal parts.

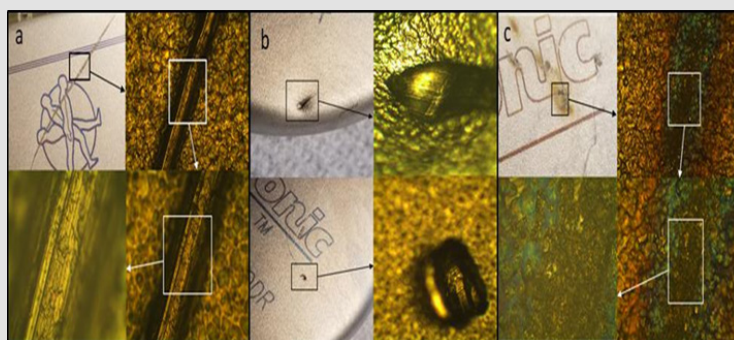
The pulse generators of all the manufacturers are made of commercially pure titanium. However, titanium accrues damage by scratching and discoloration as most devices sustained scratching, Figure 3a. 68% of the anterior surface of MDT devices, 66% SJM and 53% of BSC were scratched. The posterior surface of SJM showed no scratching on the surface, while 44% of MDT and 33% of BSC devices exhibited scratching. Surface deformation, as shown in Figure 3b was also found on both surfaces. The anterior surface sustained higher deformation than the posterior surface. Discoloration was only found on BSC and MDT anterior and posterior surfaces, as shown in Figure 3c. While burnishing was only found on the posterior surface of BSC devices, there were only three SJM devices and cannot be included in statistical analyses. All the damage modes are summarized in Figure 4 illustrating the number of devices examined for each of the manufacturers, degree of surface deformation, scratching, burnishing, and discoloration on the anterior and posterior surfaces [15].

Figure 3: Pulse Generator Damage Modes, (a) Scratch, (b) Surface Deformation, (c) Discoloration.

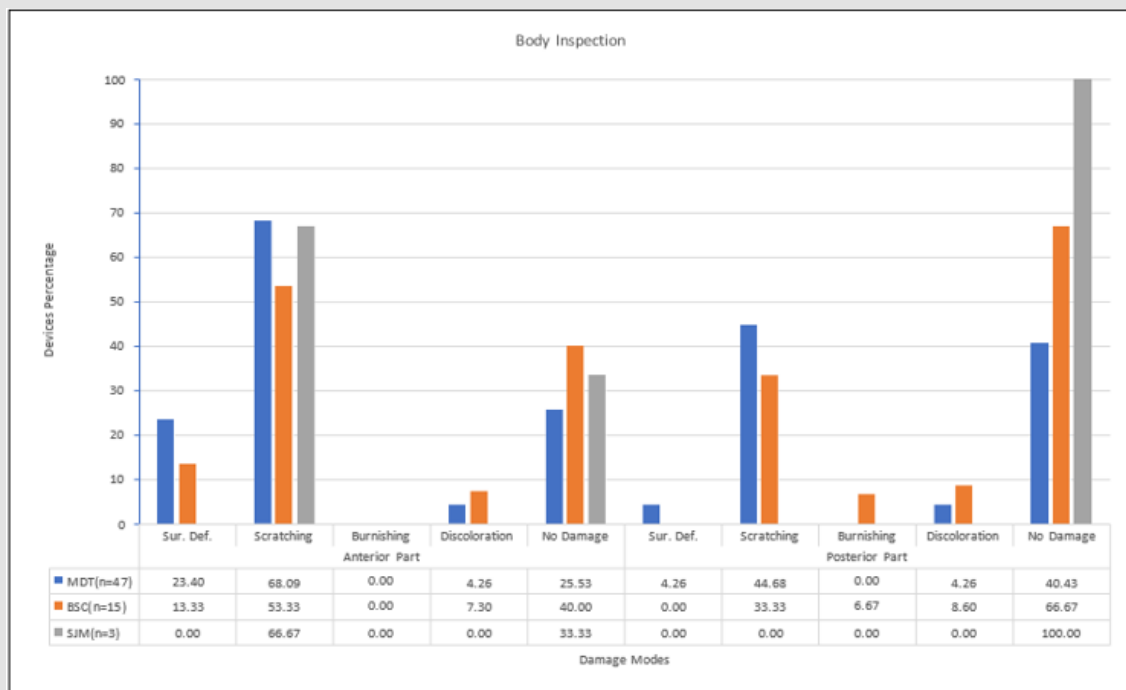
Figure 4: Pulse Generator Inspection, showing the percentage damage for each manufacturer.

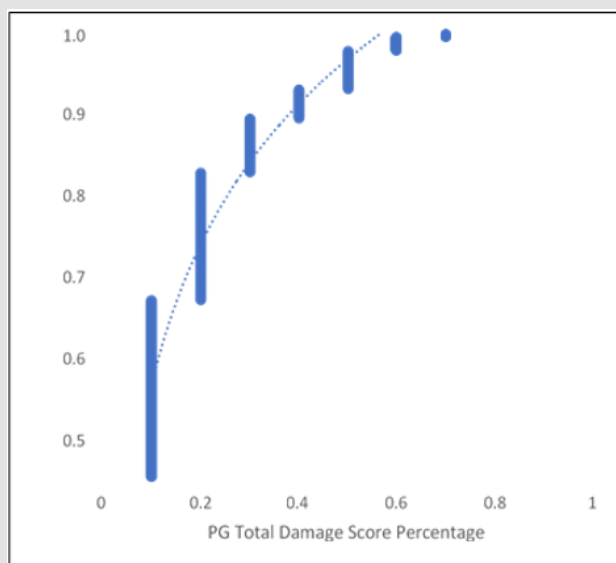
Figure 5: PG Damage Score Distribution.

student test, the results showed a significant difference for MDT when compared to BSC and SJM ($p=0.0399$). The damage modes of the pulse generator compared to each other by using Fisher’s LSD student test [16]. It showed a significant difference between scratching on the anterior and the posterior part. Also, the results showed a significant difference between scratching and other damage modes. The pulse generator damage scoring distribution showed that the damage was between 10% and 70%. Higher number of devices with 10% damage, however, as percentage damage increased to 70%, number of devices decreased. Figure 5 illustrates cumulative distribution and total damage score [17].

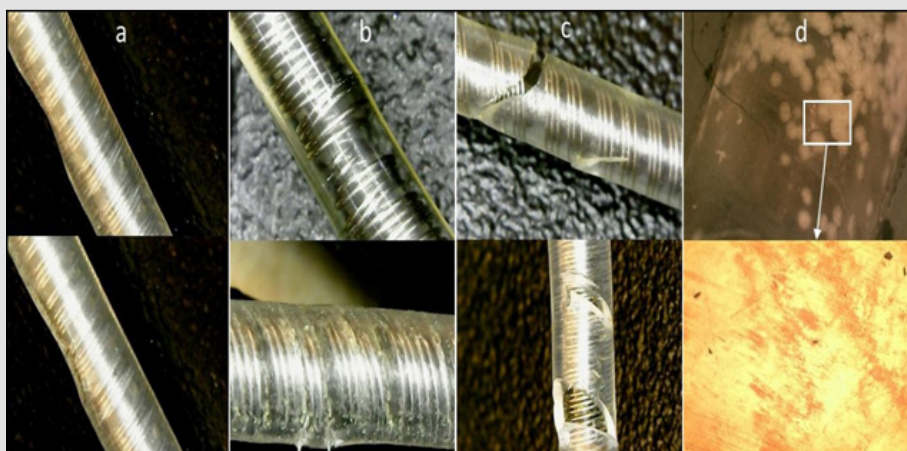
The leads showed visible cuts and stretches. The coax wires were stretched along with cuts. Optical microscope was able to resolve cuts and stretches under the insulation. The inner coil was also frayed in some parts and had numerous breaks. The coax wire on most of the devices was detached out of the insulation and appeared brittle, and in some occasions, broken easily. The distal parts of the leads were not retrieved during extraction and submitted to us for investigation. For the pacing leads, the damage modes observed on both proximal and middle parts were abrasion

Figure 6a, discoloration Figure 6d, scratching, coil damages Figure 6b and insulation defect Figure 6c. The proximal part showed fewer damage than the middle part. Abrasion and discoloration on MDT and BSC leads were significant compared to SJM, where no abrasion and discoloration found in the proximal part. On the other hand, for the middle part, discoloration, coil damage, and insulation defect were highly present on SJM leads compared to MDT and BSC. The ICD leads showed more abrasion, scratching and insulation defect in the proximal part than the middle part. BSC had the most abraded and scratched leads when compared to MDT and SJM [20]. SJM, BSC and MDT leads had almost equal insulation defect. For the middle part of the lead, discoloration was only found on MDT leads, and insulation defect was found on both MDT and BSC.

Figure 6: Samples of Lead Damage Modes, (a) Abrasion, (b) Coil Damage, (c) Insulation Defect, (d) Discoloration.

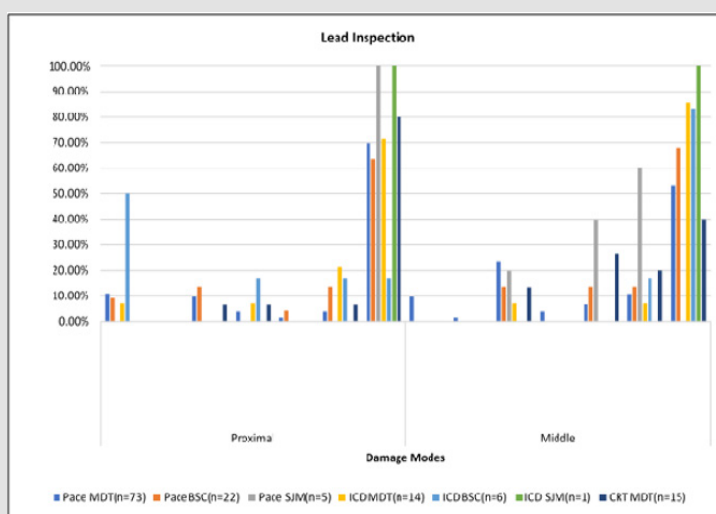
scratching and insulation defect shared the same percentage with 6.67%. While this percentage increased significantly in the middle part, in addition to coil damage. The percentage of the undamaged parts in the proximal part was higher than the percentage in the middle part of the lead [21]. The damage modes are summarized in Figure 7.

Figure 7: Lead Inspection, showing the damage modes versus different leads for different manufacturers.

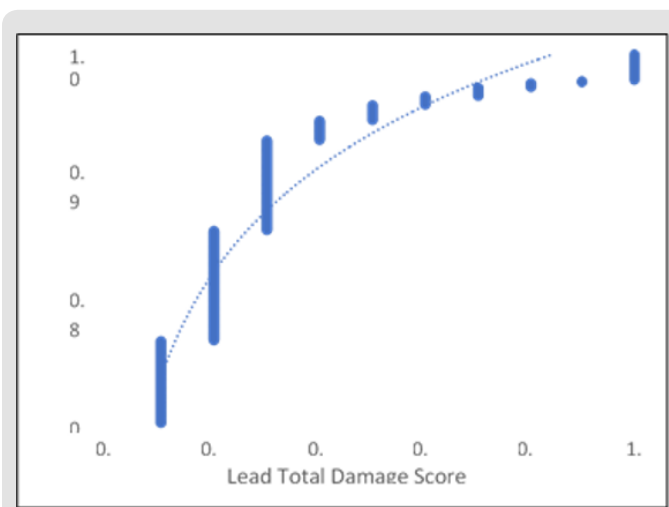
The average damage on leads ranged between 0.1-0.3 damage score. With the increment of the damage score the number of damaged leads decreased, where 17.6% (24 out of 136) of leads with total damage. Figure 8 shows cumulative distribution of the leads and total damage score. According to the characterization of operational parameters, SJM showed higher failure types than MDT and BSC with 50% of its devices. The three manufacturers shared the same conductor fracture rate. Figure 9 shows the types of failure and the distribution of each type for each manufacturer, neglecting lead types. The number of leads that were investigated is 136. The majority were manufactured by MDT (102 leads),

Figure 8: Lead Damage Score Distribution.

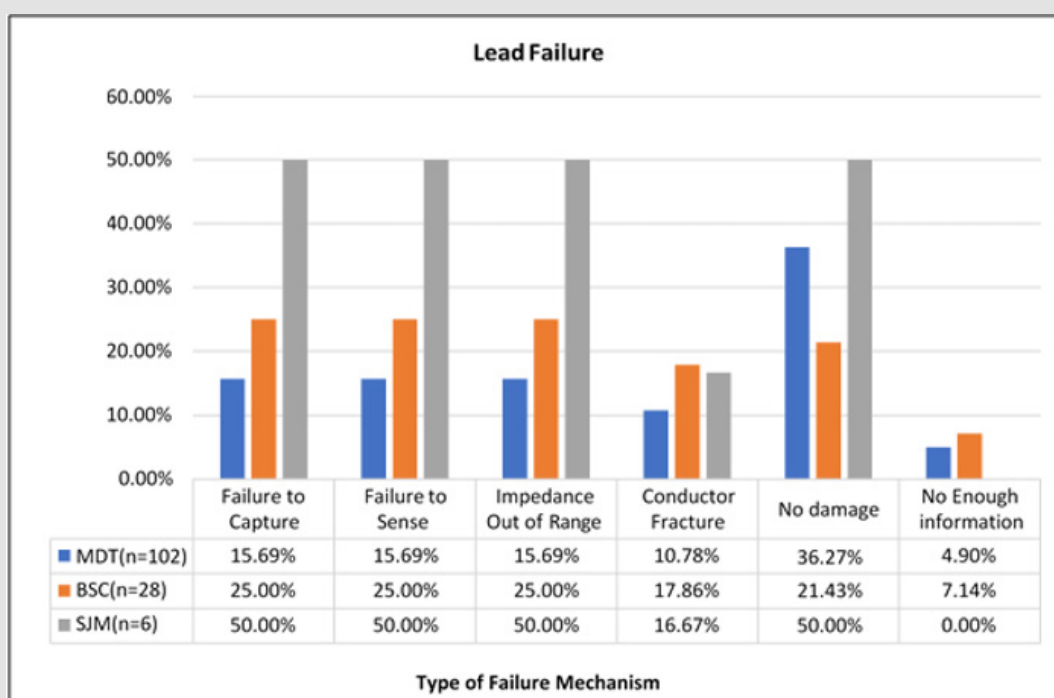
while the rest were from BSC (28 leads), and SJM (6 leads) [24]. The results show that BSC leads had 10% higher failure rate than MDT leads with respect to failure to sense, capture and impedance out of range applicable only to our unique retrieved devices which may have been damaged while extraction and transportation. The two most widely used pacing leads were taken and examined thoroughly to identify the types of failure modes [25-28]. These leads were MDT 5076 CapSureFix Novus and BSC 4470 FINELINE II. The results showed the percentage of leads failed to sense, capture and impedance out of range were higher in BSC 4470 (25.00%) than MDT 5076 (15.69%). The conductor fracture in MDT 5076 was 6.67% compared to 8.7% in BSC 4470. Insulators for MDT was Silicone (MED-4719) [36], while BSC 55D polyurethane [29].

Figure 9: Types of Failure Mechanisms in Leads, showing the percentage of each failure type for each manufacture.

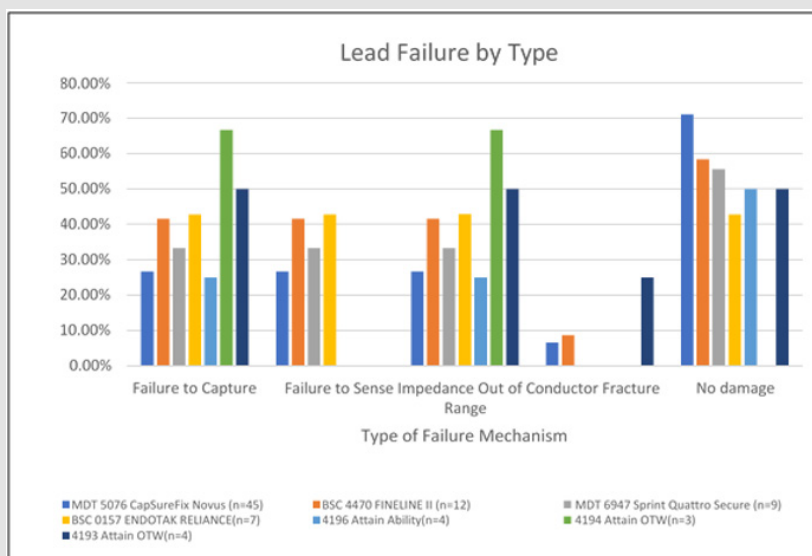
The two most widely used ICD leads were taken and inspected carefully to categorize the failure types, the leads are MDT 6947 Sprint Quattro Secure and BSC 0157 ENDOTAK RELIANCE. The percentage failure of MDT 6947 for our devices was lower than the percentage failure of BSC 0157 with 33.33% for MDT 6947 and 42.86% for BSC 0157, while no lead exposed to conductor fracture. MDT used polyurethane as the outer insulator and silicone rubber as inner insulator [30], while BSC silicone rubber as the lead insulator [30]. Therefore, three MDT CRT leads were examined to identify the

types of failure. The three inspected leads were 4196 Attain Ability, 4194 Attain OTW and 4193 Attain OTW. The results showed that the 4196 Attain Ability lead had a lower failure rate than the other leads as well as no conductor fracture. All 4194 Attain OTW leads were all failed due to the damage modes discussed previously. While 50% of the 4196 and 4193 leads exhibited no damages. Figure 10 summarizes the failure types and the percentage that occurred to the pacing, ICD and CRT leads [31].

Figure 10: Types of Failure Mechanisms in leads, showing the comparison between the pacing and the ICD leads of MDT and BSC, and three MDT CRT leads.

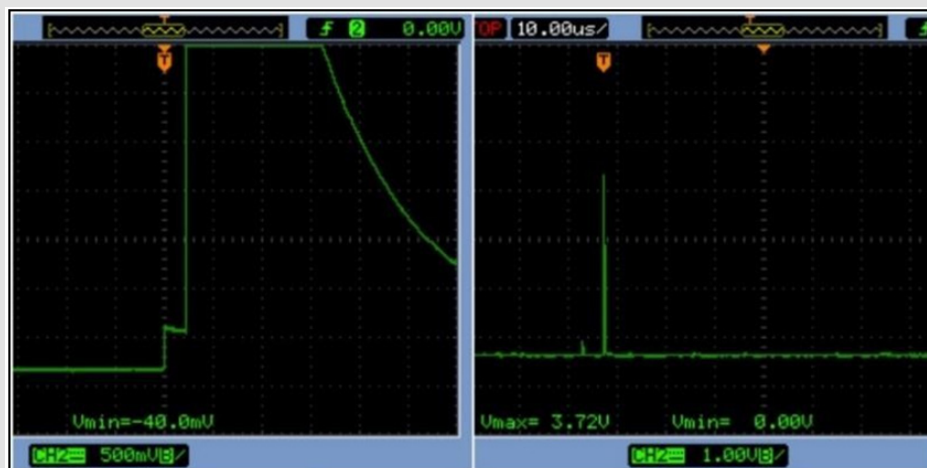
Figure 11: Pulse width and the Voltage, obtained by connecting the devices to an oscilloscope.

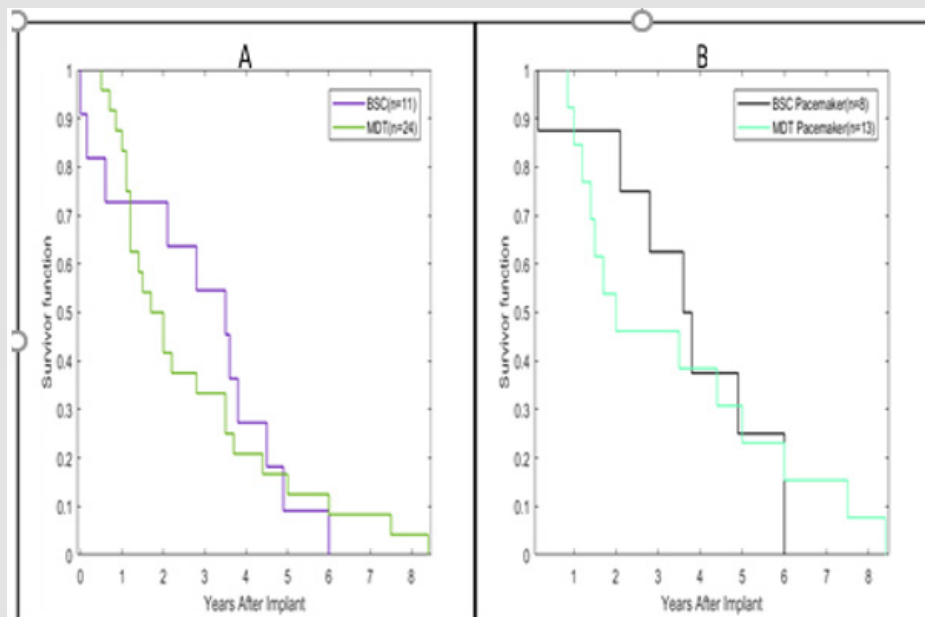
40 out of 65 devices were still functioning and have a range of longevity from 3 months to 11.5 years. These devices are listed in Appendix I and continue to be analyzed for another effort. Two of the active devices were connected to an oscilloscope to examine the functionality of these devices. The output waveform from the leads was measured [32]. Figure 11 represents the obtained waveforms that verify the functionality of the device. The course time of the pulse generator survival for both MDT (n=24) and BSC (n=11) is shown by Kaplan-Meier curves in Figure 12 obtained for 65 as received devices. The cumulative survival is 71% at one year and

10% at six years for both MDT devices and BSC devices respectively, the cumulative survival probability for MDT is 10% at six years and no survival for BSC devices. Pacemaker showed 88% survival rate after one year of implantation for both MDT and BSC. After four years, however, the survival rate reduced to 40% for MDT and 38% for BSC from the as received devices. No survival for BSC after six years of implantation, while 16% survival for MDT pacemakers. The survival probability of the leads for both MDT (n=34) and BSC (n=9) is shown in Figure 13.

Figure 12: Kaplan-Meier analysis of survival of (A) Medtronic Devices (n=24) and Boston Scientific Devices (n=11), (B) Medtronic Pacemakers (n=13) and Boston Scientific Pacemakers (n=8).

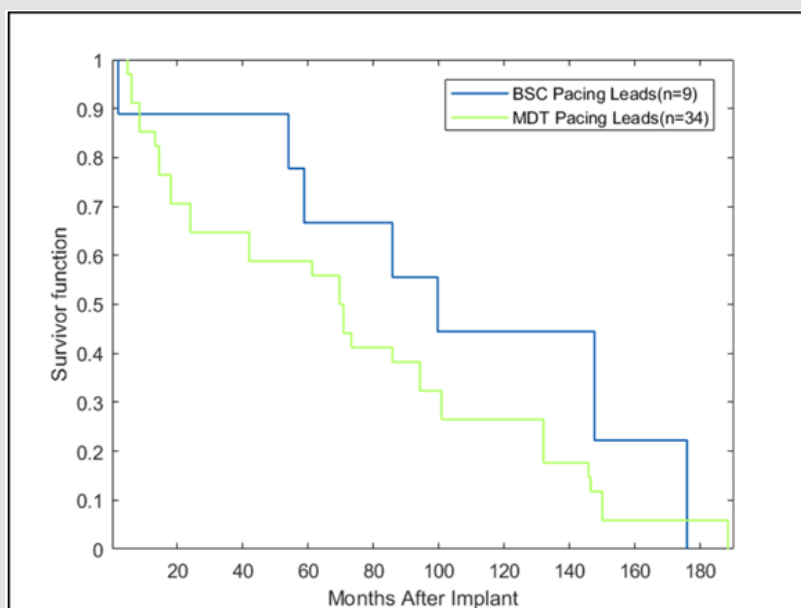
Figure 13: Kaplan-Meier analysis of survival of (A) Medtronic Pacing Leads (n=34) and Boston Scientific Pacing Leads (n=9).

After 60 months, the survival is 60% for MDT and 68% for BSC. The survival is 6% after 176 months of implantation for both the manufacturers, and no survival for BSC after 180 months of implantation, while MDT is 6% survival after 180 months after implantation. 33% of BSC devices used MDT leads for different purposes [33]. Sensitivity can be defined by the capability of the device to sense the intrinsic heartbeat. It represents the minimum cardiac signal that can be sensed by the pacemaker to initiate or terminate the therapy. The sensitivity is measured in millivolts, the higher sensitivity the lower voltage programmed. When

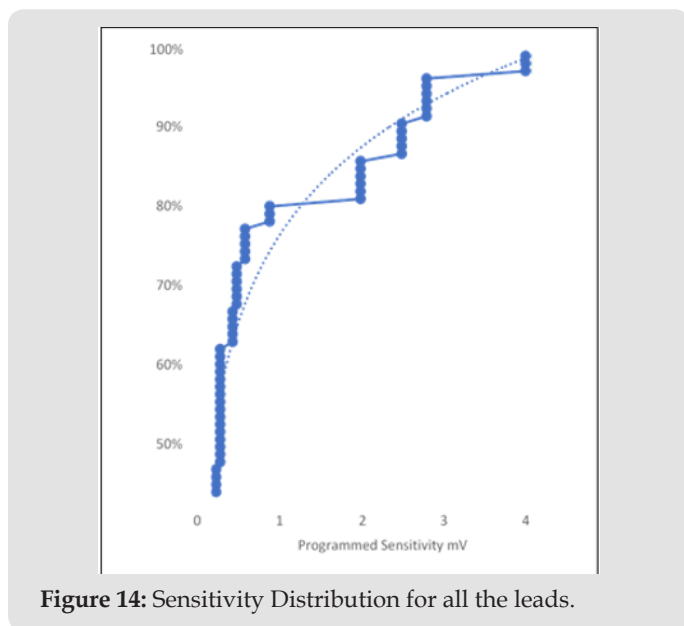
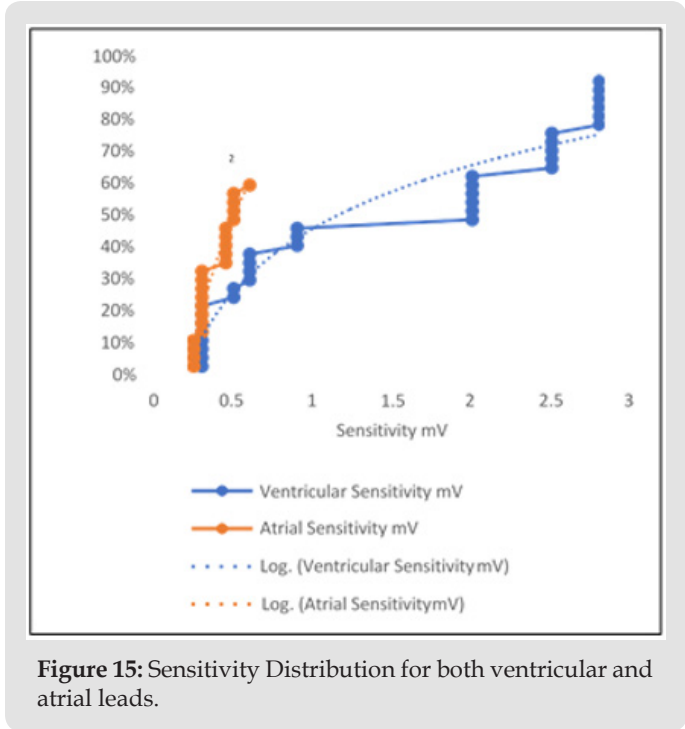
was 1.188 mV and ranged from 0.25-4 mV. Figure 15 shows the difference between the sensitivity setting of the ventricular and atrial leads, and it shows the ventricular sensitivity setting was higher compared to the atrial sensitivity setting [35].

Figure 15: Sensitivity Distribution for both ventricular and atrial leads.

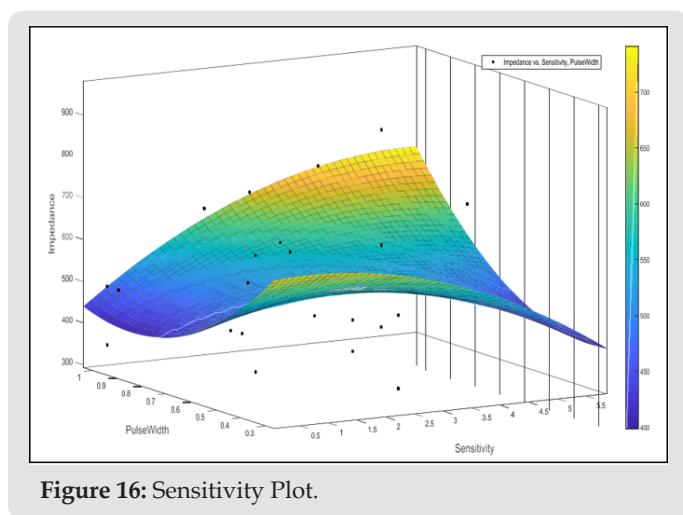
Sensitivity metric equation was created from the data that were generated during this investigation from the devices. The goal was to mathematically model the sensitivity for any given time. A principal component analysis was performed for the acquired data to isolate those parameters that are the most important to create the sensitivity metric expression (S). It was noticed that as

the voltage increased the pulse width decreased and vice-versa. Therefore, sensitivity function parameters (F) were defined in terms of voltage, (F1) and pulse width (F2) as reciprocal, (1/F2). It is important to note that if the voltage doubled, then the energy usage can be higher. Lastly, the time was a crucial component and by far the most important [42].

F1 is the voltage in millivolts, F2 is the pulse width in milliseconds, F3 is the in ohms, and lastly is F4 the current in milli-amperes. The interrogation of the devices leads to numerous discoveries, and the relation between sensitivity setting, pulse width and impedance can be revealed through the obtained reports. Sensitivity plot generated using MATLAB R2017a, that contained impedance, pulse width, and sensitivity setting as shown in Figure 16. This plot shows that with low impedance and high pulse width, the sensitivity is low. However, the impedance increases the sensitivity and pulse width, this scenario depletes the battery earlier than estimated. In general, the devices investigated in this report were from Medtronic and Boston Scientific exhibit surface damage modes, but these damages could not have affected the functionality of the device and the therapy. The main damage mode observed was scratching, and the anterior side was more exposed to damage than the posterior side. Medtronic leads showed significant resistant to different damage modes when compared to Boston Scientific and St. Jude Medical, for our sample size, and the middle part was more exposed to damage than the proximal part [43].

Figure 16: Sensitivity Plot.
