Failure Modes of Biomedical Implants

Andrew Gratton, Bert Buford, Tarun Goswami, Dana GaddyKurten, and Larry Suva

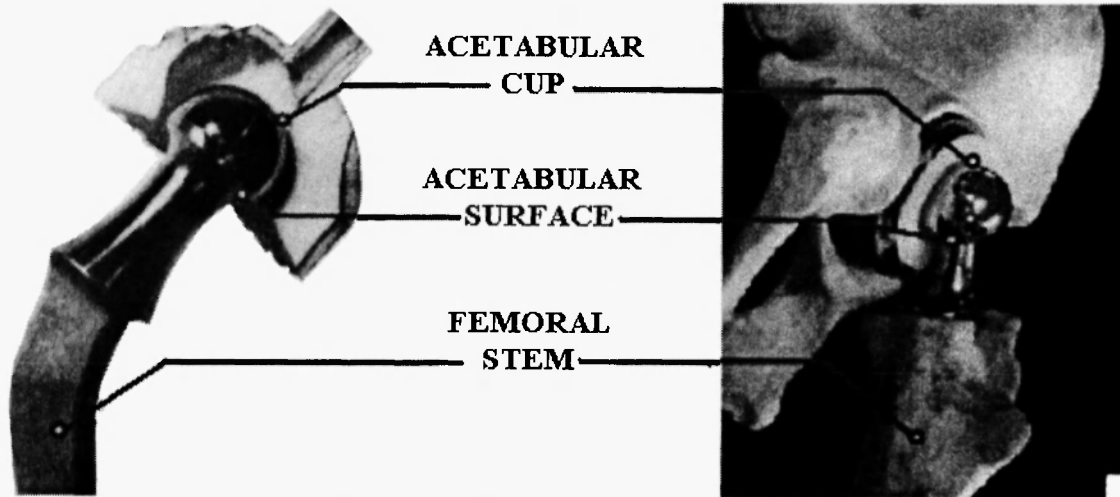
An integrated implant has a much larger stem and, subsequently, a much larger hole in the bone. An integrated prosthesis hip is generally composed of two metallic parts: the socket, which attaches to the acetabular cup (hip bone), and the ball, neck and stem piece, which attaches to the lower femoral stem (thigh leg bone). Figure 1 shows a typical integrated THR implant.

Fig. 1: Typical Integrated THR Implant /4/

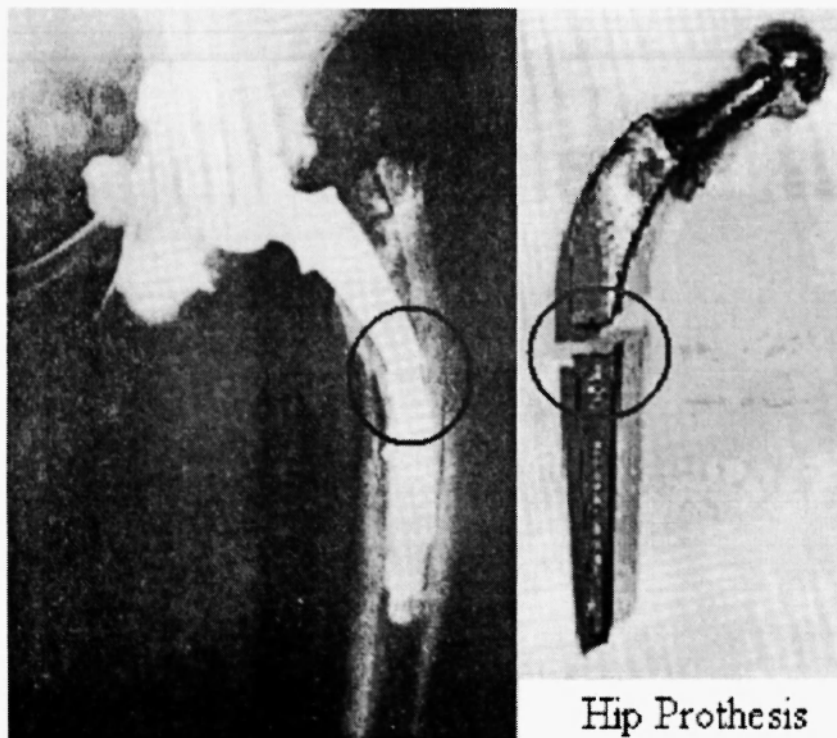
Fig. 2: Hip Prosthesis Failure

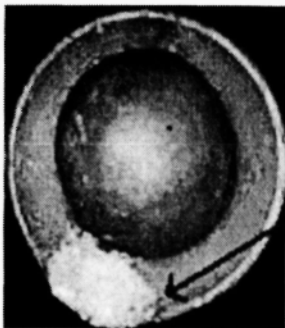
Fig. 3: Wear Particulate Infection

Polyethylene debris from an acetabular liner has been attacked by the body, resulting in giant cells that eat away bone and result in component loosening /13/.

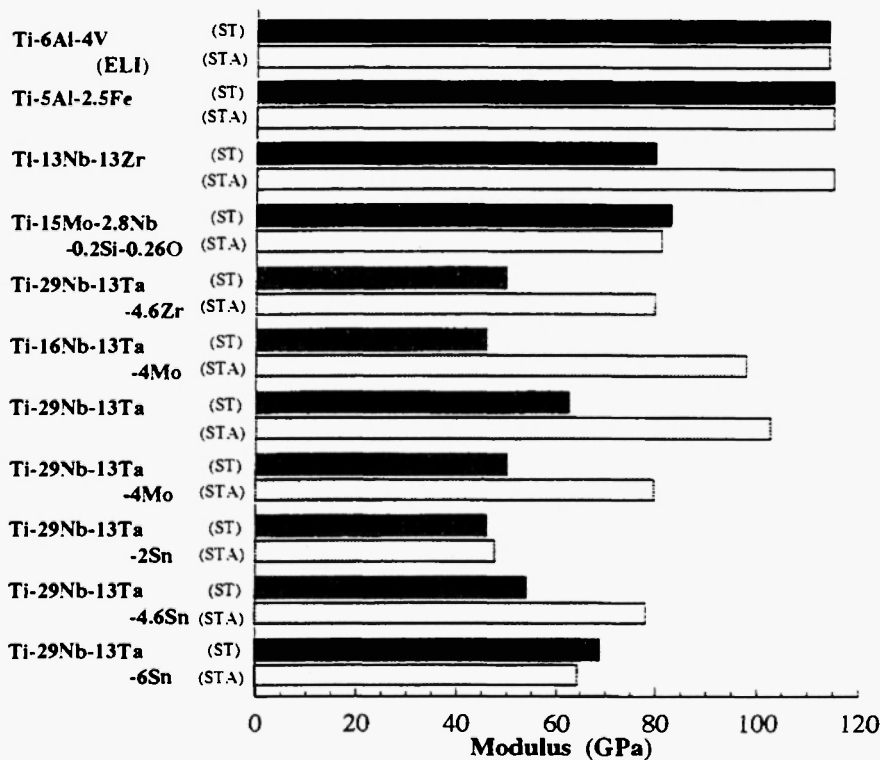
There are many alloys of titanium available for use, each with individual characteristics that make it a good solution to a certain problem. However, by making one characteristic better, other characteristics may become weaker. Figure 4 shows how the modulus of elasticity varies for different titanium alloys.

Fig. 4: Modulus of Elasticity of Varying Titanium Alloys /24/.

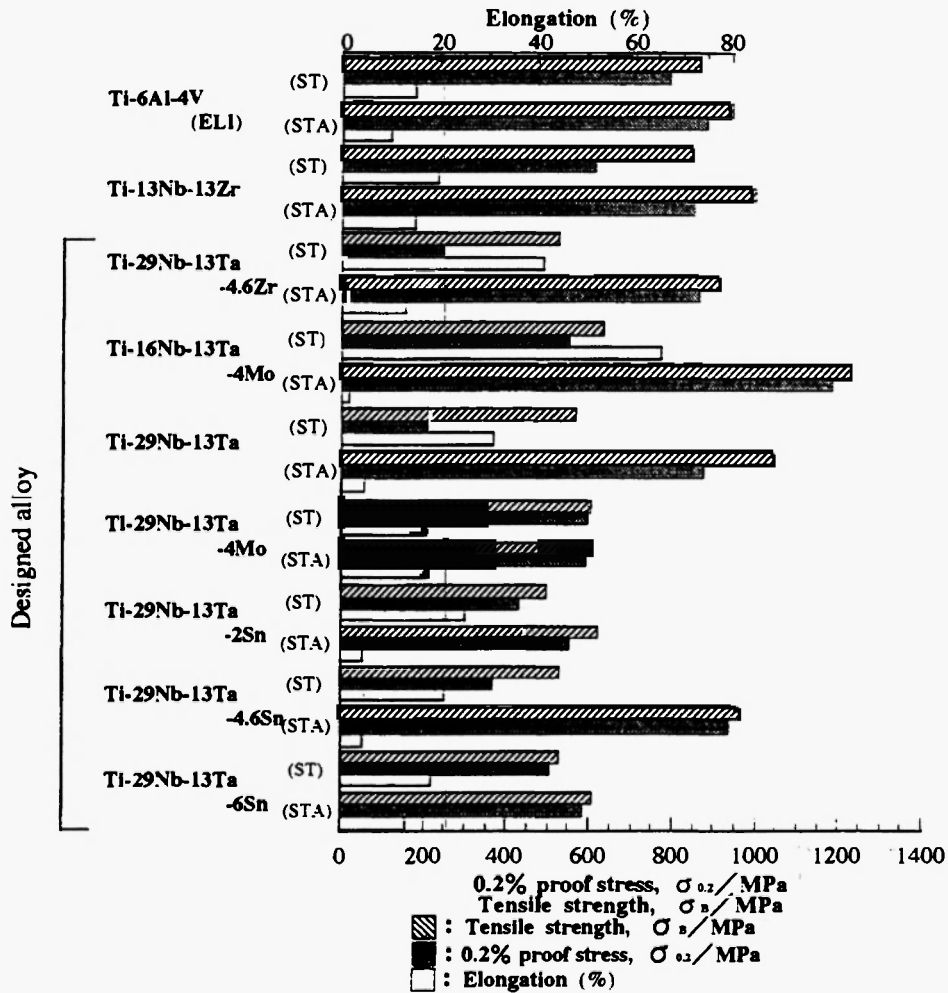
Figure 5 shows how the tensile strength of the different titanium alloys also varies.

Fig. 5: Tensile Strength of Varving Titanium Alloys /25/

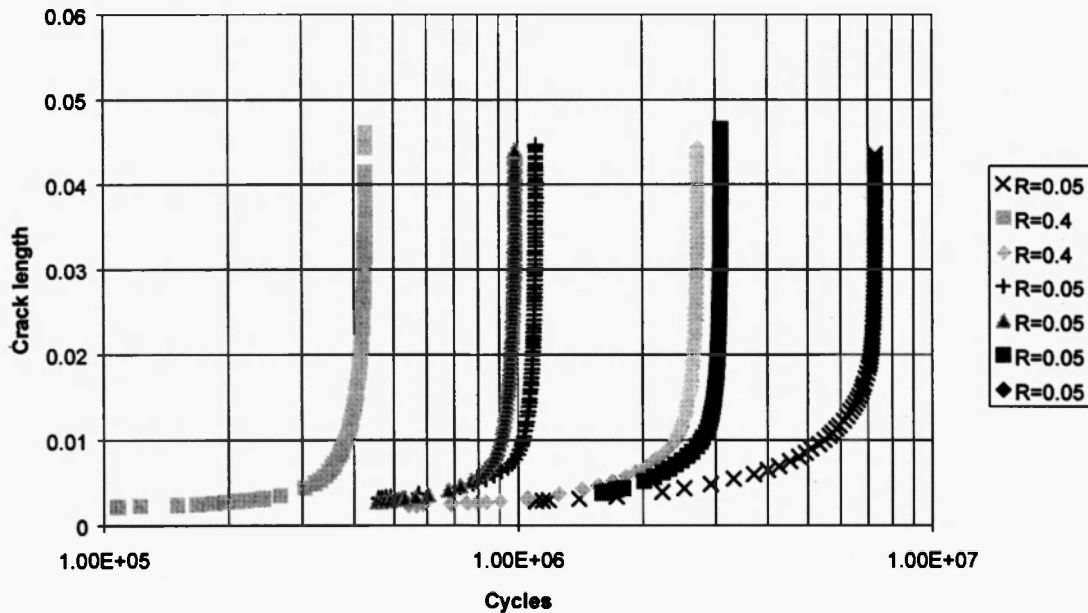
Fig. 6 : Crack length versus number of cycles for Ti-6Al-4V high humidity tests.

From Figure 6, the crack lengths of Ti-6Al-4V become longer as the number of cycles on the specimen increases. At a certain number of cycles, the crack spontaneously increases at alarming rates. The R-value indicates the stress ratio of minimum stress to maximum stress. An R-value of less than 0.5 is a conservative estimation of the stress ratios in prostheses. The figure shows data for a high humidity test environment. The data is applicable to biomaterials because *in vivo* conditions are best modeled as high humidity. This significant increase in crack length propagation applies to the material's ultimate failure due to cracking, a severe result of fatigue wear.

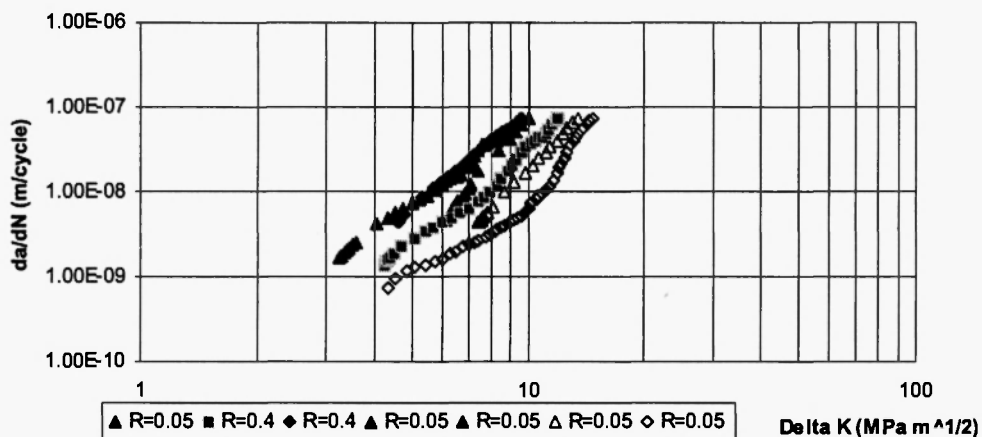
The rate of crack growth rate can also be studied. Figure 7 illustrates the rate of crack growth for Ti-6Al-4V.

Fig. 7 : Crack propagation behavior of Ti-6Al-4V in high humidity environment

The data in Figure 7 indicates that the rate of crack growth increases as Delta K increases.

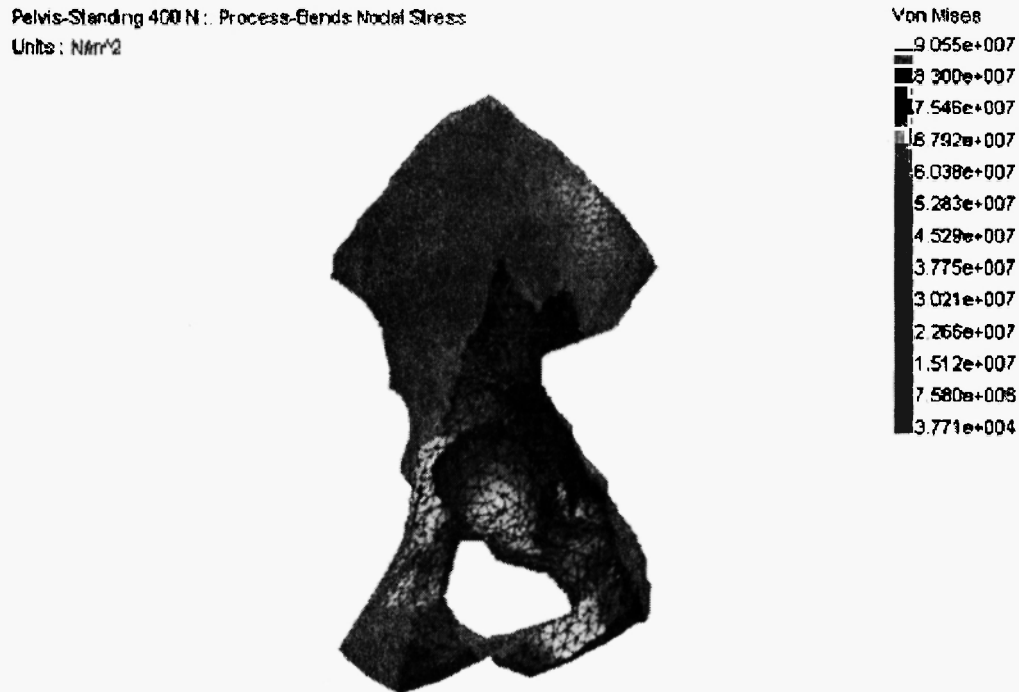
Fig. 8: Sample finite element analysis of a hip bone with 400N force applied /29/.

Prosthesis design consists of 3 design parameters: fatigue and fracture, corrosion, and wear. A prosthesis should be able to withstand 3 million cycles per year for the average sedentary individual. Fatigue analysis must take into consideration other factors that will prematurely weaken the material, such as corrosion. In addition, combined effects of material failure modes working together must be considered as well. A modern method of estimating the maximum stresses and fatigue life of a prosthesis is through the finite element method. This method splits an object into a finite number of elements that can then be subjected to a load. The stresses are then calculated using the finite element method. Also, changes in design can be easily made and the stresses found in a relatively short amount of time. An example of a finite element analysis of a hipbone is shown in Figure 8.

Unfortunately, the finite element analyses performed do not represent exact load conditions of the human body. Non-linear elements such as bone density or the directional differences in Poisson's ratio for bone cannot be modeled into the analysis. Also, the exact shape of parts is impossible to reproduce in a computer program since the size and shape of the human skeletal system is continuously growing and changing. For instance, an individual who decides to lift weights when his previous primary physical activity was running, will experience a reorganization of his skeletal system to accommodate the change in load type and distribution. As technology advances, however, the computer-generated models become more accurate and will eventually represent a very good modeling and design tool to develop better prostheses.
