#### CHURCH OF HOLY ASCENTION

**KATSIARYNA SMALIAKOVA, RAISA PLATONOVA**  
**Polotsk State University, Belarus**

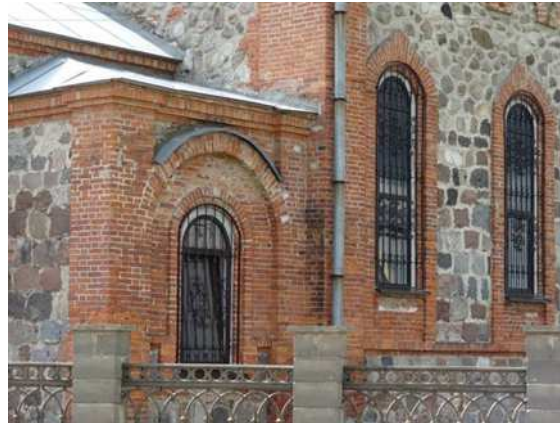
Fig. 1. Fragment of masonry

In 1879 a new temple of rubble stone and red brick was built on the site of the wooden church. Laying of quarry stone requires great effort and great skill that shows the complexity of construction (Fig. 1). It should be noted that the quarry stone was of local origin. The temple has suffered a lot of completions and reconstructions [1].

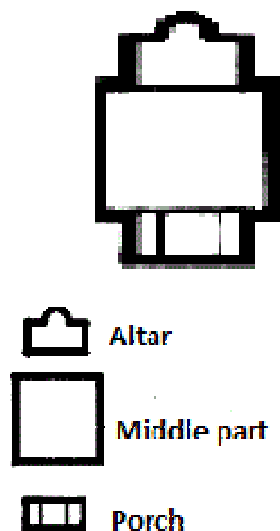
Fig. 2. Plan of the Church

The bulk of the temple in the form of a cube in the urban village of Rossony is completed with five domes. The bunk ending head bell tower with lateral extensions is joined to the temple on the oriented to the west at sunrise planning axis (Fig. 2). The main entrance is solved with heavy proportions, a squat roofed-locker on two columns in the form of barrels (a characteristic attribute of Moscow churches of XVII century). High-arched window openings are surrounded by brick architraves. [2].
