Early-age shrinkage and bond of LC-TRM strengthening in rammed earth

Rafael Ramírez Eudave^{*}, Rui A. Silva, Eduardo Pereira, Antonio Romanazzi

ISISE – Institute for Sustainability and Innovation in Structural Engineering, University of Minho, School of Engineering, Civil Engineering Department, Azurém Campus, 4800-058 Guimarães, Portugal

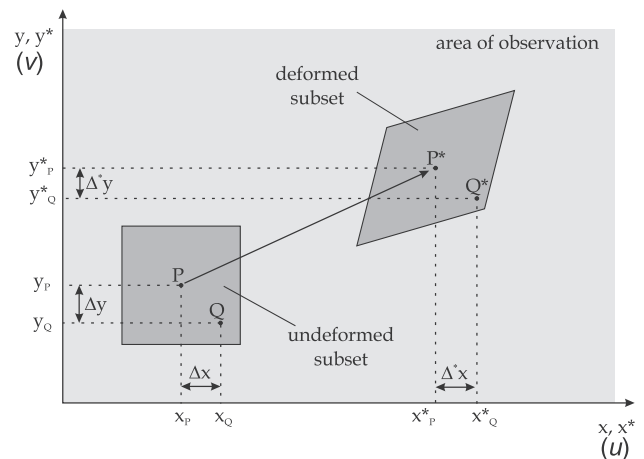
Fig. 1. Description of the displacement field of a subset in the observation area (adapted from [29]).

is based on an 8-bits value between 0 and 255 in a grayscale, where 0 corresponds to pure black and 255 is pure white. Each pixel is also associated to a local field (pattern) that permits to observe individual changes and deformations, as well as translations on the observed regions. The images permit to build maps for describing the local behaviour of entire surfaces, such as strain fields, strain vectors and micro cracks [29]. As shown in Fig. 1, the identification of regions and their corresponding control points permit to assess the relative displacement of the regions as well as the deformation of the subsets, which permits establishing a series of virtual extensometers (referred to specific points) as well as obtaining generalised maps for following deformations on the entire analysed surface.

The analysis software correlates the displaced patterns with discrete functions based on the cartesian plane. The measurements obtained by the means of the DIC technique may have resolutions of the order of 10^{-9} up to 10^2 m , with acquisition rates up to 200 MHz [30]. The frequency and the length of the experiment must be coherent with the observed phenomena. One of the most important challenges associated to the DIC technique lies on the selection of the contrasting pattern. It must not significantly interfere with the studied phenomena. Furthermore, it is desirable to have isotropic and high contrasting patterns, avoiding repetitive patterns. Of course, the pattern must not present visual alterations during the observation period.

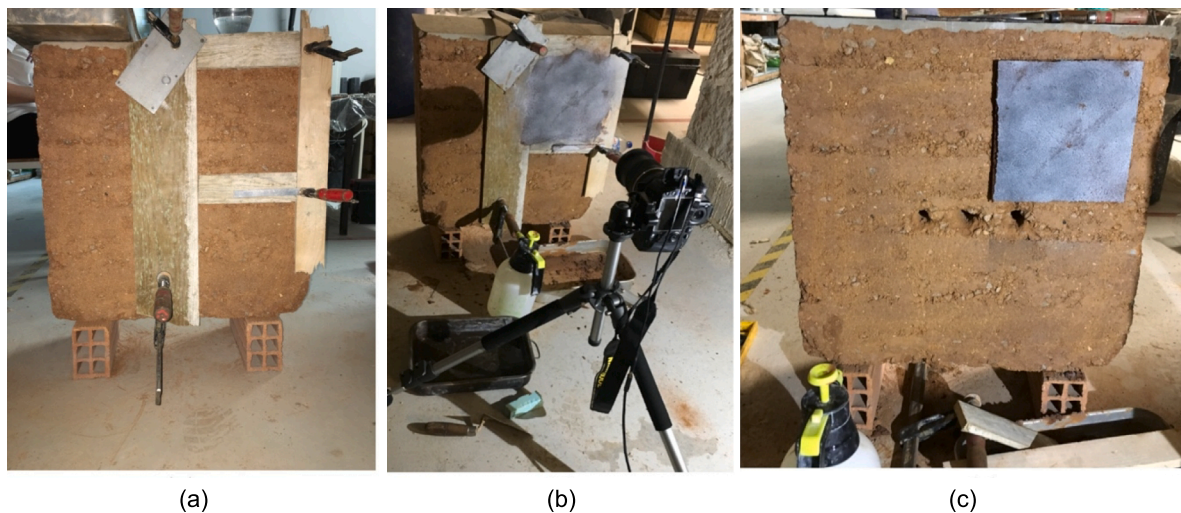
Fig. 2. Preliminary calibration tests conducted on a rammed earth wallet: (a) timber frame for applying the mortar; (b) testing setup; (c) speckle pattern of the first trial.

The observations were developed along two hours with a lapse of 30 s between photographs (Fig. 2). The analysis of the images permitted to recognise that the brightness of the humid surface in the initial stages of the observations was still problematic. Furthermore, the creation of the pattern was difficult and consumed more than 4 min, which did not permit to take images of the early stages of the drying process.

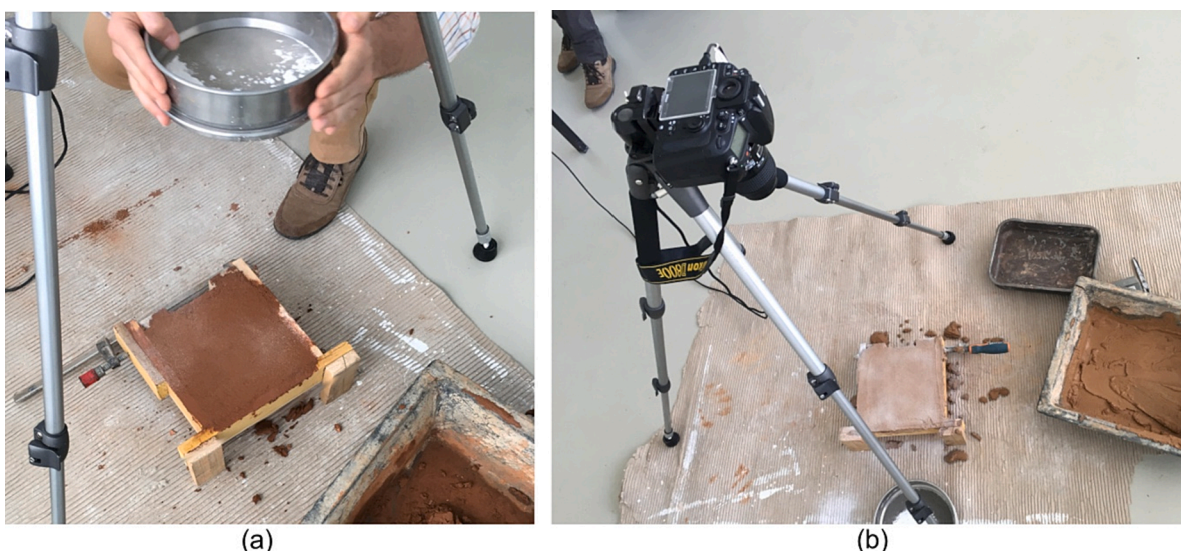
Fig. 3. Third preliminary calibration trial: (a) application of the limestone powder (b) testing setup.

The second trial consisted in repeating the procedure of the first trial, but white limestone powder was blown against the surface, instead of black and white spray paint, to create the speckle pattern. The vertical orientation of the wallet was found to be a problem for the correct application of the powder, which accumulated in some regions leading to photos with unsatisfactory quality for DIC. As a result, the third trial considered a smaller support element in horizontal orientation. For the sake of simplicity, the support element was constituted by two fired-clay bricks placed side by side. For this trial, the limestone powder was applied by means of a sieve (Fig. 3). Furthermore, the trial test was conducted in a room with very good natural lighting conditions. The images obtained along two hours of observation were considered satisfactory, since the pattern was adequately uniform and presented the quality for measuring deformations, while its application time was inferior to 1 min.

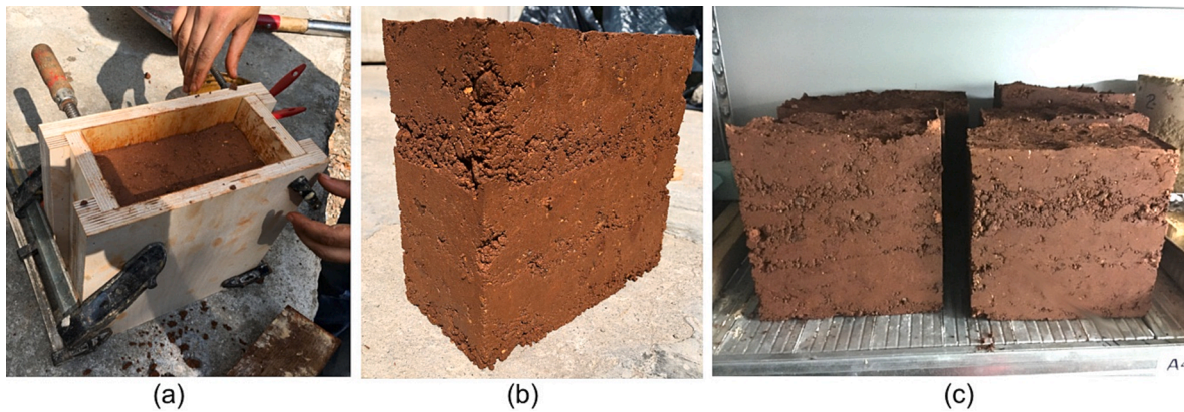
Fig. 4. Manufacturing of the rammed earth prisms: (a) timber formwork; (b) specimen immediately after demolding; (c) storing of the specimens in the climatic chamber.

Since the third trial presented the best results, the experimental program proceeded with the replication of the corresponding testing setup. Thus, nine rammed earth prisms with dimensions $200 \times 200 \times 100 \text{ mm}^3$ were manufactured using the same soil mixture of the rammed earth wallet used in the calibration trials, which is constituted by 14 % of clay, 16 % of silt, 32 % of sand and 37 % of gravel. The moisture content of the mixture was controlled by means of the drop-ball test [17]. Then, the mixture was compacted inside a timber mould in layers with initial thickness of 10 cm, which resulted in a compacted thickness of about 6.5 cm and a total of 3 layers per specimen. The layers were compacted with a steel hand rammer and the specimens were demoulded immediately after compaction. Two hours after, the specimens were stored in a climatic chamber with controlled conditions of $20 \text{ }^\circ\text{C} \pm 1 \text{ }^\circ\text{C}$ of temperature and 60 % of relative humidity. An average density of 2050 kg/m^3 was obtained after the drying of the specimens in these conditions for a period of 28 days (Fig. 4).

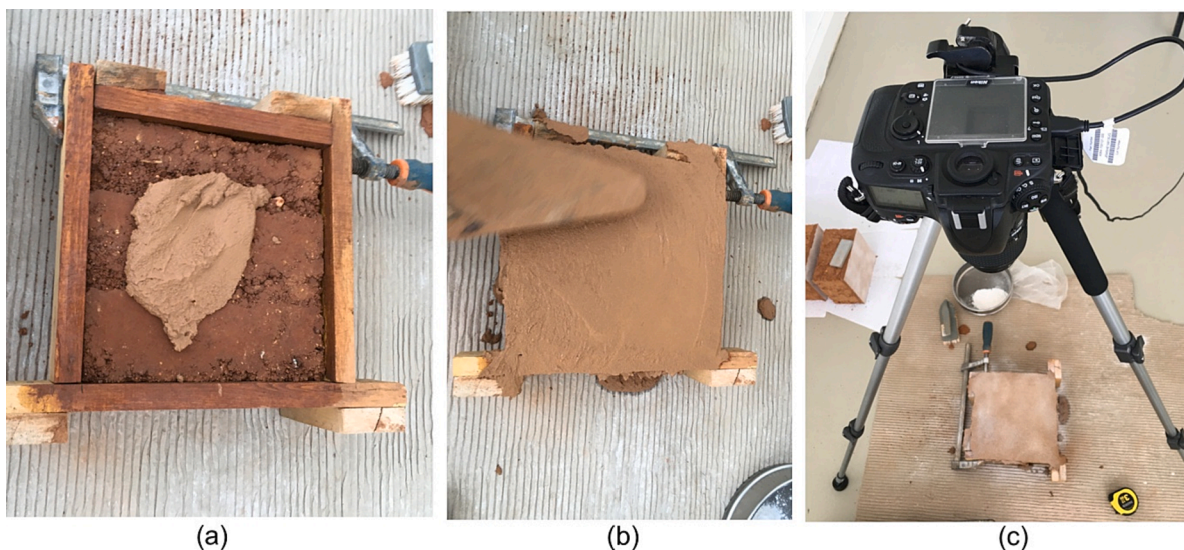
Fig. 5. Execution of the DIC shrinkage tests (PE-U specimen): (a) application of the mortar with the substrate previously moistened; (b) smoothing of the mortar; (c) testing setup.

The same testing procedure was repeated for all conducted tests, which was based on the procedure followed in the third calibration trial. Firstly, all the elements were positioned, namely the camera was fixed and the rammed earth specimen was placed in its definitive position, which allowed to calibrate and focus the camera. Before the application of the mortar, the surface of the prism was brushed with a nylon brush and subsequently sprayed with water. A timber frame was fixed to the prism to facilitate the application of the mortar in terms of thickness control. Then, the mortar was applied in a single 10 mm layer when the solution being tested did not include reinforcement. When it included reinforcement, a first layer of mortar of about 5 mm of thickness was

The surface of the mortar was smoothed with a trowel before applying the speckle pattern, which consisted in spreading a small amount of limestone powder on the surface with a sieve with aperture 0.149 mm. The test started immediately after, with the acquisition of images during about 200 min with a sampling period of 30 s (Fig. 5). Despite all concerns had in the preparation and execution of the tests, some difficulties were still observed, such as minor changes in natural lighting conditions through time or slightly colour changes during the drying process. However, they did not compromise the data acquisition process and subsequent analysis. Furthermore, all tests were conducted under similar laboratory environmental conditions, namely temperature of 23 ± 2 °C and relative humidity of 60 ± 10 %.

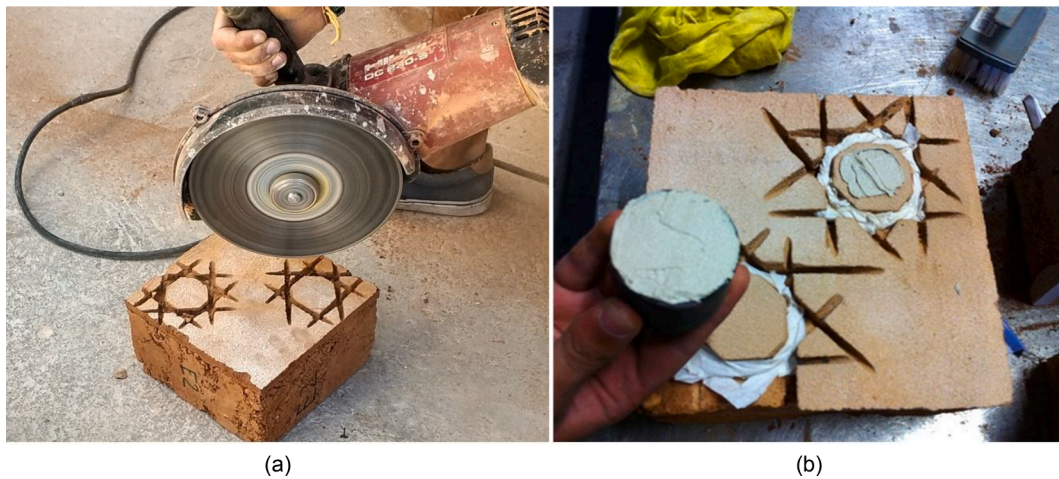
Fig. 6. Preparation of the specimens for the pull-off tests: (a) process used for isolating the cores with octahedral shape.; (b) bonding of the steel plates with epoxy resin.

All the specimens were tested after the DIC experimental program was concluded, implying a drying process of more than 28 days. The cuts for isolating the cores were performed with a circular manual saw respecting an internal circumference with a diameter of 50 mm. The cutting reached a minimum depth beyond the substrate-mortar interface. Despite each specimen would be originally suitable for isolating four cores, the manipulation of the sample (in some cases) provoked a detachment of the plastered surface. Thus, the isolation of the cores was performed in two phases: the cores corresponding to a diagonal were firstly isolated and tested. Then, the process was repeated on the other two cores. The surface of the cores was cleaned, and the steel plates were glued to it by using an epoxy adhesive that, given its consistency, permitted a satisfactory adjustment. The tests were performed after a 30-minute period after the application of the glue in order to guarantee its correct hardening (Fig. 6).

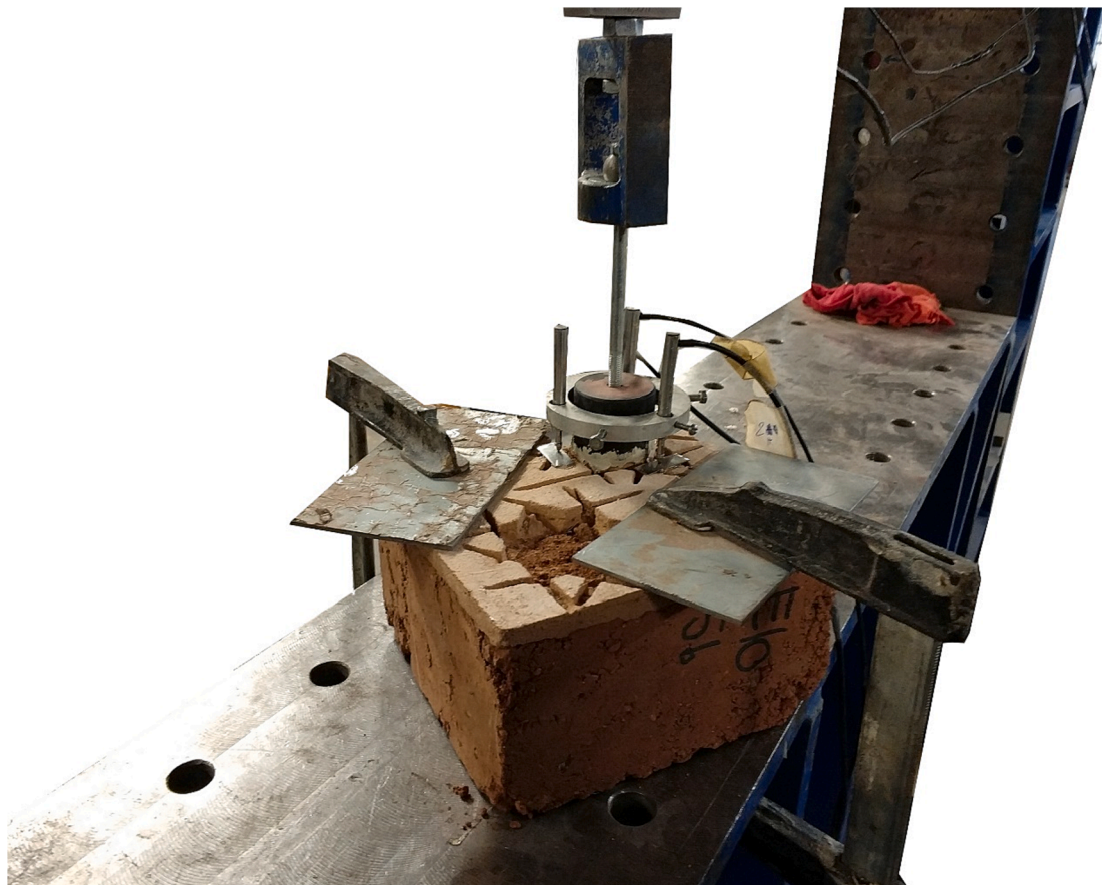
Fig. 7. Testing setup of the pull-off tests.

The tests were carried-out with a servocontrolled actuator in which the load was monotonically applied, with a displacement-based control of $1 \mu\text{m/s}$, similar to the procedure reported by Luso [36]. The specimens were fixed to a rigid frame and the testing plates were fixed to the actuator, keeping a vertical configuration. The loads were monitored by using a load cell with a capacity of 10 kN, while the strain was registered

with three LVDT (Lineal Variable Differential Transformers) radially distributed (Fig. 7).

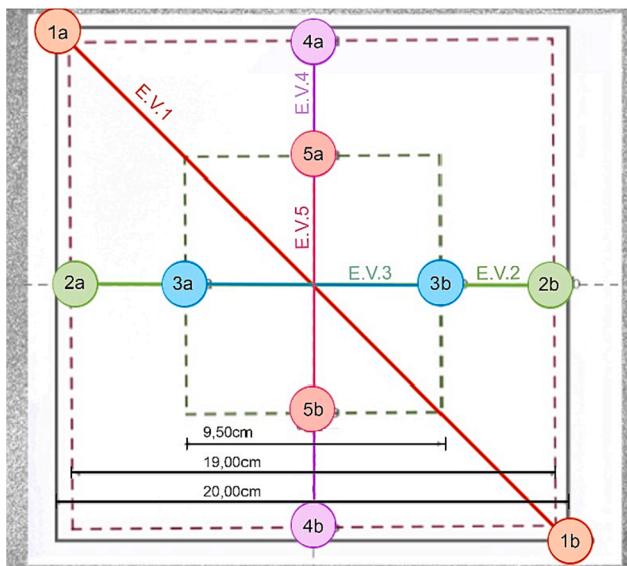
Fig. 8. Position of the digital extensometers considered for the analysis of the results.

For sake of simplicity, the results were first analysed by considering a set of digital extensometers located on the surface of each specimen, as illustrated in Fig. 8. Virtual Extensometer 1 (E.V.1) corresponds to the

line between points 1a-1b, with a total initial length of 28.3 cm that correspond to the maximum diagonal of the surface. Extensometers E.V.2 and E.V.4 correspond to a cross of the X and Y axis passing through the geometrical centre of the surface, having a length of 19.0 cm. The control points are located 0.5 cm from the boundary between the mortar and the formwork in order to avoid any potential effect caused by this last element, mostly given the volumetric variations of the wooden formwork due to the water absorption. Extensometers V.E.3 and V.E.5 are situated on the axes as well, but with a centred length of 9.5 cm. Behavioural differences between extensometer pairs E.V.2–E.V.4 and E.

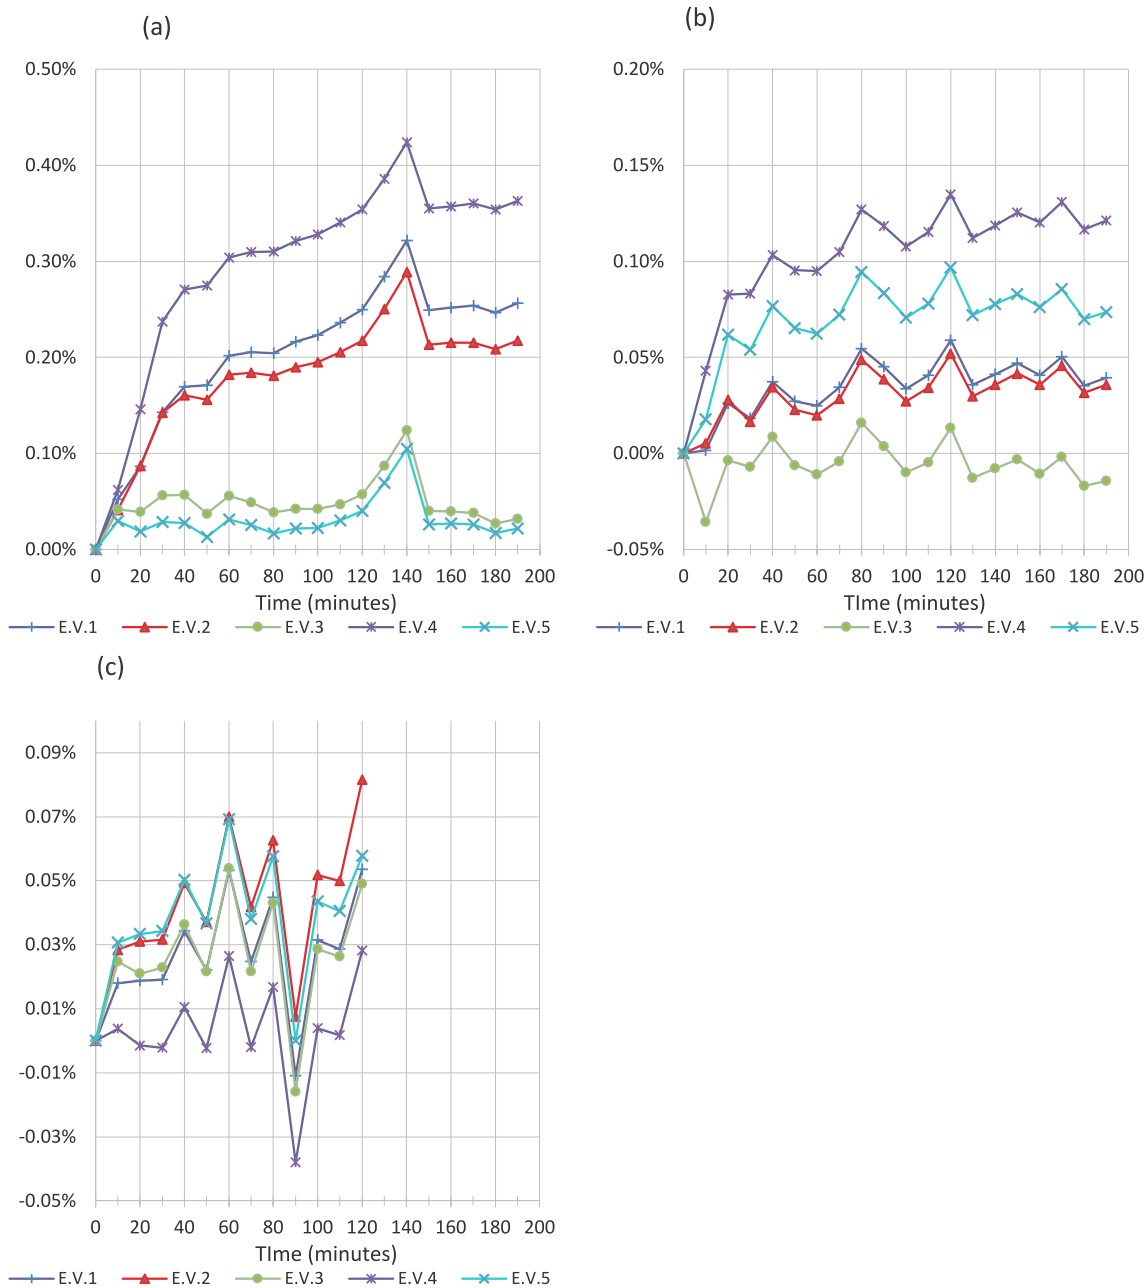
Fig. 9. Strains by Digital Extensometer for all specimens with application of the mortar EM2.0: (a) PE-U; (b) PE-G2; (c) PE-G8.

Plotting the deformation values obtained for each digital extensometer against time allows to observe the evolution of the shrinkage during the period of observation. Fig. 9 presents the curves of the three specimens that used the earth-based mortar EM2.0, where a significant difference in deformation can be observed from the unreinforced to the reinforced specimens. This difference is especially notorious for extensometers 1, 2 and 4, which are the longest ones and have measuring points located near the borders of the specimens. On the other hand, the extensometers 3 and 5 present near zero values for all specimens. Such behaviour seems to reflect that shrinkage at the central region is more constrained than at the borders of the specimen, probably due to the lack of continuity. Hence, this effect at the borders could be strongly related to the scale of the specimens.

The unreinforced EM2.0 mortar presented high deformations, in the order of 0.7 mm, while the reinforced solutions of the same mortar exhibited a maximum value of 0.25 mm. The glass-fibre mesh reinforcement presents higher dispersion of deformations than the nylon mesh reinforcement. It should be noted that the observation of some peaks during the measurements can be associated to specific artifacts of lighting variation, yet such perturbations do not compromise the observed long-term tendencies. Observations of the PE-G8 specimen were interrupted after 120 min, given a perturbation on the light conditions that forced to stop the experiment.

Despite the relevant shrinkage deformations of the unreinforced mortar EM2.0, no visible cracks were observed after complete drying, which can be attributed to the capacity of the mortar to accommodate such deformations during the hardening, due to the typically high plasticity found in earth-based mortars. However, the presence of the meshes is shown to produce a significant reduction of the shrinkage deformations of the mortar.

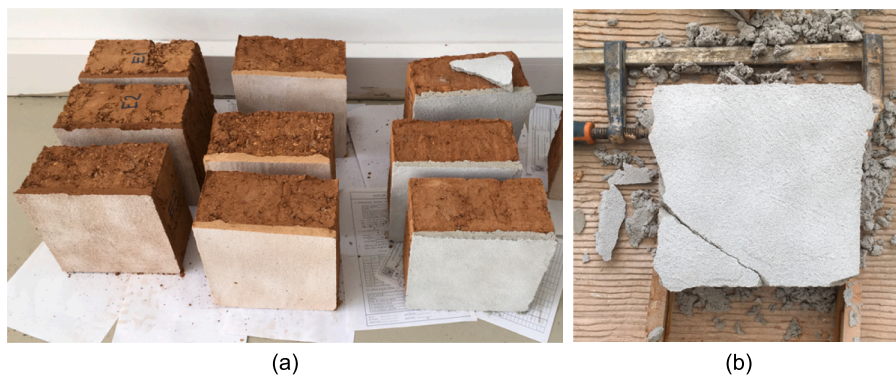
Fig. 12. Specimens after monitoring with DIC: (a) general view after 2 weeks; (b) cracking and detachment of the specimen PEC-U.

Nevertheless, a notable difference was observed in behaviour after the end of the DIC monitoring. The PEC-U specimen presented a crack and partial detachment of the mortar in the second day after the test (Fig. 12a). This observation suggests a weak bond between the substrate and the mortar, which is expected to be a consequence of the long-term shrinkage deformations occurring from the hardening process. Such behaviour seems to have been prevented by the presence of the reinforcement meshes in the specimens PEC-G2 and PEC-G8 specimens. The reinforcing meshes limit the shrinkage deformations of the mortar, which impedes further degradation of the bond during the hardening process.

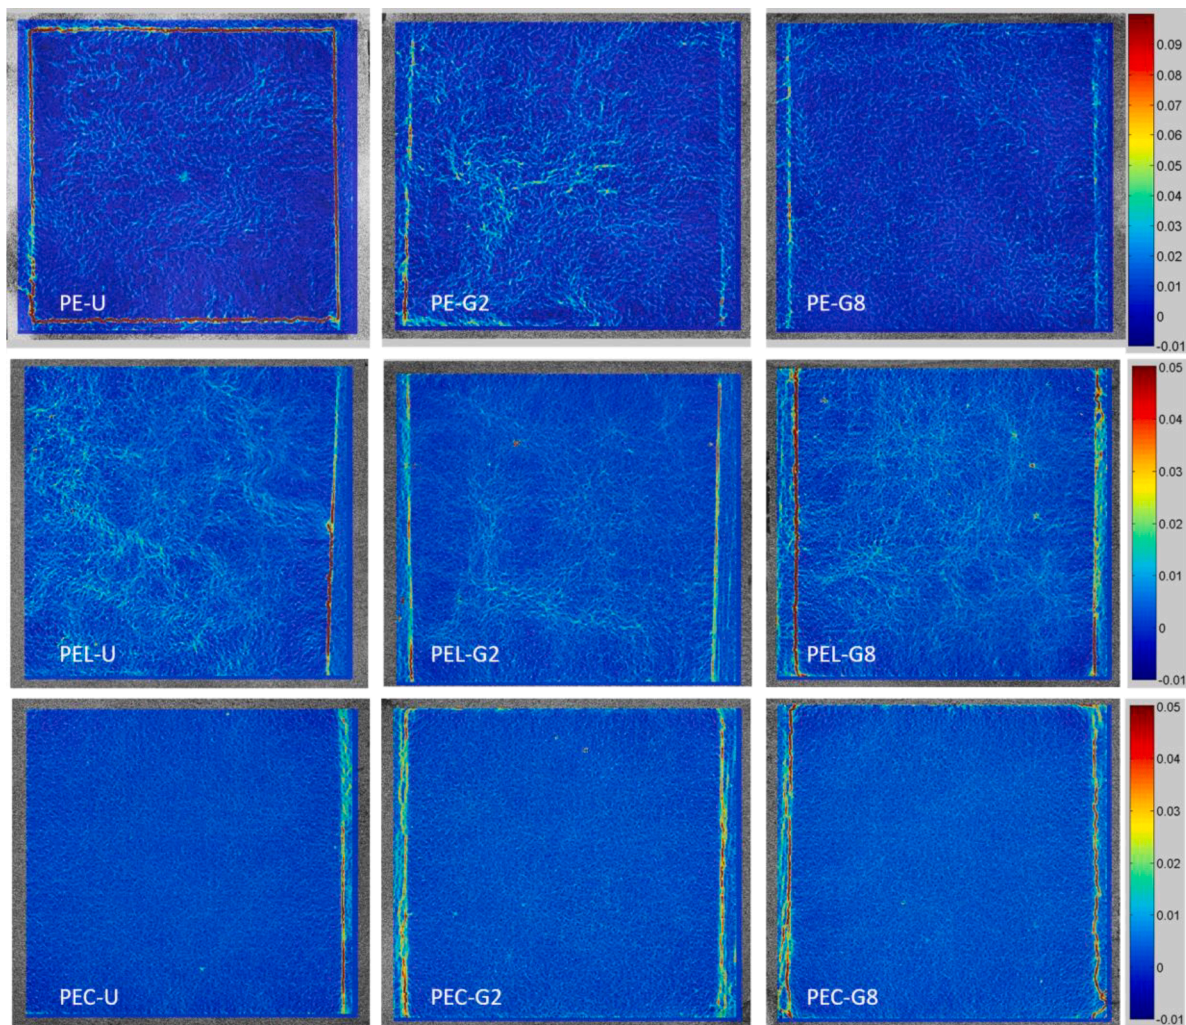
Fig. 13. Contour map of the tensile principal strains of each specimen at about 3 h of age.

The DIC monitoring also allowed to generate contour maps of the maximum principal strains, as shown in Fig. 13 for all specimens at an age of about 3 h. In general, the specimens with coatings applied with the earth-based mortars EM2.0 or S20EM2.0 generated distributed strain patterns, which contribute to dilute the shrinkage deformations through all application area, avoiding visible cracking development of these mortars, despite their high linear shrinkage. Such observation also evidences the contribution of the plastic behaviour of these earth-based mortars in avoiding cracking. Furthermore, the reinforcement of these mortars led to formation of zones around the mesh with concentration of tensile strains for both tested meshes. With respect the specimens with coatings applied with mortar CHM, a similar behaviour was observed for the unreinforced and reinforced specimens. A total absence of distribution of shrinkage deformation is observed, which may explain the lower tolerance of this mortar to accommodate long-term shrinkage deformations.

Finally, the observations conducted in all specimens evidence a different shrinkage behaviour between the central regions of the coatings and their boundaries. The contour maps of the tensile strains (see Fig. 13) also exhibit a clear cracking development at the perimetral limits of the mortar in all specimens. This observation is probably

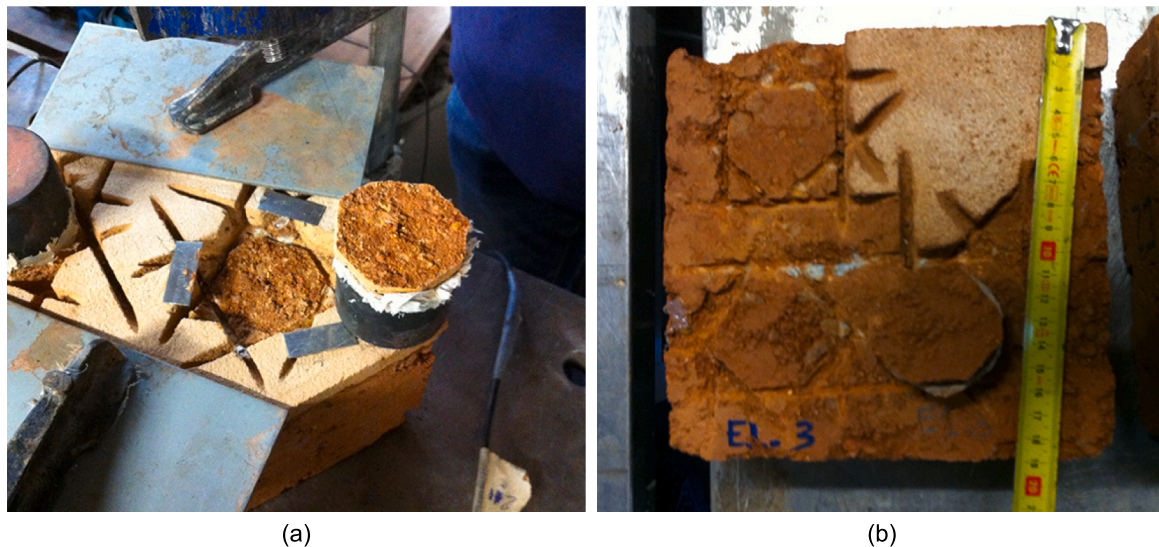
Fig. 14. Failure modes observed in the puff-off tests: (a) example of failure at the interface LC-TRM–substrate, showing a slim superficial layer of the substrate attached to the mortar; (b) large regions of the plaster detached during the experiments.

obtained in each test, as well as the failed attempts. Given that all the cores exhibited failure due to detachment at the interface LC-TRM–substrate (Fig. 14), the presence of the mesh does not seem to be relevant for conditioning the bonding behaviour. Nevertheless, some material of the substrate’s surface was always glued to the mortar cores, which suggest that the rammed earth at the surface has lesser cohesiveness than the inner material. This may be explained by the exposition to the environment of the surface and/or by some damage induced during the preparation of the specimens and testing setup. In fact, the most problematic stage of the experimental program was to isolate the cores trying not to induce damage to the specimens.

stabilised the material. The tests performed on the PC specimens (those with a mixture of cement) were characterised by fragile failures and spontaneous detachment of large regions.
