Archaeological Survey Of The Proposed Grapevine Aerial SS Repair Tarrant County, Texas

GRAPEVINE AERIAL SS REPAIR

Cultural Resources Report 2018-37 June 14, 2018

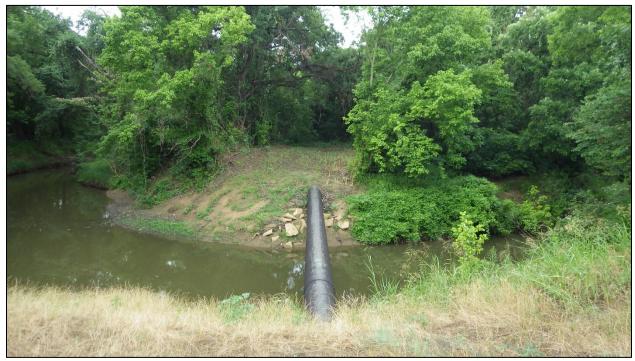
Figure 3. The existing aerial sanitary sewer across Big Bear Creek, looking southwest from the north bank.

The existing aerial sanitary sewer and project area are located on a horseshoe bend in the floodplain of Big Bear Creek (Figure 3). Most of the project area is covered in oak, elm, mesquite, and hackberry trees. Additionally, there are various shrubs, grasses, grapevines, and greenbriar, leaving zero-percent ground visibility in most of the project area (Figure 4). The only area with any ground visibility was a the existing sanitary sewer right of way (center of Figure 3). This area has been overlain with erosional control netting which extends from the bank approximately 15-meters southwest and comprises the visible, open, area.

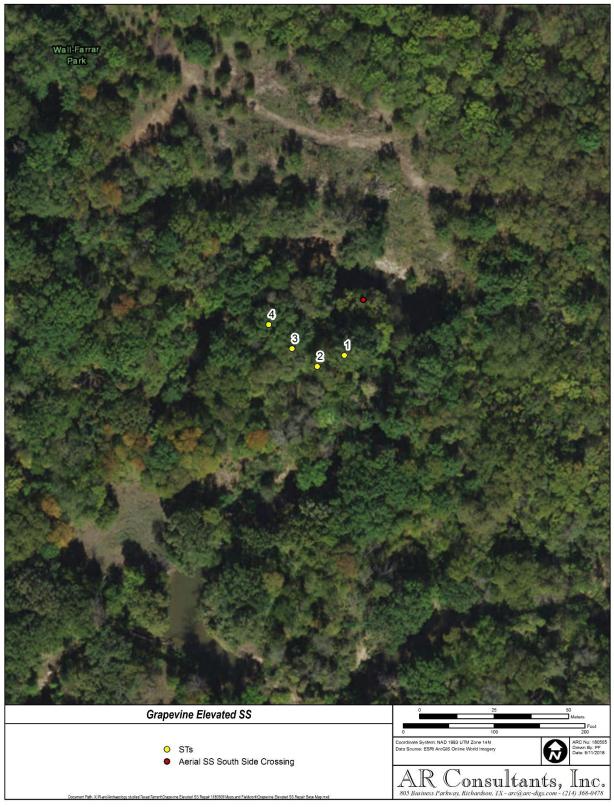
Figure 5. Shovel test locations for the Grapevine Aerial SS Repair shown on a recent aerial photograph.

Four shovel tests were excavated throughout the project area in the horseshoe bend of Big Bear Creek (Figure 5 and Table 2). As the open area described above was previously disturbed, ST locations were chosen on either side of the buried sanitary sewer near where Gabion construction has been proposed. Two STs (1-2) were placed on the east side between the sanitary sewer and the creek channel, and an additional two STs (3-4) were placed on the west side between the sanitary sewer and the creek channel.

STs1 and 2 had similar profiles, revealing 75-80 cm of dark grayish brown sandy loam above a brown sandy clay loam. STs 3 and 4 also revealed a similar profile to each other as well as STs 1-2. The top layer consisted of 40-65 cm of dark grayish brown sandy loam. However, this sandy loam transitioned with depth into a dark grayish brown sandy clay loam that extended between 75 to 80 cmbs. Below this was a brown sandy clay loam to clay loam. No artifacts or features were noted in the shovel tests.
