INTENSIVE CULTURAL RESOURCES SURVEY OF THE PROPOSED REALIGNMENT OF COUNTY ROAD 176, WILLIAMSON COUNTY, TEXAS

TEXAS ANTIQUITIES PERMIT NO. 7718
JULY 2018

PREPARED BY
SWCA Environmental Consultants

ADDENDUM REPORT: ADDITIONAL
INTENSIVE CULTURAL RESOURCES SURVEY
OF THE PROPOSED REALIGNMENT OF
COUNTY ROAD 176, WILLIAMSON COUNTY,
TEXAS

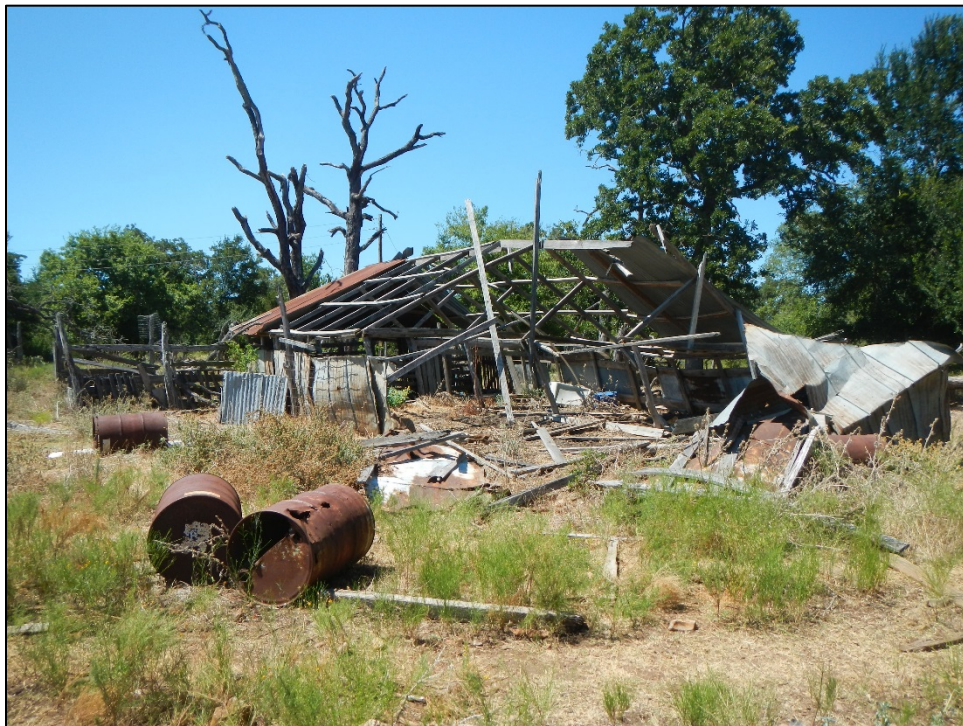
The farm complex was examined for architectural significance. Structure 1 is a very dilapidated early- to mid-twentieth-century vernacular outbuilding measuring approximately 20 feet (6.1 m) east to west by 30 feet (9.1 m) north to south (see Figures 5 and 7). The structure is constructed in rectangular plan using a wooden frame of machined 2×4-inch wooden boards and beams of various measurements. Much of the standard pitch roof is exposed, although corrugated sheet metal partially covers its northern and southern portions. The eastern and western elevations are partially clad in corrugated sheet metal, with some wood planks cladding a small section of the western elevation. A large open entryway is located on the southern elevation and two doorways are located on the western. Debris associated with the structure is located inside the building and along all four sides. The debris consists of 50-gallon drums and construction materials. Additionally, a wooden pen made of cedar posts and machine-cut wooden planks is located at the southeastern corner of the structure.

Figure 7. Overview of Structure 1 at 41WM1342; facing southwest.

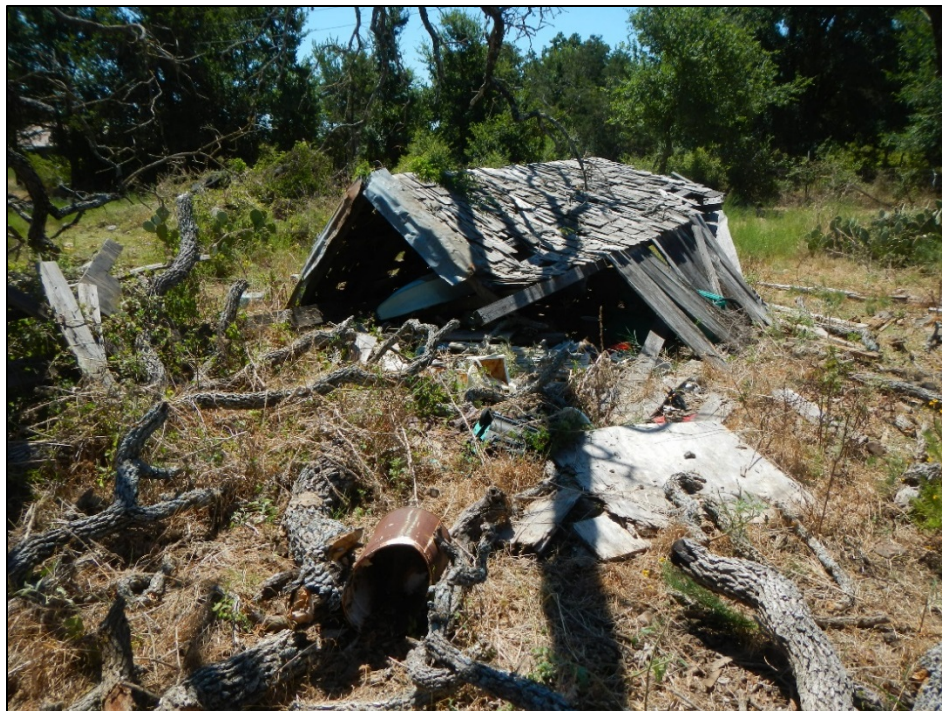
Structure 2 is located approximately 57 feet (17 m) southeast of Structure 1 and is a small, collapsed vernacular outbuilding measuring approximately 6 feet (1.8 m) east to west by 10 feet (3 m) north to south (see Figures 5 and 8), constructed in the early to mid-twentieth century. The standard pitch roof is clad in overlapping wood shingles attached to a wooden plank frame, with sheet metal on its northern and southern edges. Only the western wall remains intact and is clad with wooden planks attached to a 4×6-inch post runner along the base of the roof. Debris associated with the structure is located on the inside and around the sides of the building. Debris consist of a metal bucket, construction material, a plastic bin, wooden pallet, and a coiled strand of barbwire.

Figure 8. Overview of Structure 2 at 41WM1342; facing southeast.

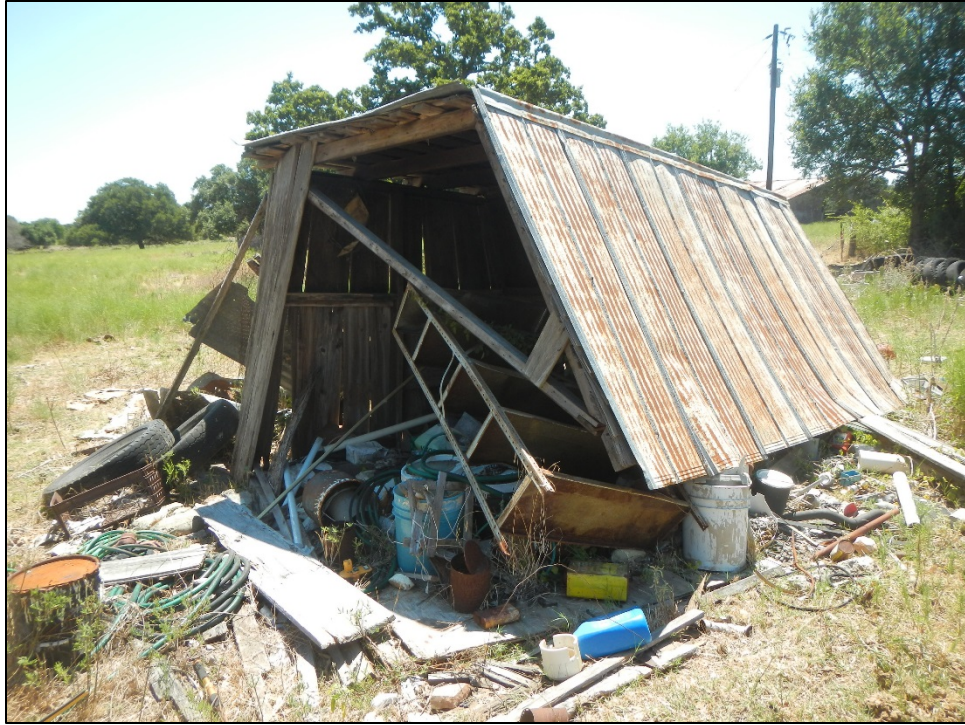
Structure 3 is approximately 27 feet (8 m) northeast from Structure 2 and is a collapsed early- to mid-twentieth-century vernacular outbuilding measuring approximately 10 feet (3 m) northeast to southwest by 15 feet (4.6 m) northwest to southeast (see Figure 5 and Figure 9). The standard pitch roof is clad with corrugated sheet metal overlying a wooden frame composed of mixed length machine-cut 2×4-inch wooden beams. The southwestern wall has been removed; it is propped up along the northeastern elevation by a wall constructed of wooden planks overlying the machine-cut wooden beam frame. The inside of the makeshift shed is filled with construction materials, a ladder, and hoses. Debris surrounding the structure consists of hoses, chicken wire, tires, and construction material.

Figure 9. Overview of Structure 3 at site 41WM1342; facing east.

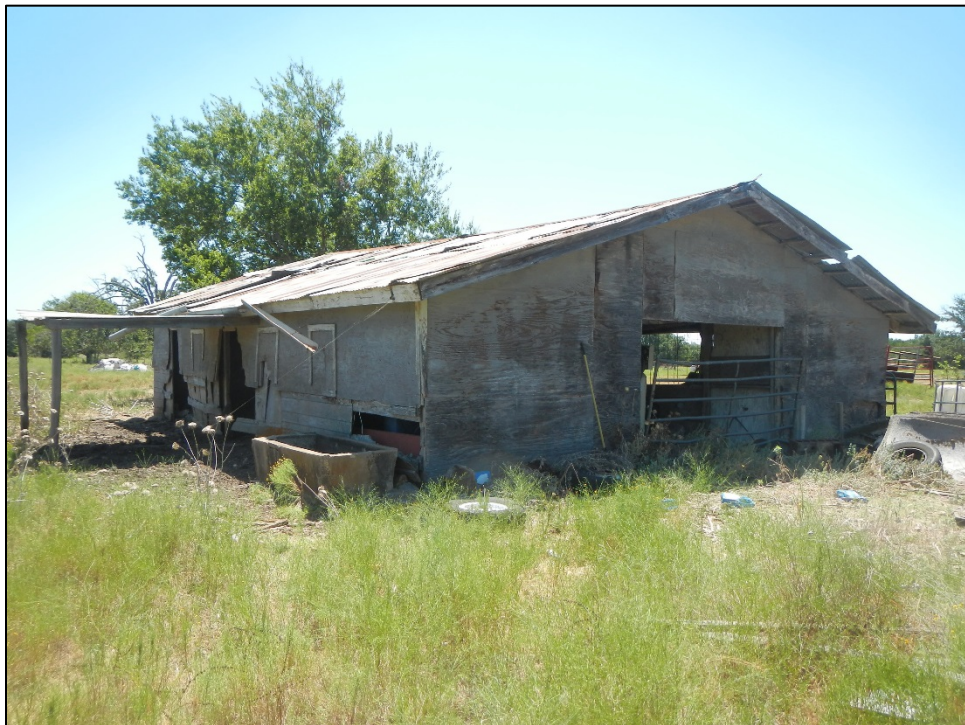
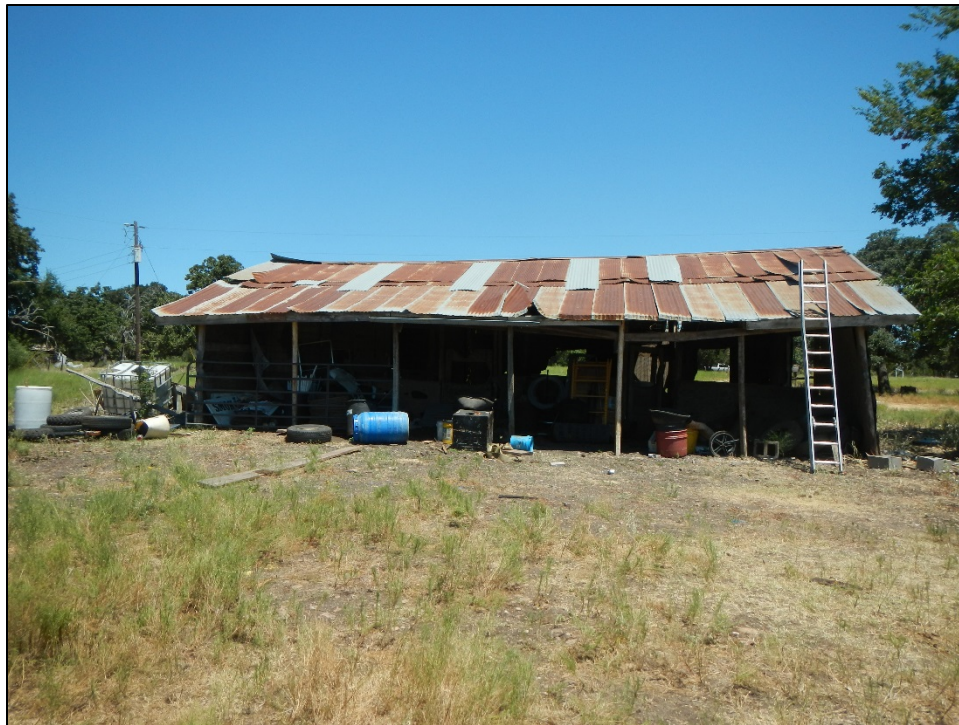
Structure 4, located approximately 170 feet (52 m) southeast from Structure 3, is a mid-twentieth-century vernacular outbuilding in partially ruinous condition that measures approximately 44 feet east to west by 33 feet north to south (see Figures 5, 10, and 11). The structure has a machine-cut wooden frame and standard pitch gable roof clad in corrugated metal panels. What appears to be the original main entrance is centered in the western elevation, covered by a flat corrugated sheet metal shed roof supported by two 4×6-inch wooden posts. The east elevation is open, whereas the other elevations are clad in plywood with openings. The western elevation has three boarded windows and two openings, including the shed-roofed entranceway. The northern and southern elevations each have a large entrance at their centers. Currently, the structure is being used for storage of ranching materials and construction material. Surrounding the structure debris are several tires and a cement water trough.

Figure 10. Overview of Structure 4 at site 41WM1342; facing northeast.

Figure 11. East view of Structure 4 at site 41WM1342; facing west.

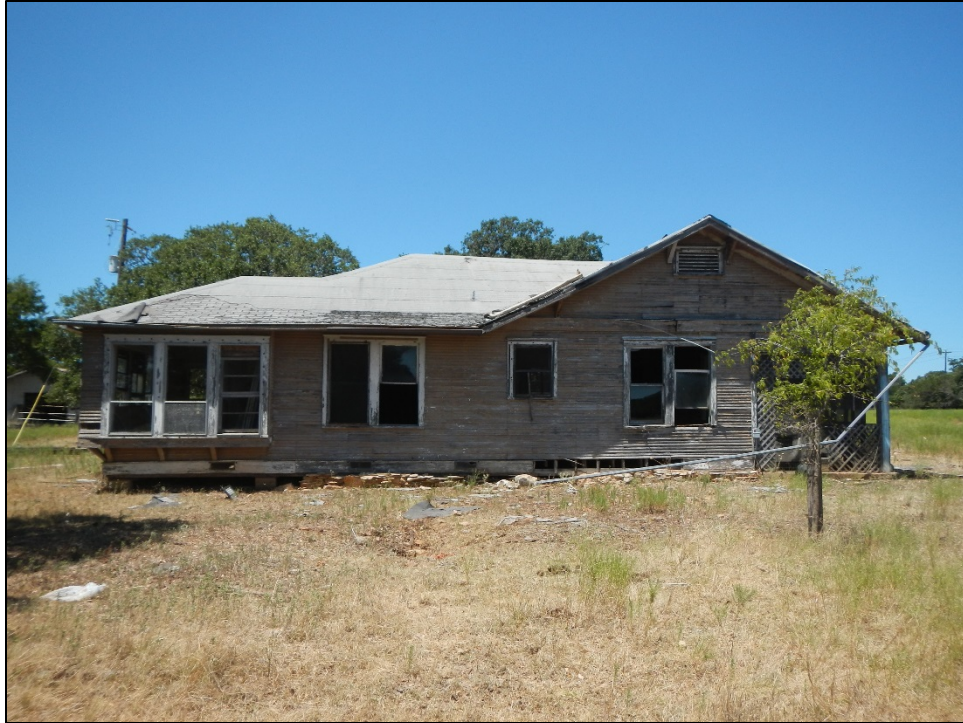
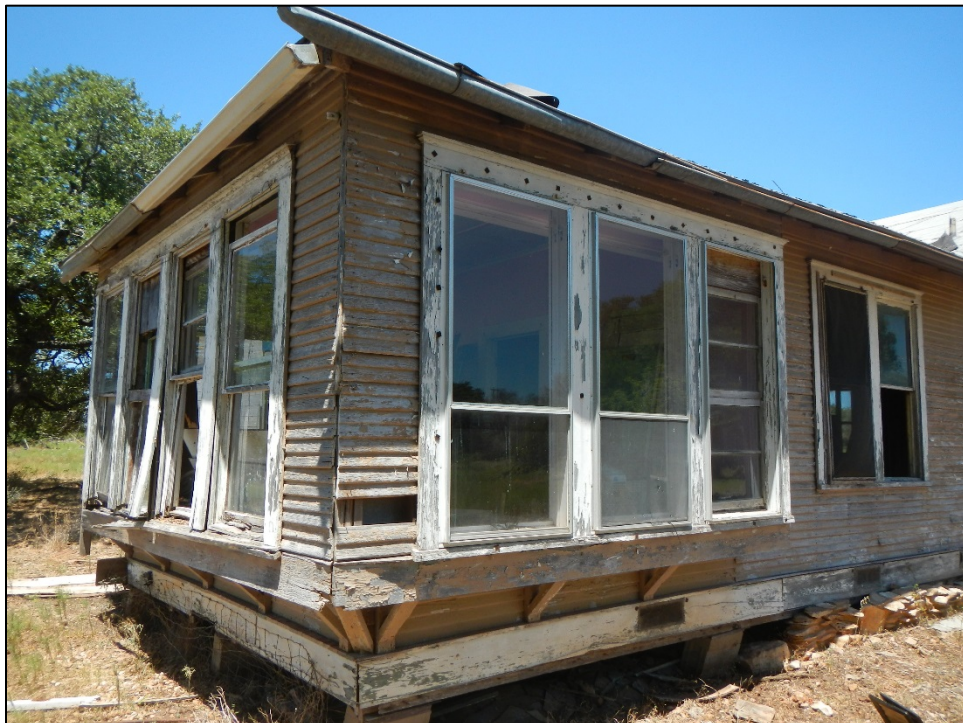
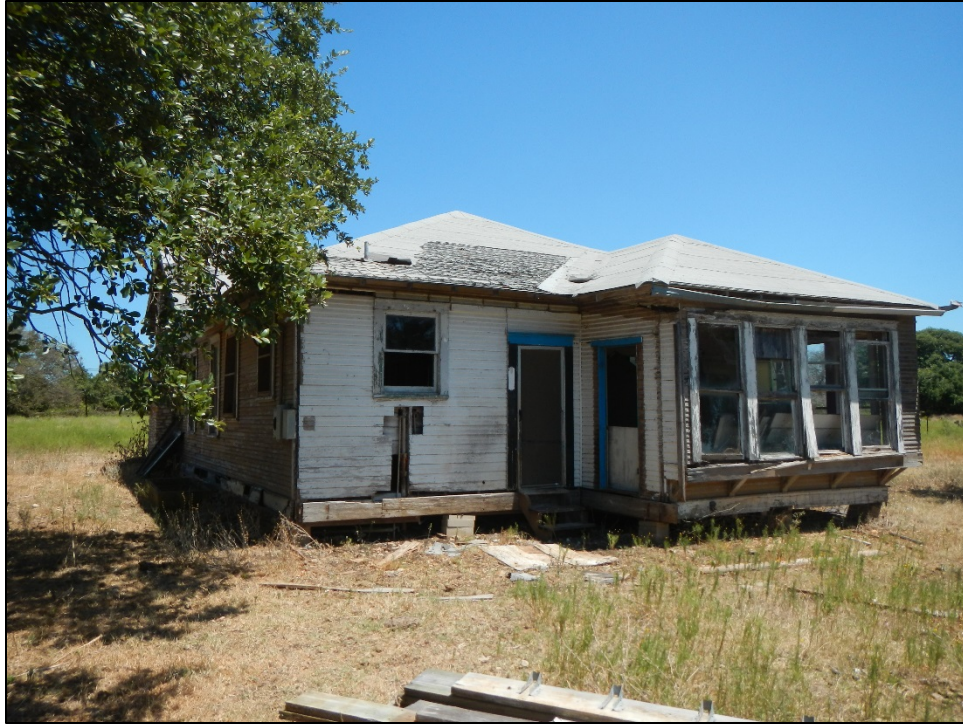
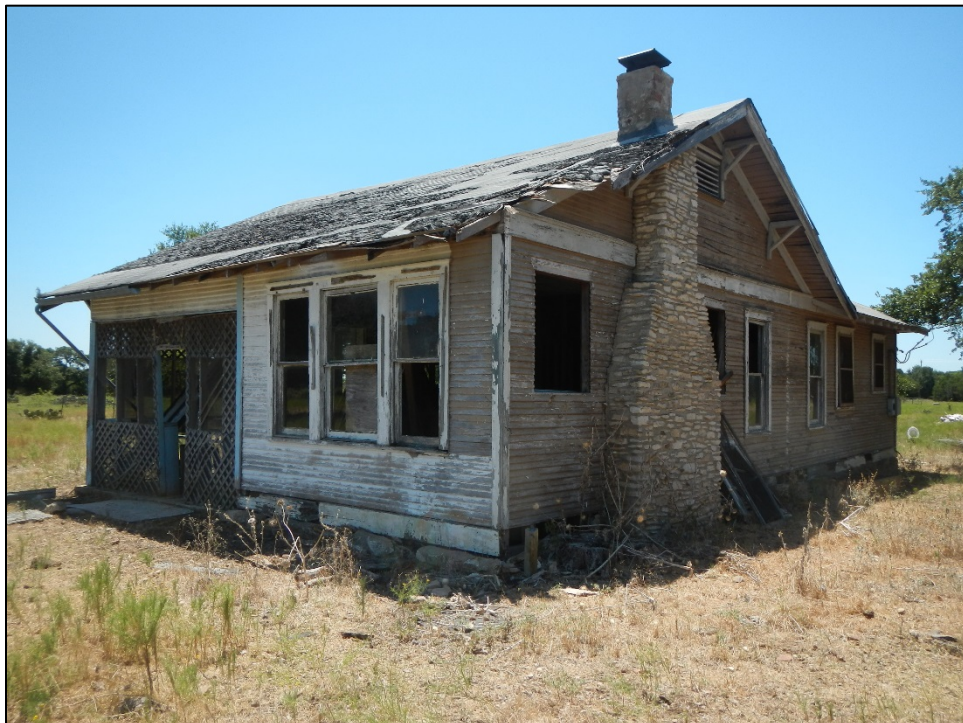
Structure 5, located approximately 124 feet (38 m) northeast of Structure 4, is a 28-foot (8.5-m) east to west by 58-foot (18-m) north to south mid-twentieth-century residential building (see Figures 5 and 12). The abandoned structure is set upon a pier and beam foundation with a stacked limestone and mortar skirt (Figure 13). It has a combination hip and valley/gable standard pitch roof with decorative gable brackets, clad in composite shingles. The structure is framed using machine-cut lumber and clad with horizontal narrow-gauge wood clapboard siding. The primary (north) façade has an offset screened porch entrance. The rear southern-facing elevation has two doorways entering the structure and an addition with bay windows, both covered by a hipped roof (Figure 14). A limestone and mortar chimney with a red brick flume is attached to the west elevation; the section above the roofline is not in line with the main flue and was constructed using different stone (Figure 15). All windows are 1/1 aluminum sash replacement windows surrounded by wood frames. Debris surrounding the structure consists entirely of construction material.

Figure 12. Overview of Structure 5 at site 41WM1342; facing east.

Figure 13. View of the foundation of Structure 5 at site 41WM1342; facing west.

Figure 14. View of the south elevation of Structure 5; facing north

Figure 15. View of the north and west facades of Structure 5, facing southeast.

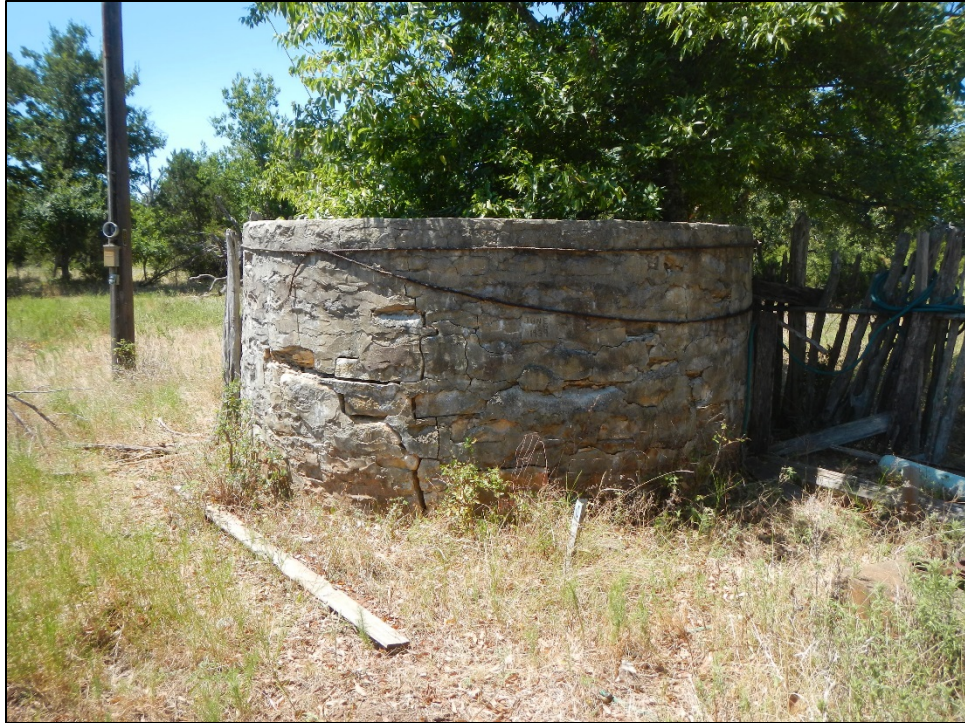
Feature 1 is an aboveground cut limestone and plaster cistern located approximately 41 feet (12 m) southwest from Structure 1 in the western portion of the site (see Figures 5 and 16). The feature stands approximately 6 feet (1.8 m) tall and is 6 feet (1.8 m) in diameter. Much of the plaster has deteriorated, exposing the cut limestone and large cracks along the face. Approximately 2 feet (0.6 m) below the top, on the north side of the feature, a date of “JUNE 15th 1939” has been etched into a plaster plaque (Figure 17).

Figure 16. Cistern at site 41WM1342; facing south.

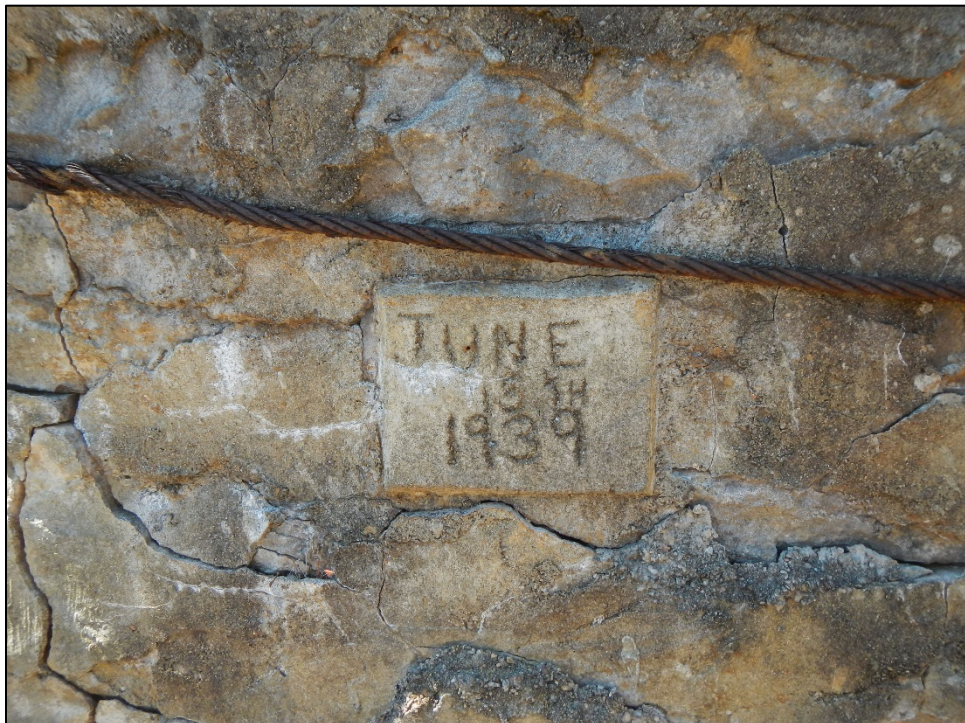
Figure 17. Plaster plaque that has been etched with "JUNE 15th 1939"; facing south.

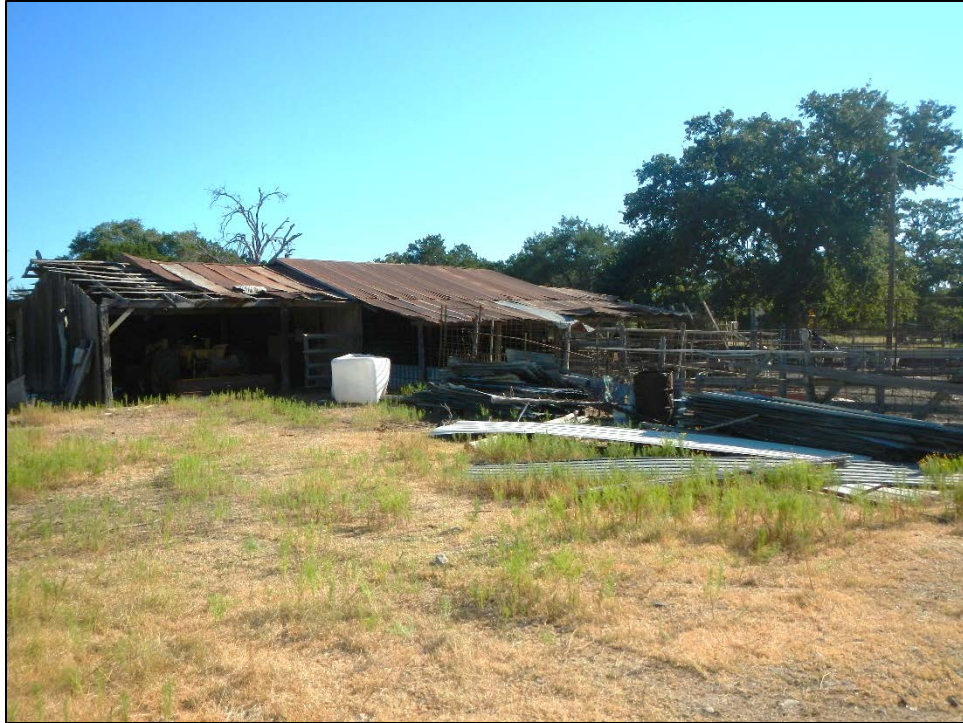
Structure 3, located approximately 37 feet (11.5 m) east of Structure 2, is a large mid- to late-twentieth-century vernacular storage outbuilding and goat pen addition, both currently in use (see Figure 18 and Figure 23). Structure 3 is rectangular in plan with a standard pitch gable roof and measures approximately 40 feet (12.2 m) east to west and 25 feet (7.6 m) north to south. The gable sheet metal roof appears to have been extended by an additional 10 feet (3 m) to the north and south. This extension has been made to accommodate a portion of the 55×55-foot (15.2×15.2-m) goat pen attached to the southeast corner of the structure. Structure 3 is clad with a combination of corrugated sheet metal and machine-cut 2×4- and 4×6-inch wooden posts. The primary (southern) elevation is open, whereas the western elevation is enclosed by machine-cut wooden planks. The eastern elevation is partially enclosed using machine-cut wooden planks, allowing for vehicle entry. The northern elevation is clad with corrugated sheet metal. Debris associated with the structure includes fencing material, corrugated sheet metal, a large plastic tank, machine-cut wood, and a non-functional vehicle.

Figure 23. Overview of Structure 3 at site 41WM1343; facing northeast.

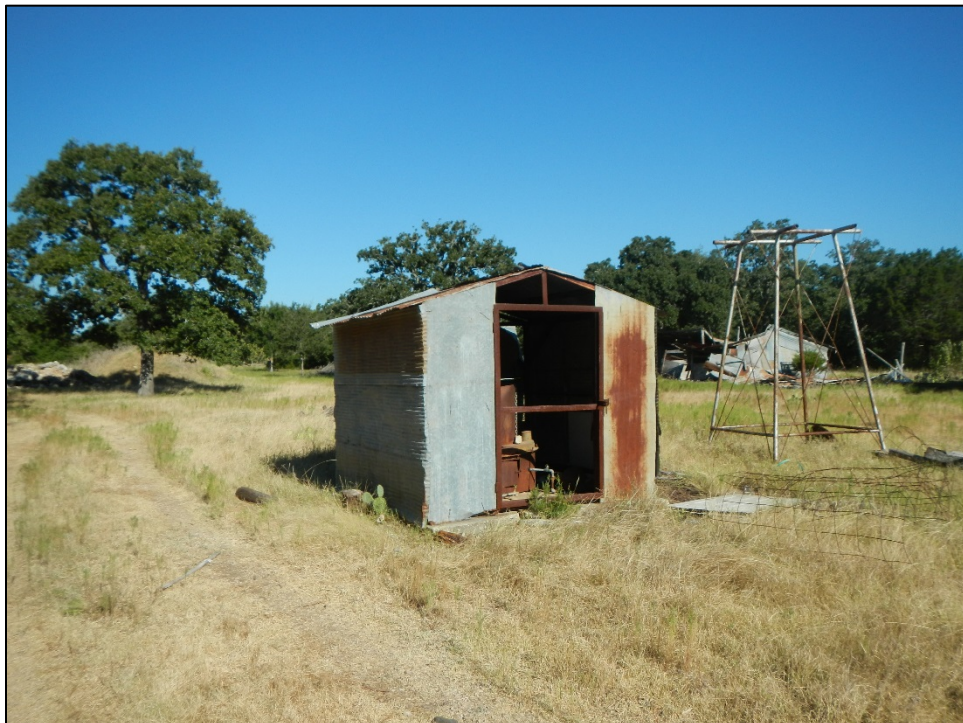
Structure 4, located approximately 43 feet (13 m) south of Structure 2, is a small square plan mid- to late-twentieth-century vernacular outbuilding clad in metal overlying a metal frame (see Figures 18 and 24). It is set on a concrete slab foundation (see Figure 24). The structure measures approximately 10 feet (3 m) east to west by 10 feet (3 m) north to south. The roof is a standard pitch gable; the northern, southern and western elevations are clad by corrugated sheet metal, while the eastern (primary) elevation is sealed with sheet metal and an open-door frame. Inside the structure is a metal “hog” cooker, which according to Mr. Diaz is no longer in use. Debris surrounding the structure consists of hog wire, a metal tower frame, a tire rim, a 50-gallon metal drum and old telephone poles. Approximately 20 feet (6.1 m) west of the structure is an 8×8-foot (2.4×2.4-m) cement slab similar to one observed near Structure 1 (Figure 25). The cement slab is affixed with a cast iron dish that has the brand “DAISY” stamped along the divider of the dish (Figure 26). According to Mr. Diaz, the dish was a hog waterer.

Figure 24. Overview of Structure 4 at site 41WM1343; facing northwest.

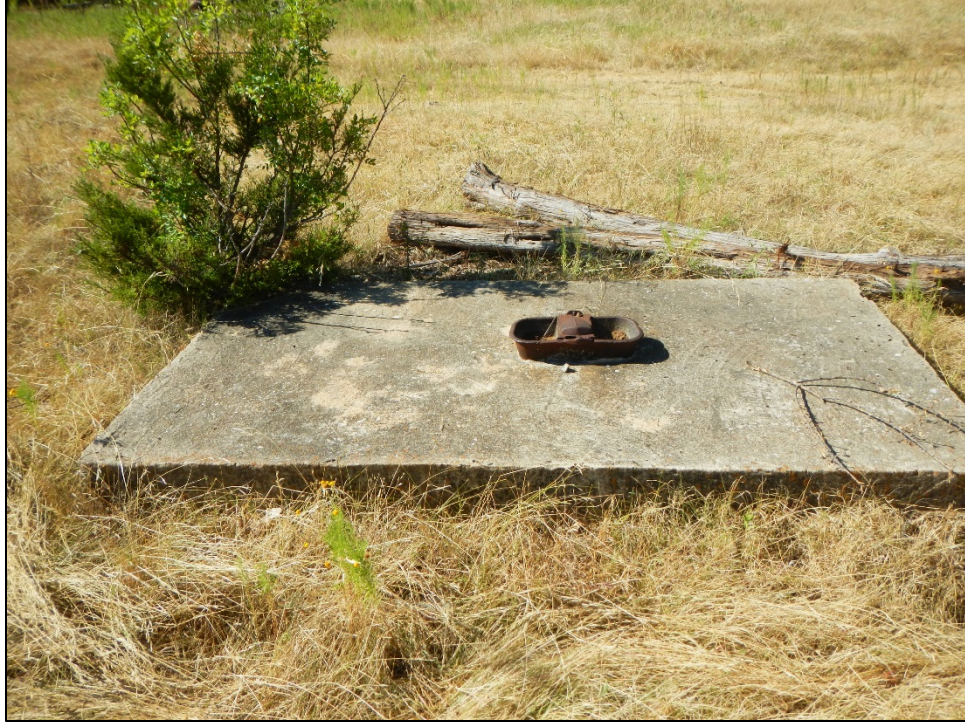
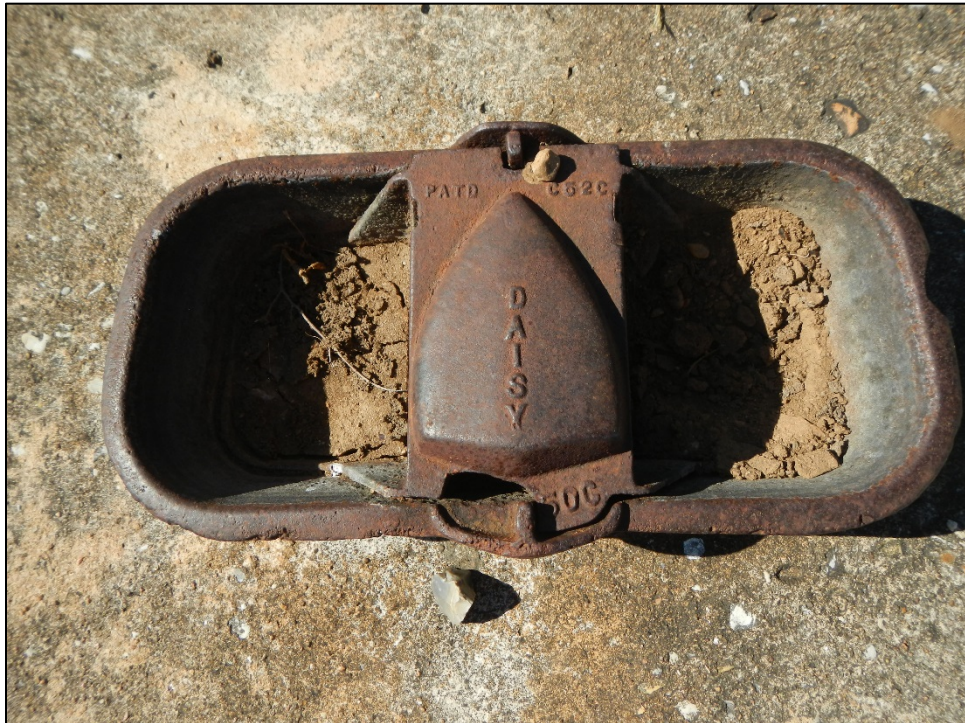
Figure 25. Overview of cement slab with a cast iron dish; facing north.

Figure 26. Overview of the "DAISY" hog waterer.

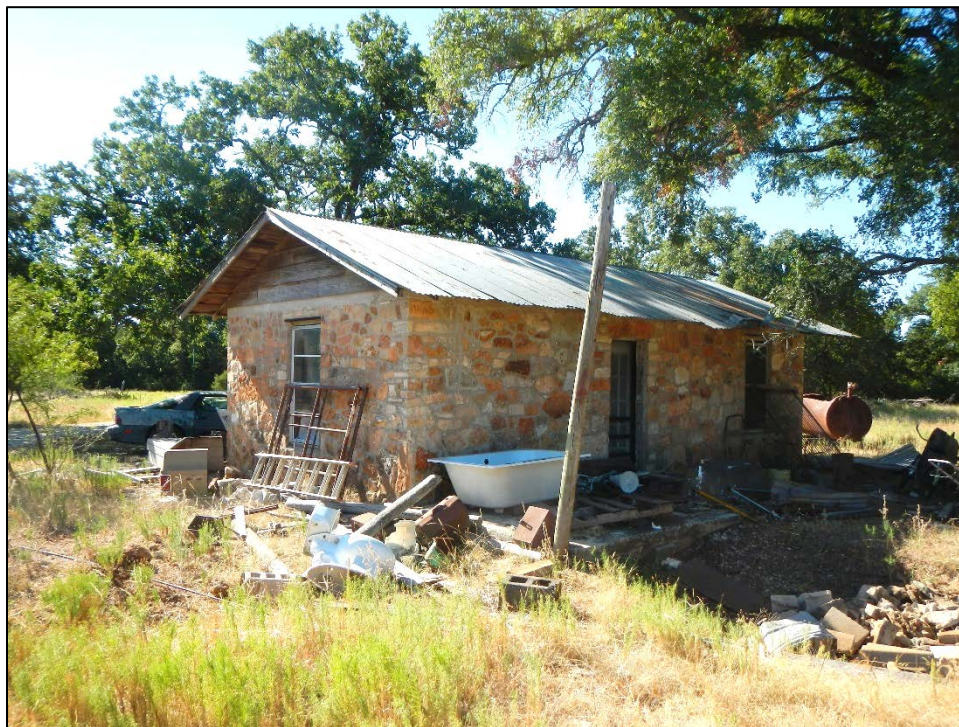
Structure 5, located approximately 77 feet (24 m) southeast of Structure 4, is a mid-twentieth-century vernacular building in rectangular plan, clad in worked limestone and mortar (see Figures 18 and 27). It has a standard pitch gable roof and a concrete slab foundation with a porch on its eastern (primary) elevation; the entrance is centered (see Figure 27). The building measures approximately 20 feet (6.1 m) east to west and 30 feet (9.1 m) north to south and has seven 1/1 metal windows. The windows and door of the building are non-original. According to Mr. Diaz the building was on the property when his family purchased the property in the 1960s; however, the roof was missing at the time. After purchasing the property, the roof was added, clad with machine-cut lumber and tar shingles. The building is currently used for storage and is surrounded by a large metal tank, windows, a door, a metal table, non-functional vehicles, a bathtub, toilet, several cinder blocks, and other debris. A review of aerial photographs dating from 1941 to 2014, although at a coarse scale, show evidence of Structure 5 on the property beginning in 1953. Structures at the location of Structures 1–4 appear on aerial photographs from 1976 up until 1995, showing all three in a cleared area enclosed by a fence. Structures 1–4 appear relatively the same from 1976 to 1995; however, by 2008 change in the structures due to degradation have occurred.

Figure 27. Overview of Structure 5 at site 41WM1343; facing southwest.

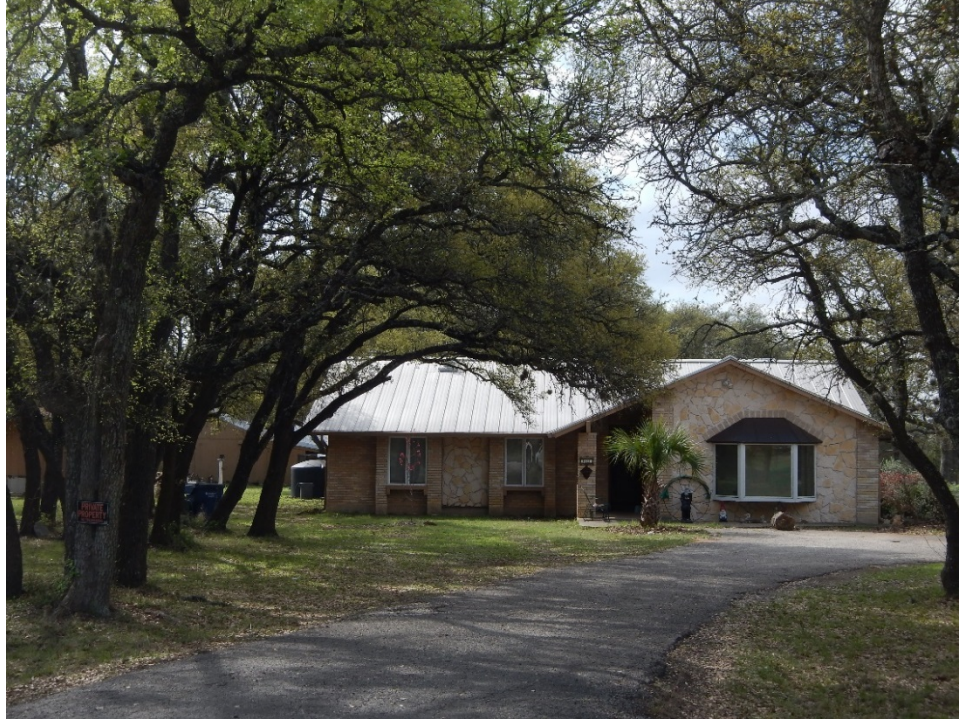
The house located on parcel R038530 at 148 Deer Draw is a one-story, ranch dwelling with a moderate pitch side gable roof clad with modern standing seam metal (Figure 8). Built on an L-plan, the house also has a front gable roof wing. The porch is inset under the front gable roof, which is supported by a short wood post on a square brick column. Windows are modern vinyl units and the door is obscured. The house is clad with a combination of brick and stone veneer. Williamson CAD data lists 1977 as the date of construction, but lists another 1977 dwelling and a 2011 barn as being on the parcel (WCAD 2018). Aerials show the location of these two buildings; however, they are not visible from the ROW. None of the buildings appear on the 1976 aerial, which confirms they are all not historic age.

Figure 8. Overview of existing buildings at on Parcel R038530.

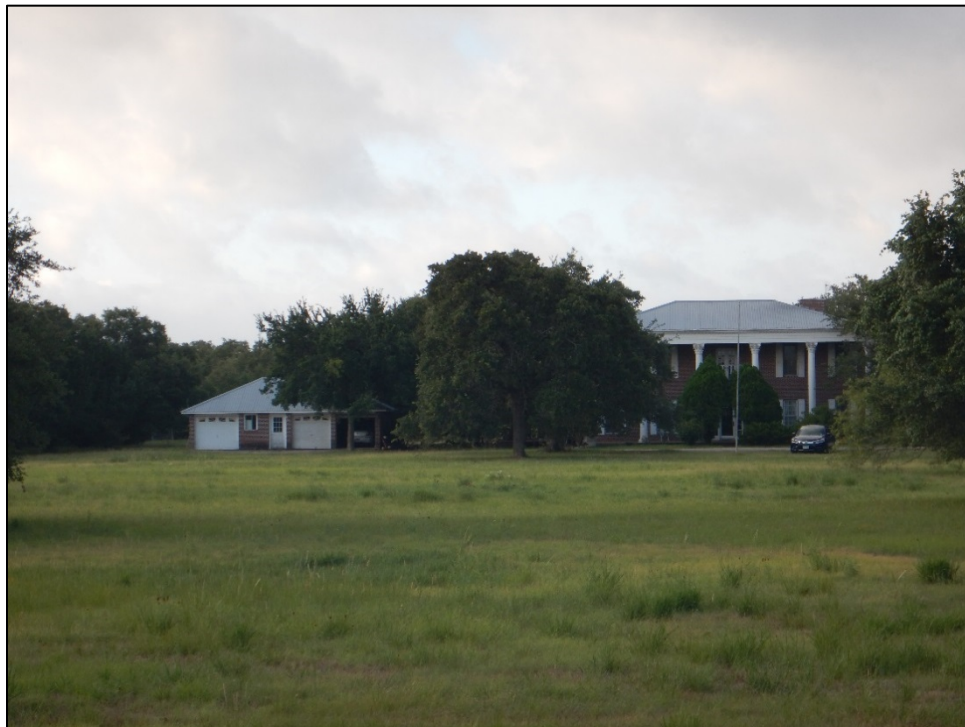
The building located on parcel R038509 is listed in CAD records with a 1984 date of construction (Figure 9; WCAD 2018). Based on historic aerials and field evaluation, SWCA agrees with the CAD record for this property (see Figures 6 and 7) (Banks 2017). The remaining two buildings within the indirect APE are a large metal outbuilding and a one-story dwelling. CAD data lists the date of construction for the outbuilding as 2003 and the dwelling as 1982 (WCAD 2018); therefore, neither are historic age.

Figure 9. Overview of existing buildings on Parcel R038509.
