# General Study Case Description of TMV 23: A Multi-Storey Office Building and Living Lab in Denmark

Aalborg University Department of the Built Environment Division of Sustainability, Energy & Indoor Environment

**Technical Report No. 306**

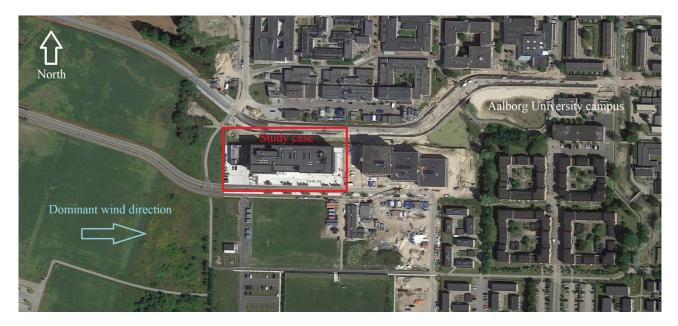
The building is surrounded by low-rise (2-3 floors) office buildings to the north, medium-rise office buildings to the east (5 floors) and flatland open fields to the south and west (see *Figure 3*).

*Figure 3:* Aerial view of the TMV 23 building in its surrounding environment on the Aalborg University main campus.

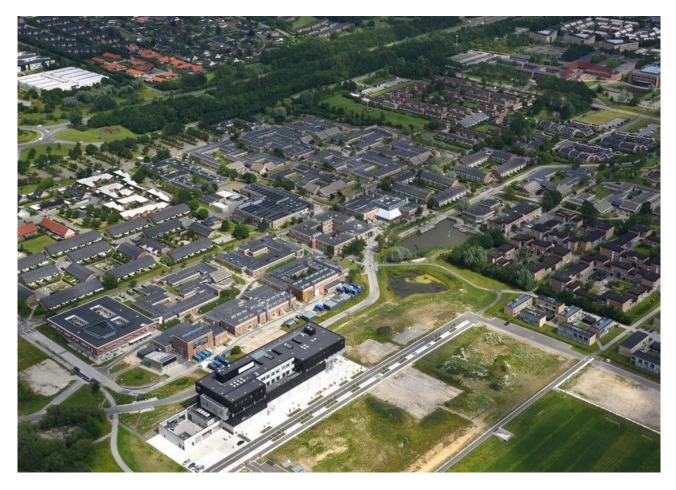
**Figure 9:** Aerial view of the TMV 23 building in its surrounding environment on the Aalborg University main campus. The South façade, the West façade and the roof of the building are visible. In 2022, a new building was built on the East side of the TMV 23 building (the upper right corner of the TMV 23 building in the picture) but was not visible yet in that aerial view (credit to Aalborg University).

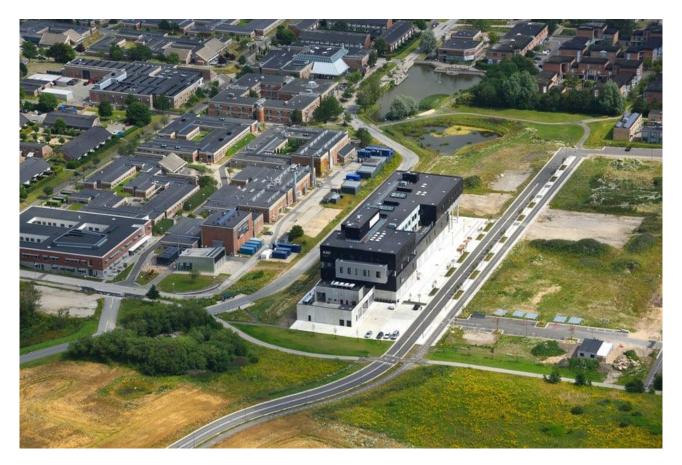
**Figure 10:** Aerial view of the TMV 23 building in its surrounding environment on the Aalborg University main campus. The South façade, the West façade and the roof of the building are visible. In 2022, a new building was built on the East side of the TMV 23 building (the upper right corner of the TMV 23 building in the picture) but was not visible yet in that aerial view (credit to Aalborg University).

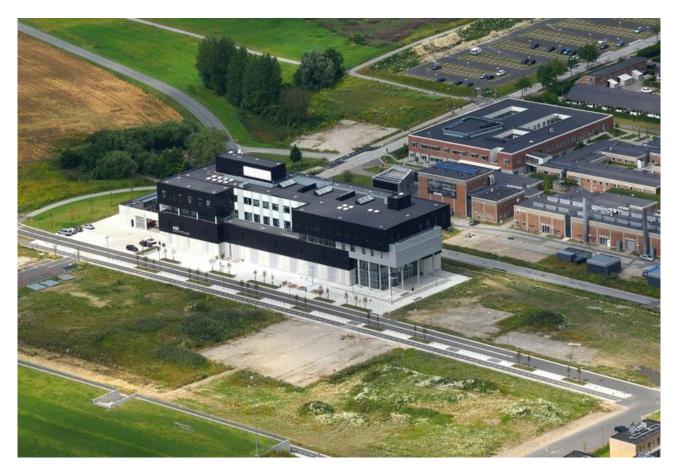
**Figure 11:** Aerial view of the TMV 23 building in its surrounding environment on the Aalborg University main campus. The South façade, the East façade and the roof of the building are visible. In 2022, a new building was built on the East side of the TMV 23 building (the right side of the TMV 23 building in the picture) but was not visible yet in that aerial view (credit to Aalborg University).
