SERBIATRIB '19

16th International Conference on
Tribology

REPAIR OF A DAMAGED TURBOCHARGER

Abstract: *The turbocharger is among the highest quality assemblies for modern internal combustion engines. Its contribution to engine operation is immeasurable – it increases the power output of the engine while indirectly reducing fuel consumption. Like all devices, turbochargers require quality maintenance as they are susceptible to failure. Faulty turbochargers are either repaired or replaced with new ones. Repair ensures substantial financial savings. The paper presents the consequences of damage to the turbocharger and the process of its repair.*

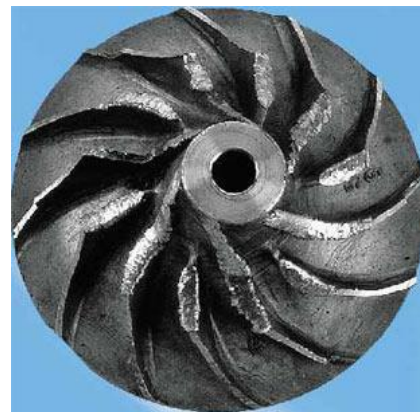
Figure 1 shows damage to the turbocharger caused by the entry of a foreign object into its housing. The foreign object has damaged the compressor wheel at the front i.e. inlet, leading to a partial fracture of its blades. Blade damage causes rotor imbalance as well as rapid wear to the bearings and seal rings. This results in increased lubricating oil consumption, power loss and black or white smoke coming from the exhaust pipe. Also, these problems are often accompanied by a squeaking sound, which clearly indicates

turbocharger malfunction. Foreign objects may enter the inlet manifold: due to a damaged air filter, due to holes or cracks in the air hoses or worn-out hose clamps, or if the entire air supply system has not been properly cleaned during the previous servicing of the turbocharger [2].

Figure 1. Compressor wheel damaged by a foreign object

Before reinstalling the turbocharger, it is necessary to determine the routes of foreign object ingestion into the turbocharger in order to prevent recurring impact damage. To this end, the inlet manifold hoses should be inspected and washed, the hose clamps and the air filter should be checked for foreign objects and replaced as required. Otherwise, the turbocharger will suffer the same failure.

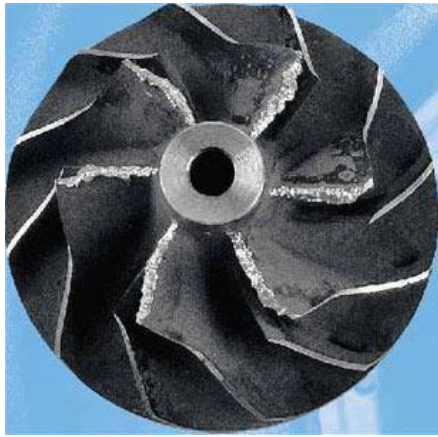
Figure 2. Compressor wheel damaged by a large foreign object

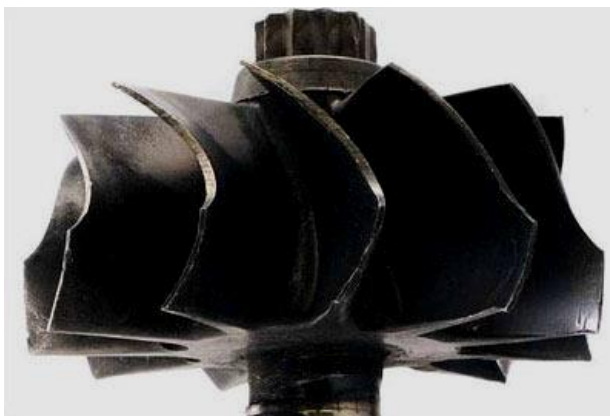
Figure 4. Rotor damaged by foreign objects with soot build-up

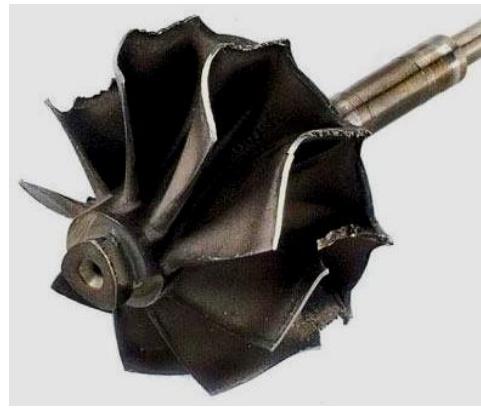
Figure 5. Rotor damaged by foreign objects

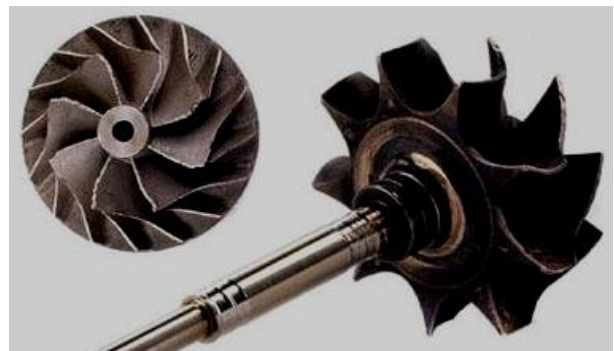
After disassembly of the turbocharger, damage typical of a partial or complete blockage in the exhaust pipe has been identified. This type of blockage in the pipe causes a high exhaust gas pressure in the turbine housing. As exhaust gases cannot exit the engine freely, they push the turbocharger rotor forward to the compressor side. Therefore, on the front side of the turbine wheel, there are clearly visible marks of its unallowable wear against the flame guard, leading to turbocharger oil leaks. This failure is caused by a faulty (blocked) engine brake (a faulty brake cylinder or a clogged butterfly valve shaft) or by a foreign object blocking the exhaust pipe.

Figure 6. Damage to the turbocharger rotor due to blockage in the exhaust pipe

Before reinstalling the turbocharger, the cause of the failure (in this case, the faulty engine brake and/or blocked exhaust pipes) must be eliminated.

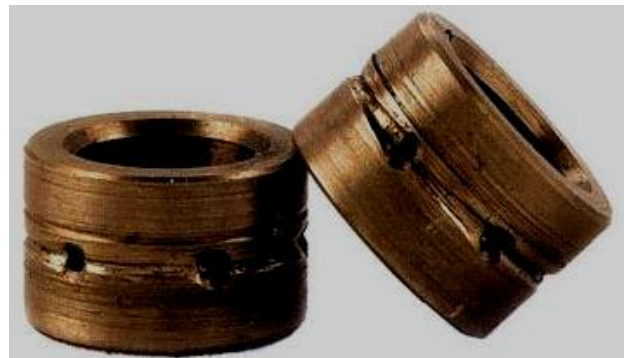
After the core assembly of the turbocharger has been dismantled, high wear rates of the sliding surfaces of the bearings and the shaft have been found. Wear marks i.e. furrows in characteristic places, due to dirt in the lubricating oil, are clearly visible. The oil is contaminated with combustion by-products and shavings of engine parts. Depending on the degree of oil contamination, the gap between the bearings and the shaft increases over time, causing wear to the seal rings, imbalance of the turbocharger rotating assembly and even striking of the turbine and compressor wheel blades against the housing. The turbocharger consumes oil, the engine has no power, and black or white smoke appears at the exhaust outlet. When installing the hose with oil supply and return fittings, sealants must not be used because only original gaskets are permitted.

Figure 8. Radial bearings damaged by dirty oil

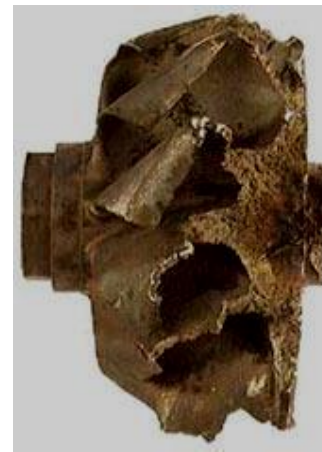
In older types of turbochargers which do not have VSG valves, failure is caused by disruption in the fuel combustion system, due to which exhaust gas pressure and temperature exceed predetermined values. At high rotational speeds, the rotor material undergoes internal stress, which leads to blade fracture, and the turbocharger bearings cannot withstand such loads, resulting in frequent rotor impeller cracks. Turbochargers equipped with VSG valves are designed to operate at higher rotational speeds compared to the turbochargers without VSG valves. When the exhaust gas pressure in the turbocharger reaches the critical, maximum allowable value, the role of the VSG valve is to direct the exhaust gas flow out of the rotating zone of the rotor, thus reducing its rotational speed.

Figure 11. Typical fracture of the turbocharger impeller

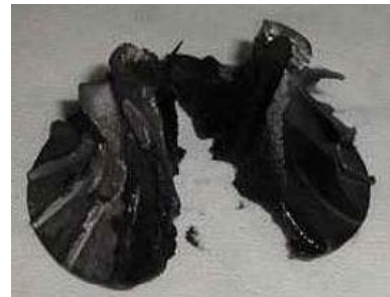
Figure 12. Effect of high temperature on the turbocharger rotor

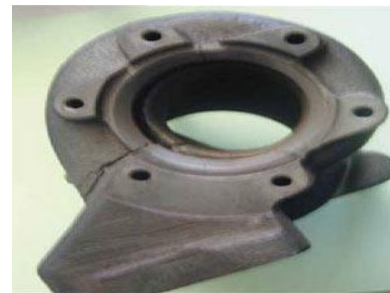
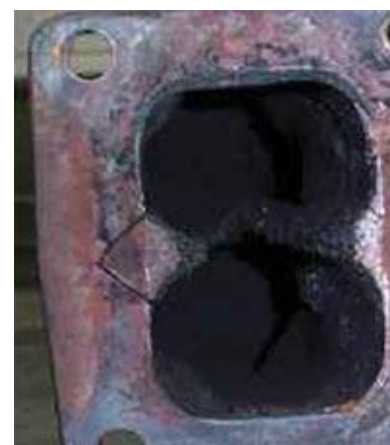
In the new generation of turbochargers having variable geometries, in addition to the abovementioned role, the electromagnetic valve regulates both the amount and pressure of exhaust gases during the operation. When the VSG valve is damaged or unprofessionally adjusted, the turbocharger rotor rotates at a rotational speed higher than the maximum limit. Therefore, the engine consumes more oil and loses power, and the turbocharger produces a characteristic squeaking sound. Often, the turbocharger rotor breaks due to internal load. In variable geometry turbochargers, there is damage to the rotor, the variable geometry and the central housing, and the only solution is to replace the turbocharger with a new one.

Figure 13. Cracks in the turbine housing due to a high exhaust gas temperature

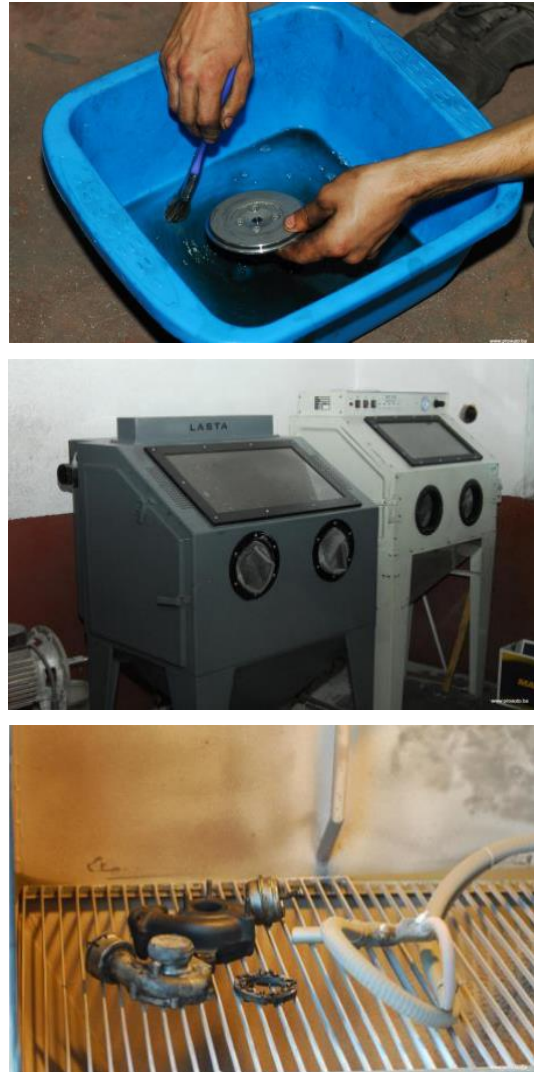
Before repair, all dismantled parts are thoroughly cleaned using a special liquid solvent, or petroleum, or a certain amount of a degreasing agent. After drying, they are subjected to sandblasting, which involves smoothing of large rough surfaces occurring due to mechanical operation, which may subsequently lead to undesirable effects. Since blasting is performed by quartz crystals of small grain size, all parts should be additionally washed in a solvent additive or in petroleum

after the process. Also, they should be dried either with a soft cloth or simply under compressed air. It is only after these detailed cleaning and drying operations that certified service providers can determine the degree of repair needed.

Figure 15. Cleaning, degreasing and sandblasting [1]

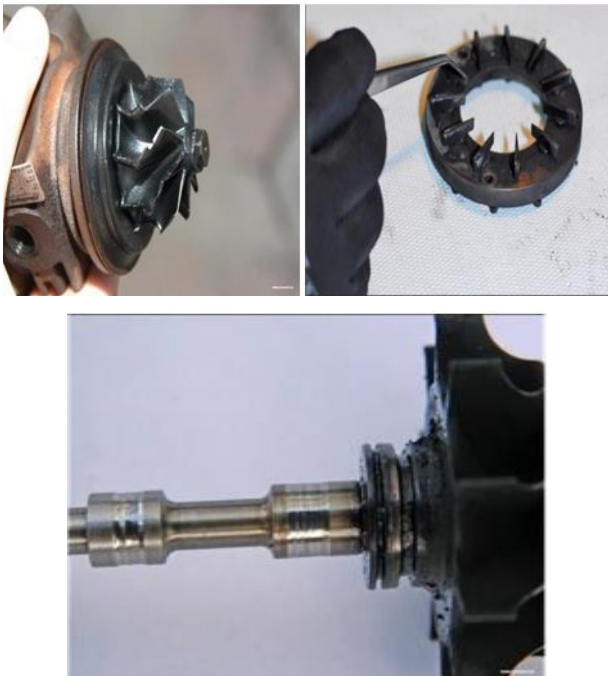
Turbine failure is generally determined by visual inspection. The shaft with the blades on both sides is the most visible and, practically, the key part of the turbine. The blades on the side through which clean air passes are the most vulnerable. If any particle of dirt enters this area, at least one vane will become damaged, which will automatically lead to mass imbalance and unbalanced rotation. Such rotation will, by all means, cause damage to the nearest bearing in no time. If, for example, a stone or a piece of glass or some other hard object gets into this area, the entire section will be destroyed and the blades

broken. This damage will probably result in a complete loss of symmetry in the shaft.

Similarly, the drive blades can suffer damage due to poor combustion and extremely high temperatures. The blades in such an operating environment erode over time, which reduces the operating life of the turbine.

Another reason for turbine damage is poor lubrication. The turbine shaft is lubricated with oil from the engine, and the oil also serves as a coolant. If for any reason lack of lubrication or oil starvation occurs, the bearings (bronze rings) will be the first to suffer damage. Also, due to increased temperatures and loss of balance during rotation, seal rings will become permanently damaged.

Figure 16. The most common types of damage [1]

Even in prolonged contact with lubricating oil, these rings will not be able to retain hot oil under pressure, and over time the oil will leave the lubrication area through them. Although damaged, the turbine can be reconditioned.

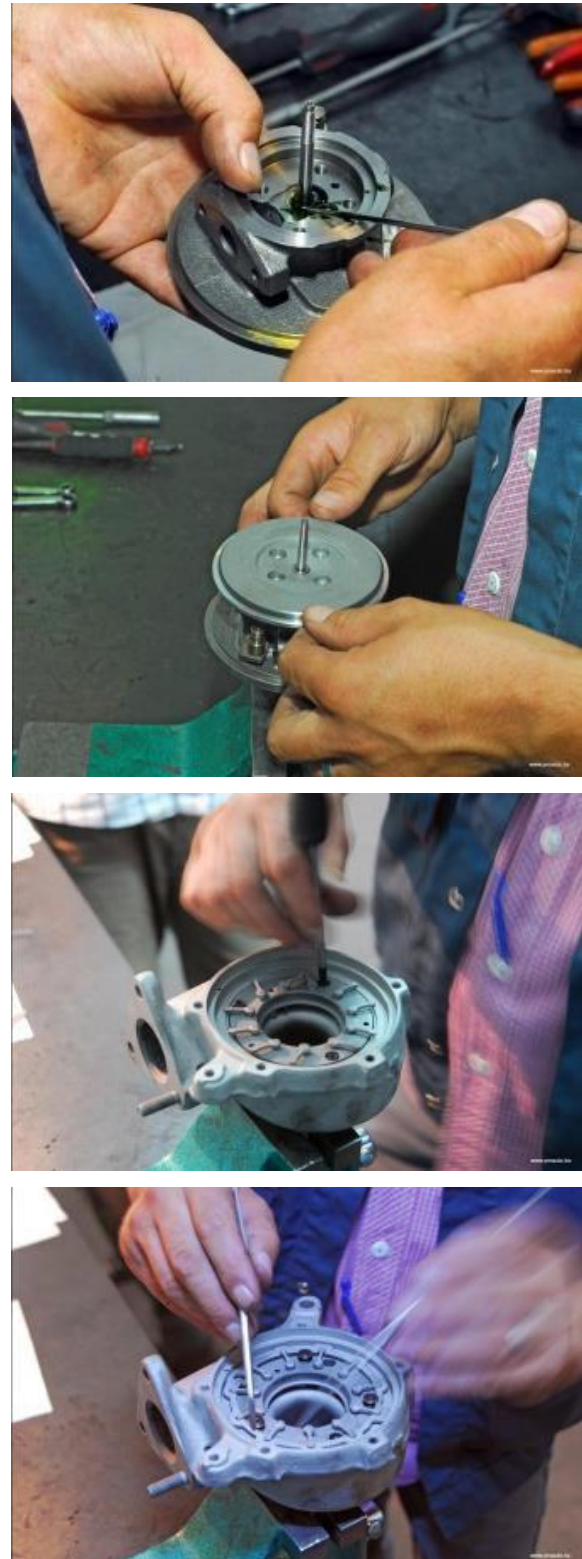
Any reconditioning operation after turbine disassembly involves the replacement of seal rings, bronze bearings and rubber seals. Well-equipped service providers use kits including the replacement components required during turbine disassembly. The turbine contains the so-called seal plate or housing cover, which is generally not replaced. In variable geometry turbines, the stator section should also be

replaced in major overhauls. Undamaged components are reinstalled in the housing in reverse order.

Figure 17. Reconditioning of turbine parts [1]

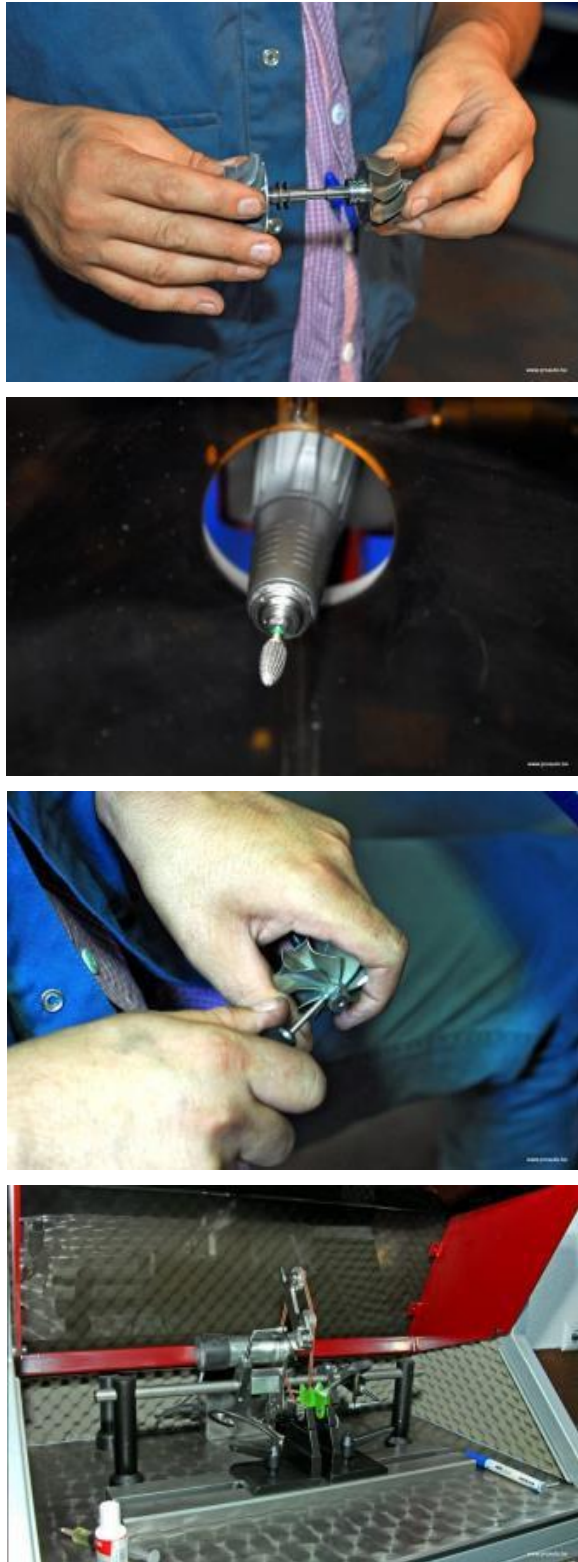
When reinstalling the existing shaft and blades or installing new components, the assembly should be additionally balanced. It is only after this operation that the turbine can

be assembled. Balancing is among the most sensitive processes during turbine reconditioning. It is performed only by trained service providers. Excess removal of the material during the balancing operation may cause permanent damage to the turbine.

Figure 18. Balancing of the shaft and blades [1]
