Analysis Of Land Use In Rockbridge County, VA From Pre-Colonial Times To Current Day And Consequences For Riparian Ecosystems

ANALYSIS OF LAND USE IN ROCKBRIDGE COUNTY, VA FROM PRE-COLONIAL TIMES TO CURRENT DAY AND CONSEQUENCES FOR RIPARIAN ECOSYSTEMS

Kallan Wilde, Nelson Ham
Eva Lyon¹, and Margaret Anne Hinkle¹,
¹Washington & Lee University

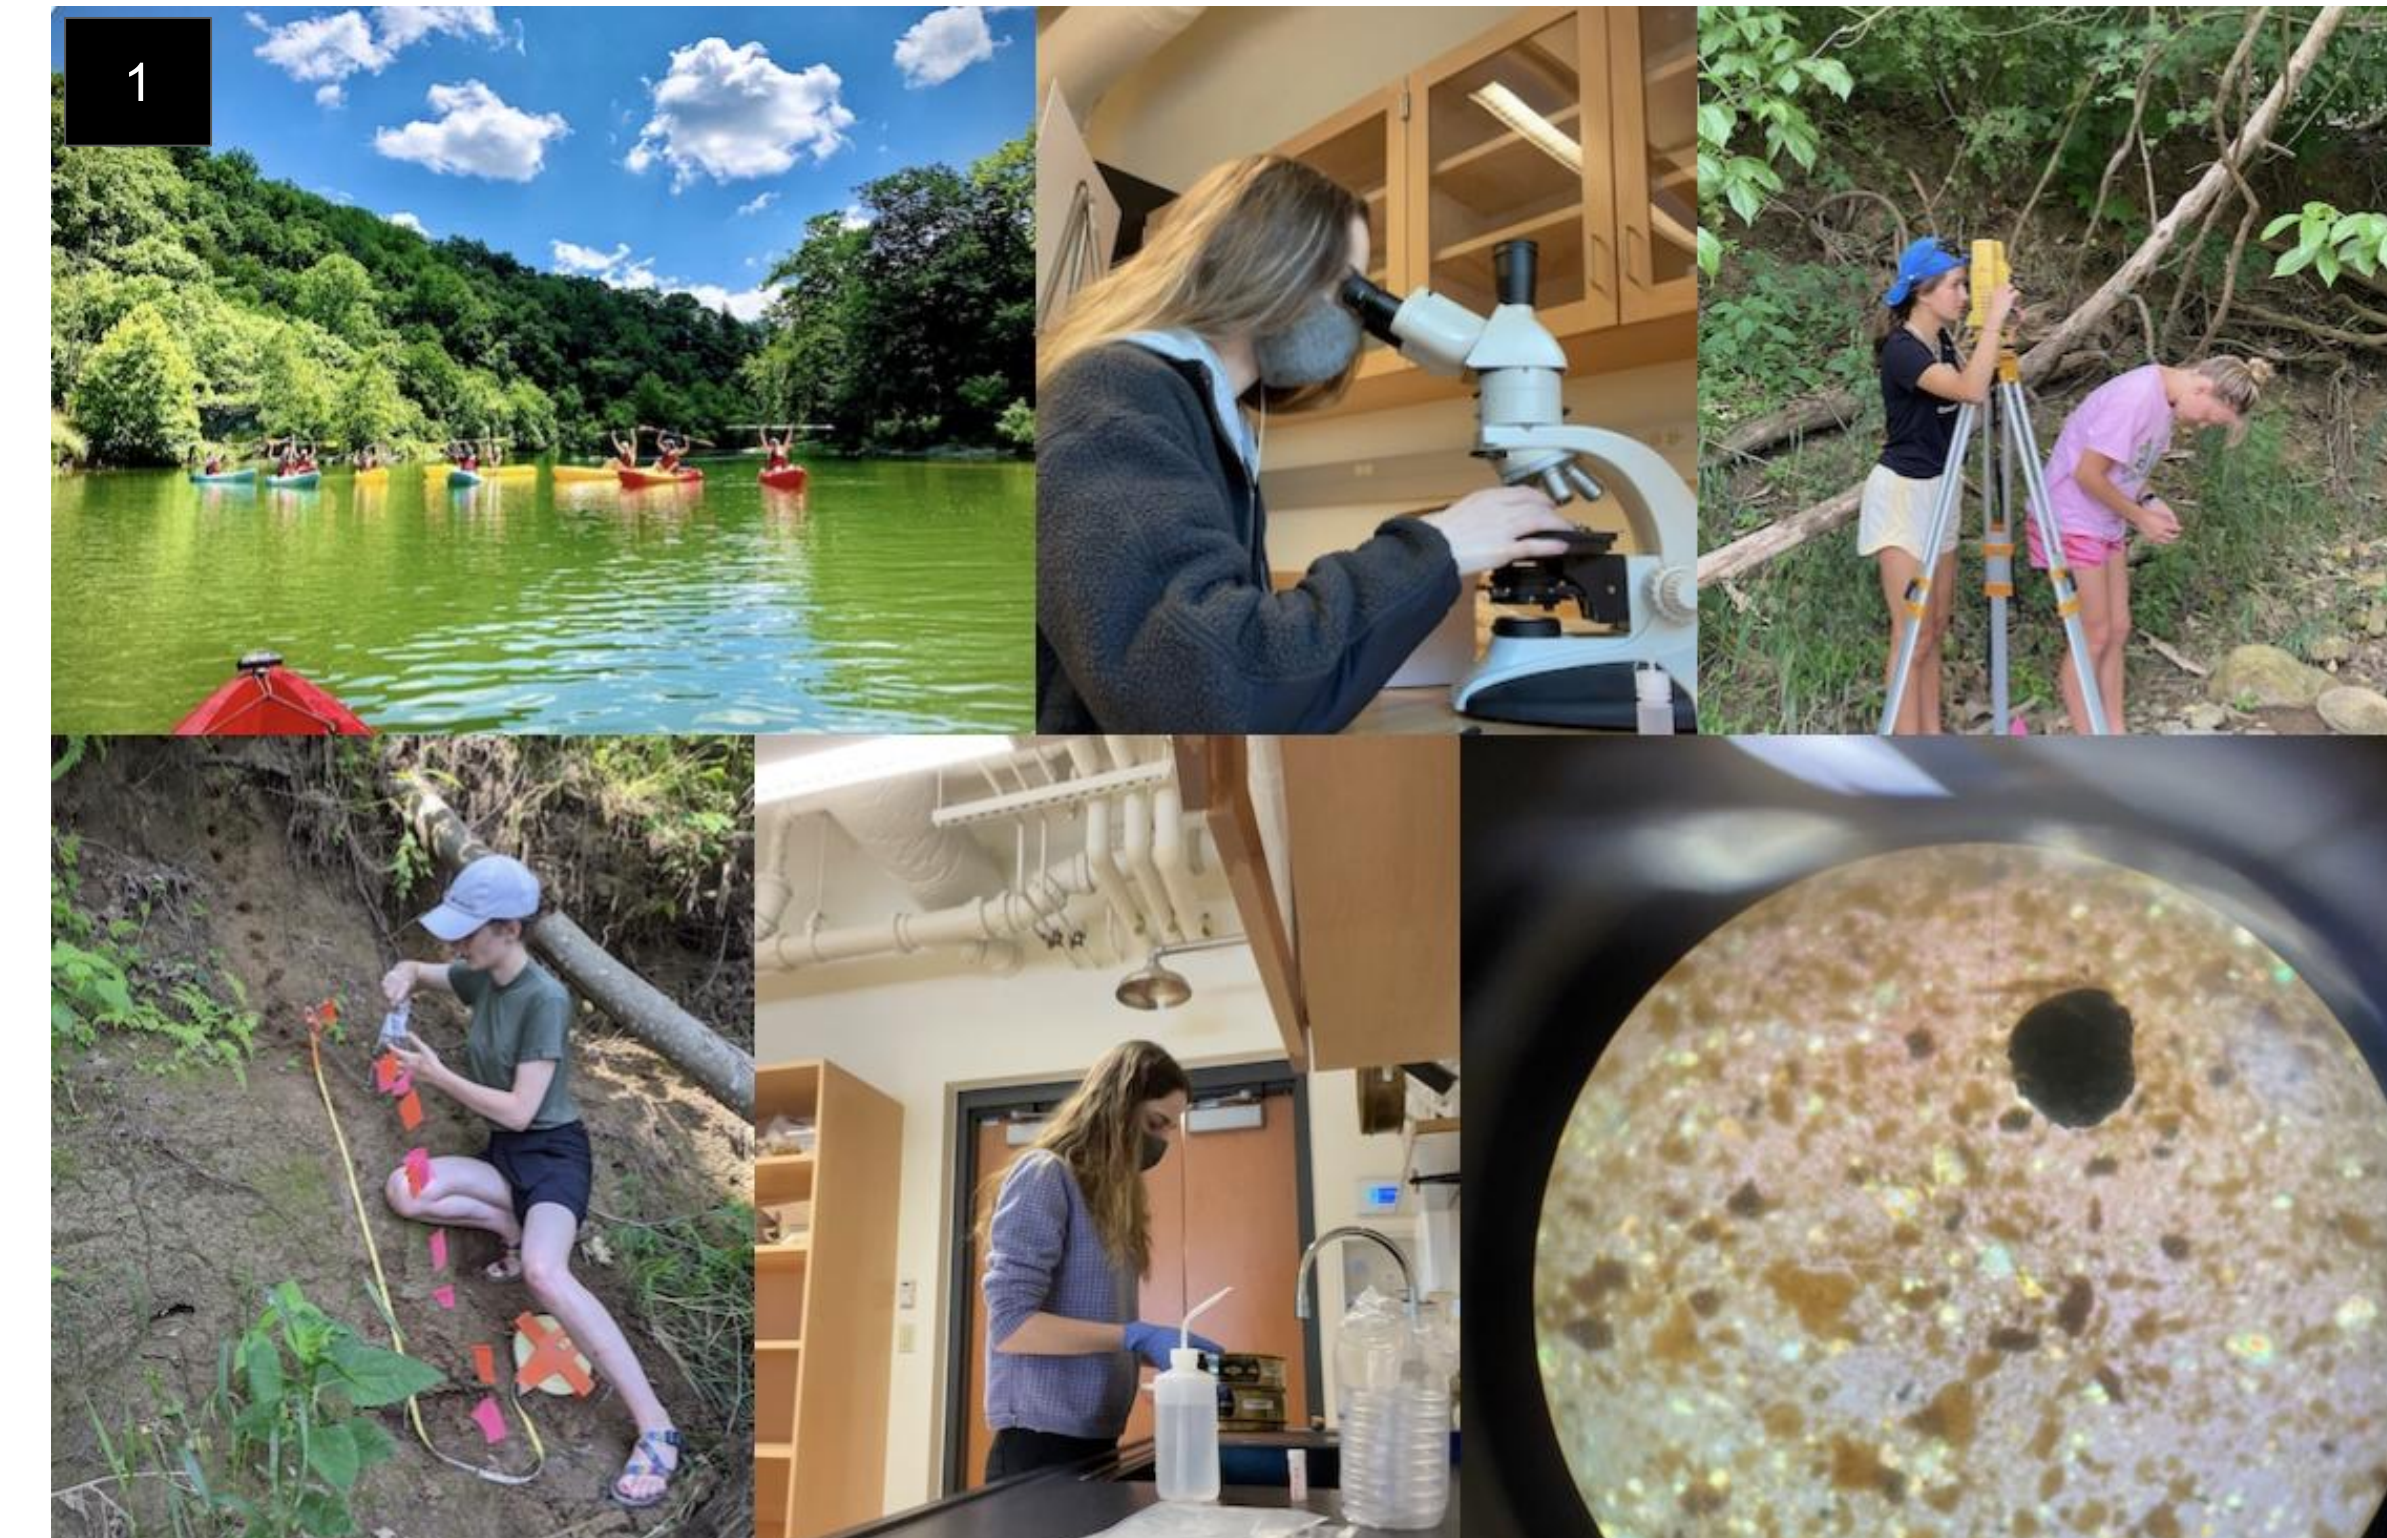
Figure 1: Collection of photos from in the field and from lab prep of samples for carbon dating.

This study is based off of 1 month of field research (Figure 1) and uses maps and other historical data to construct GIS visualizations of past and present land use, and create estimates of floodplain and water levels during the various intervals of history in the watershed. Age dating of sediment was attempted to create a more accurate time scale of what is being seen in the banks than what is currently determined by assumption from dates known from implementation and removal of dams.
