Factors Contributing to Landslide Activity in the Winter of 1995-96, Clearwater County Near Orofino, Idaho

FACTORS CONTRIBUTING TO LANDSLIDE
ACTIVITY IN THE WINTER OF 1995-96,
CLEARWATER COUNTY NEAR OROFINO, IDAHO

In Partial Fulfillment
of the Requirements for the Degree
Master of Science
Geology

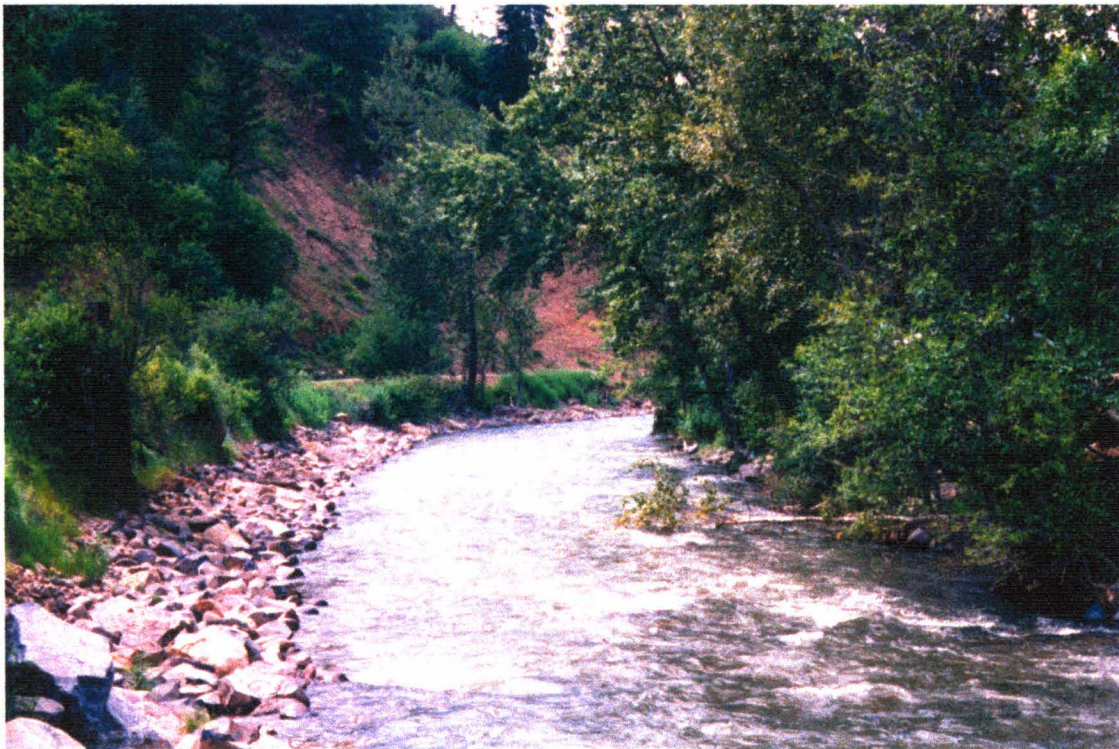
Figure 11: Photograph showing landslide site 23. (Notice mitigation of stream channel.)

The landslide at this site is relatively large with an estimated volume of over 600 cubic feet of displaced material. Orofino Creek flows at the base of this landslide (Figure 11). The landslide that initiated at this site is on a NE facing slope. The landform here is on a slope hollow. Steepness is more than 40-45%. There are natural springs approximately 5 feet from the top of the landslide.

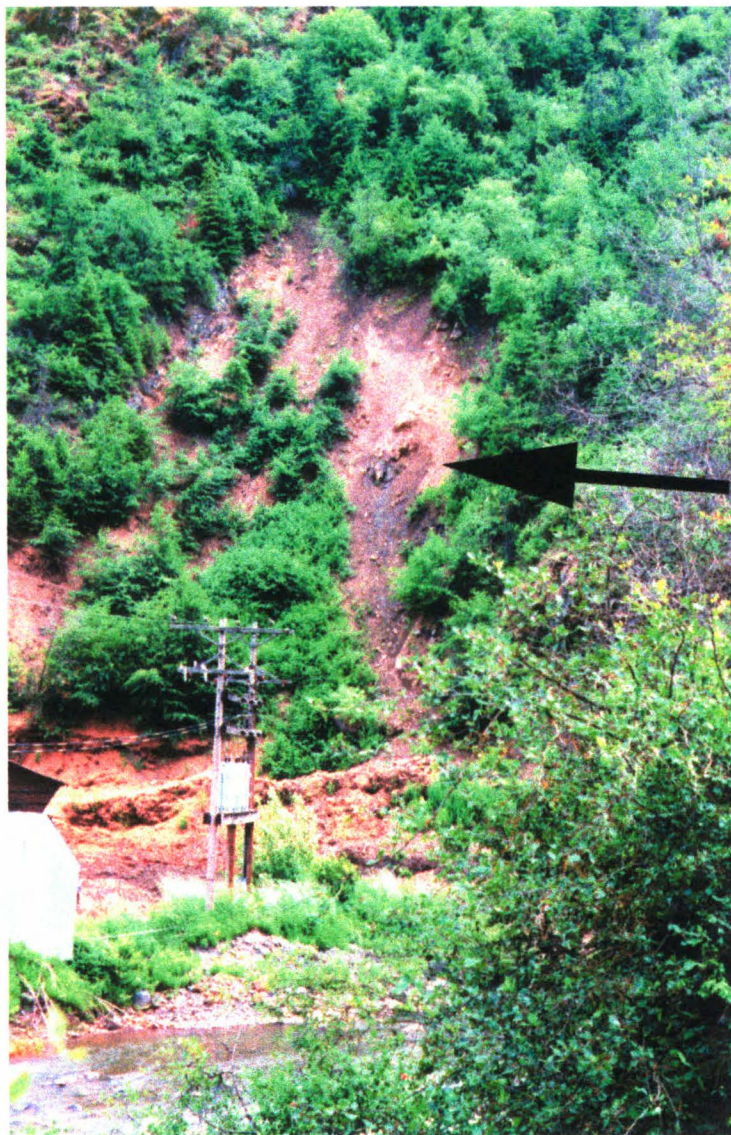
Figure 14: Photograph of landslide at site 27. Arrow indicates location of springs.

The landslide at this site is relatively large with an estimated volume of over 600 cubic feet of displaced material. Orofino Creek flows at the base of this landslide (Figure 14). The landslide that initiated at this site is on a NNE facing slope. The landform here is on a slope hollow. Steepness is more than 50%. There are natural springs approximately 5 feet from the top of the landslide.

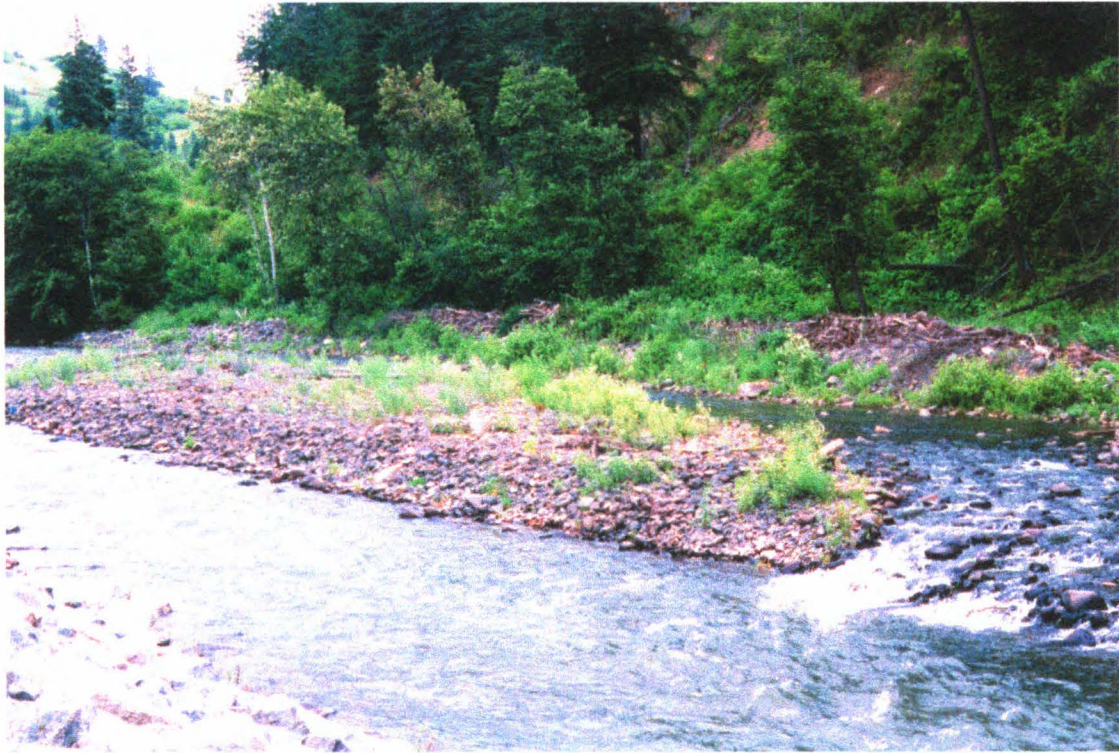
Figure 16: Photograph of debris levee formed from displaced material. Landslide site 30 in background (center).

The landslide at this site is relatively large with an estimated volume of over 800 cubic feet of displaced material. Orofino Creek flows at the base of this landslide (Figure

16). The landslide that initiated at this site is on a NW facing slope. The landform here is on a slope hollow. Steepness is more than 50%. There are natural springs approximately 5 feet from the top of the landslide.

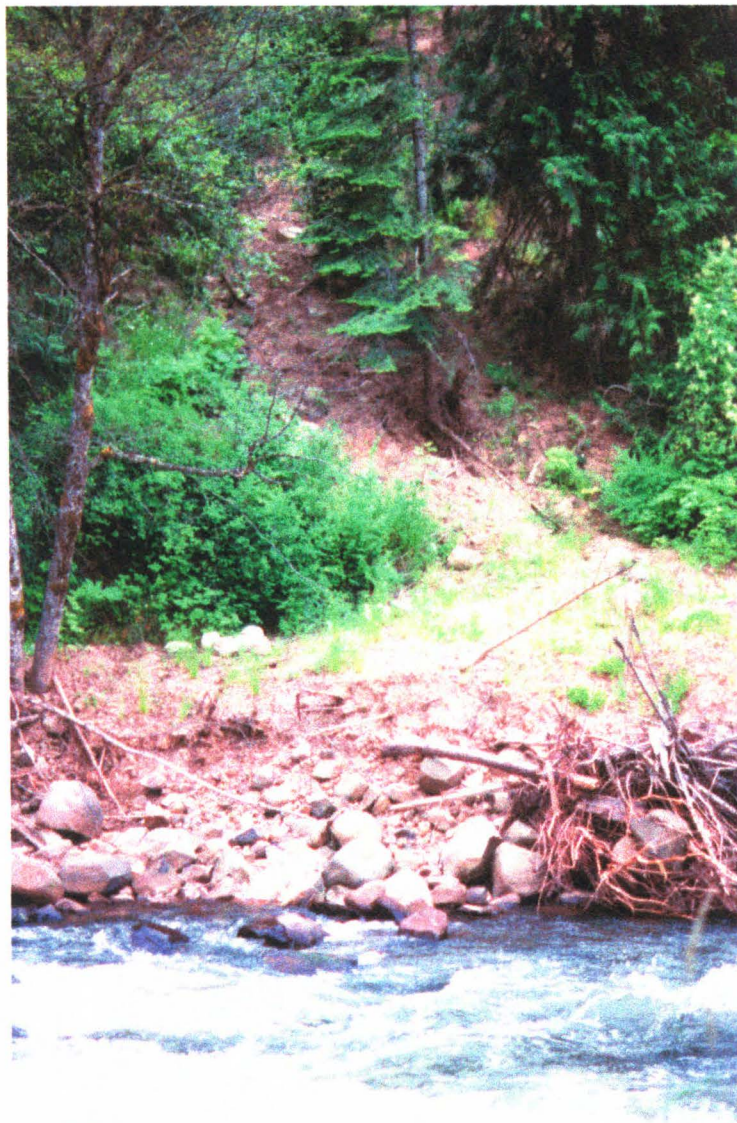
Figure 17: Photograph of Landslide at site 31.

The landslide at this site is relatively large with an estimated volume of over 600 cubic feet of displaced material. Orofino Creek flows at the base of this landslide (Figure 17). The landslide that initiated at this site is on a north-facing slope. The landform here is on a slope hollow. Steepness is more than 50%. There are natural springs approximately 5 feet from the top of the landslide.

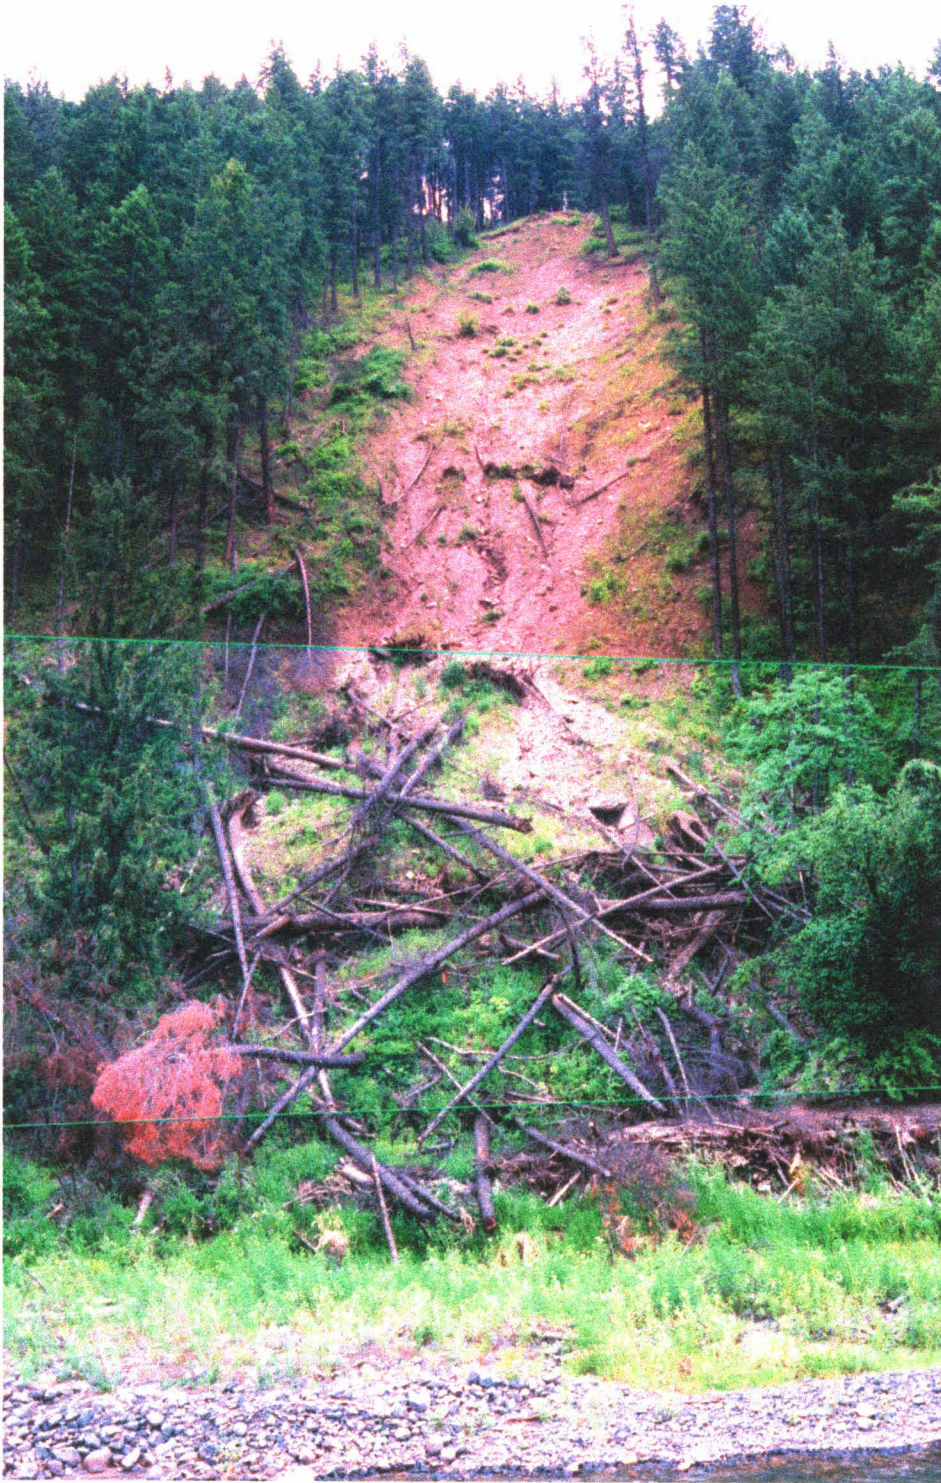
Figure 18: Photograph of Landslide at site 32. Notice pile of mixed debris at bottom of slope.

The landslide at this site is relatively large with an estimated volume of over 700 cubic feet of displaced material. Orofino Creek flows at the base of this landslide (Figure 18). The landslide that initiated at this site is on a north-facing slope. The landform here is on a slope hollow. Steepness is more than 50%. There are natural springs approximately 5 feet from the top of the landslide.

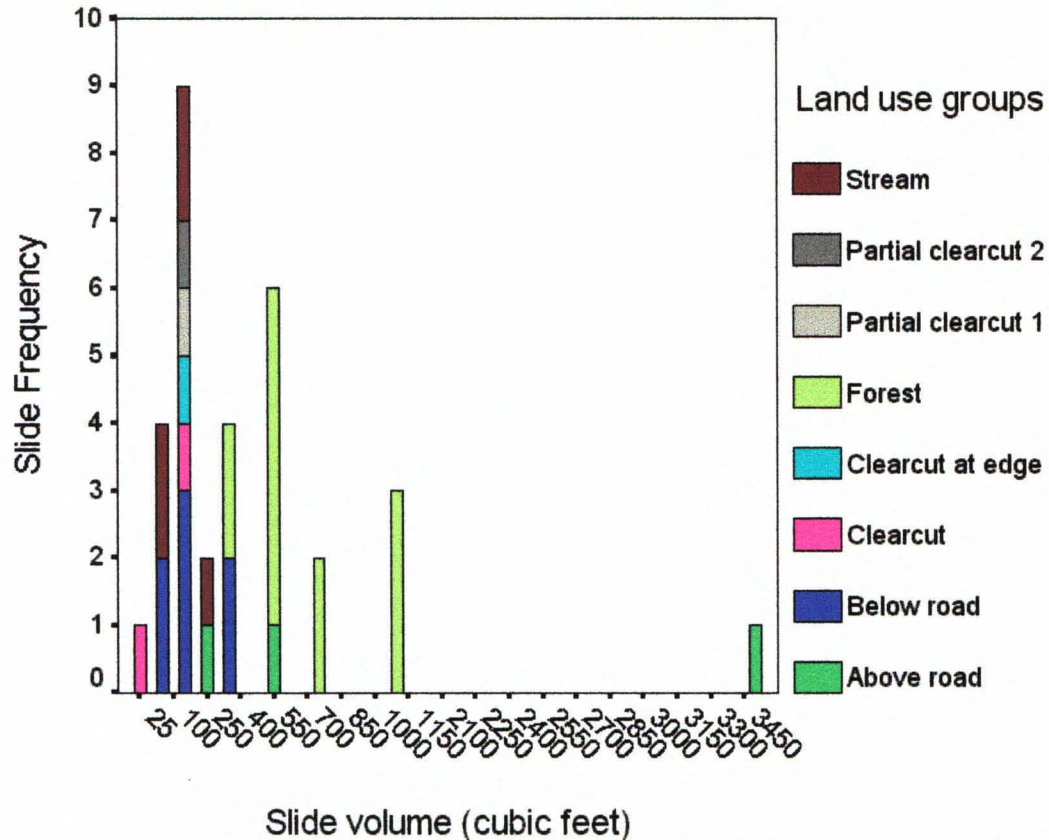
Figure 19: Landslide frequency distribution of landslide volume classes segregated into land use groups.

Landslides occurring in forested areas showed the highest mode at 750 cubic feet. The dominance of smaller volume classes associated with impacts may be a function of sampling bias and location. Smaller landslides are easier to identify and access is better in areas of road and/or clearcut impact. Landslides occurring on lower portions or slopes, along roads and near stream have a limited slope length and therefore smaller volumes. Alternatively, the mechanism of failure may vary due to the variation in land use areas and forested lands. Increased landslide frequency along roads can also be partially attributed to the formation of cut slopes and fill practices. Often the fill or cut slope is the material that fails and results in a small volume.

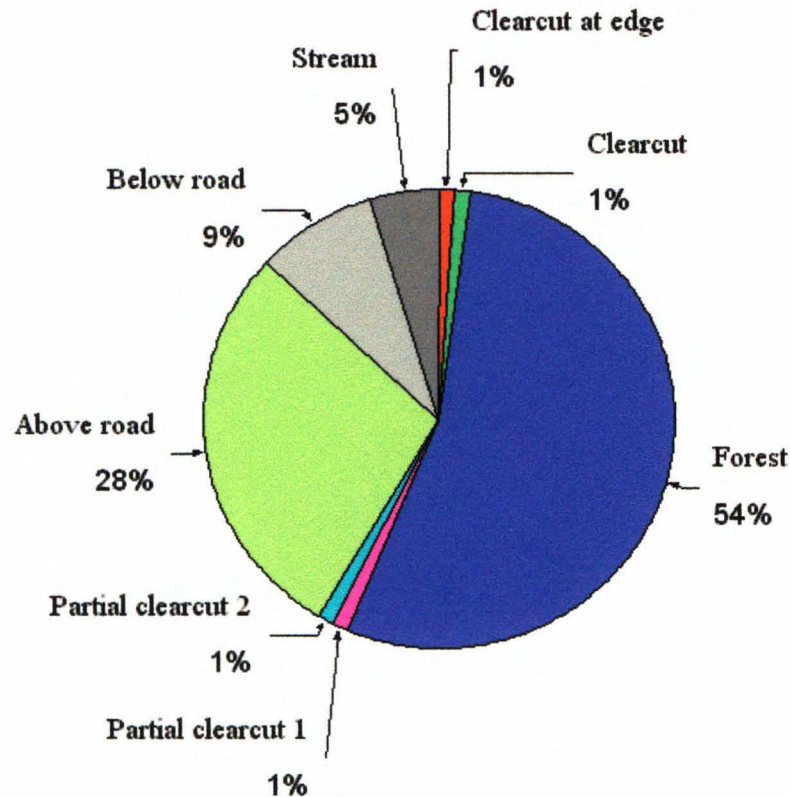
Figure 20: Pie diagram showing percent total landslide volume per land use group.

The total volume of the 32 landslides selected for this study is 15,175 cubic feet. Figure 20 shows the relationship between landslide volume and land use group. This diagram shows that 41% of the total landslide volume was derived from clearcut, partial clearcuts, and road construction. Forested areas produced 54% of the landslides in the study area. Areas where clearcut or partial clearcuts were the only impact have 2% of the total, and 5% of the total landslide volume was ascribed to streams.

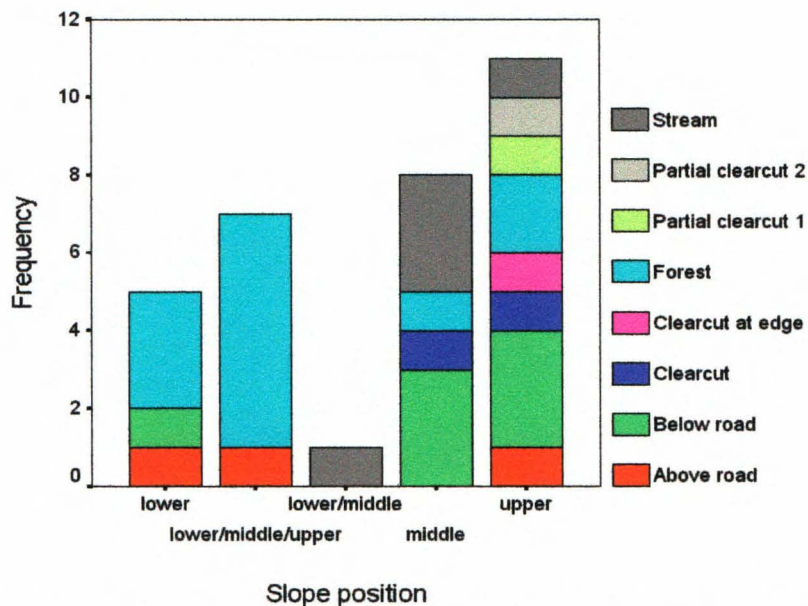
Figure 24: Landslide frequency distributions of slope positions, segregated into land use groups.

The majority of landslide features in the study area originate on the upper third of the slopes (Figure 24). Land use sites show a strong preference for the middle and upper slopes. Nearly 22% of the landslides in the study area involved the entire slope from ridge top to valley bottom. These generally occurred in forested areas that were not effected by land use.

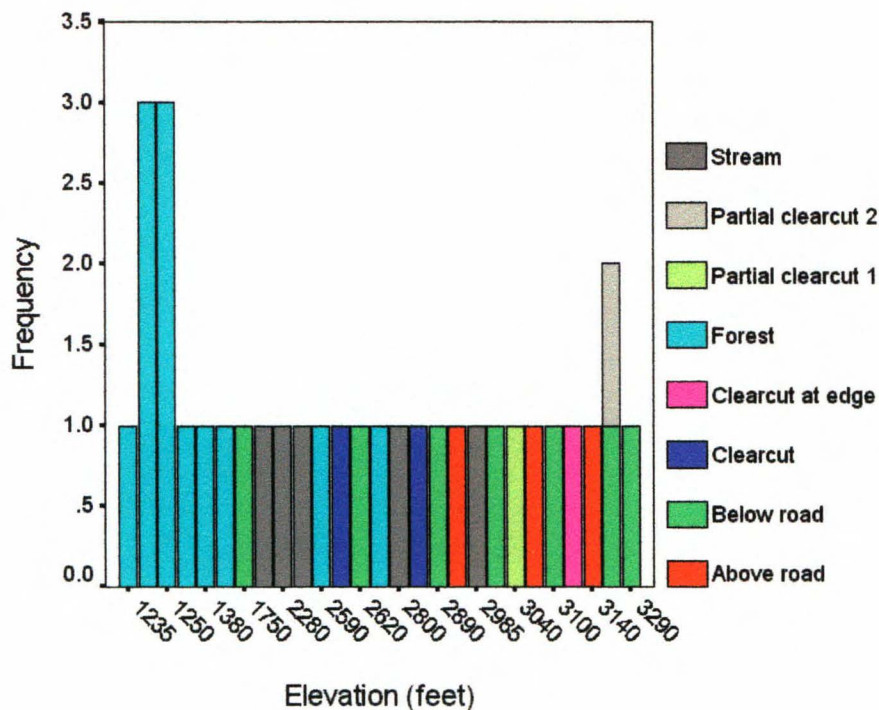
Figure 26: Landslide frequency distribution of elevation segregated into land use groups.

Nearly all the landslides occurring in forested areas or influenced by streams are located lower than 2,400 feet. Areas impacted by roads and/or clearcuts are found at the higher elevations and account for less volume than those of the lower elevations (Figure 26).

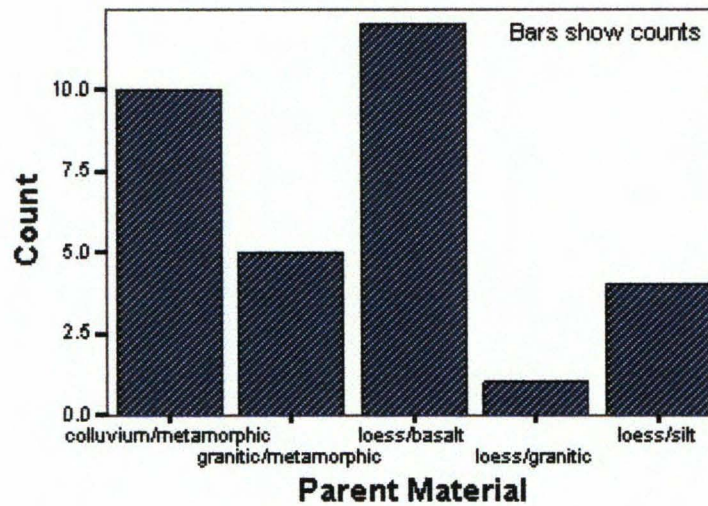
Figure 27: Frequency of landslide activity for each parent material type.

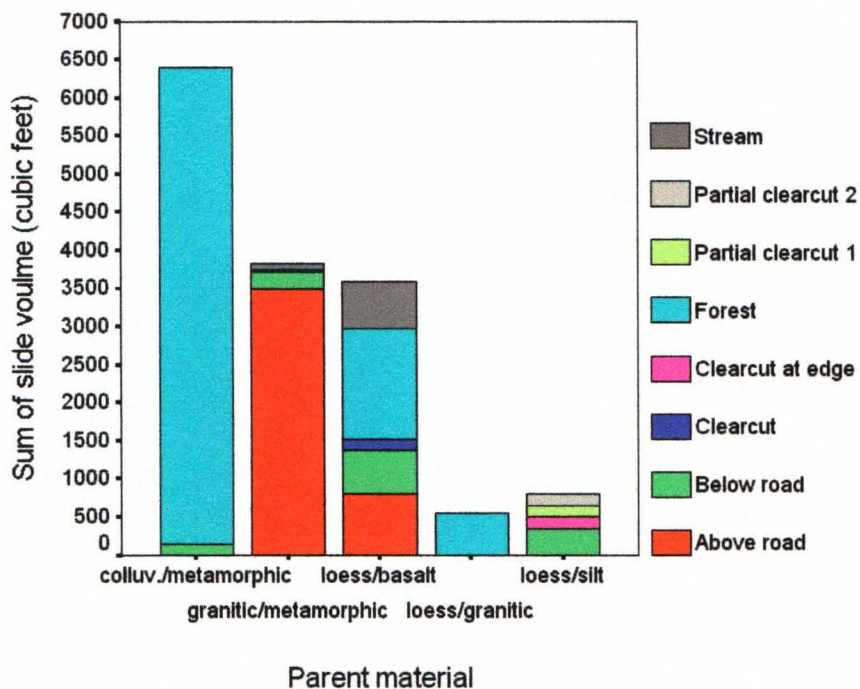
Figure 28: Landslide volume distributions of parent material segregated into land use groups.

slope stability during saturated ground conditions. The greatest volume of material is associated with colluvium/metamorphic parent material type.

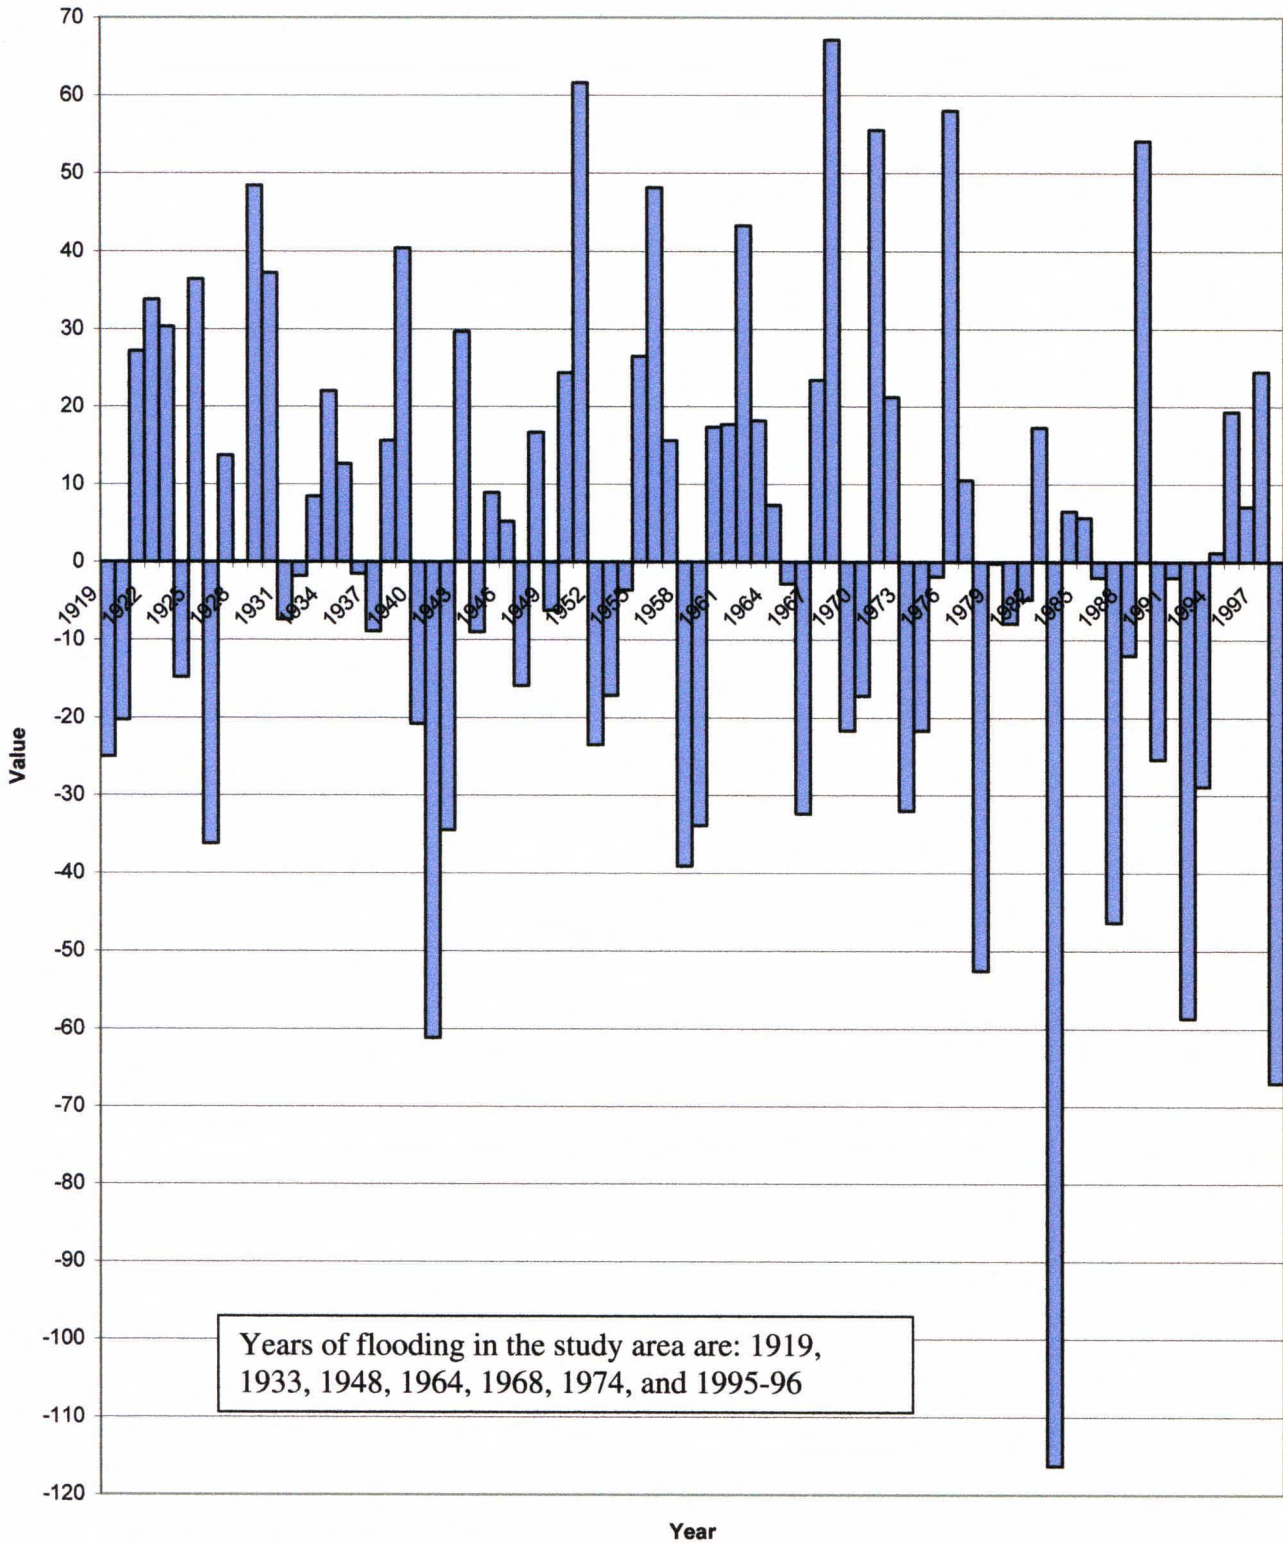
Southern Oscillation Values from 1919 to 1998 for months November thru February

Figure 29: Graph showing values of Southern Oscillation from 1919 to 1998
