Reconnaissance of Landslides and Debris Flows Associated with the July 2022 Flooding in Eastern Kentucky

Report of Investigations 13, Series XIII, 2023

Abstract

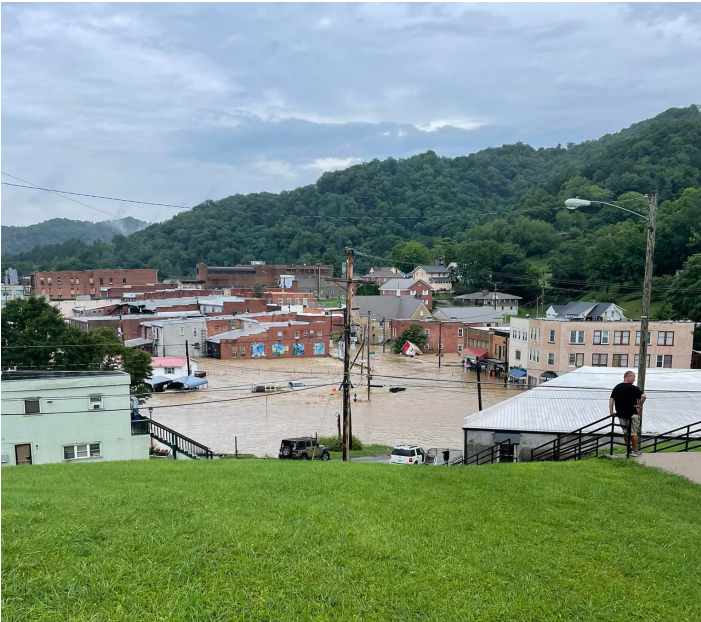
Figure 2. "Severe flash flooding caused extensive damage in downtown Whitesburg, KY." (NOAA National Weather Service, 2022).

The July flood event damaged miles of roads, bridges, culverts, and water treatment and communications infrastructure (Figs. 2-3). Approximately 100 bridges require full replacement and thousands of others (including private crossings) require inspection or were deemed impassable (Kentucky Transportation Cabinet, 2022). As of early September, 225, 253 tons of debris in more than 5,000 truckload have been removed from state and county roads (Commonwealth of Kentucky, “Governor Beshear Provides Team Kentucky Update”, 2022). A total of 1,334

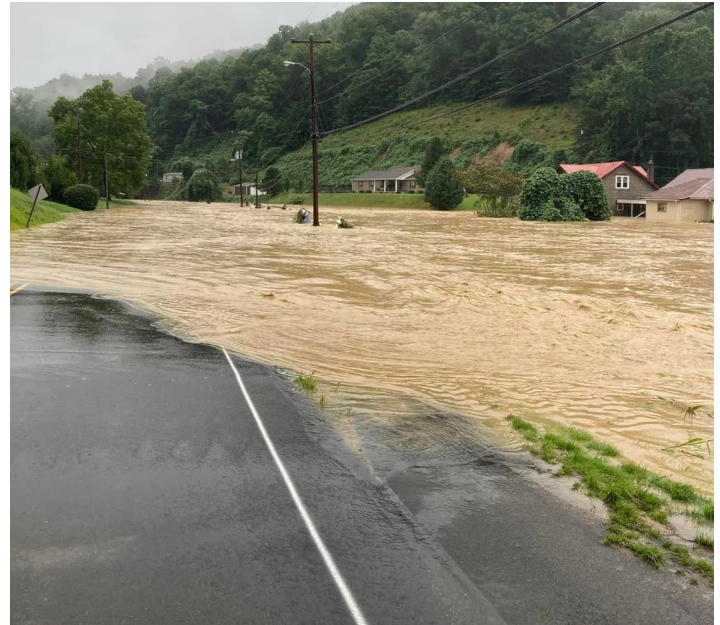
Figure 3. "Flood waters over roads and surrounding houses in Hindman, KY." (NOAA National Weather Service, 2022).

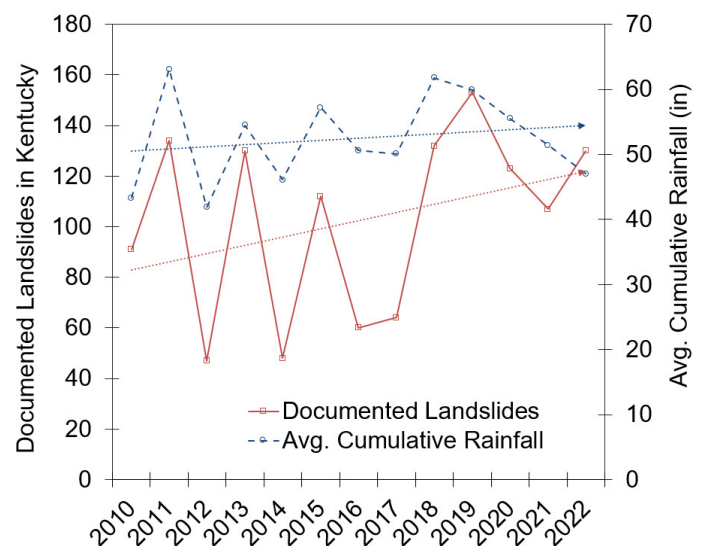
Figure 7. Annual documented landslides and annual statewide average rainfall in Kentucky. Landslides triggered by the July event are not included in this plot.

Most landslides in Kentucky are rainfall-triggered, meaning that an increase in pore-water pressure (a force) occurs as rain infiltrates the soil and underlying rock. This force overcomes the strength of the soil and rock material, causing landslides. This relationship is demonstrated by the strong correlation between the number of landslides in Kentucky and the statewide average rainfall over the past 10 years (Fig. 7).

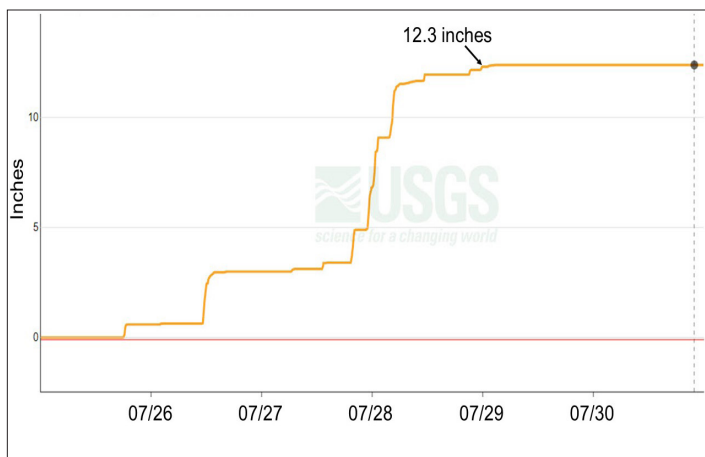
Figure 10. Total precipitation at Buckhorn Lake from July 26 through July 30. Plot modified from U.S. Geological Survey stream gage monitoring location 03280800 at Buckhorn Lake, Perry County.

A site in Buckhorn Lake in Perry County measured 8.0 inches of rain in a 24-hour period. The four-day total from July 26 to July 30 at Buckhorn was 12.3 inches, which is a record (Fig 10). A site near Carr Creek Lake in Knott County reported 6.71 inches in the 24-hour period ending 7 AM on July 29, after receiving 6.5 inches in the previous 24-hour

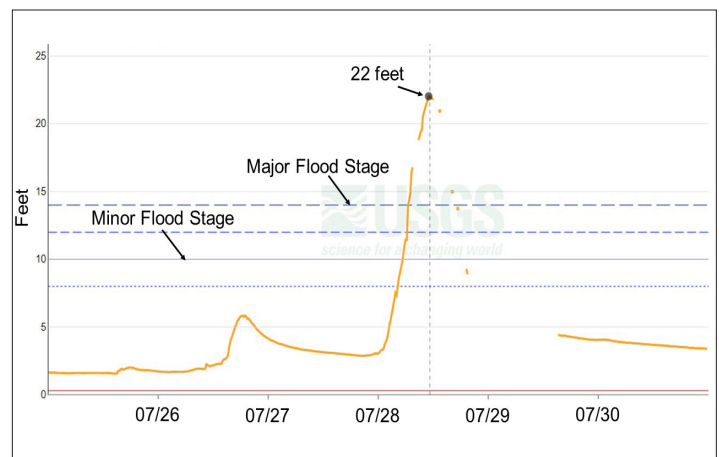
Figure 11. Water elevation gain from July 26 to July 30 at the North Fork of the Kentucky River near Whitesburg. Plot modified from U.S. Geological Survey monitoring location 03277300.

The Kentucky River near Jackson, Ky. experienced a rise of about 25 feet in 24 hours, giving way to a river crest of 43.47 feet, breaking an old record 43.1 feet. Preliminary field evidence of observed debris in trees along roads suggests floodwater heights of 40 to 50 feet above normal stream levels, particularly in the heaviest rainfall areas. The North Fork Kentucky River at Whitesburg, Ky. rose about 18 feet within 10 hours (Fig. 11), breaking a flood stage record by about six feet and recording about 11 feet above flood stage (Weather Underground, 2022).

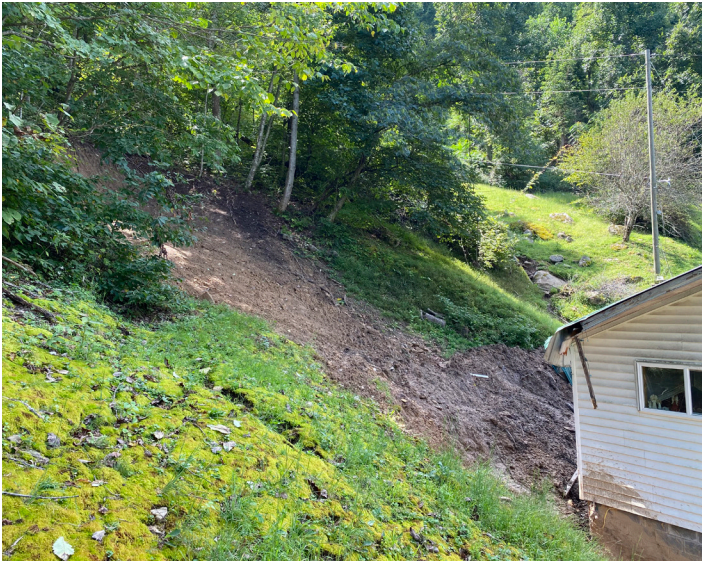
Figure 18. Photo of a translational landslide behind home, triggered by the July storms.

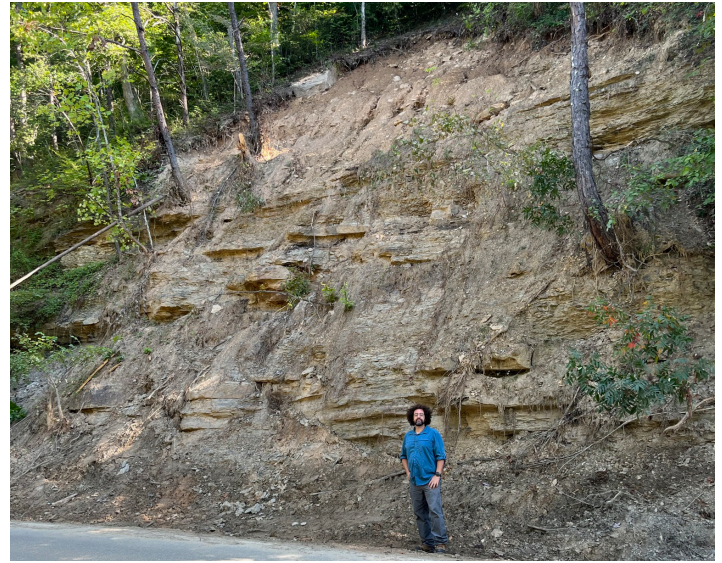
Figure 20. Photo of translational landslide along KY 2446 in Perry County, triggered by the July storms.

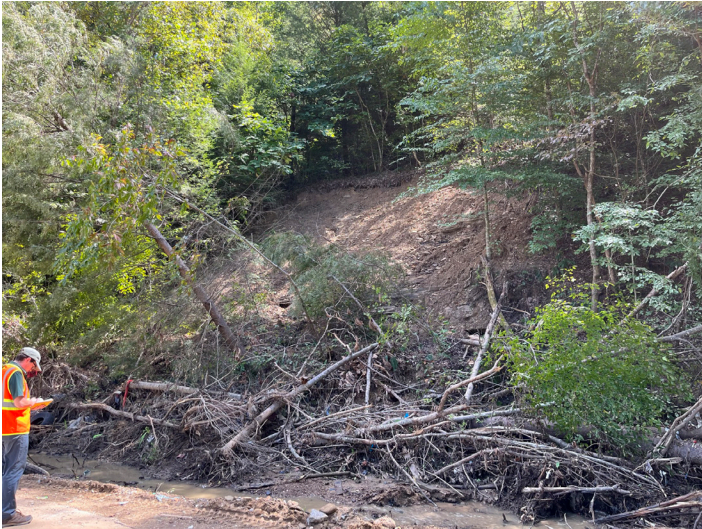
Figure 19. Photo of translational landslide along Hardshell Caney Road in Breathitt County, triggered by the July storms.

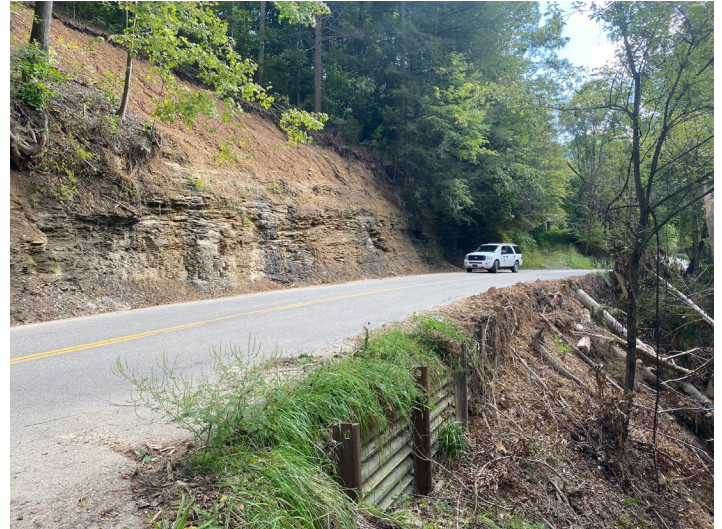
Figure 21. Photo of translational landslide along KY 28 in Perry County, triggered by the July storms

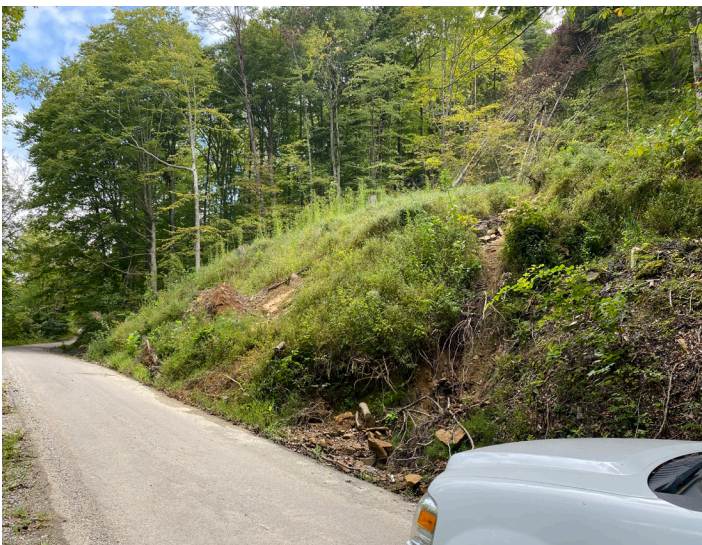
Figure 22. Slump observed off KY 28 in Perry County. Note tilted trees in the upper part of the slide.

Rotational slides, also called slumps, are distinguished by a curved surface of rupture (Fig. 5). The initial headscarp displacement is commonly vertically downward, but much of the displaced soil, rock, or trees further downslope can be tilted backward (upslope toward headscarp) creating a hummocky surface and thick deposit at the toe of the slide. Rotational slide velocity ranges from slow (less than 1 foot every 5 years) to moderately fast (5 feet per month) (Cruden and Varnes, 1996; Hungr and others, 2014). Figures 22 - 23 show two slumps observed during field reconnaissance.

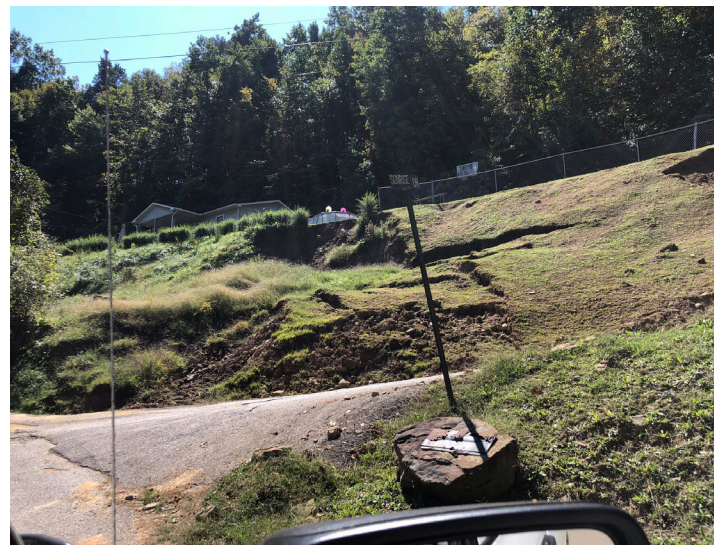
Figure 23. Slump observed off 451 in Perry County. Note the thick soil and bulging toe along the road.

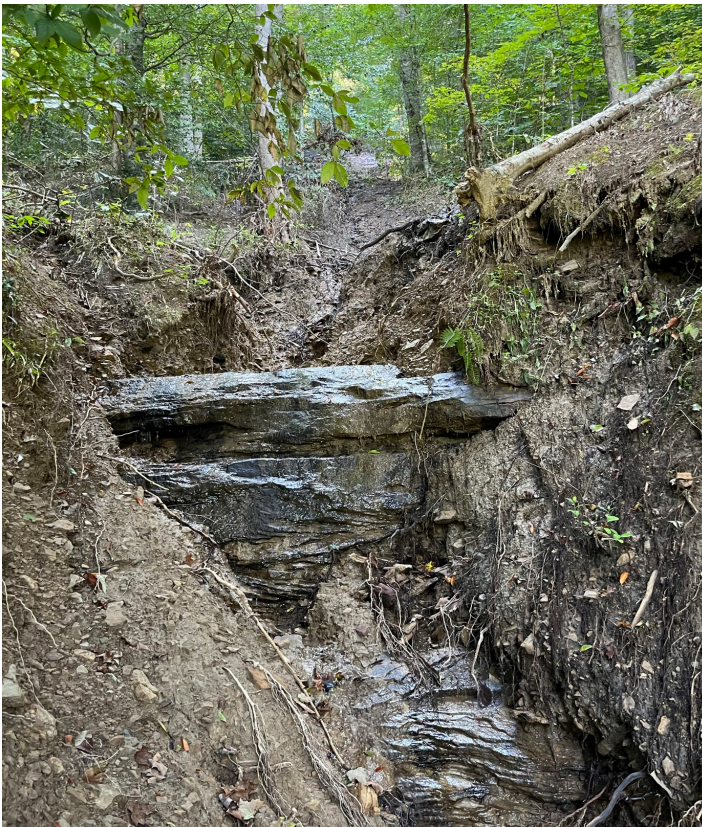
Figure 24. Narrow debris flow channel along KY 2446 in Perry County.

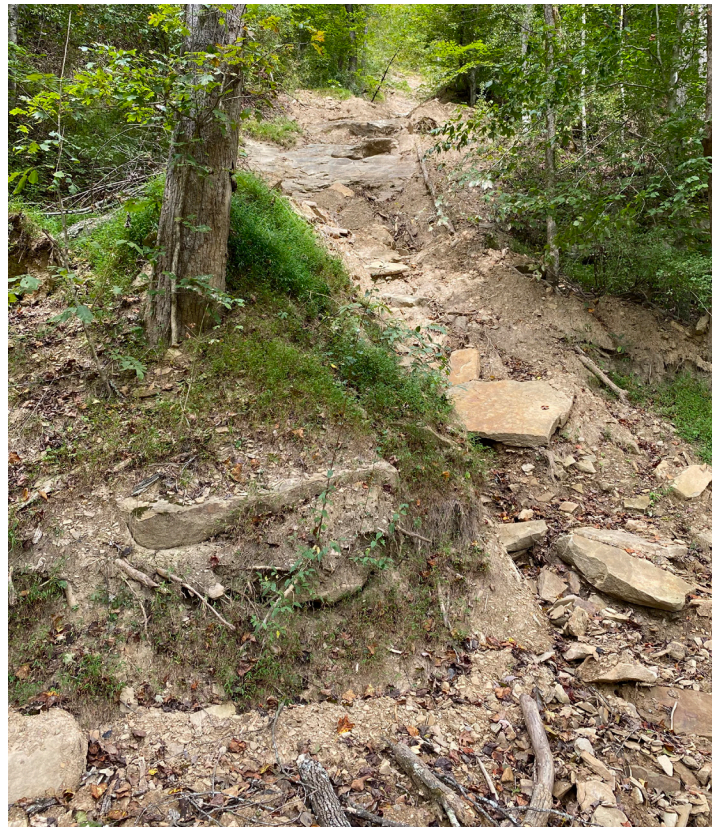
Figure 25. Narrow debris flow channel and fan deposit toward the mouth of channel along Middle Fork River Road in Perry County.

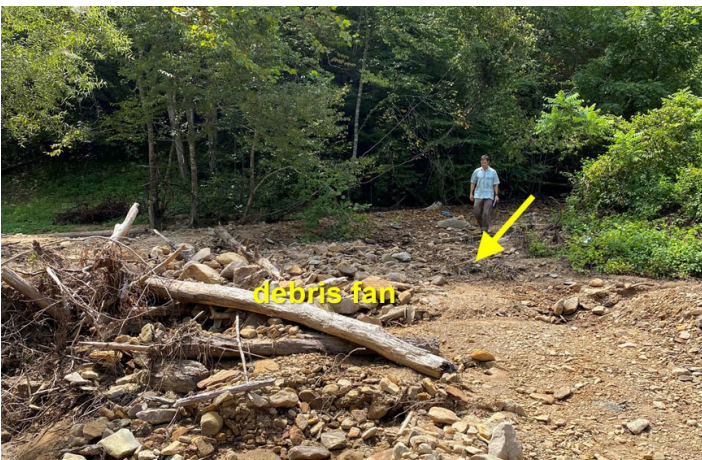
Figure 26. Debris fan along Middle Fork River Road in Breathitt County. These deposits initiate upslope and are not overbank flood deposits.

Flows are a type of landslide that commonly include debris flows, earth flows, and creep (Fig. 5). Debris flows are a widespread, rapid, and often dangerous occurrence in mountainous terrain. They are distinct from other landslides by the fact that they often occur in established channels, drainages, or ravines that have collected soil and rock over time. Debris flows are rapid movements with a velocity of up to 5 m/s and extents ranging from a few hundred meters to several kilometers (Hunger and others, 2014). Often, existing translational slides or slumps can be subsequently reactivated, morphing into more mobile flow-type movements. Many debris flow channels were left entirely scoured out, free of soil and rock debris (Figs. 24-25). We observed many debris fans associated with initiation in upslope catchments or channels (Figs. 26-29).

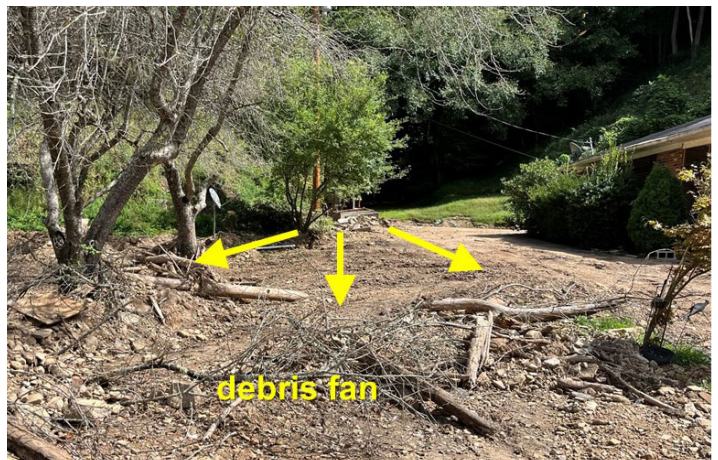
Figure 27. Debris fan along KY 3392 in Knott County. These deposits initiate upslope and are not overbank flood deposits.

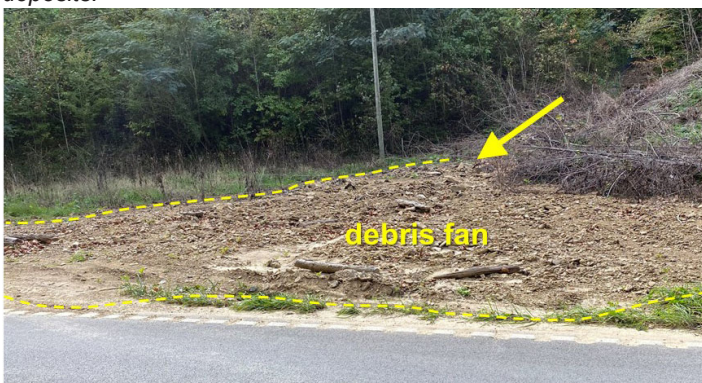
Figure 28. Debris fan along KY 28 in Breathitt County. These deposits initiate upslope and are not overbank flood deposits. Note the lobe shape to the fan. .

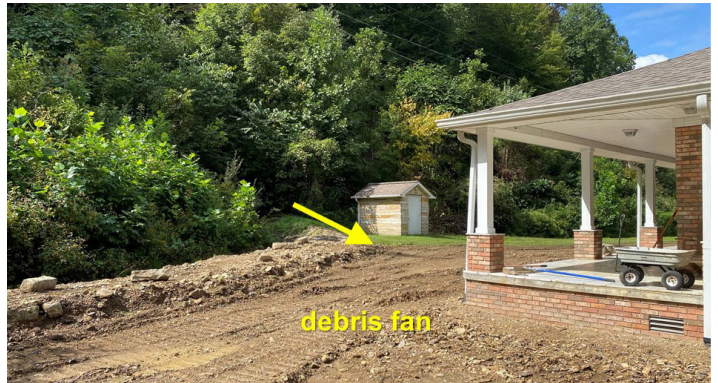
Figure 29. Debris fan that inundated a home along KY 28 in Perry County. These deposits initiate upslope and are not overbank flood deposits.

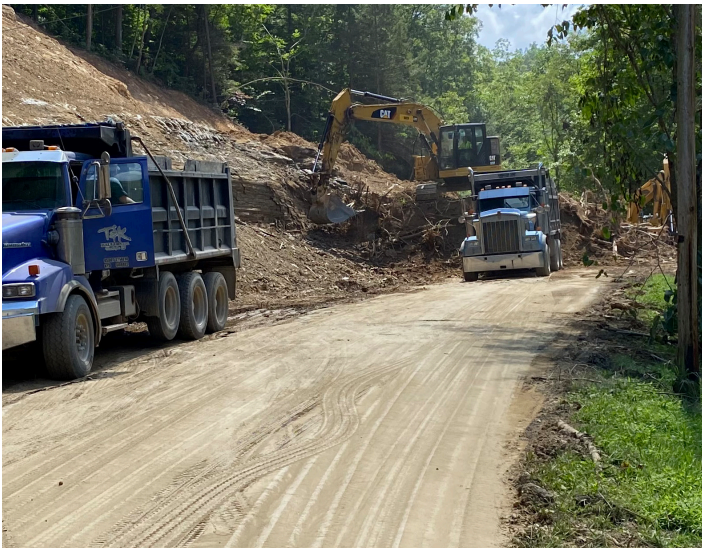
Figure 30. Trucks hauling away landslide debris along KY 267 in Perry County. The road was closed for several weeks.

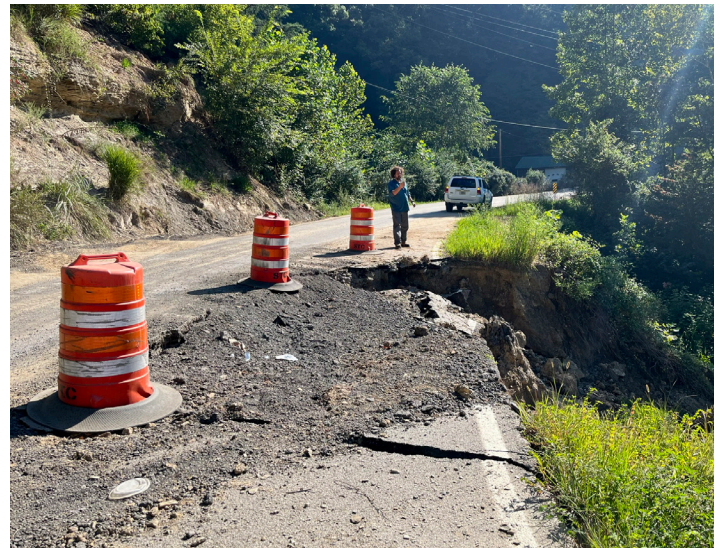
Figure 31. Landslide-damaged road along KY 2446 in Perry County.

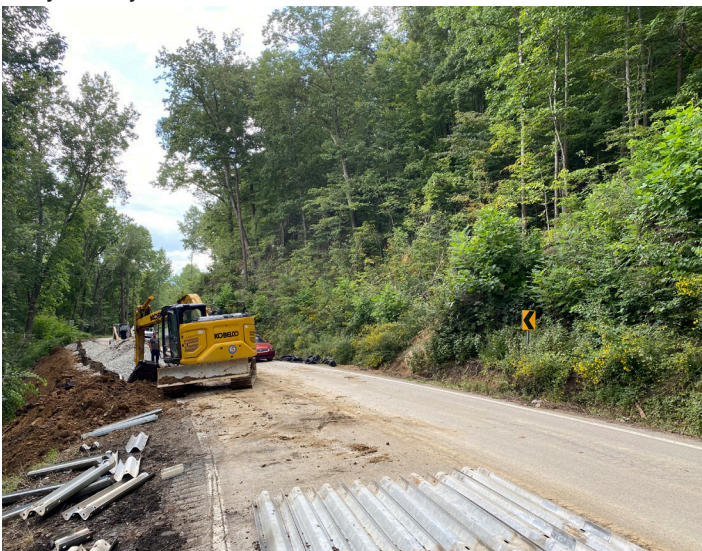
Figure 32. Road stabilization work after a landslide damaged KY 28 in Perry County.

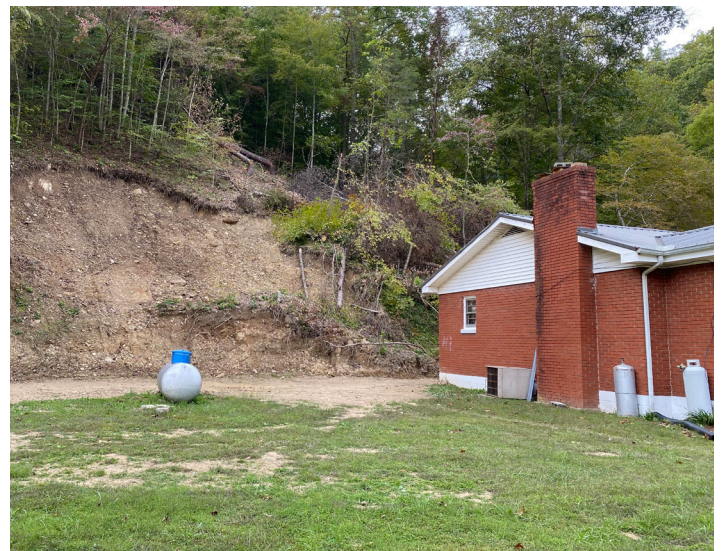
Figure 33. Translational landslide behind home near KY 28 in Breathitt County.

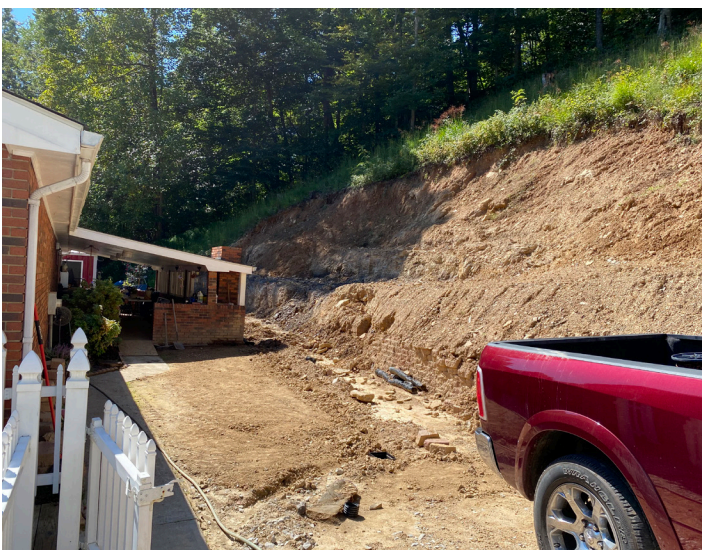
Figure 34. Translational landslide behind home near KY 451 in Perry County.

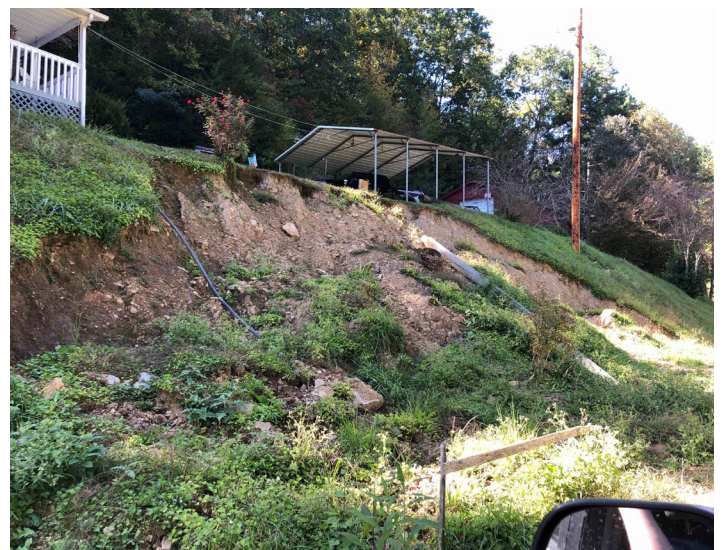
Figure 35. Landslide-damaged property in front of home off KY 484 in Perry County.

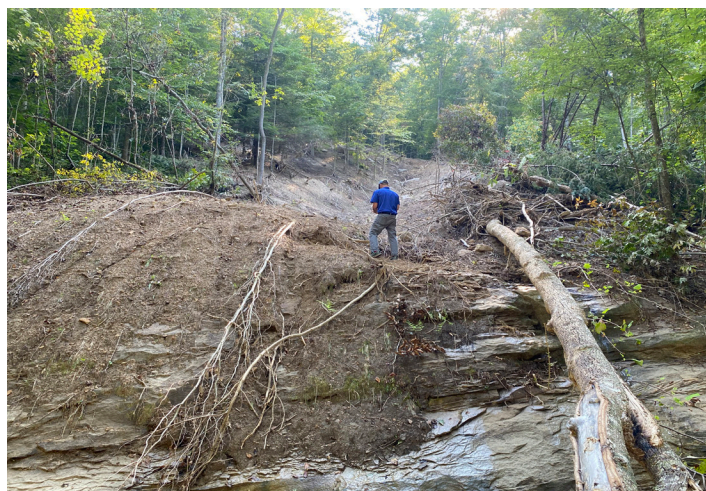
Figure 40. Field-checked debris flow from Figure 39 identified in HazMapper. The debris flow is approximately 700 feet long near Little Leatherwood Road in Breathitt County.

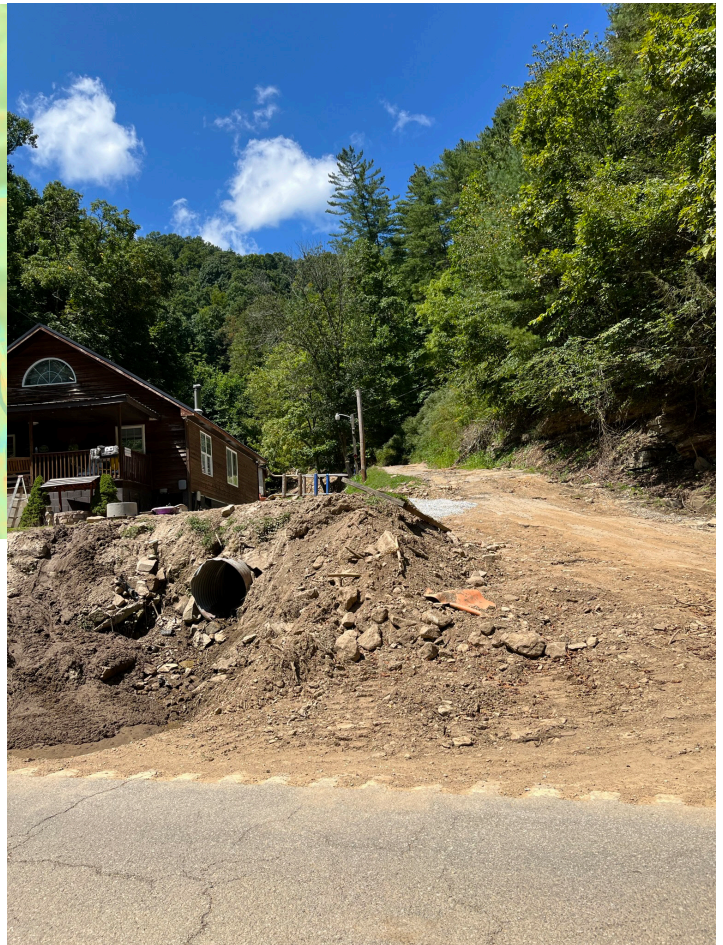
Figure 42. Field-checked debris flow from Figure 41 identified in HazMapper. The debris fan at the mouth of the catchment (marked by the star on the rdNDVI map) threatened the home and was deposited along KY 550 in Knott County.

Here we show two examples of debris flows identified using HazMapper. Figure 36 shows the program interface, rdNDVI classification, and the event parameters window. The red arrow points to a thin, elongated area of pixels classified as a lost in vegetation. To establish that this feature may be a debris flow, we checked the pre-and post-event Sentinel images (Figs. 37-38). In the post event image, the elongated area of vegetation loss appears as tan-colored pixels and is free of cloud or other atmospheric artifacts. We interpreted the vegetation loss to be a debris flow and then field checked the interpretation, verifying a debris flow track approximately 700 feet long (Figs. 39-40). A second example shows a long, thin, curving area of vegetation loss along a narrow channel approximately 1,300 feet long. Similarly, we noticed pixels in the post-event Sentinel data that appeared to be free of vegetation, and we interpreted the feature to be a debris flow. Field checking the area confirmed this interpretation as we observed a large debris fan deposit at the mouth of the catchment (Figs. 41-42).
