# Characteristics, multi-functionality, and water quality of reservoirs in North-East Ghana

## FIELD SURVEY REPORT

Mary Amponsah (Consultant)

December 2022

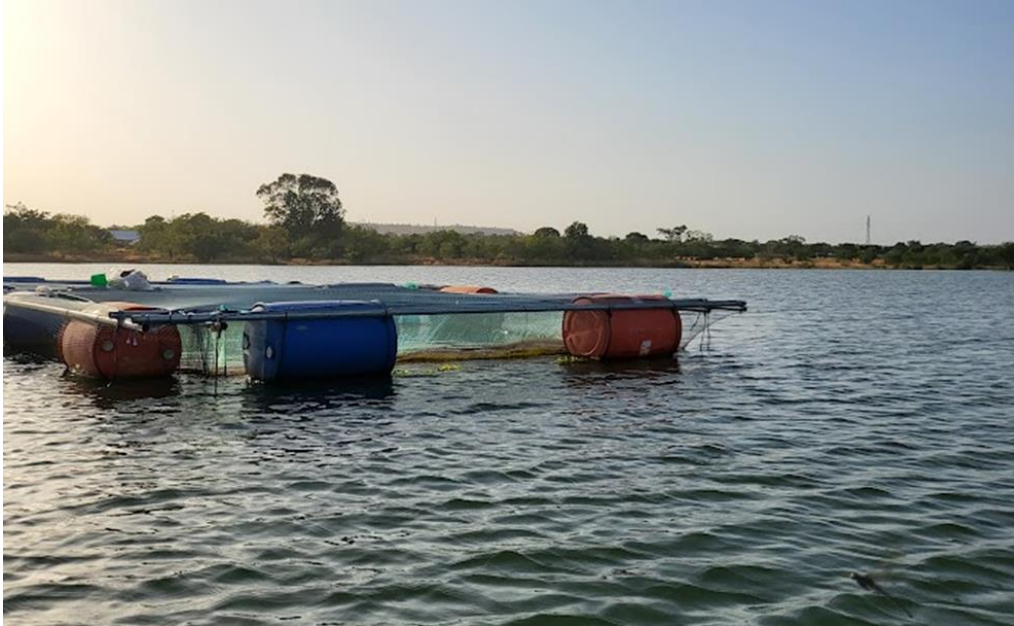
The reservoir serves the following purposes to the community; aquaculture practices, construction purposes, domestic uses, source of water for drinking, fishing, irrigation, and brick making. Approximately, 50 to 300 users access the reservoir per day. There is active fish cage farming in the reservoir. From time to time, fishermen within the community and neighboring communities are given authorization by the chief or overlord to fish in the reservoir. Some of the fishes harvested include Tilapia, Catfish, Citharinus, Synodontis, Mormyrus, Bricinus nurse, Small Clupeids, Mormyridae, and Tilapia Zilli. Per the survey, the level of security is high and safe for fish farming.

**Figure 3. Fish cage farming in the Nalerigu reservoir.**

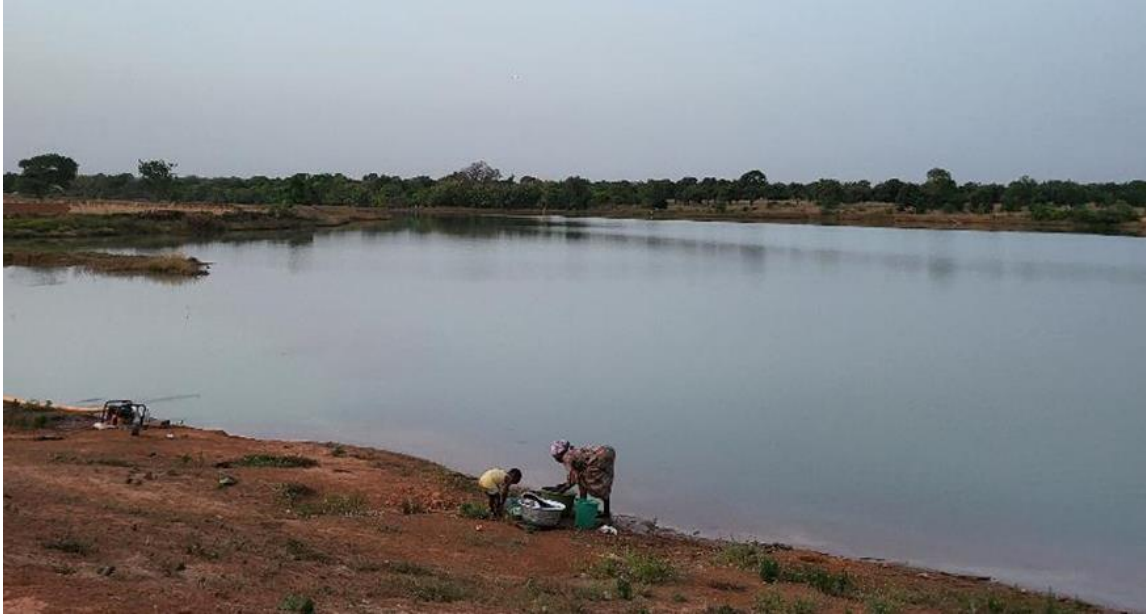
Washing in the dams with detergent is a common practice in the community. Some mentioned natives leaving worn-out clothes around the dam after washing. There are farms close to the dam that use the water for irrigation. The presence of upstream water, agriculture activities, and construction activities close to the dam causes the dam to be silted. Surface runoffs from rainfall are the major cause of sedimentation. Domestic waste, defecation, disposal of rubbish, fertilizer containers, and washing products close to the dam are some of the sanitation challenges faced. The water is said to be turbid during rainy seasons from surface runoff and the construction of bricks and blocks along the dam.

**Figure 6. Washing activities and irrigation using a water pump at the Langbensi dam.**

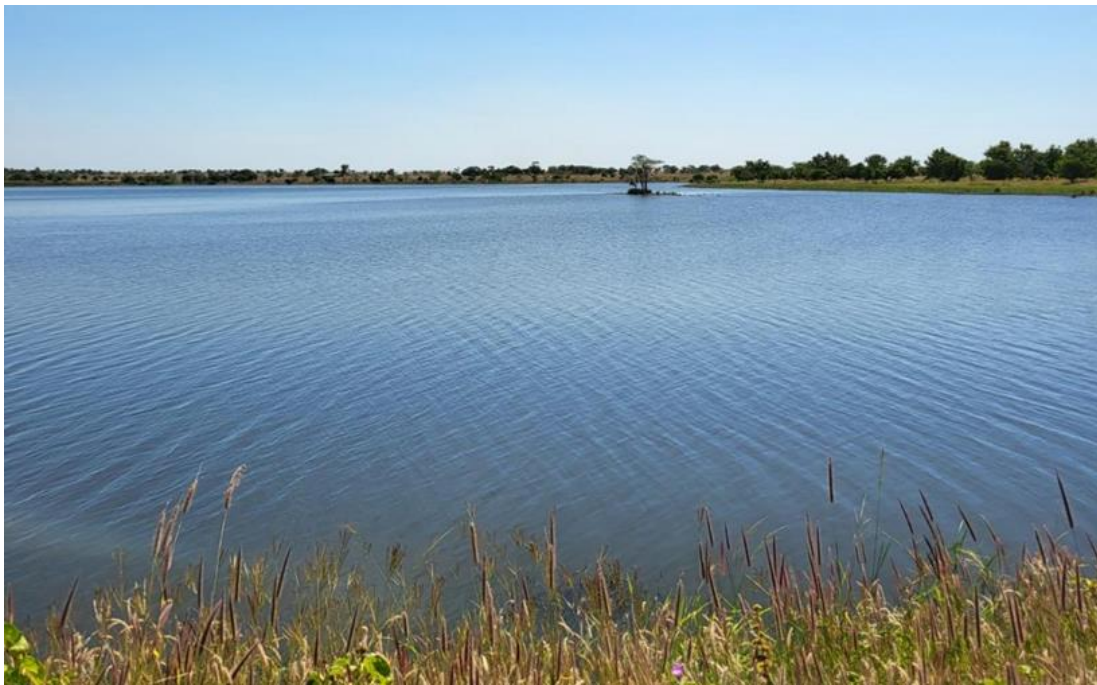
Since the water serves as a source of drinking water for the communities, measures are put in place to ensure that the dam and its surroundings are kept as clean as possible. There are no sanitation challenges and washing especially the use of detergents is prohibited. Upstream water sources, agriculture practices, and domestic uses affect siltation, and runoff from surfaces during heavy rainfall causes sedimentation.

**Figure 8. A picture of the Nansoni dam.**

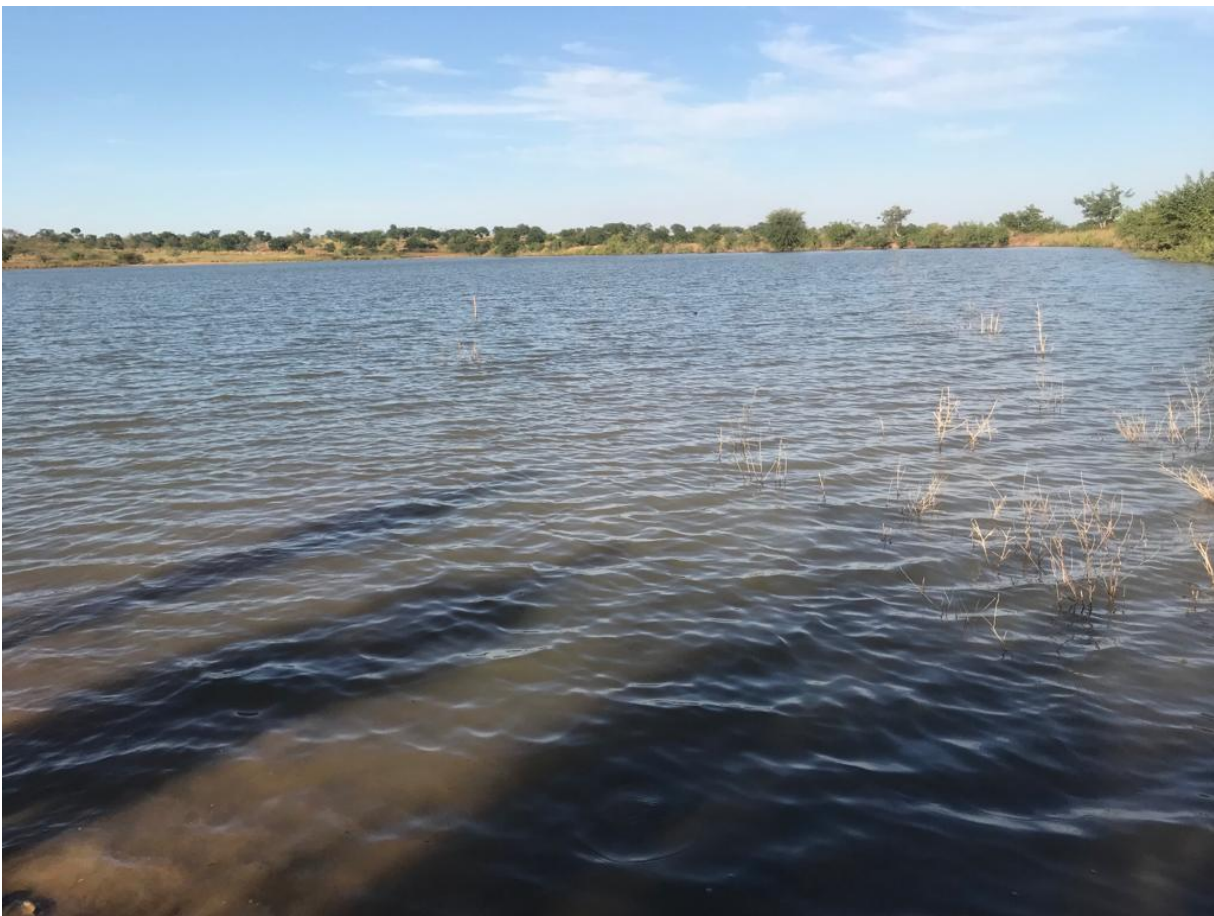
There are no sanitation challenges or reports and the community does not wash clothes in the dam. Some activities that cause the dam to be silted are water from upstream sources, agriculture and domestic activities, and animal water watering. Sedimentation results from surface runoff during heavy rainfalls.

**Figure 10. A picture of the Tombu dam.**

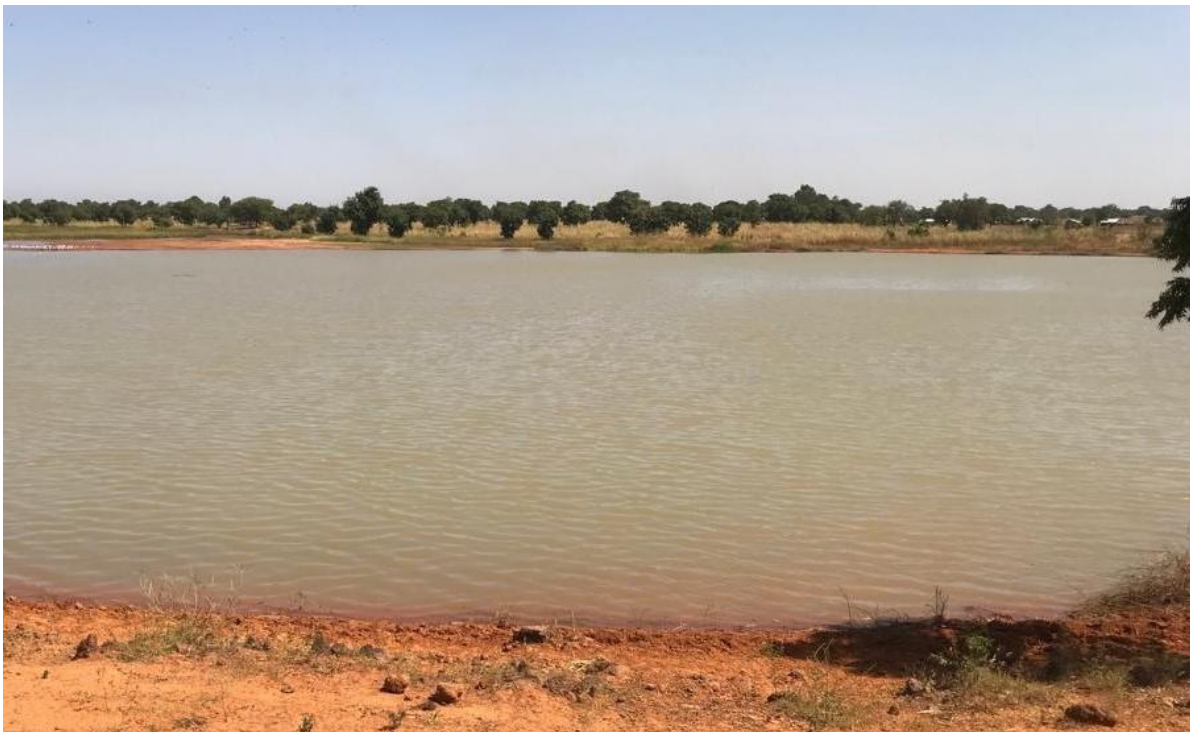
Water quality challenges faced are the turbidity of the water from sediments and contamination of the water from animal excreta left after animals are watered. Sediments from surface runoff from heavy rainfall and soil residues from the brick construction cause sedimentation. Siltation is mainly caused by upstream water sources, brick construction, and domestic, and agricultural activities. The community of prohibited from washing close to the dam.

**Figure 12. A picture of the Diani dam**

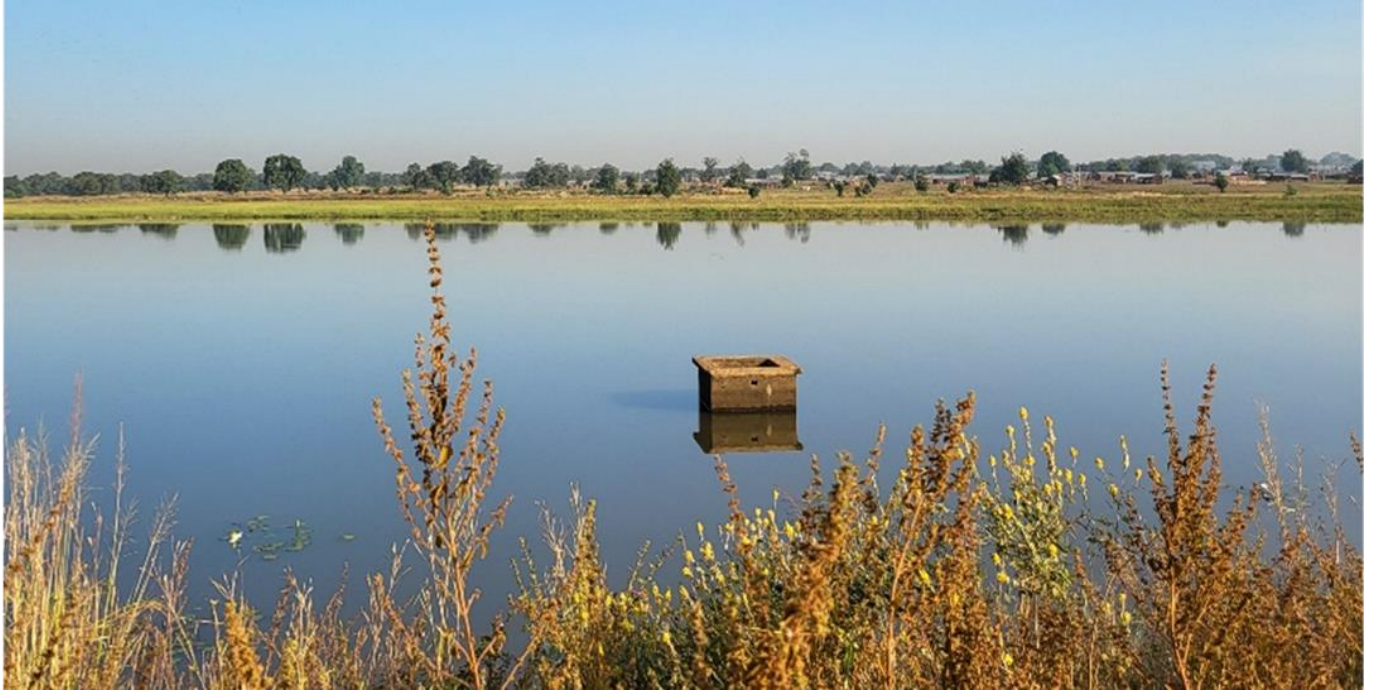
In the meeting with the chief and his elders, the team was informed of the unsuitability of the dam to be used for fish farming as the outlet of the dam is broken and the heavy siltation of the dam. Five respondents, three males, and two females were interviewed in this community.

Aside from the turbidity of the water as a result of surface runoff from heavy rainfall, there are no sanitation or water quality challenges. The surface runoff from the rains also causes the dam to be sediment. Activities such as farming activities such as vegetable and rice farming around the dam, upstream water flow, domestic uses, and surface runoff lead to the siltation of the dam. The community is prohibited from washing in the dam.

**Figure 14. A picture of the Nayorko dam**

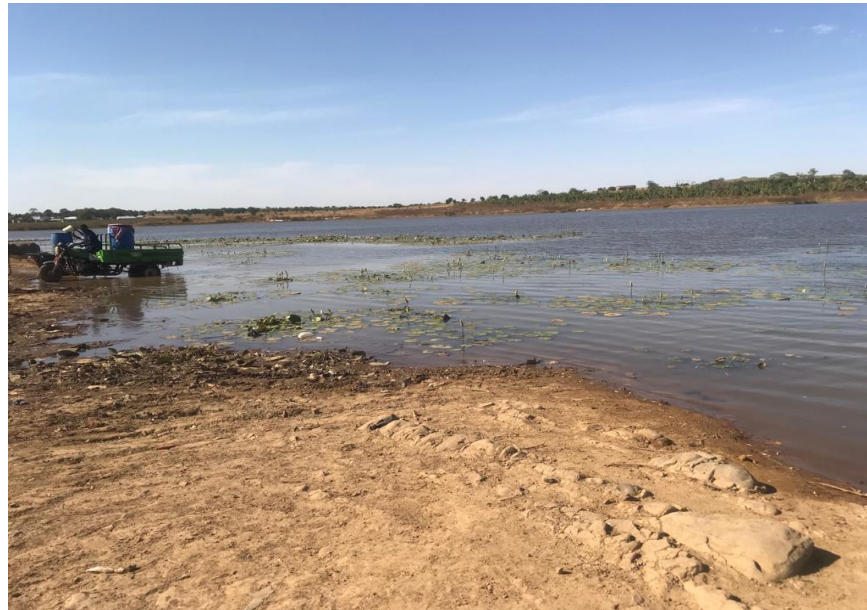
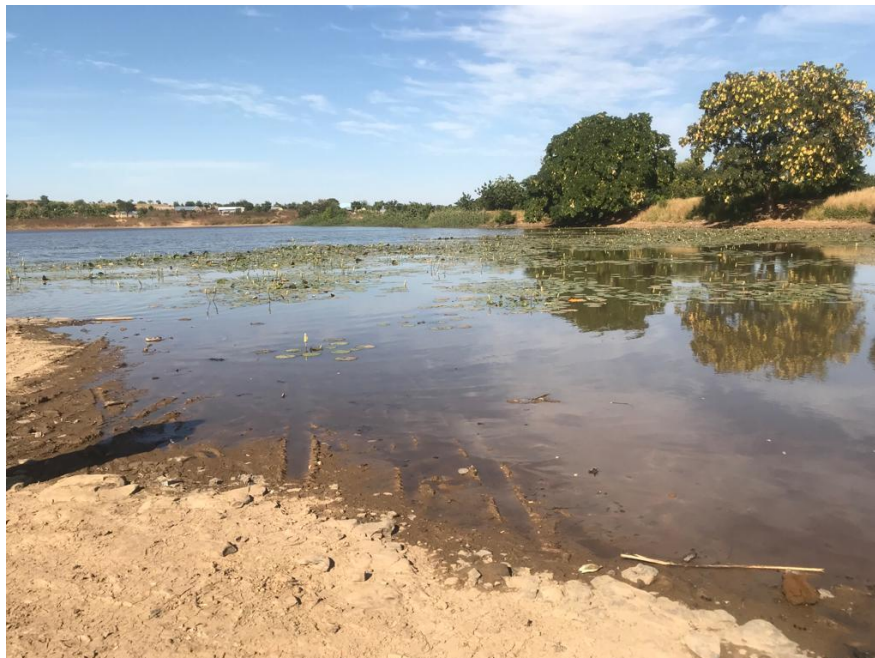
The Chereponi dam is located in Chereponi in the Chereponi district of the North East region. The officer in charge of the dam advised that the dam will not be suitable for fish farming due to the insecurity issues in the community. He added that the dam was not kept clean, and also the dependency ratio on the dam was too high as it was the major source of water for the community. An aquaculture initiative was not advisable.

**Figure 15. Pictures of the Chereponi dam**
