Citation: Muigai, Magdaline N., Mwema, Fredrick M., Akinlabi, Esther, Jen, Tien-Chien, Fatoba, Olawale S., Leso, Tshenolo P., Obiko, Japheth O. and Mphasha, Percy (2022) TIG Welding Methods of Repairing Steel Components with Stainless Steel Coatings. *Tribology in Industry*, 44 (3). pp. 434-448. ISSN 0354-8996

TIG Welding Methods of Repairing Steel Components with Stainless Steel Coatings

Structural steel components tend to wear when exposed to corrosive and cyclic loading environments. These components can be repaired by welding on failure. This study studied the weld parameters and weld quality (porosity, depth of penetration, and coating thickness), hardness, corrosion, and wear resistance during repair welding. Mild steel samples were weld coated by varying alternating (AC) and direct (DC) currents: 40 A, 50 A, 55 A, 60 A, 65 A, and 70 A. The base material used was AISI 1045 steel, and Castolin 6825 was used as the welding electrode. The results showed that three wear mechanisms were dominant: abrasion, adhesion, and delamination. The porosity in the coated samples increased with increasing currents for both AC and DC. The welding current and current type influenced the coati

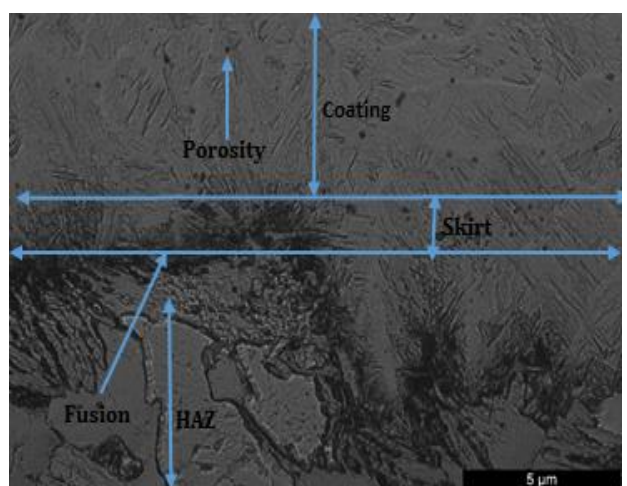
Fig. 5. Porosity in the sample coated at 60 A DC. The optical microscopic image was taken along the coating-substrate cross-section.

Figures 4 and 5 show the samples coated at direct currents of 55 A and 60 A, respectively. The visibility of porosity at 55 A was lesser than that at 50 A. At 55 A, Penetration depth was higher (2.592 mm) than at 50 A (2.328 mm). Hence, causing a lower porosity formation. Therefore, at 55 A, most of the melt pool had penetrated the substrate, and little was left on the surface to trap gases (oxygen) and create porosity. At 60 A, the visibility of pores was observed compared to 55 A. An increase in temperature heated the weld pool, which absorbed gas particles into the molten weld pool. Once the pool solidified, porosity was formed.

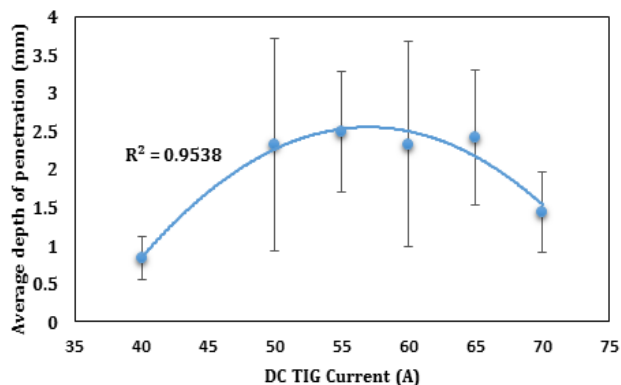
Fig. 14. An illustration of the relationship between the depth of penetration and TIG direct current.

The results showed that 65 A direct current had the highest penetration depth, as shown in Figure 14. The relationship between DOP and welding current exhibited a hook-like shape. A quadratic polynomial with a regression coefficient of 0.9538 was used to fit this trend. As the current increased from 40 A to 55 A, the depth of penetration increased. The observation is attributed to increased amperage, which increased DOP as more melt pool was heated (more heat melts more melt pool) and penetrated the substrate. However, from 65 A to 70 A, too much current caused the welder to move too quickly. As such, there was lower metal deposition on the surface. At 40 A and 70 A, the DOP values were closer than at 50 A, 55 A, 60 A, and 65 A (as indicated by the

error bars in Figure 14). Closer DOP values indicated an almost uniform penetration of the melt pool into the substrate. Unequal penetration indicated the presence of unequal weld beads/coatings thickness.

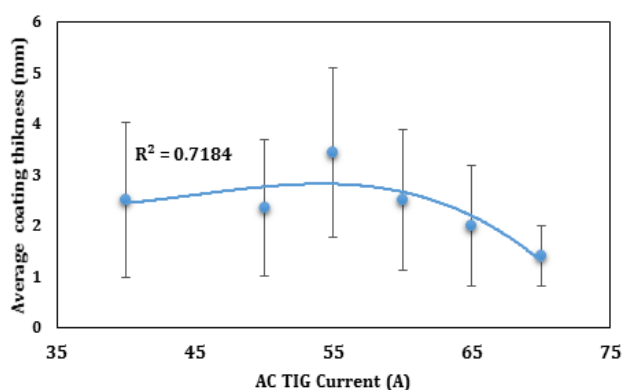
Fig. 17. A graph of average coating thickness versus alternating current.

As shown in Figure 17, 55 A had the highest coating thickness. Generally, the coating thickness decreased with the increasing current (except for 55 A, which did not follow the trend). As the welding current increased, an increase in heat input melted the melt pool, which penetrated the substrate. A little melt pool was left on the surface to form coatings. The error bars in Figure 17 indicate that the deviations of the coating thickness

at each current were massive. The non-uniformity in the trend (the curve shown in Figure 17 is not perfect) was caused by the variation of the alternating current voltage, which resulted in variable heat inputs—the coating thicknesses formed at each current varied from the average thickness. Generally, the samples coated using direct current had higher coating thickness than alternating current coated samples. The observation is attributed to the steady and fast heating effect provided by the direct current, which led to more melt pool deposited on the surface.

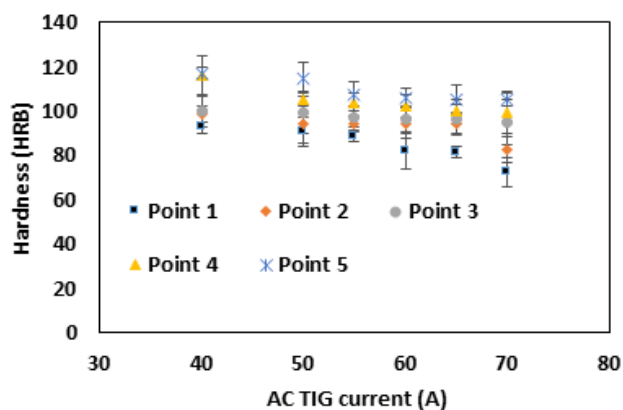
Fig. 19. A graphical representation of the relationship between hardness measured at various points on the samples coated using AC.

The hardness of the coated samples is shown in Figures 18, 19, 20, and 21. Figure 18 shows that 40 A direct current had the highest hardness values. For direct current, the hardness values ranged from 69.08 HRB to 121.92 HRB. Figure 19 shows that the sample coated at 40 A (alternating current) exhibited the highest hardness values. The hardness values for alternating current-coated samples varied from 72.5 HRB to 117.2 HRB.

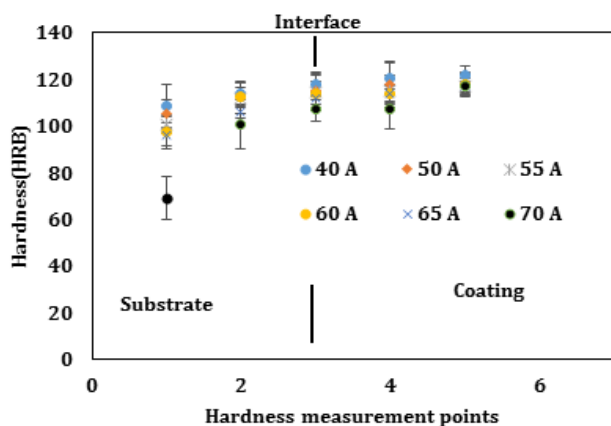
Fig. 21. A graphical representation of the relationship between hardness measured at each welding current at various points on the coated samples for DC.

The hardness increased from the substrate to the coating's surface for alternating and direct currents, as shown in Figures 20 and 21. The coating surface showed higher hardness than at the interface (point 3) and the centre of coated samples (point 4). The behaviour may be due to the rapid solidification of the surface caused by exposure to the atmosphere. As such, there was the formation of fine-grained structures and chemical homogeneity, and according to existing literature, fine-grained structures are known to exhibit improved hardness [21].

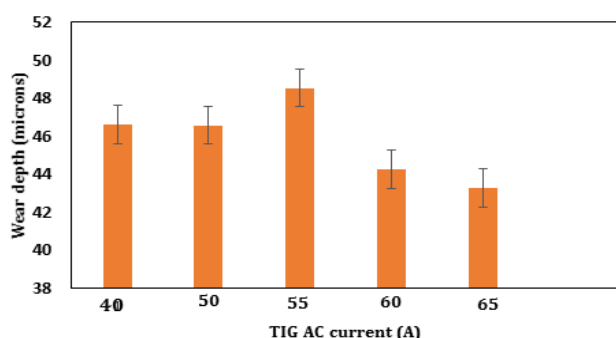
Fig. 28. Illustration of the variation of the depth of wear and welding current for AC.

The wear depth was plotted against the welding current, as shown in Figures 27 and 28. As shown, there was no linear relationship between the wear depth and the welding current used. The highest wear depth was observed at 55 A AC and 65 DC. These samples had lower coating thicknesses. As such, they experienced the most wear as the coating thickness was not thick enough to protect them from wearing out. The sample coated at 55 A alternating current experienced a greater wear (with a depth of wear above 48 microns) than at 65 A direct current (depth of wear is below 46.5 microns). The difference can be due to 55 A (alternating current) having a coating thickness of 0.719 mm, whereas, at 65 A (direct current), the coating thickness was 1.755 mm. The larger coating thickness resulted in better wear resistance properties. Also, hardness values were slightly higher at 65 A (direct current) than at 55 A (alternating current). Therefore, the higher hardness increased the wear resistance of the sample.
